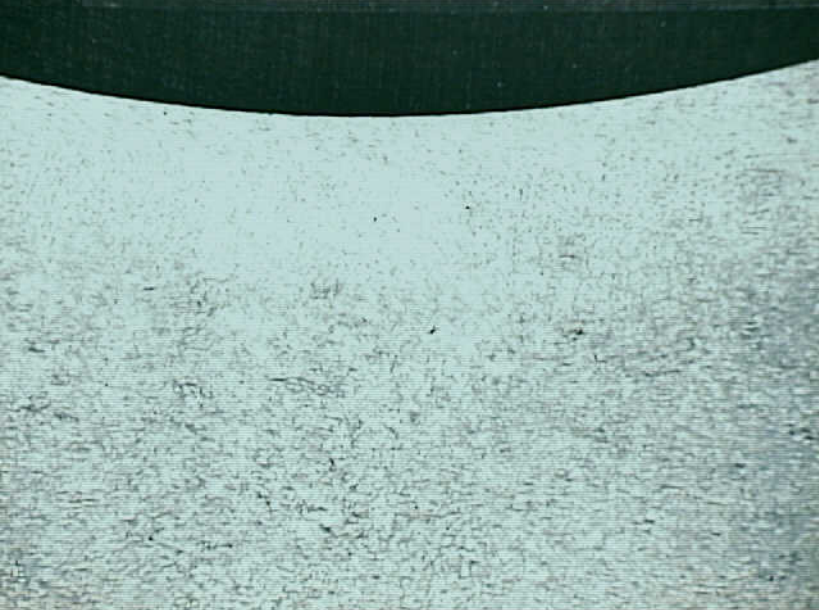
Photo 28. Microstructure of hole #52 showing deformed and overheated material. Mag. 32X.
