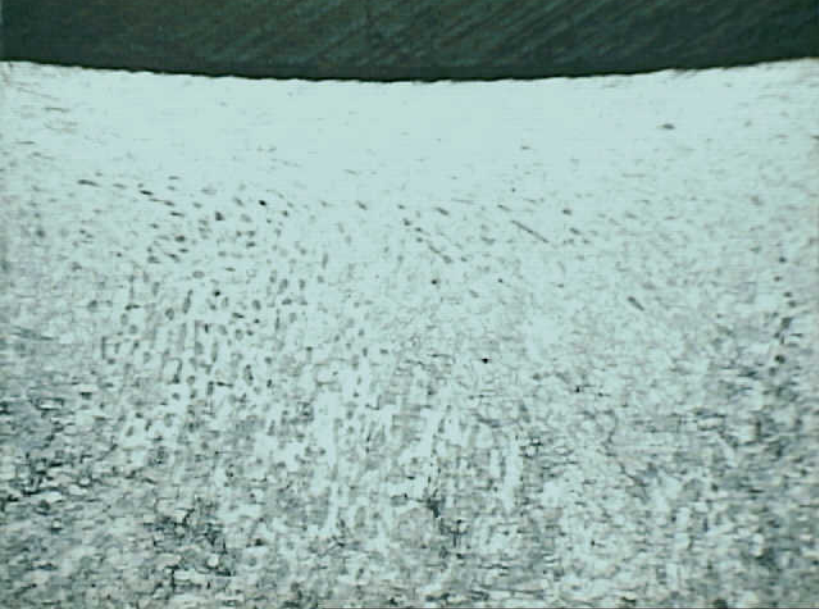
Photo 29. A close up of photo 28. Microstructure of hole #52 showing deformed and overheated material to a depth of 0.6 - 0.7 mm (0.024-0.028 inch). Mag 64X.
