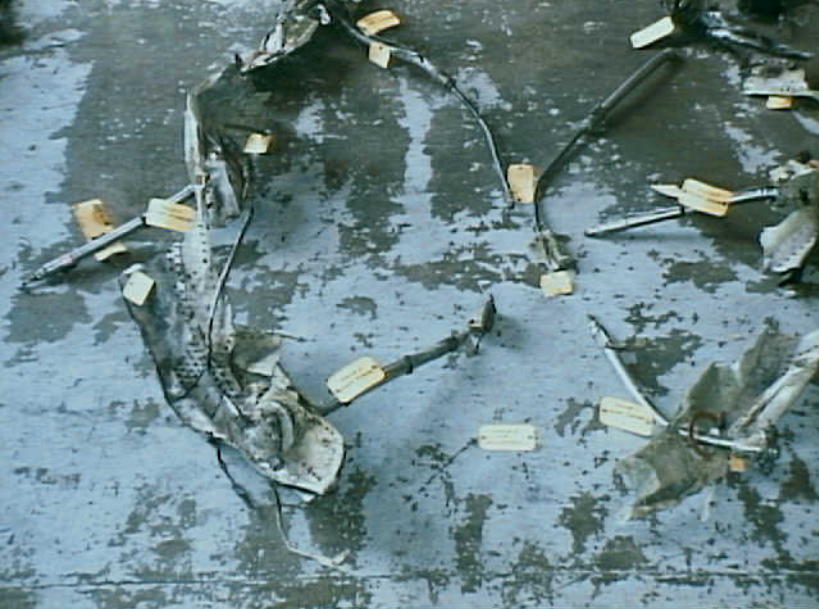
Photo 29. No. 2 engine reverser hydraulic actuators and TB/FW fragments
