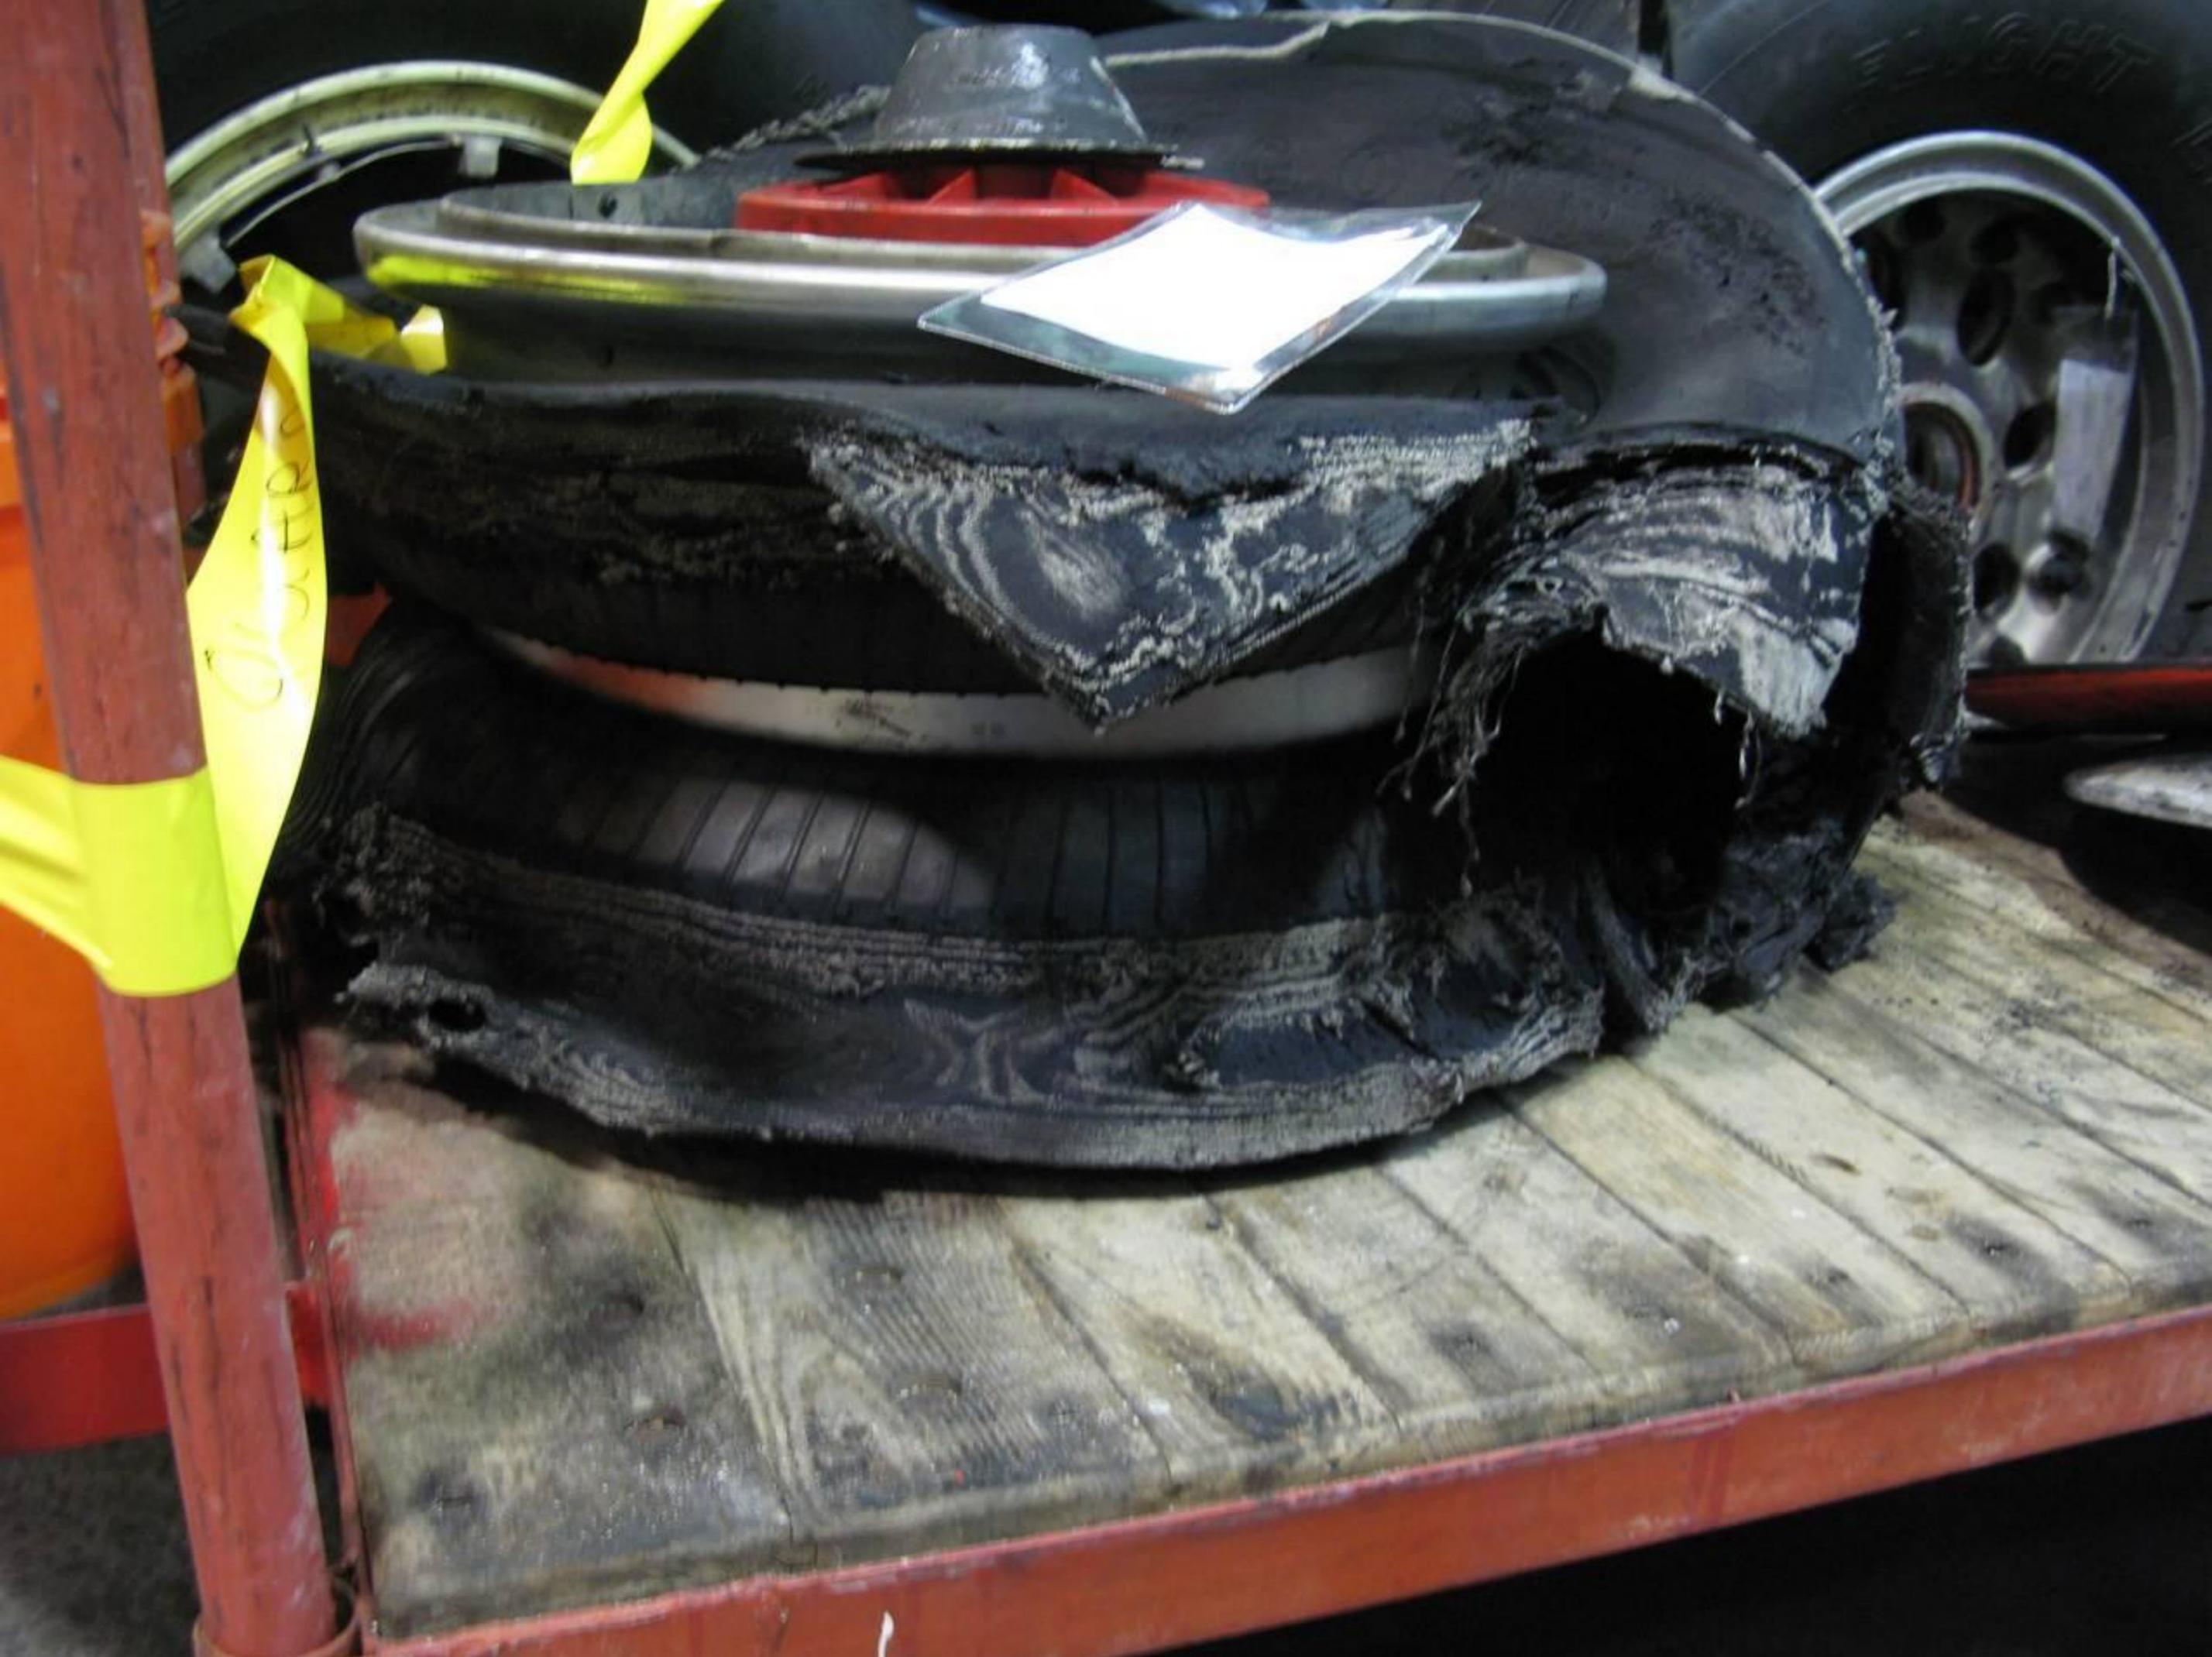
Photo 3 - Showing Damage to Right Inboard Tire
