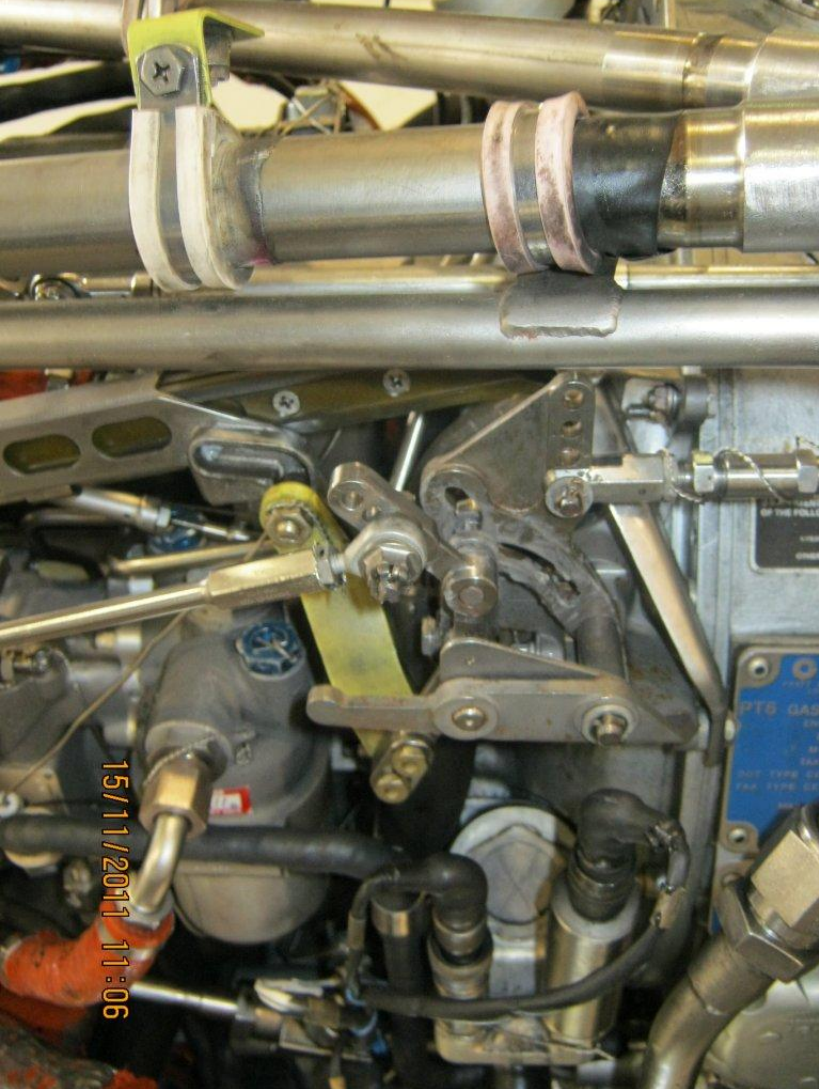
Photo 3 - View of Left Engine Reversing Linkage (Maintenance Personnel)
