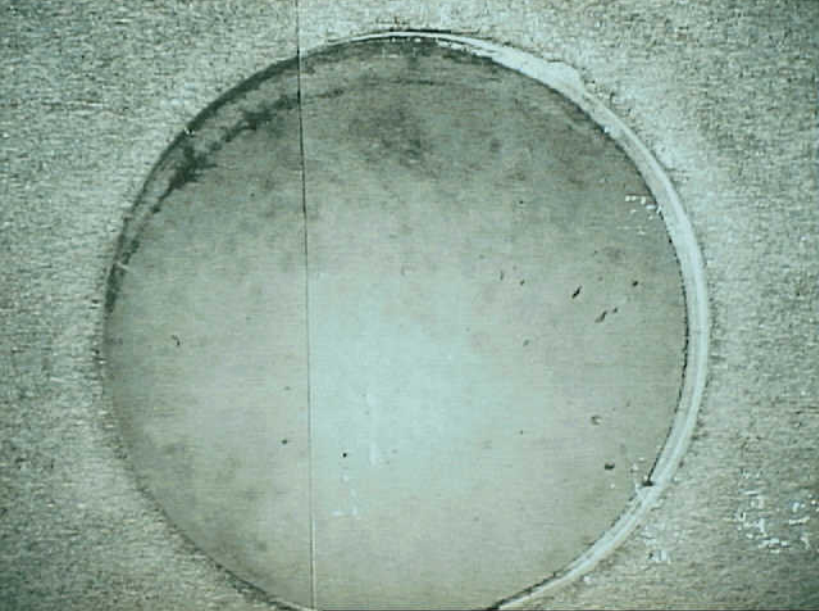
Photo 3. Cross section of hole #2B quite close to the location of the drill breakdown. Mag. 7-8X.
