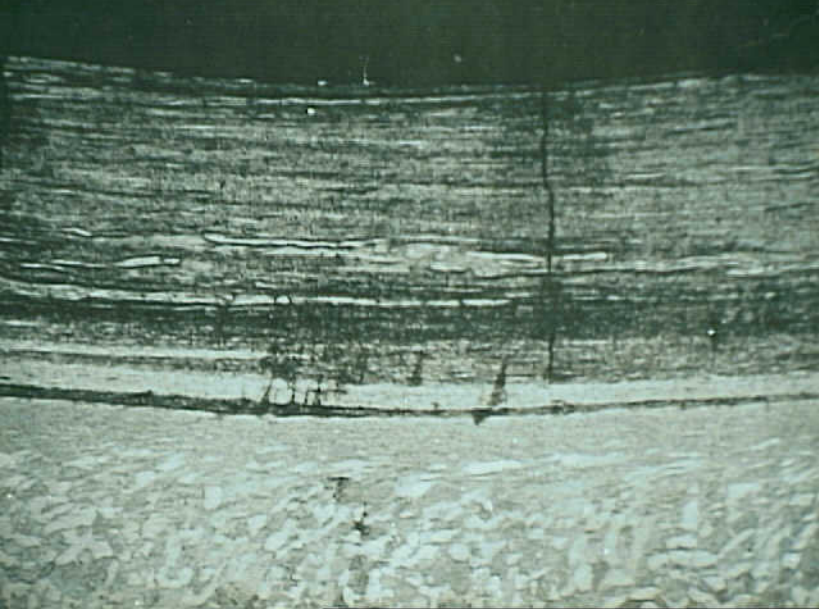
Photo 4. Cross section of hole #2B quite close to the location of the drill breakdown showing a surface layer with cracks and a appearance similar to the failed
