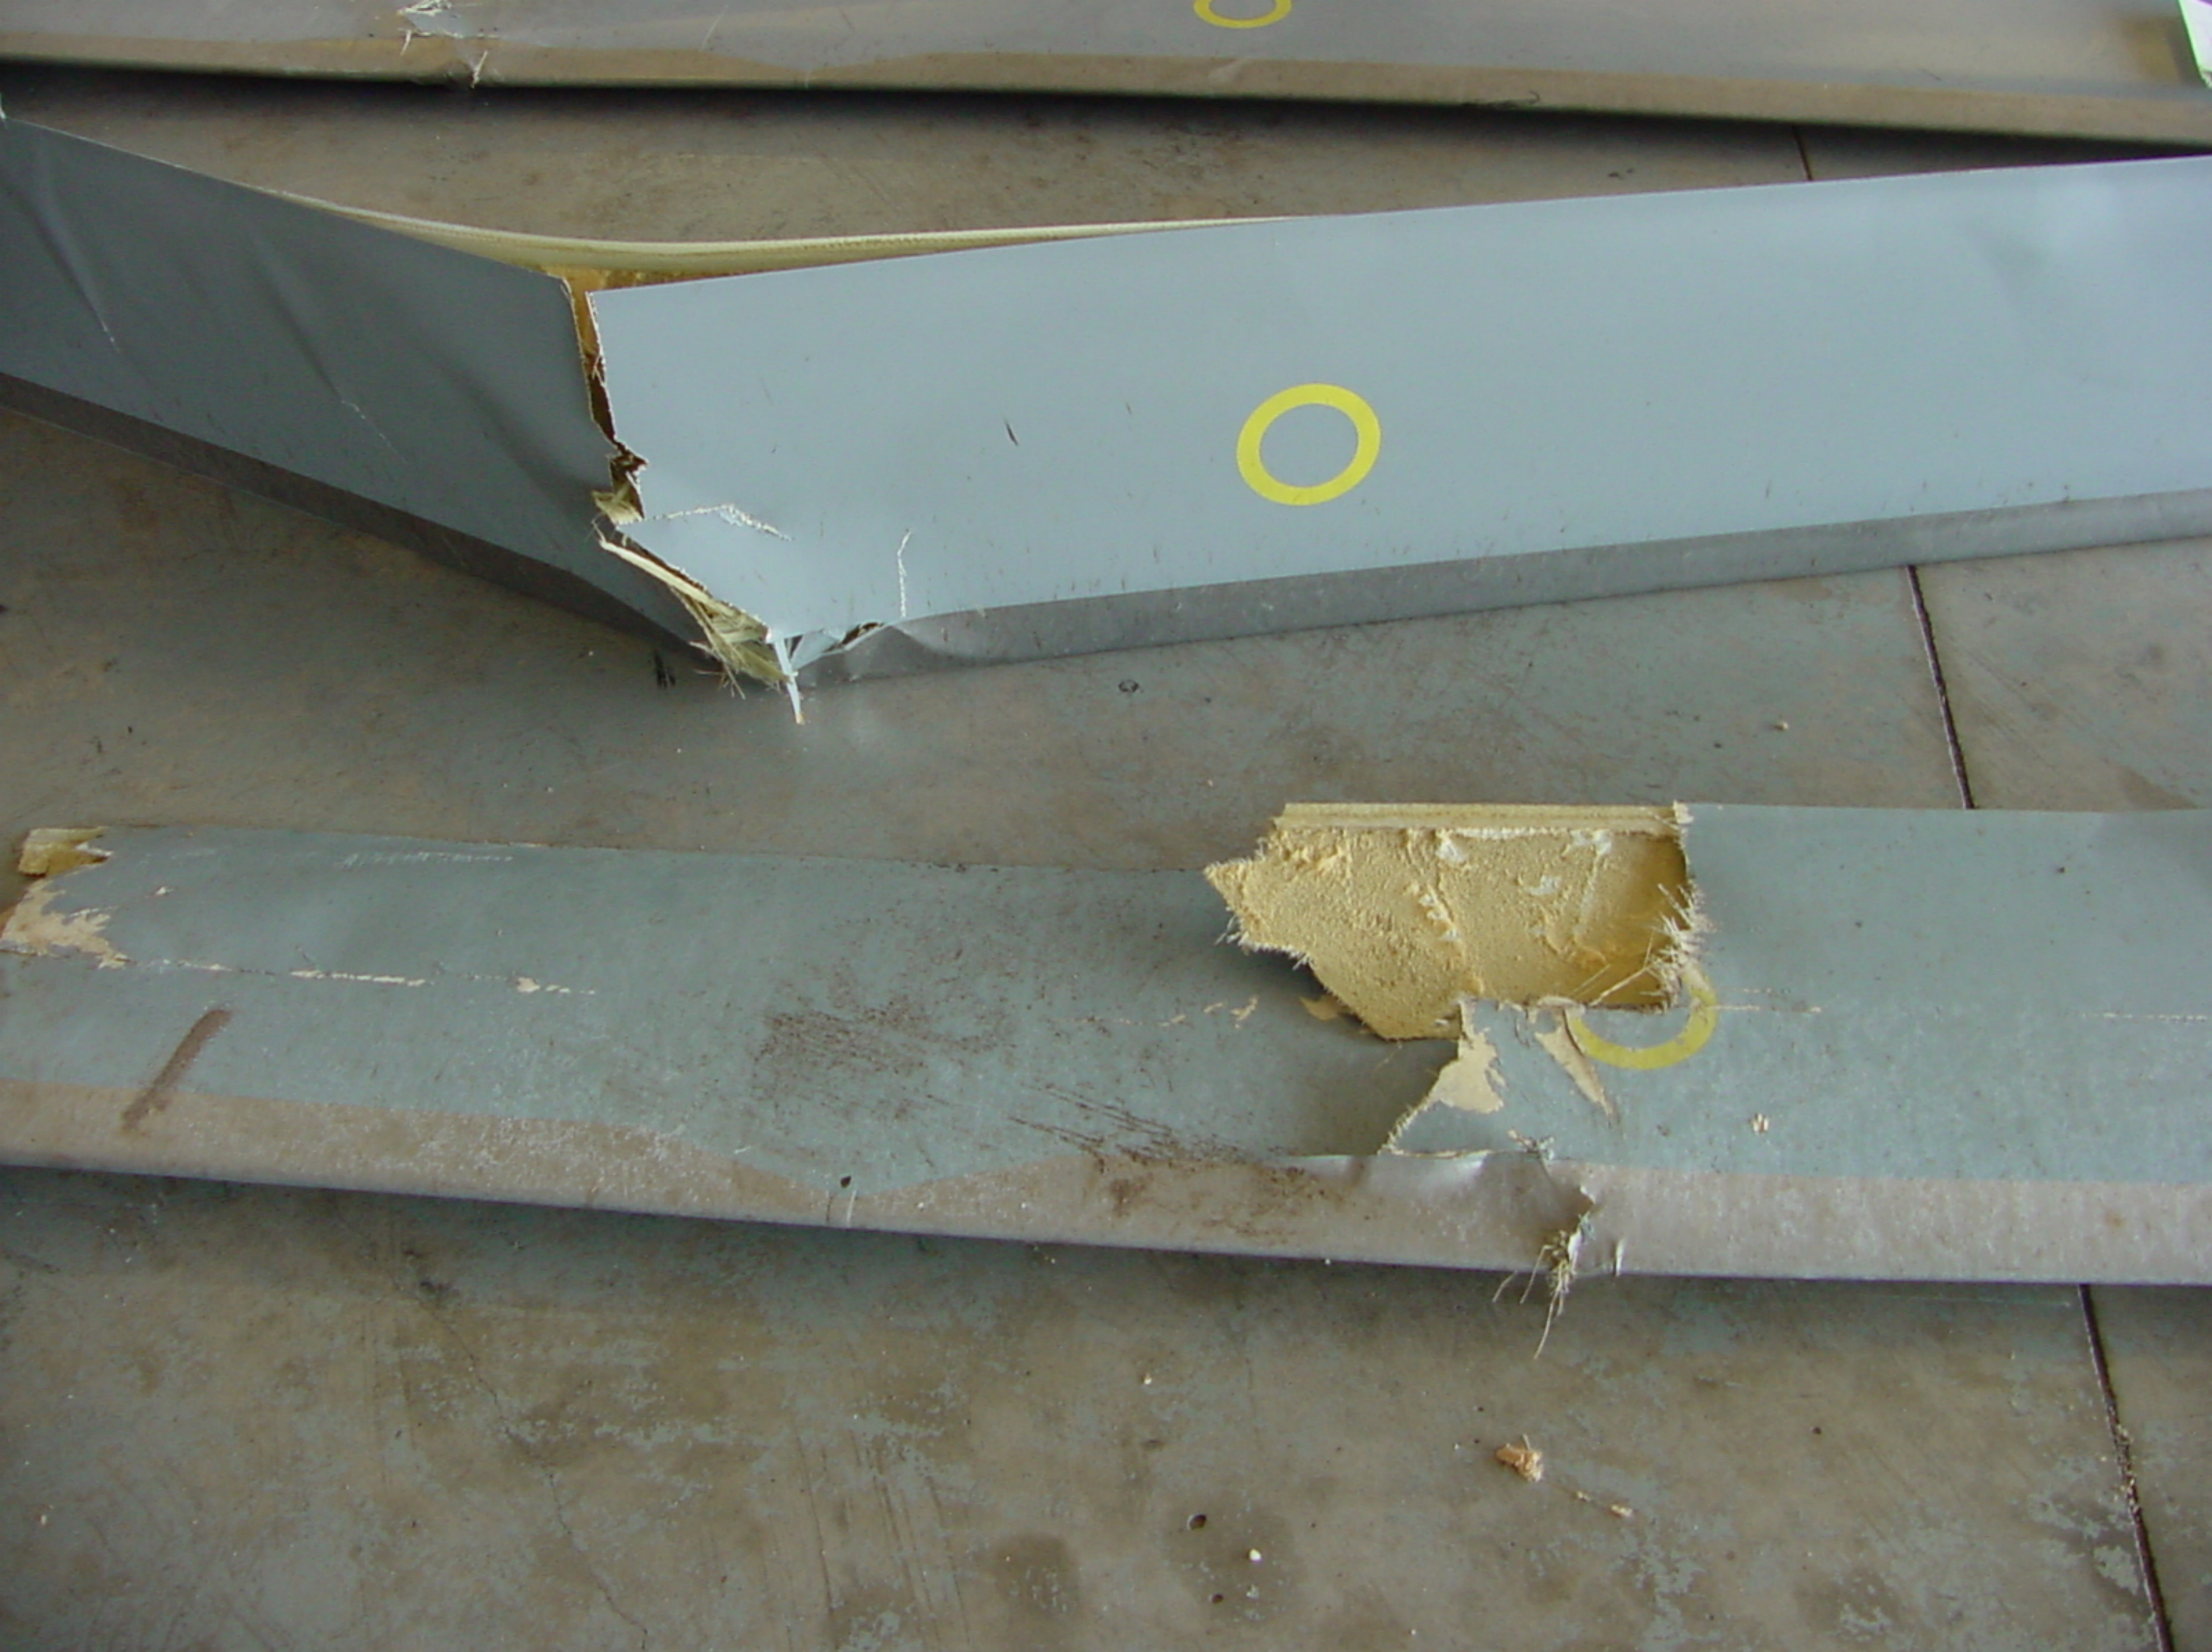
Photo 44. Inboard Fracture on Blue Main Rotor Blade. Yellow Main Rotor Blade in Background (Eurocopter Photo)
