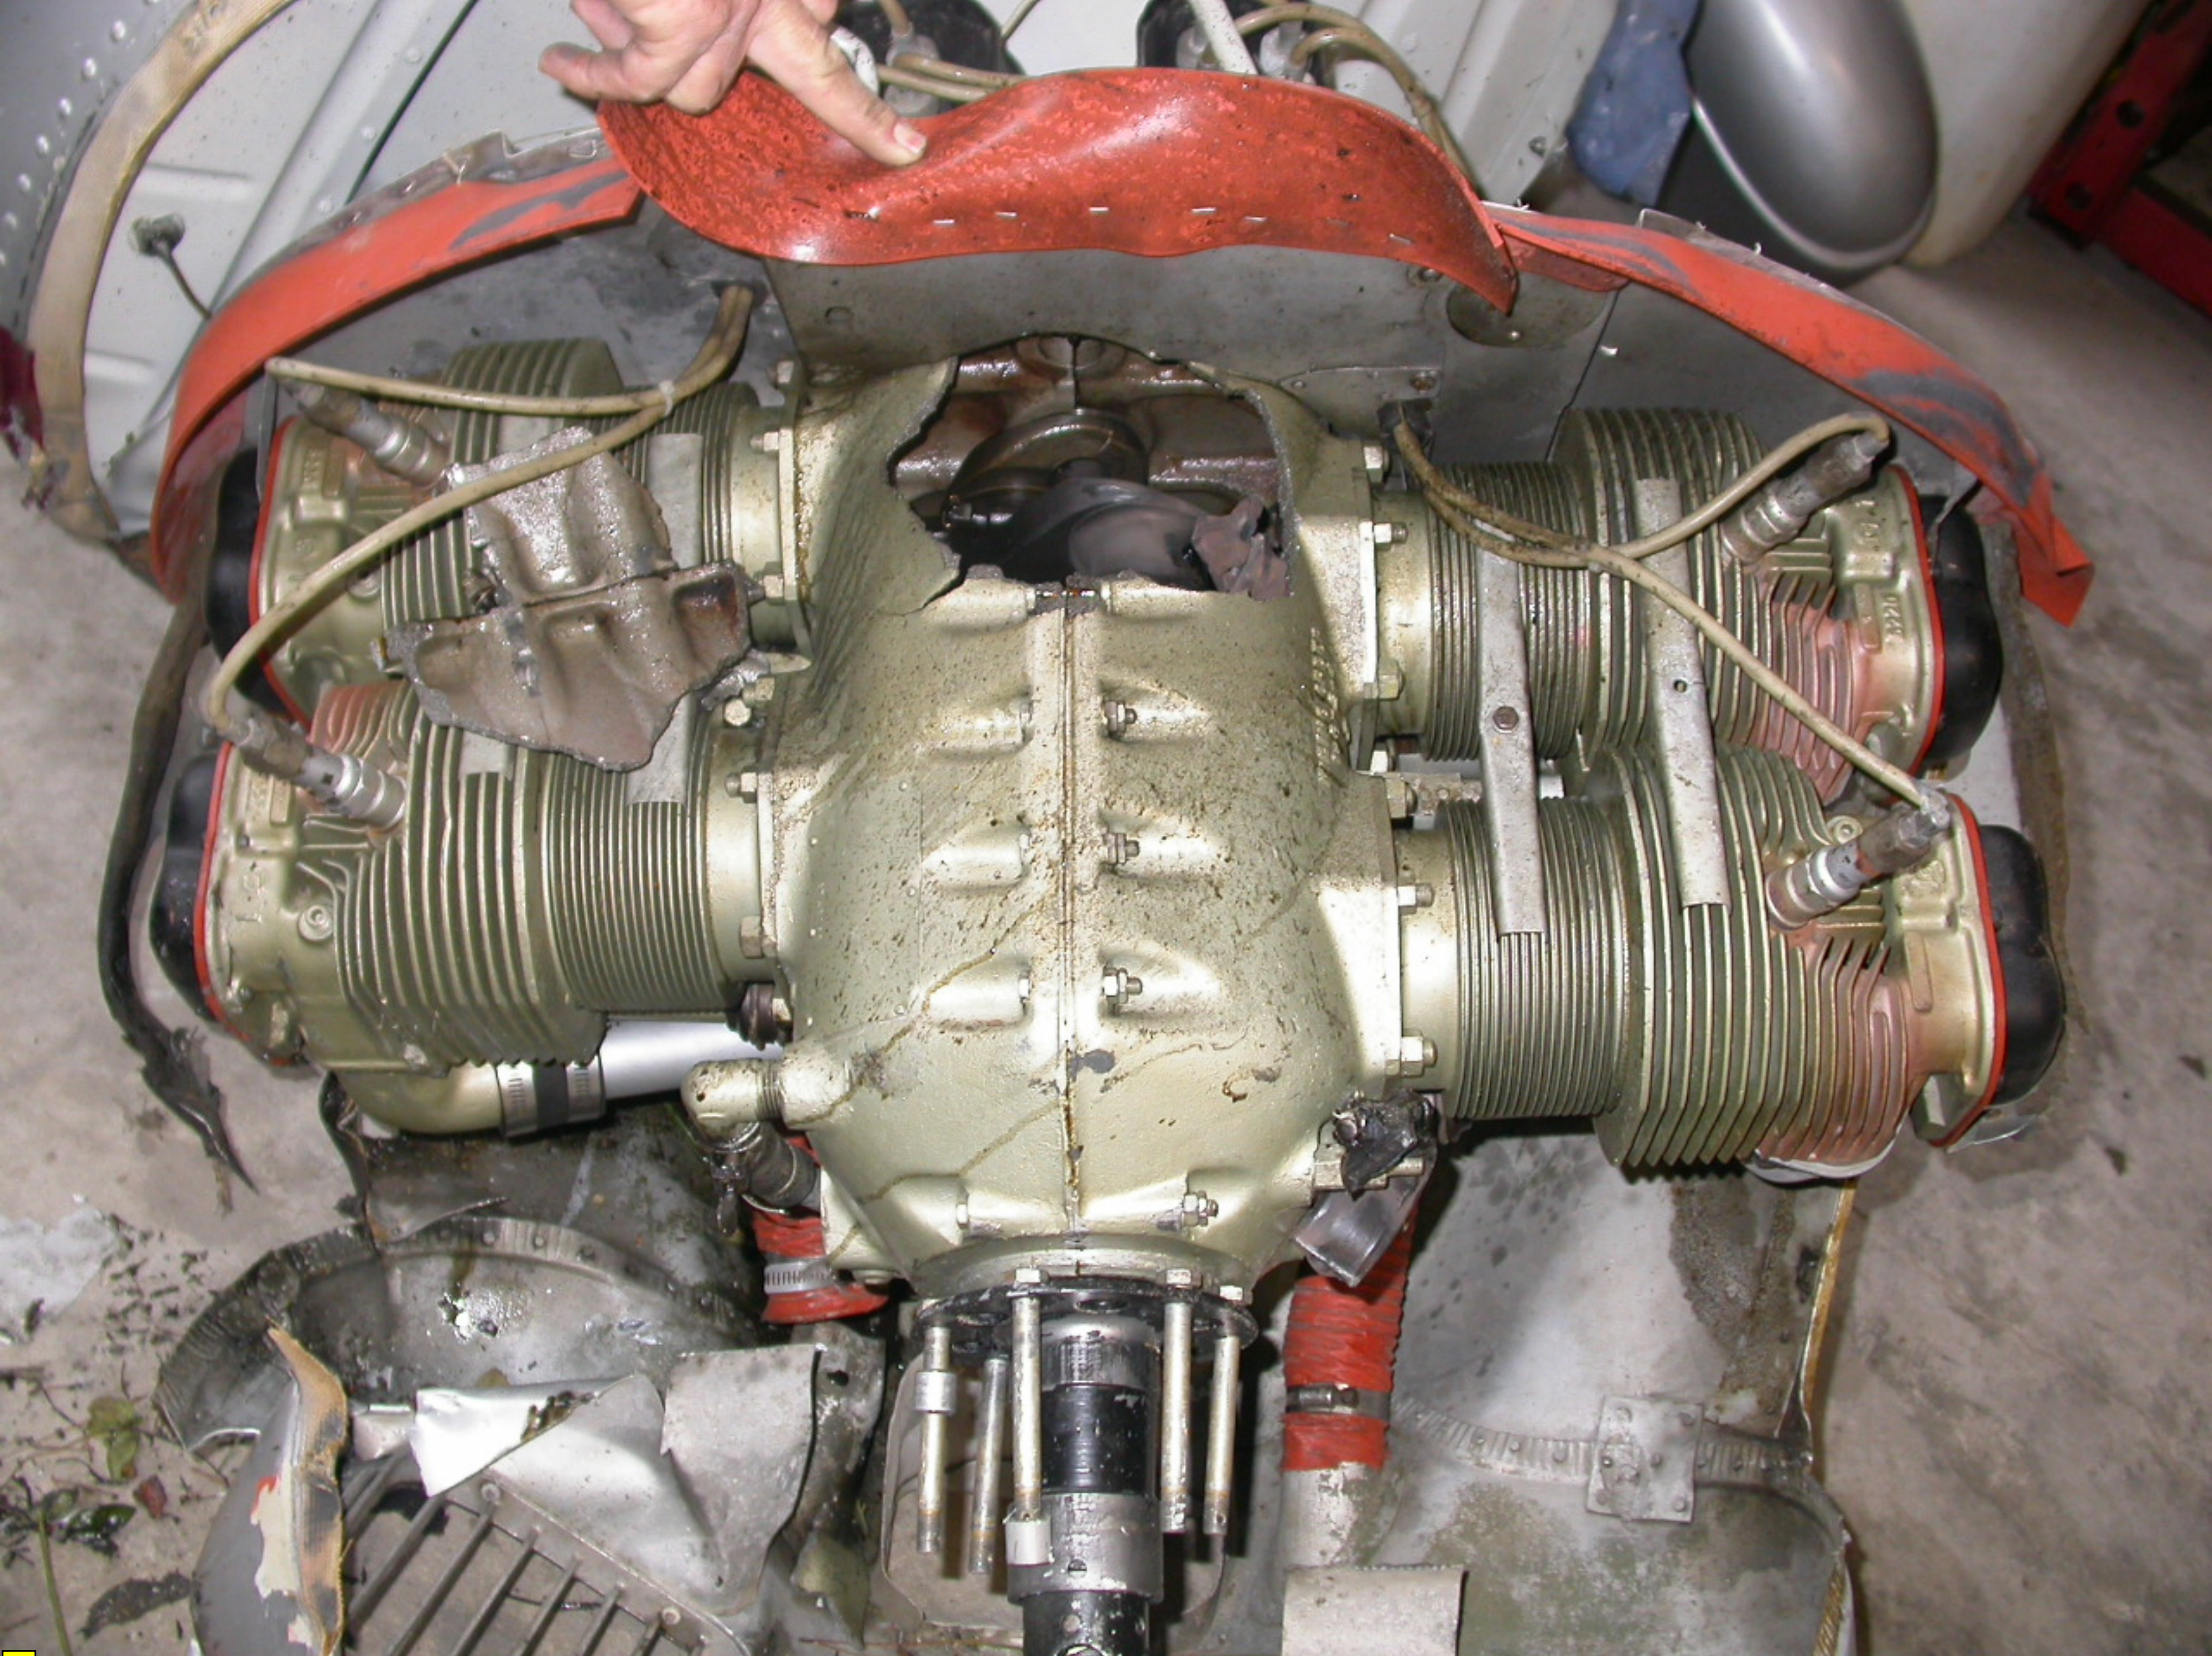
Photo 5: Top side engine damage.
