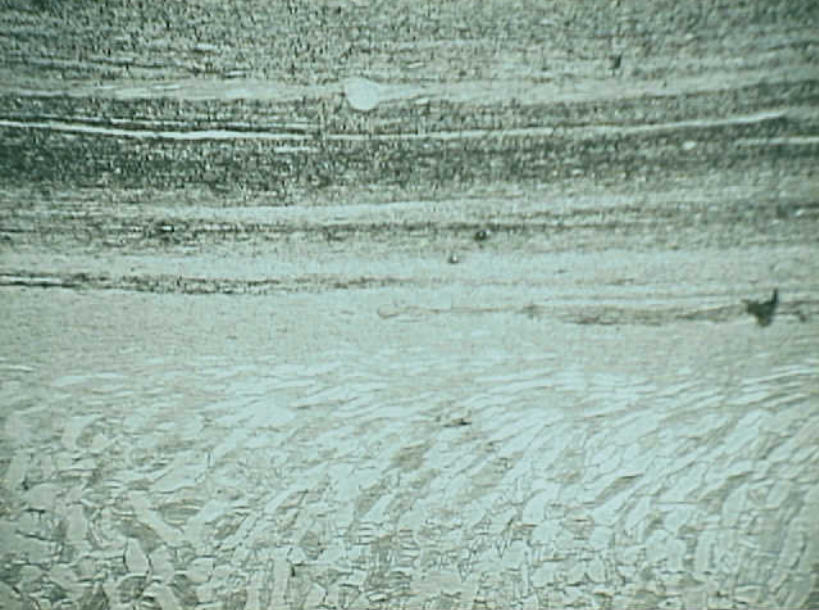
Photo 5. Cross section of hole #2B quite close to the location of the drill breakdown showing a surface layer with an appearance similar to the failed JT8-hub. Mag. 128X.
