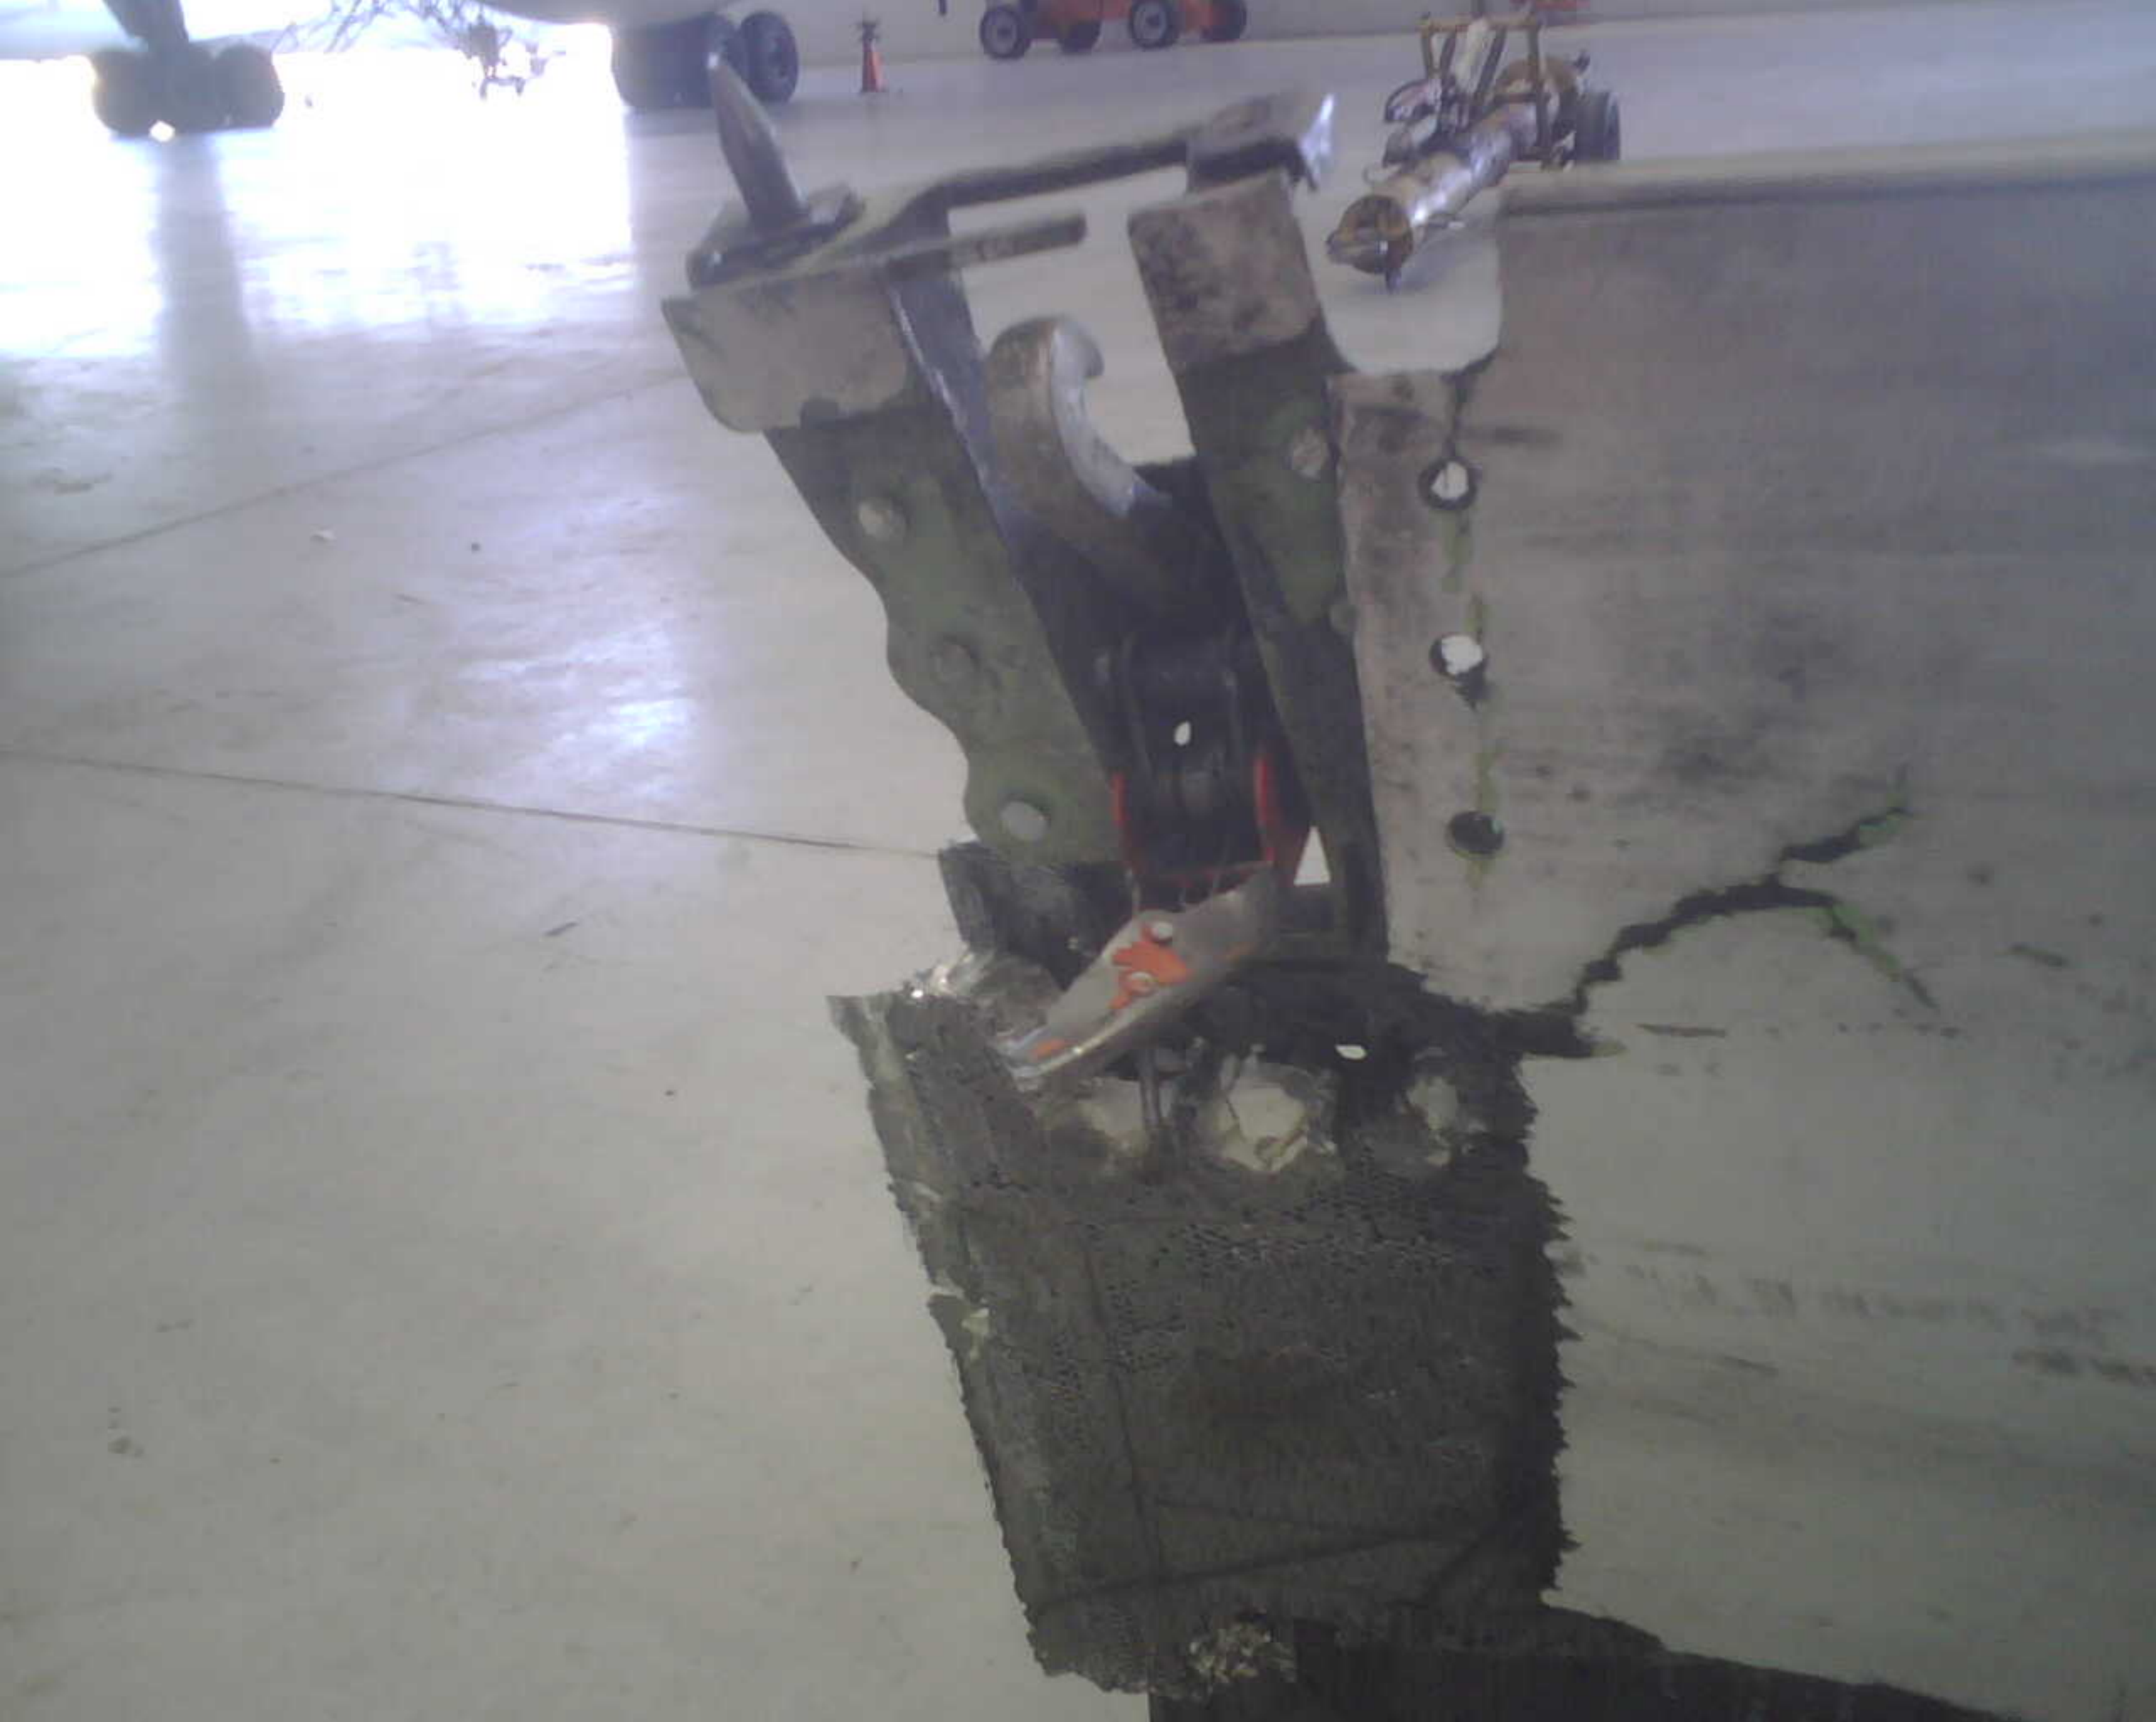
Photo 5. Damage to Engine Pylon Structure (FAA Photo)
