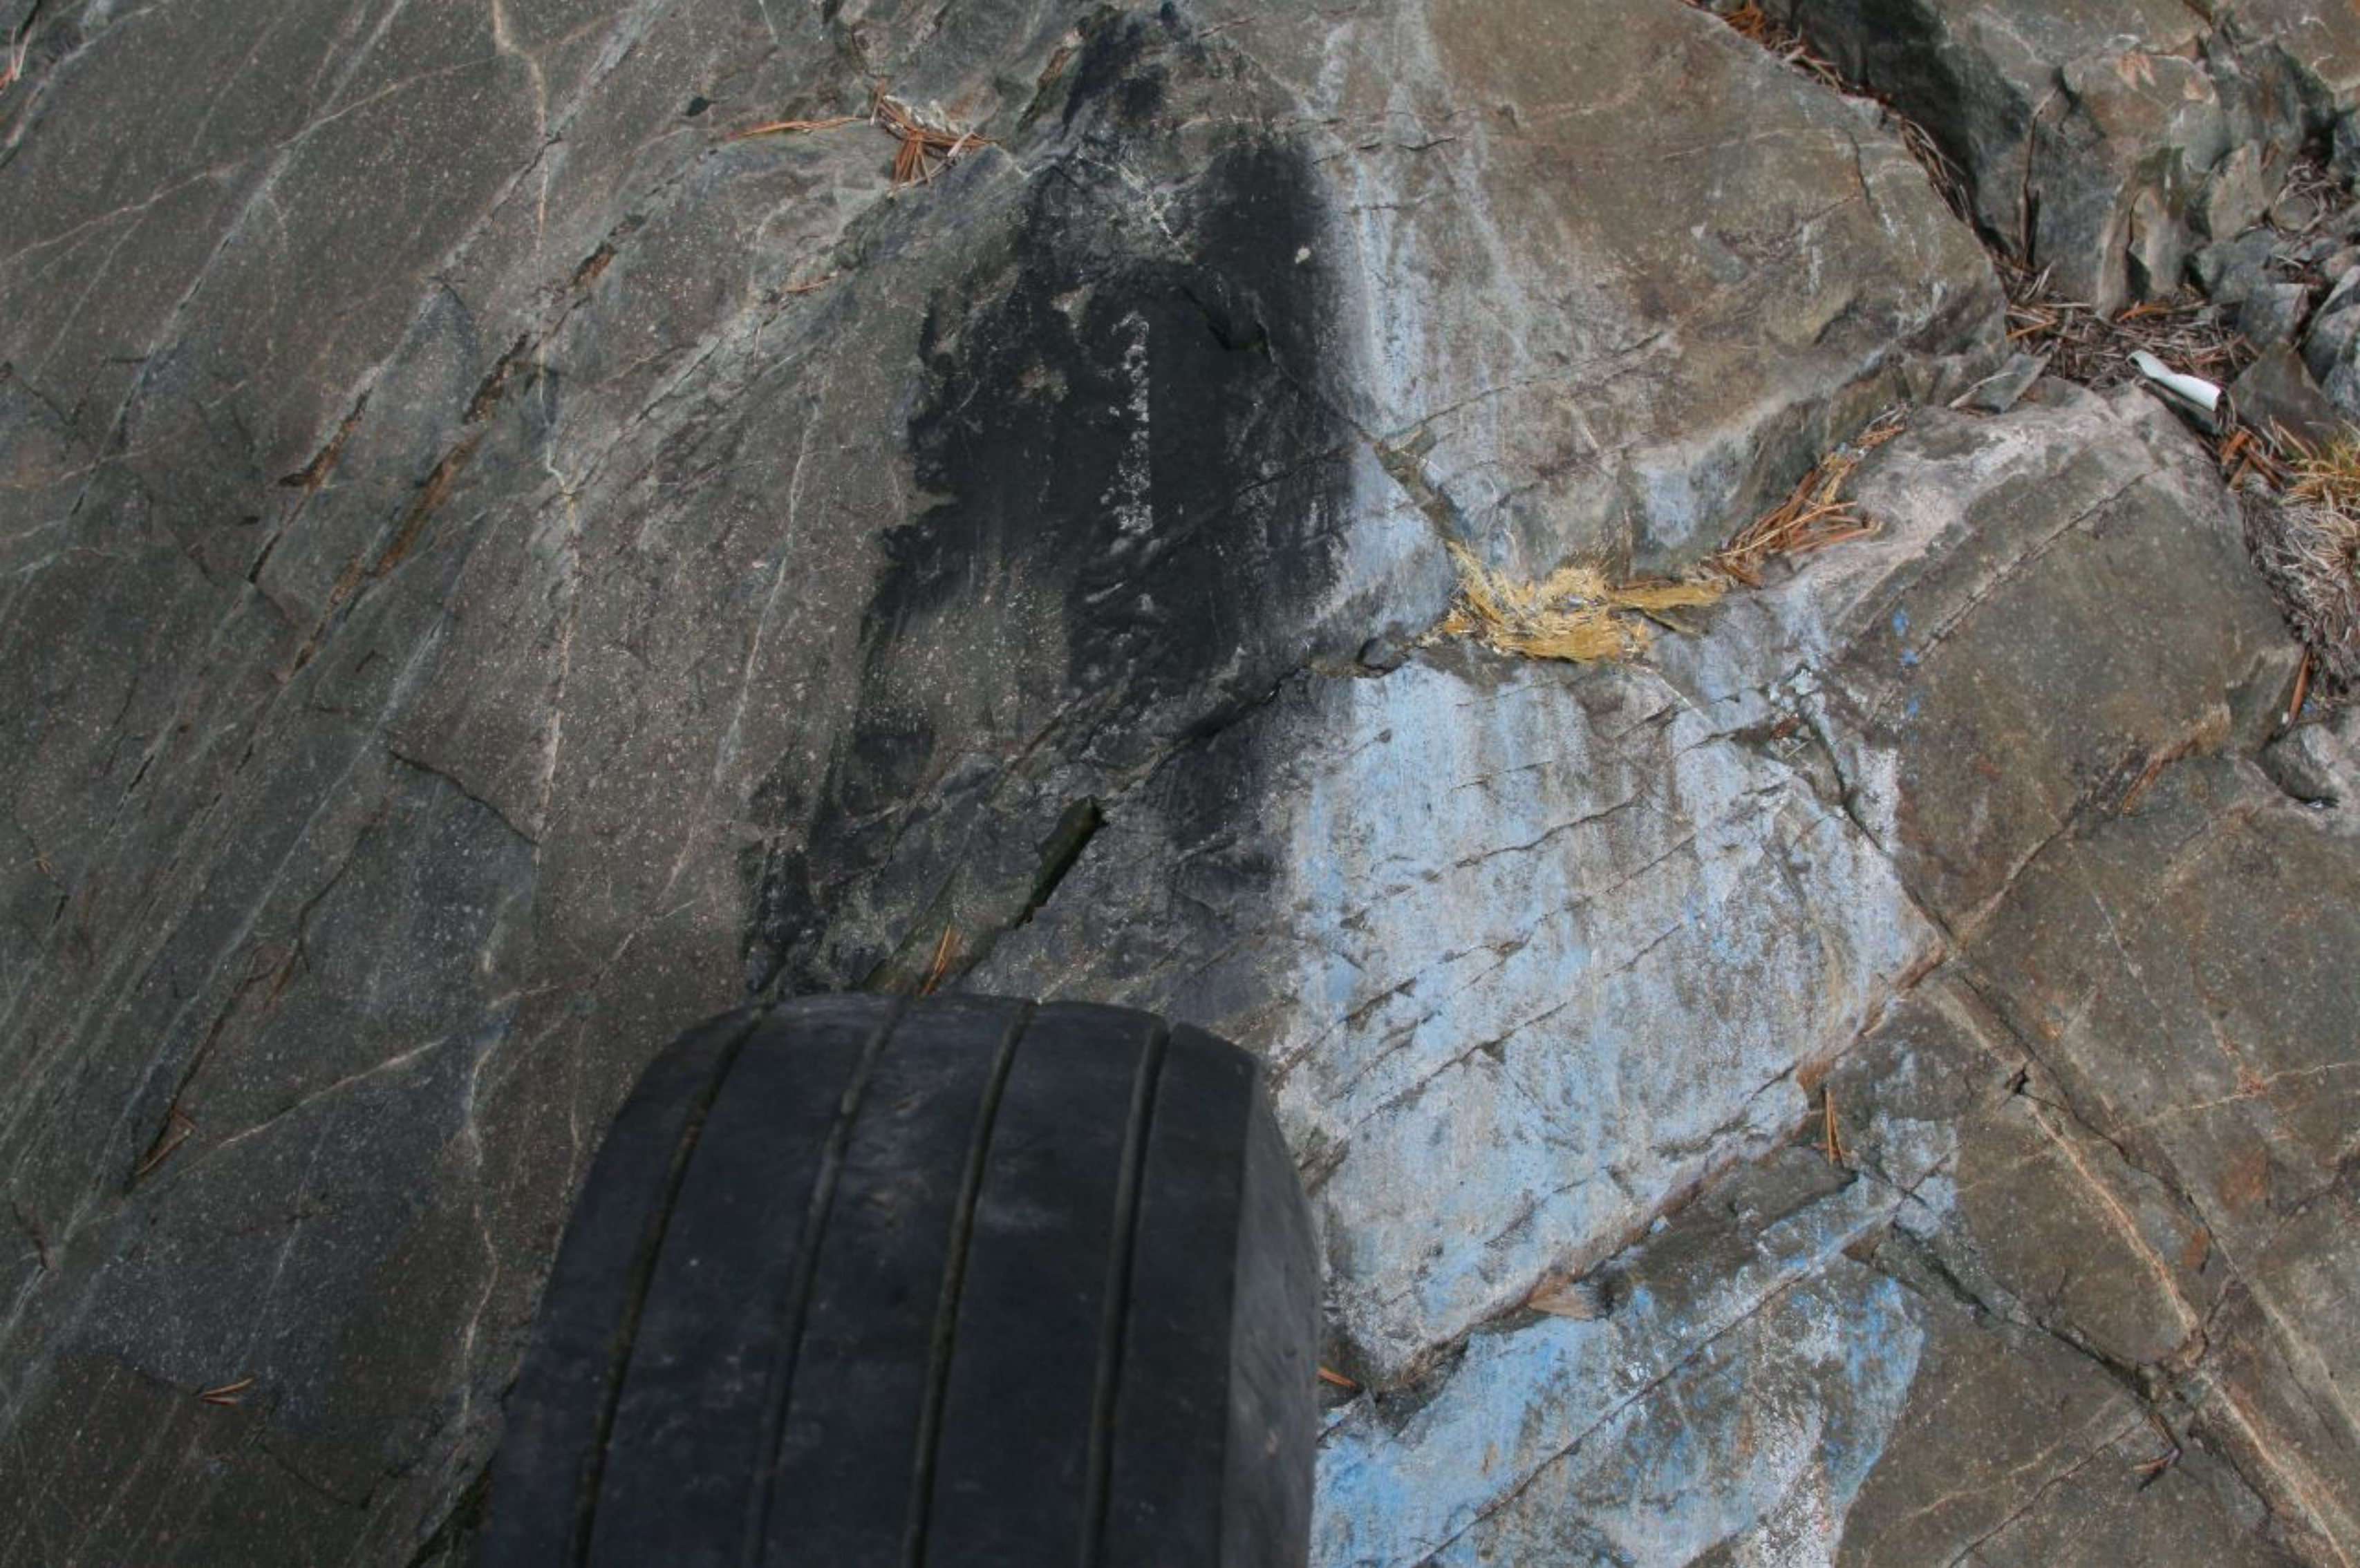
Photo 5. Paint and rubber transfer at IIP.
