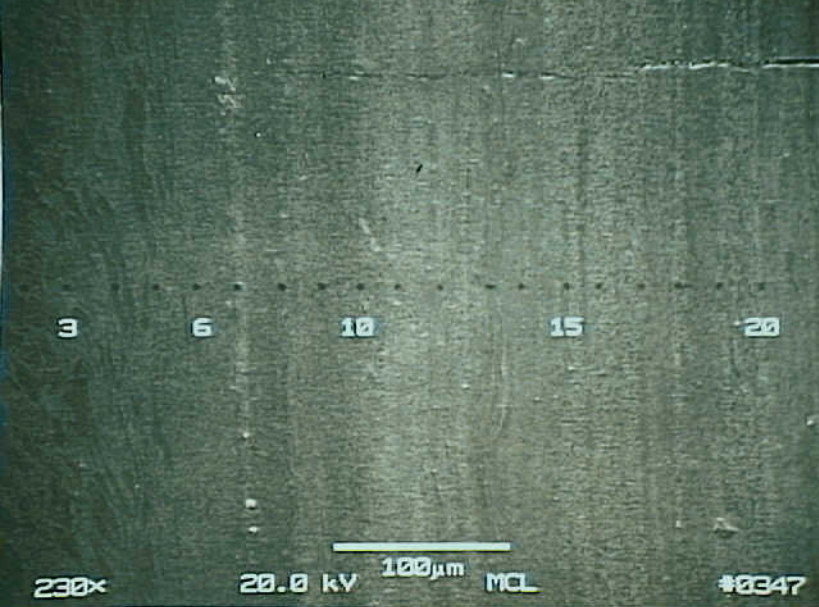
Photo 6. Cross section of hole #2B quite close to the location of the drill breakdown showing a surface layer with a appearance similar to the failed JT8-hub.
