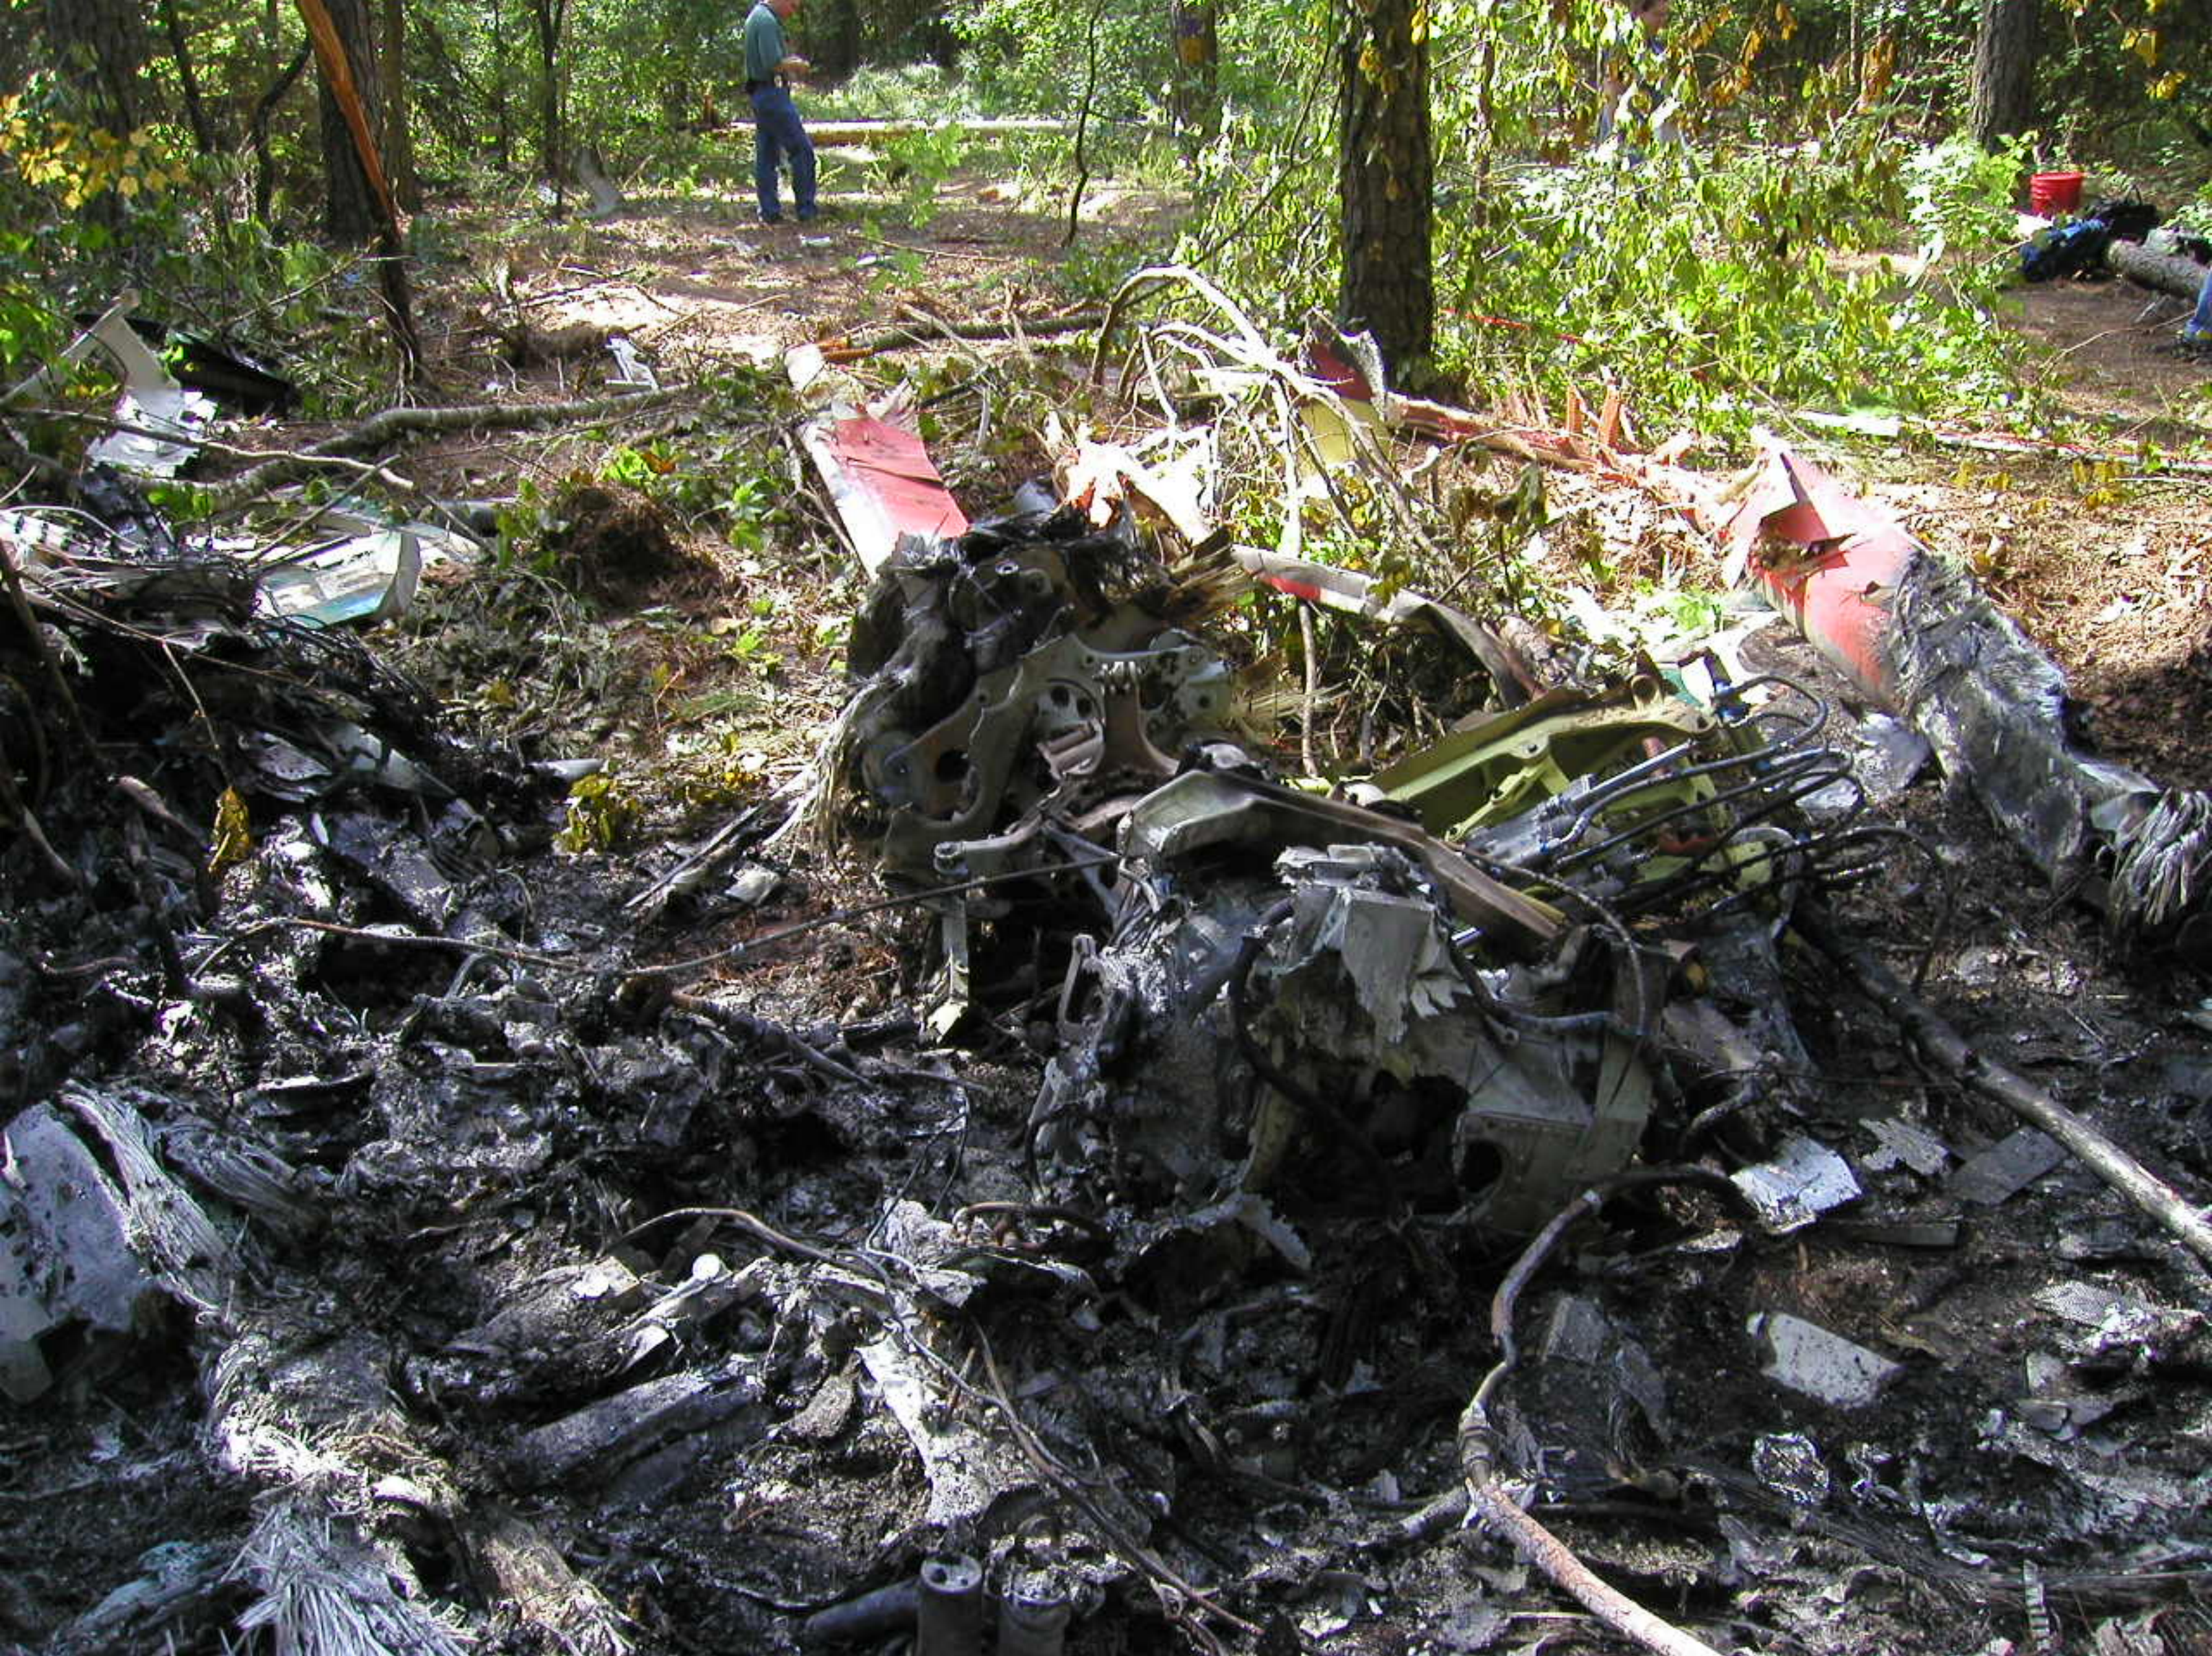
Photo 6. Main Wreckage Looking Towards the Initial Ground Impact Point
