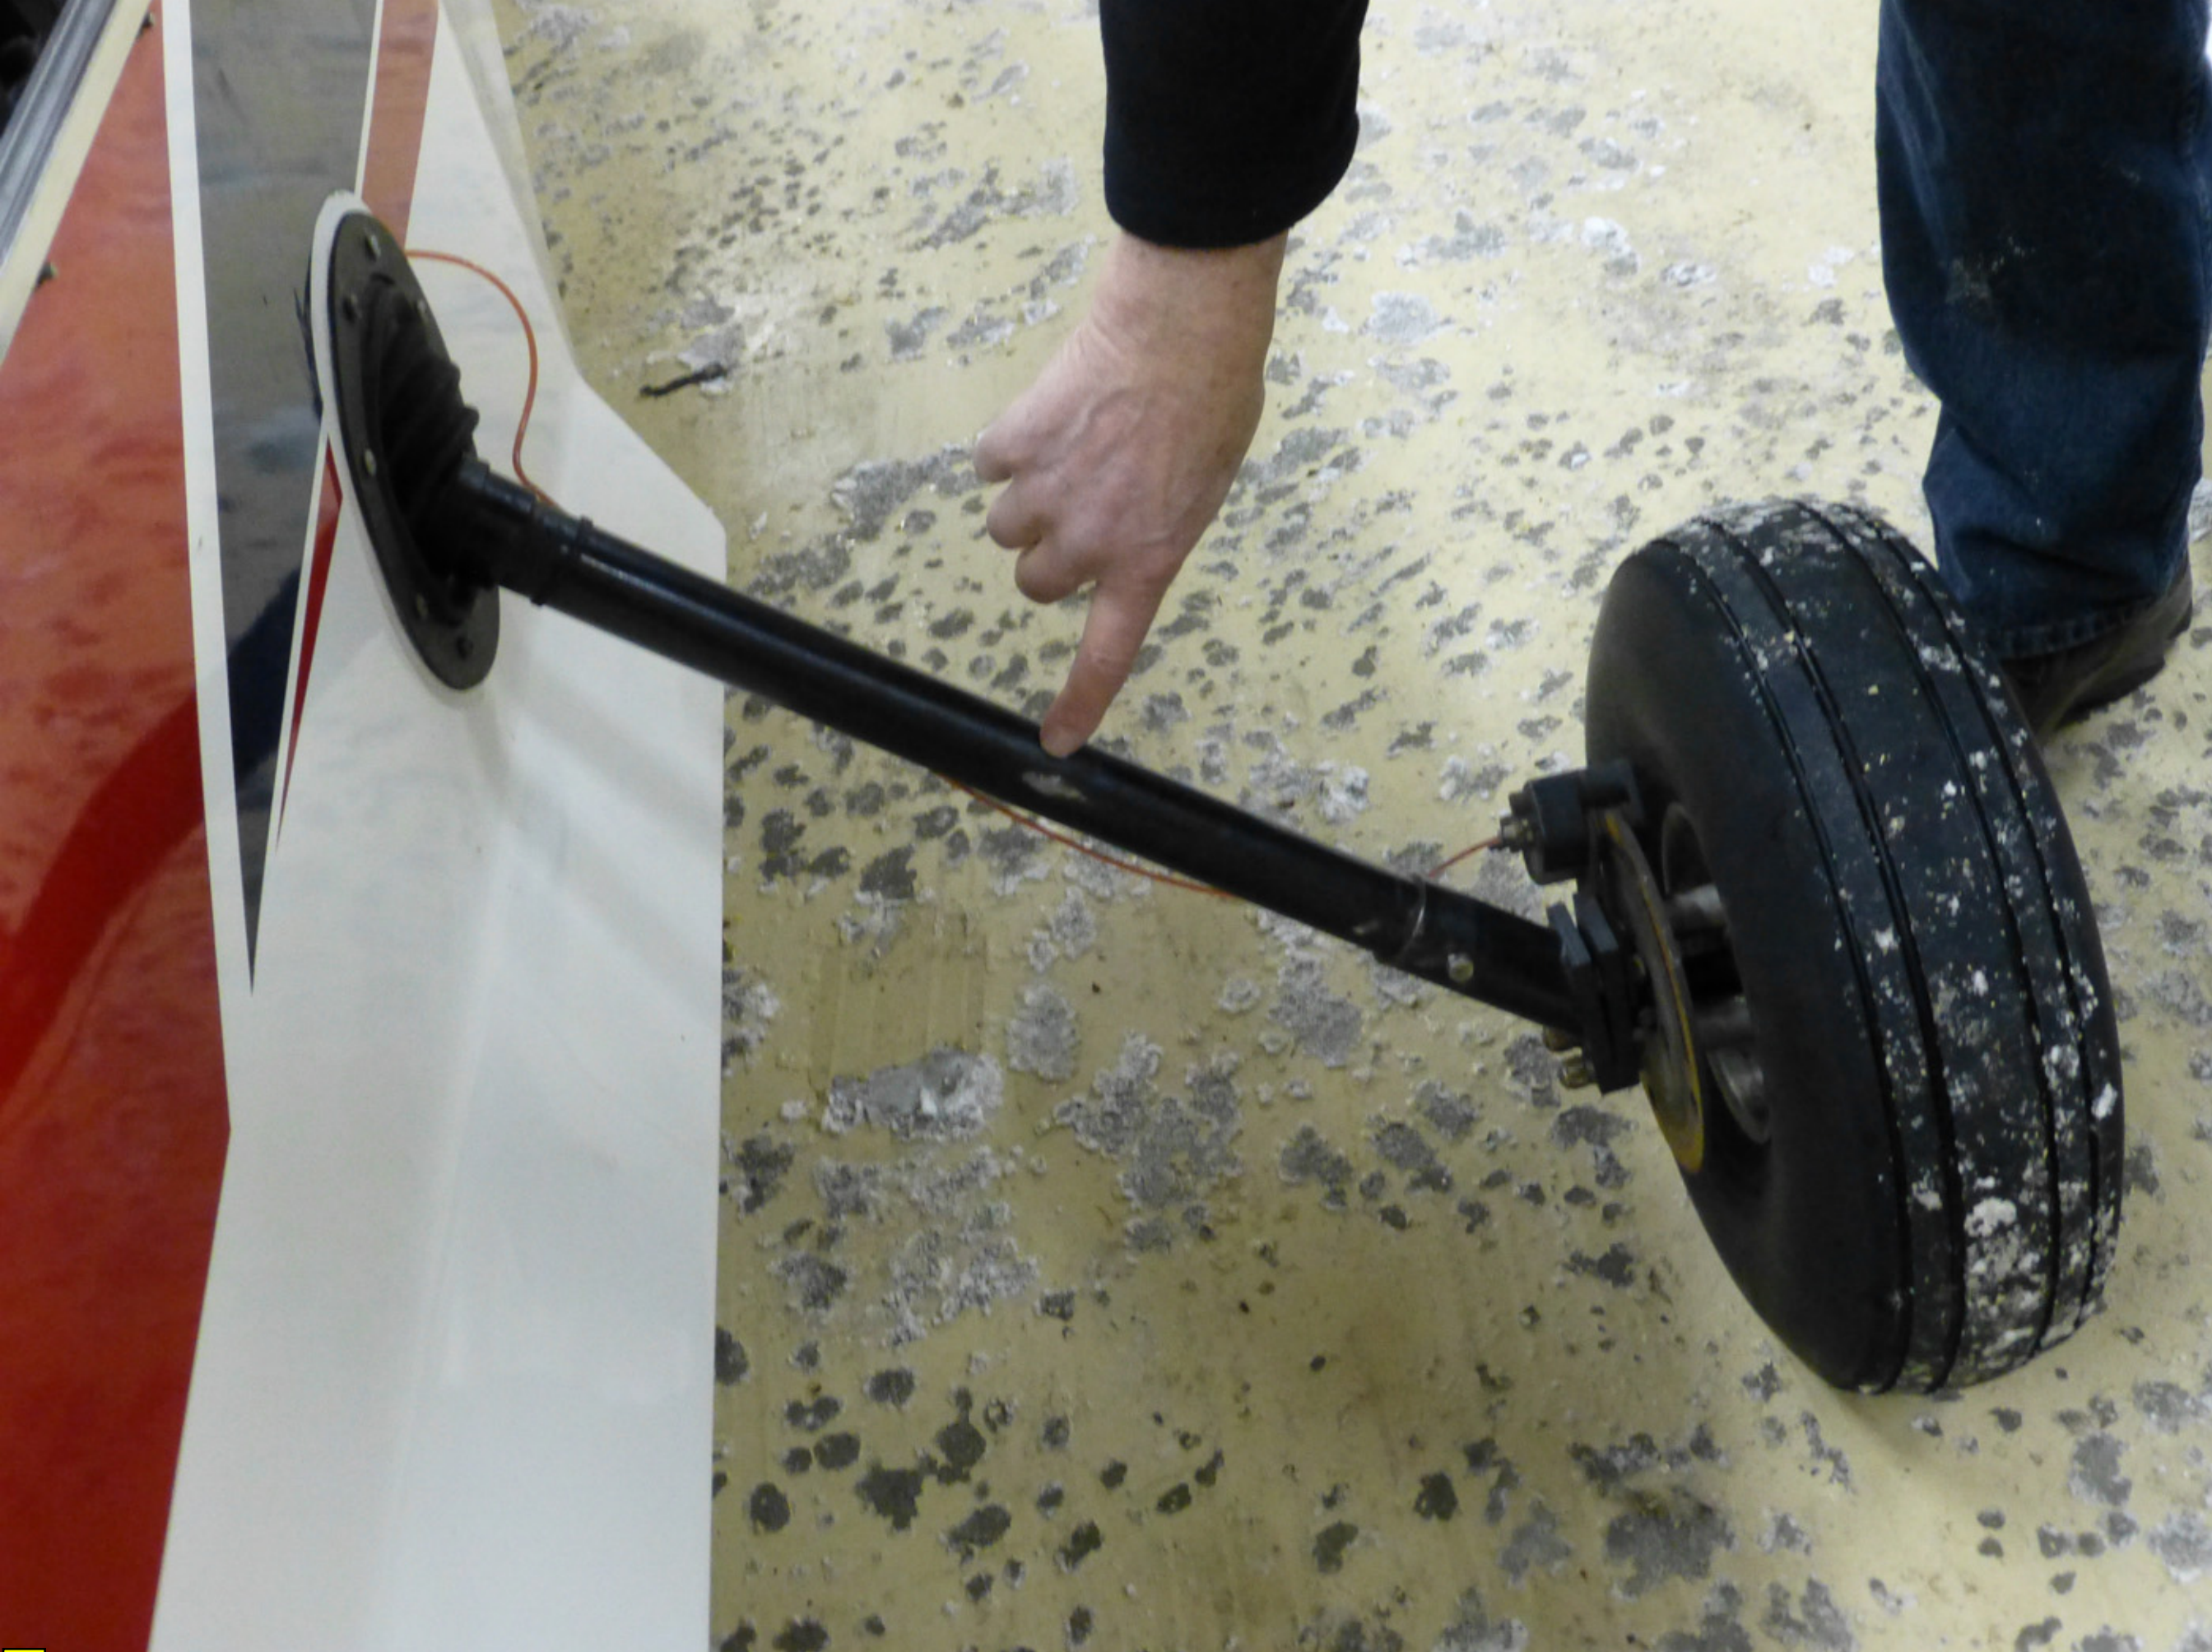
Photo 6. Wire Strike Mark, Left Main Landing Gear
