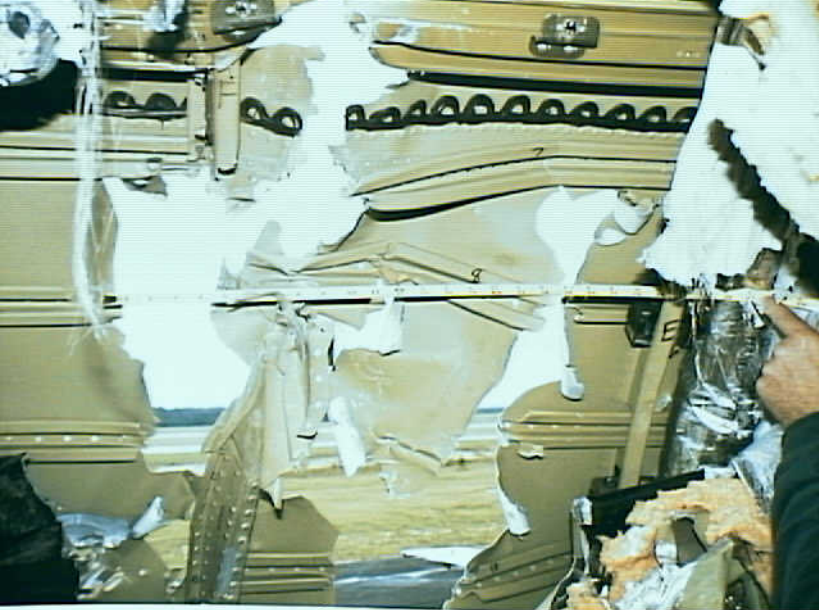
Photo 8. Interior view of left fuselage penetration damage adjacent to row 37.
