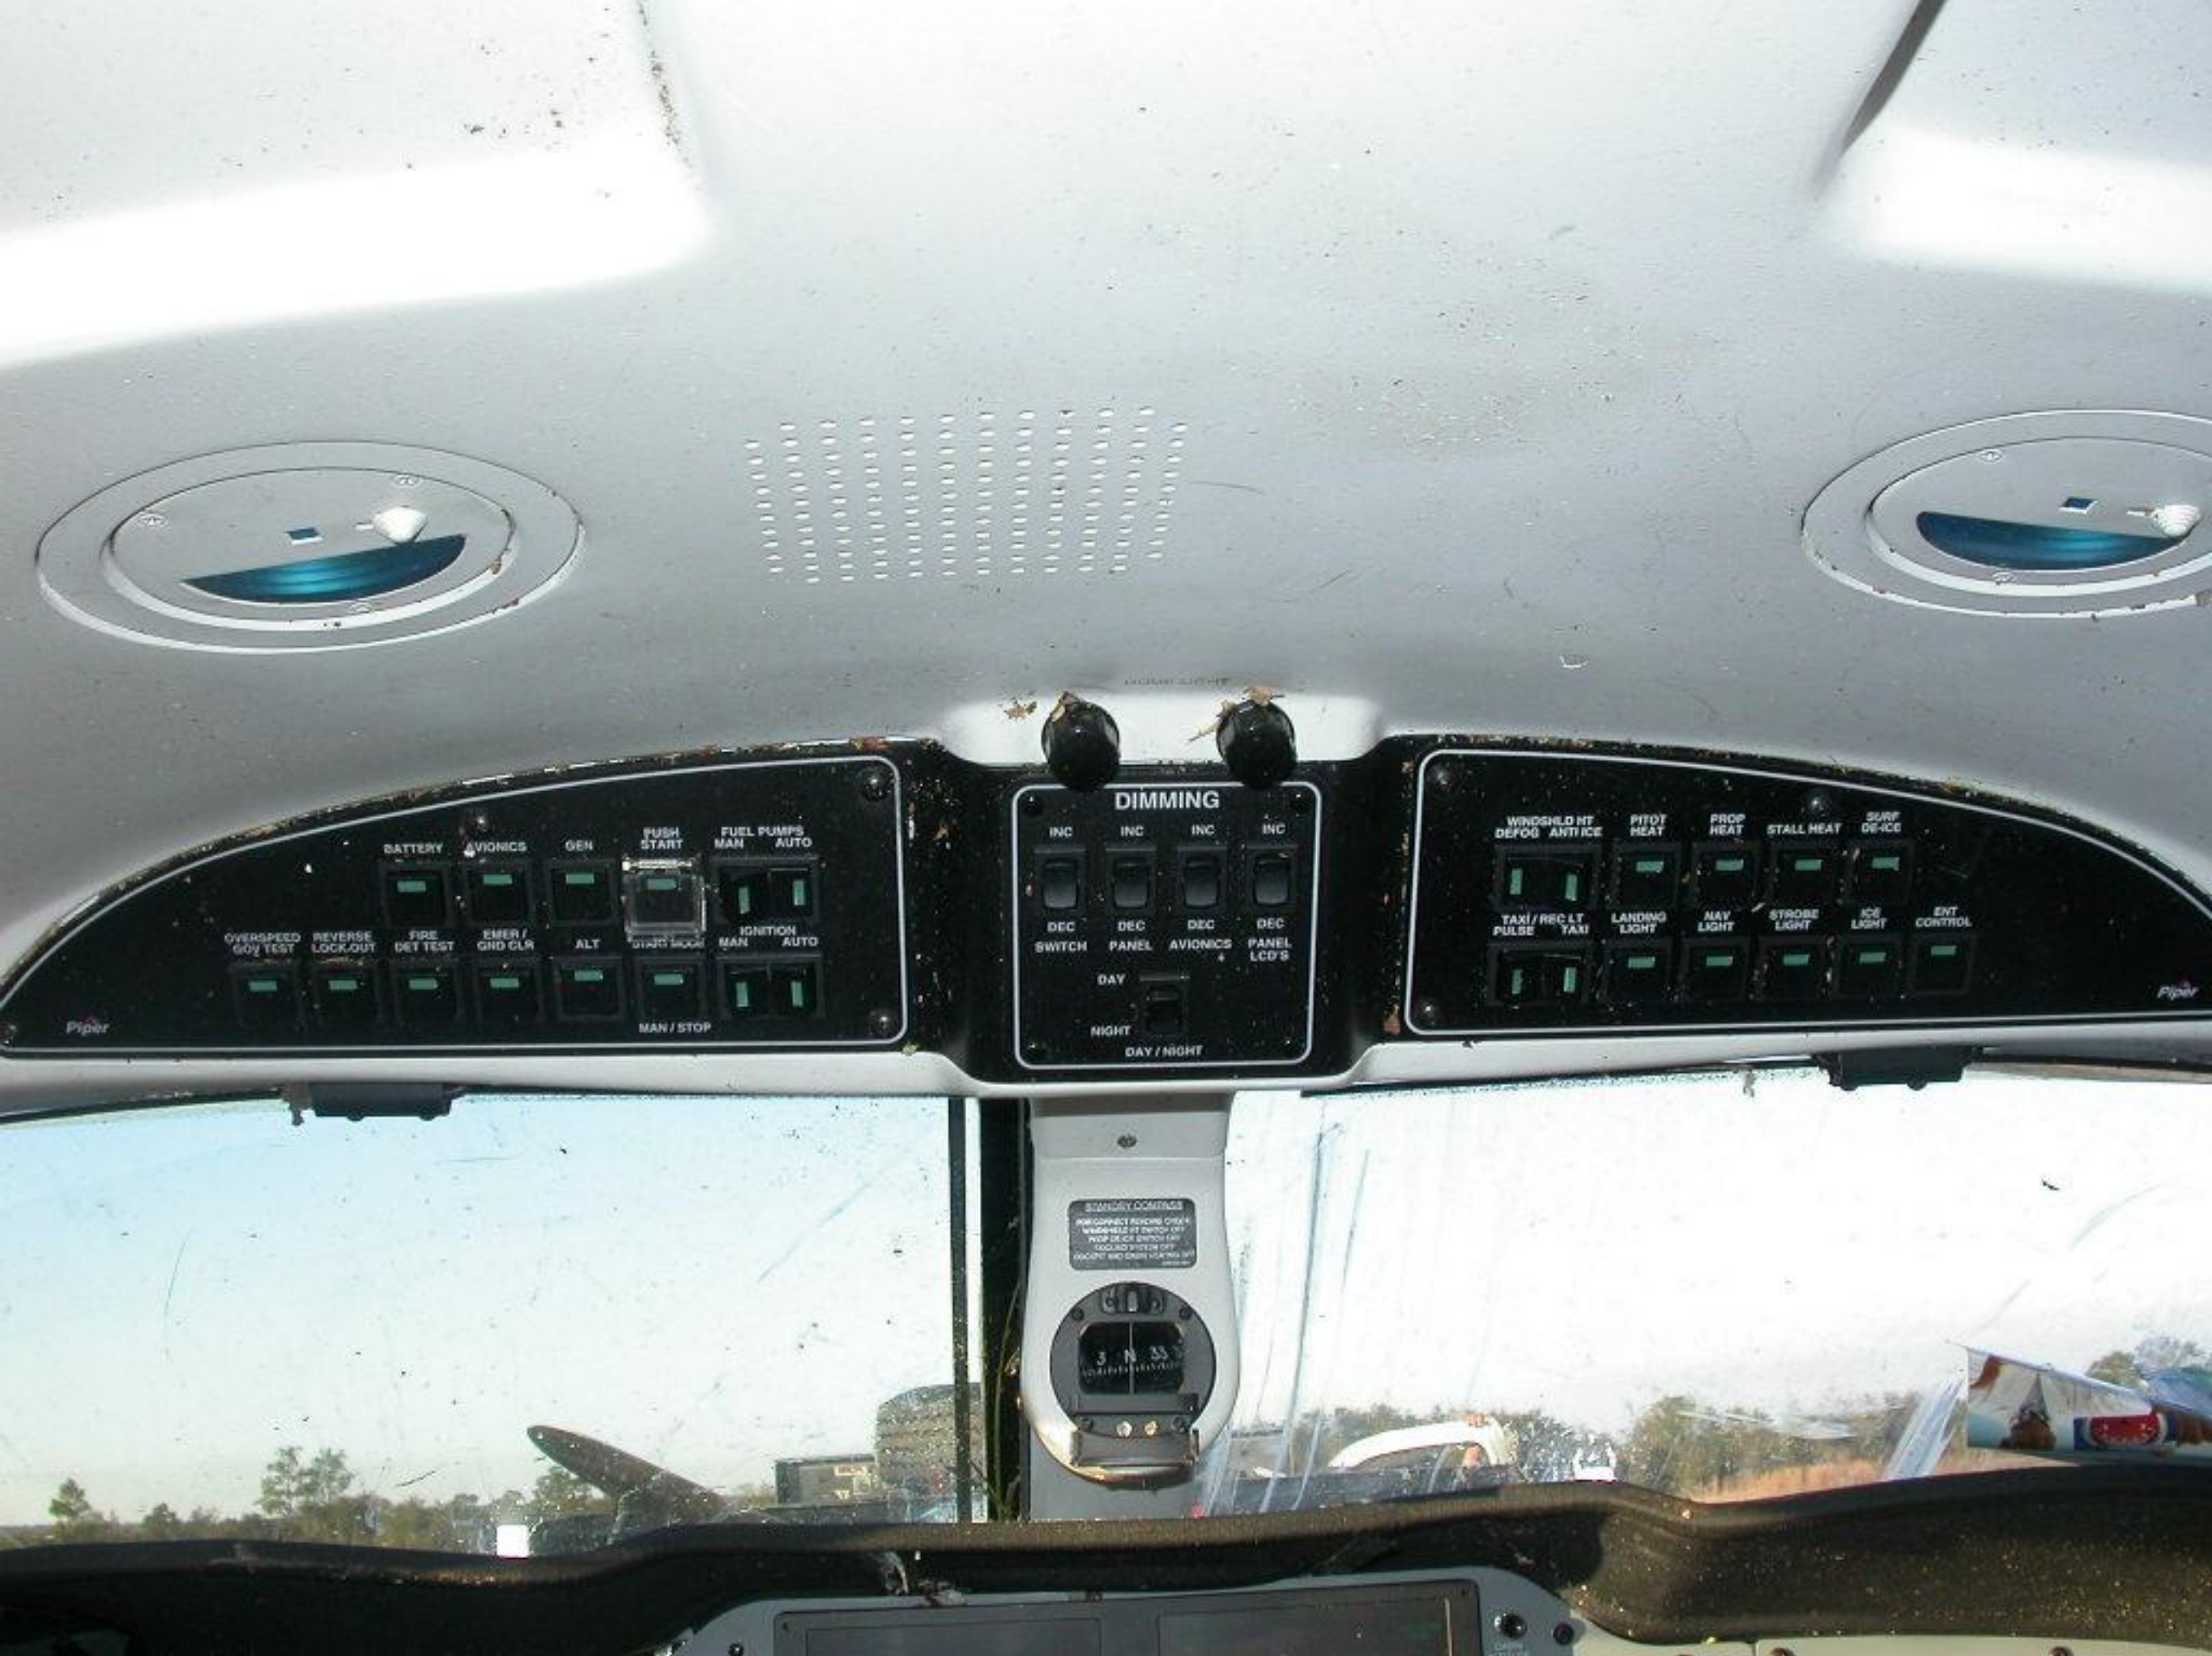
Photo 9: Front windshield (after aircraft recovery)
