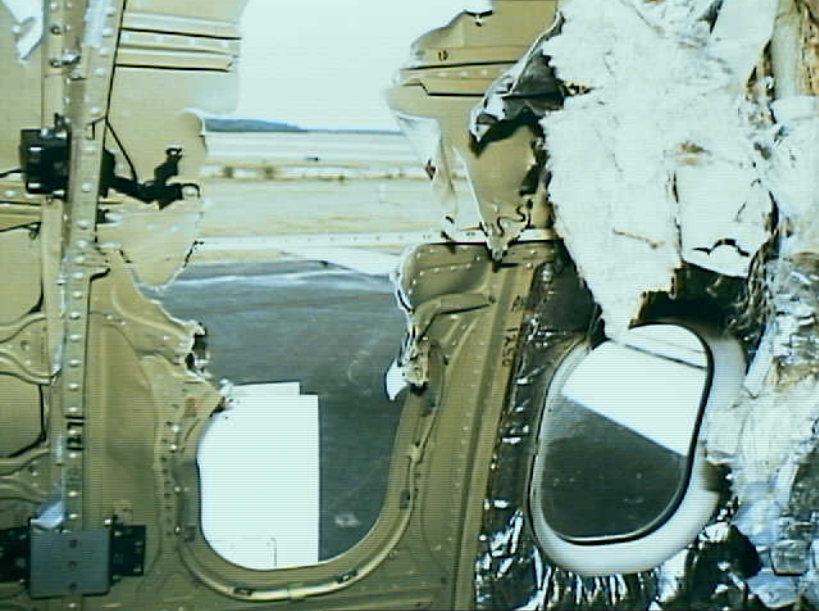
Photo 9. Interior view of left fuselage penetration damage adjacent to row 37.
