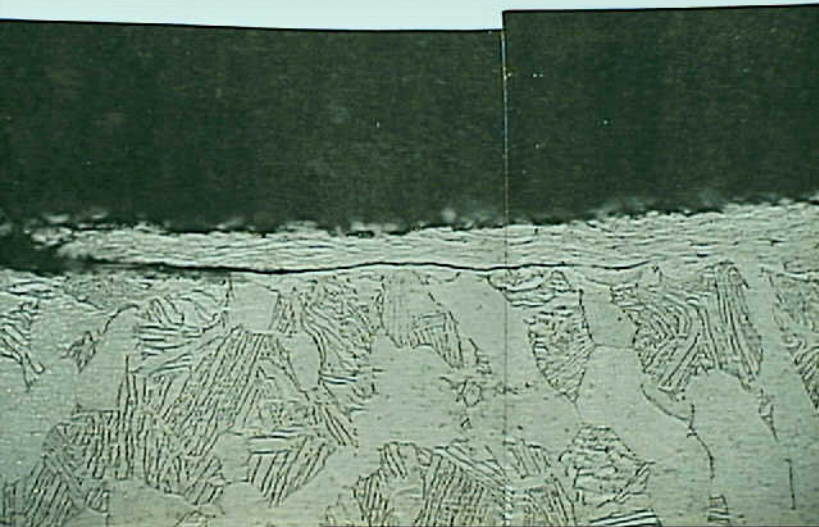
Photo 9. Longitudinal section of hole 2 through a BEA indication, arrow B in photo 7. A chip with deformed microstructure is smeared into the hole surface. Mag.
