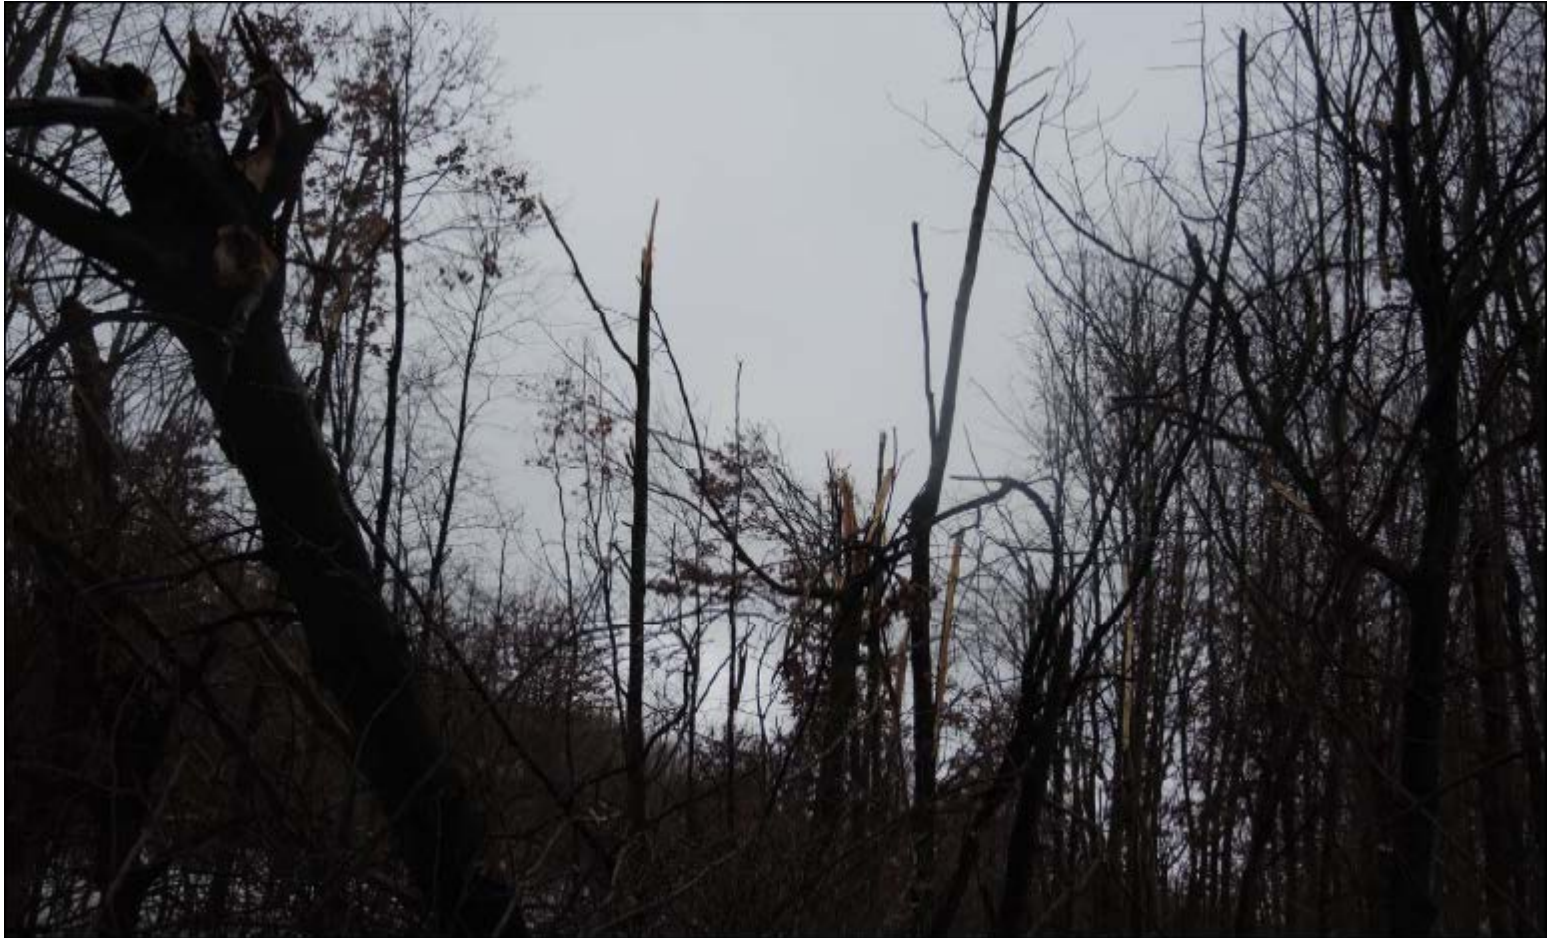
Photo 1 – The photo shows the wreckage path through trees as viewed toward the west.

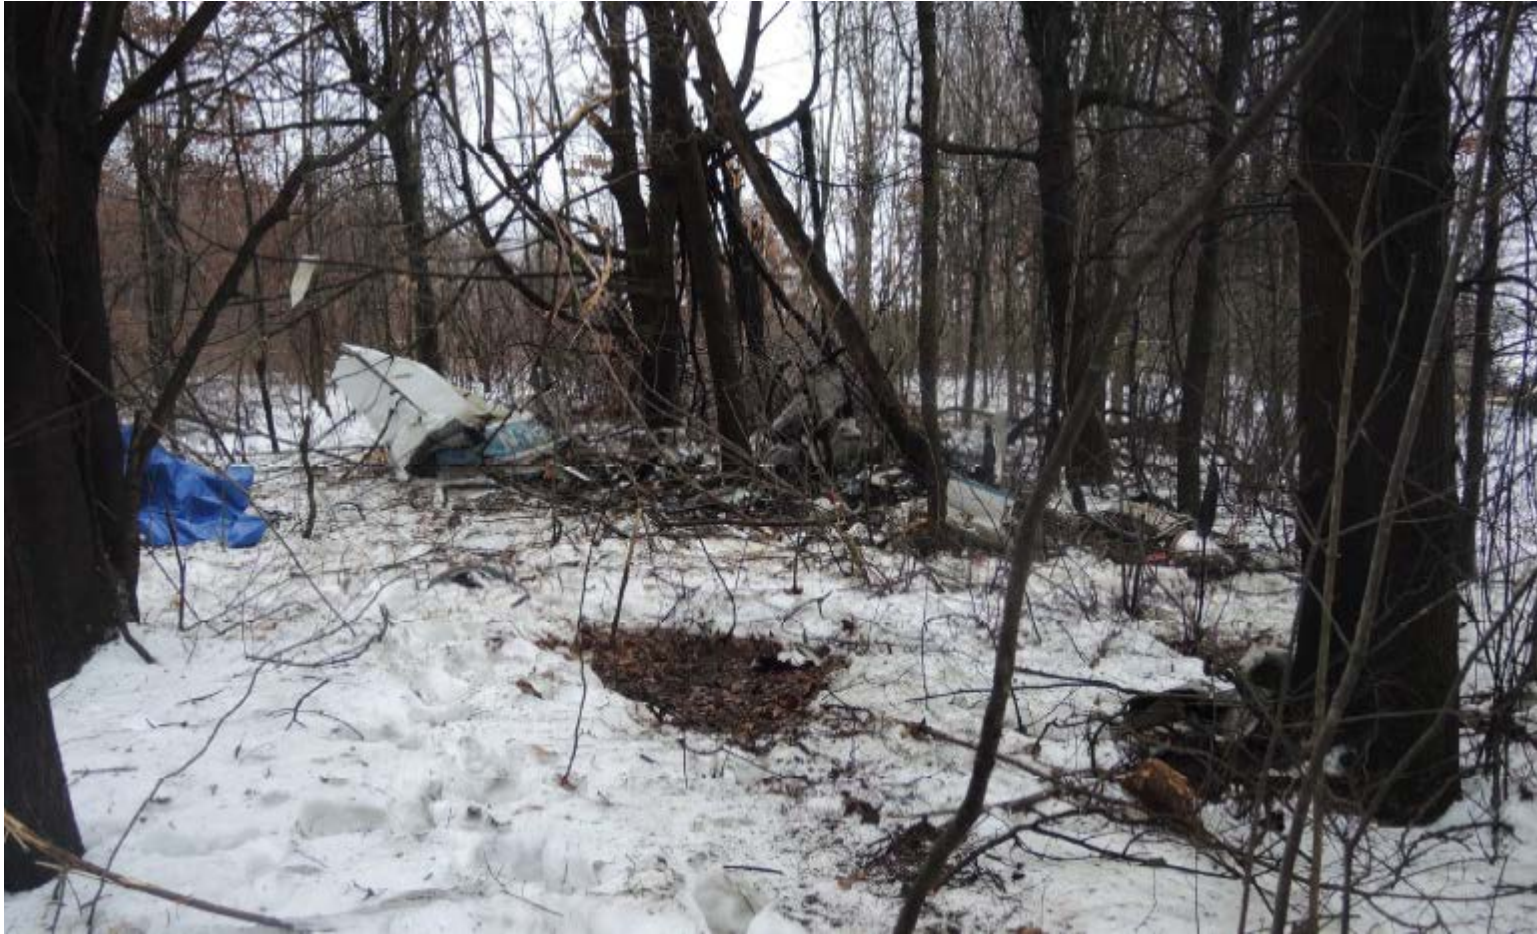
Photo 2 - Photo of main wreckage along wreckage path as viewed toward the west with engine in view.

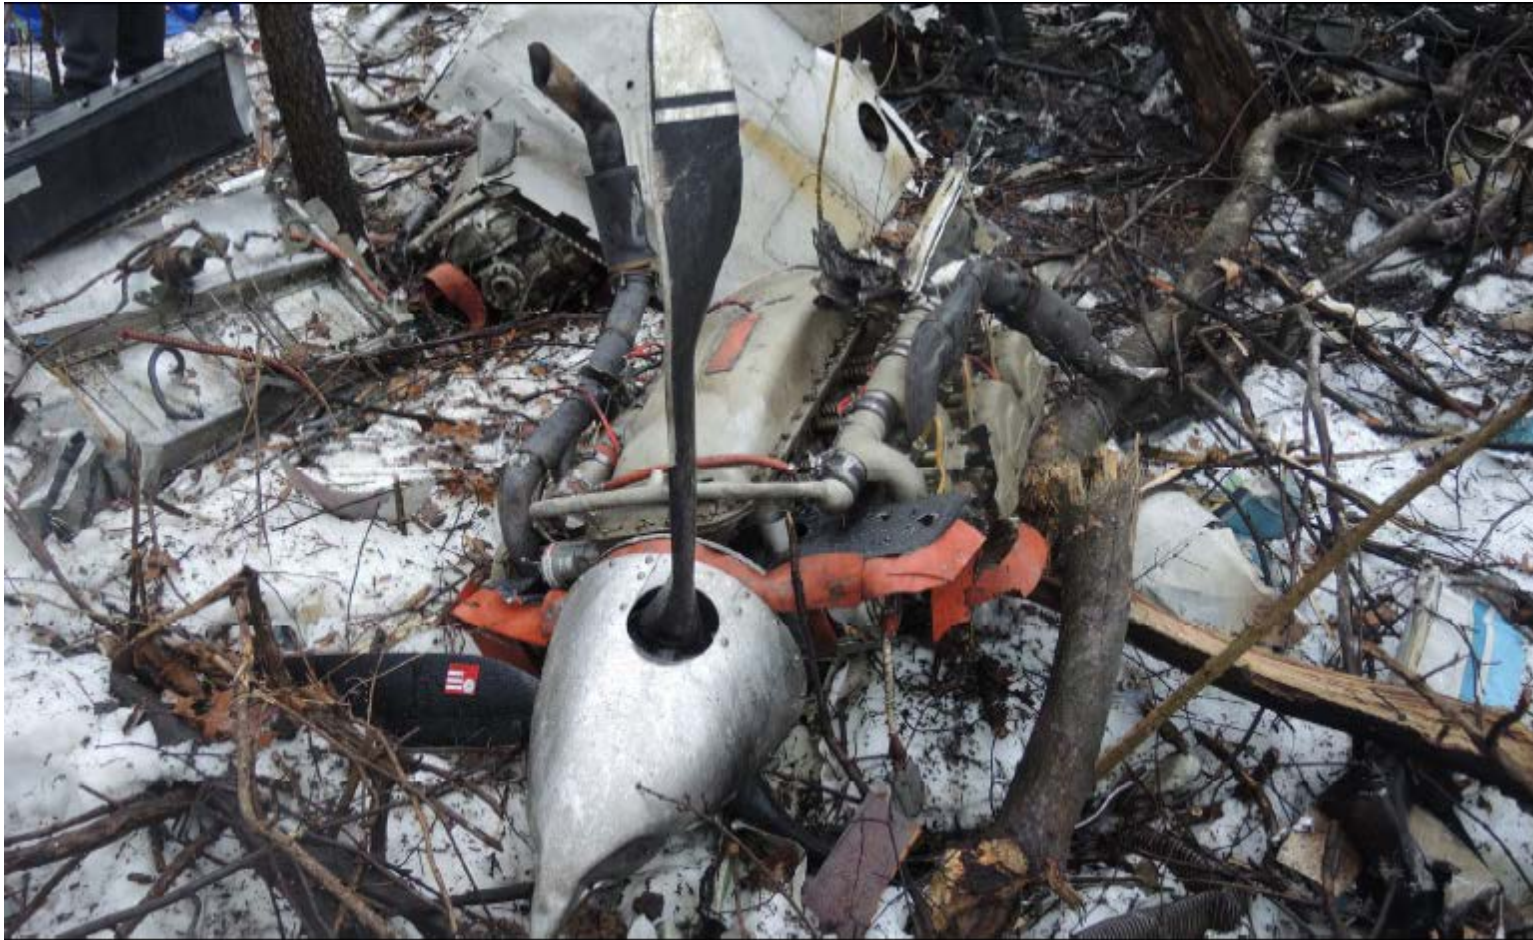
Photo 3 - Photo of engine with attached propeller near main wreckage.

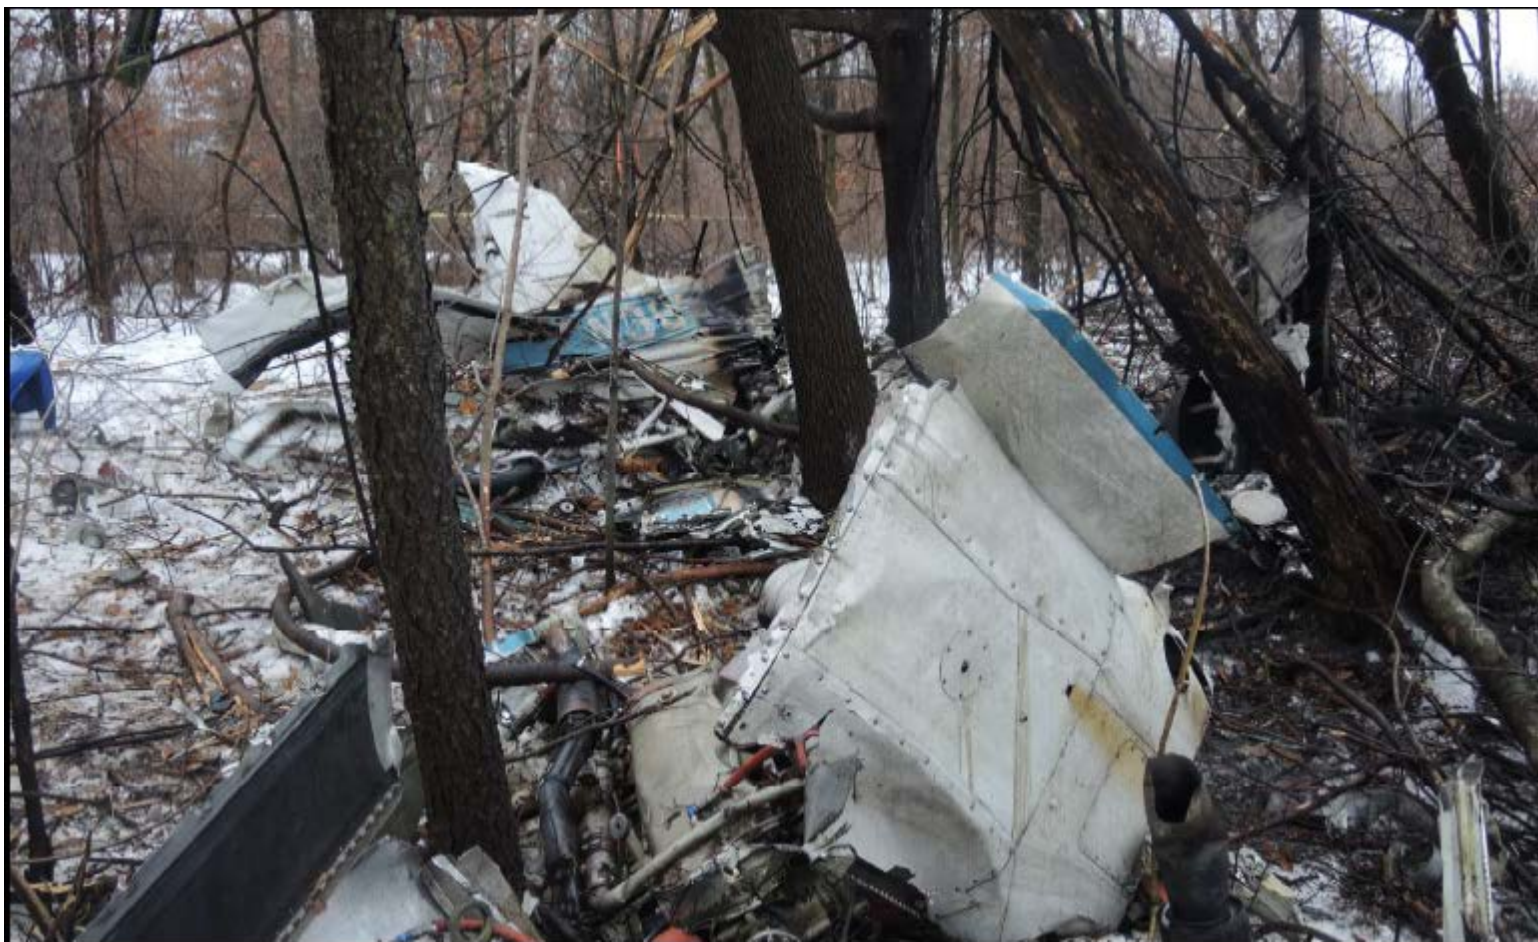
Photo 4 - Photo of second engine near main wreckage without propeller attached.

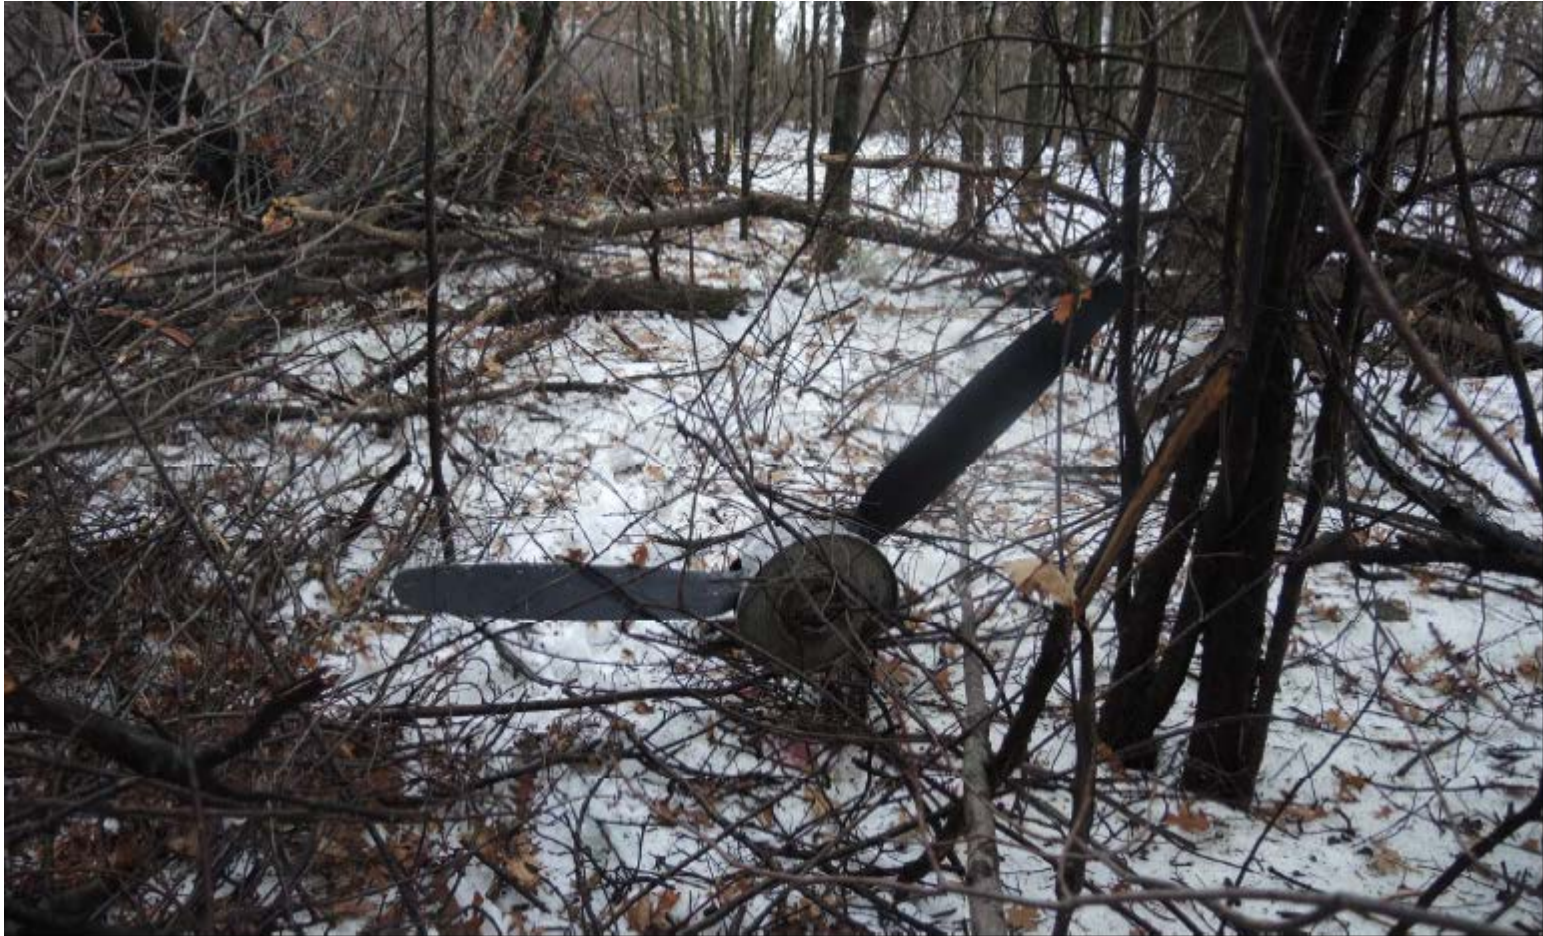
Photo 5 – Photo of second engine's detached propeller that was separated at the propeller hub.
