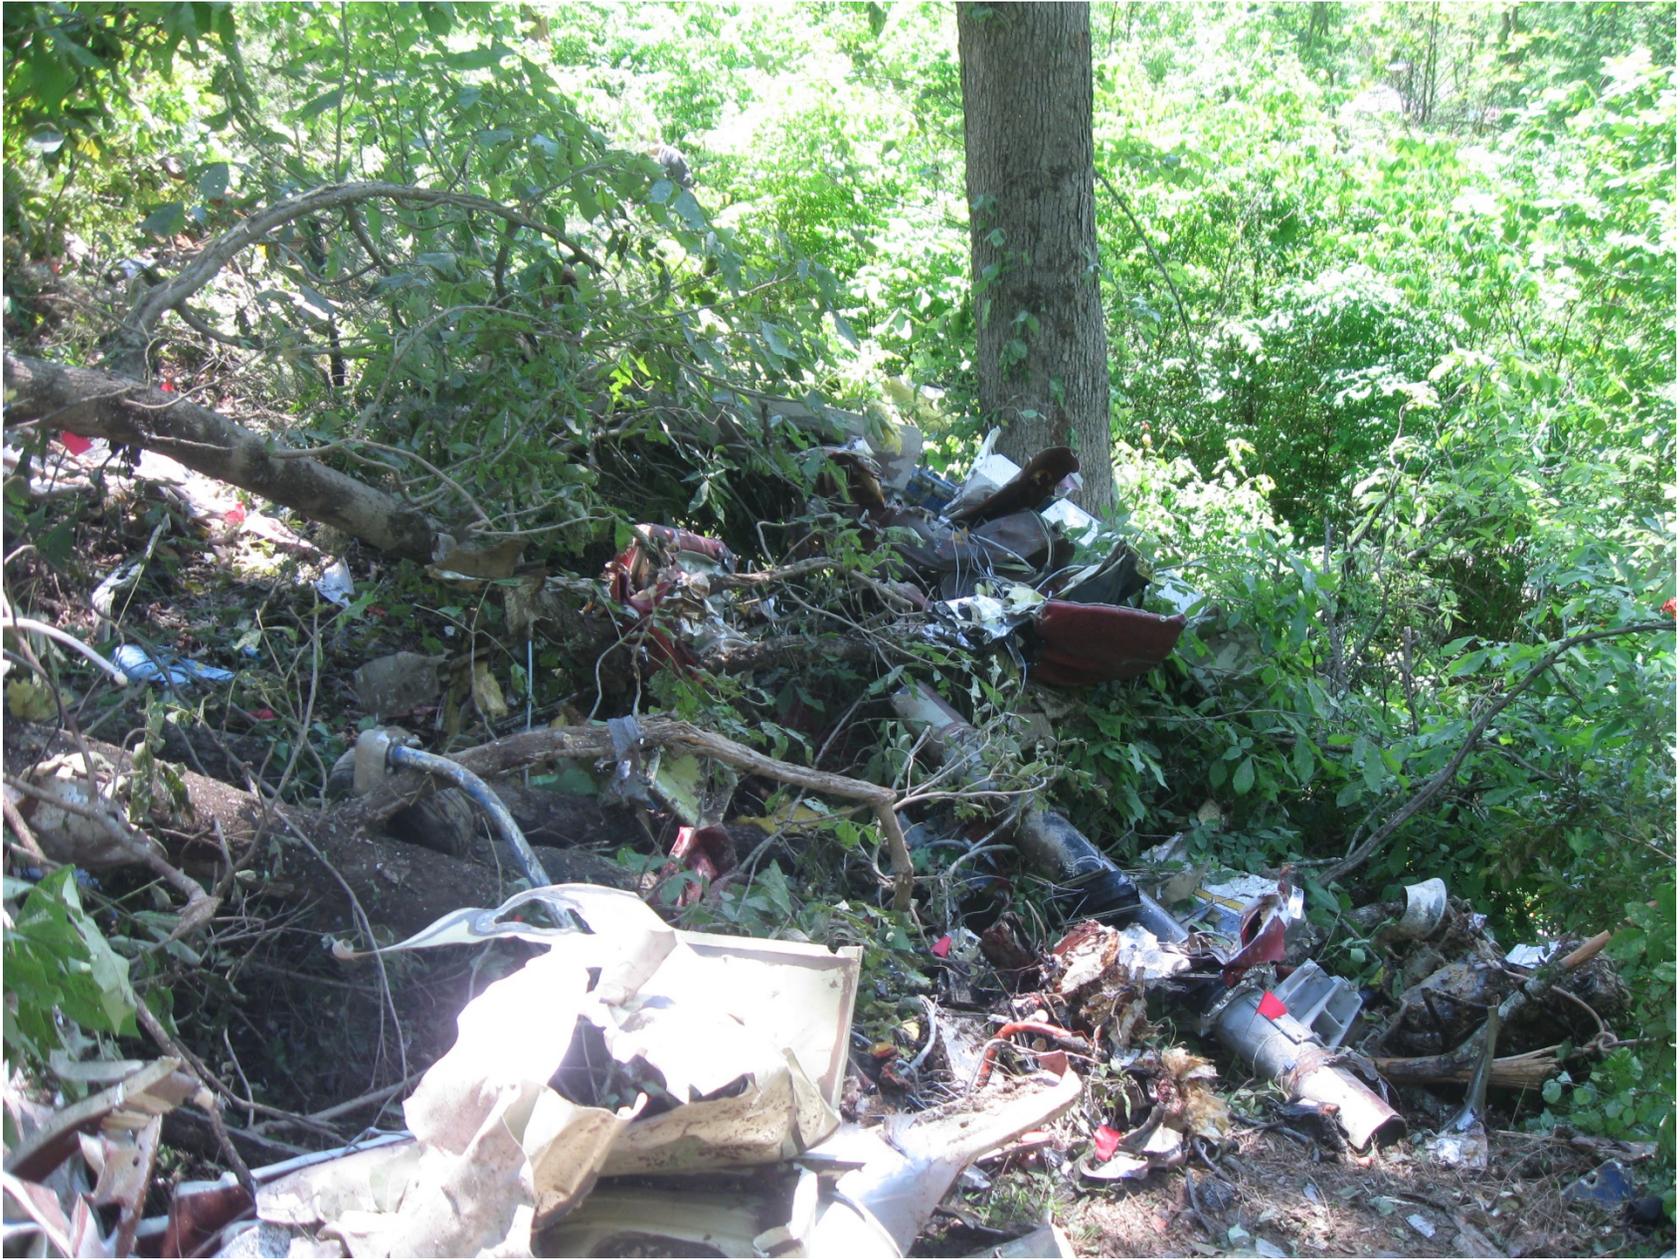
Photo 1 – Main Wreckage

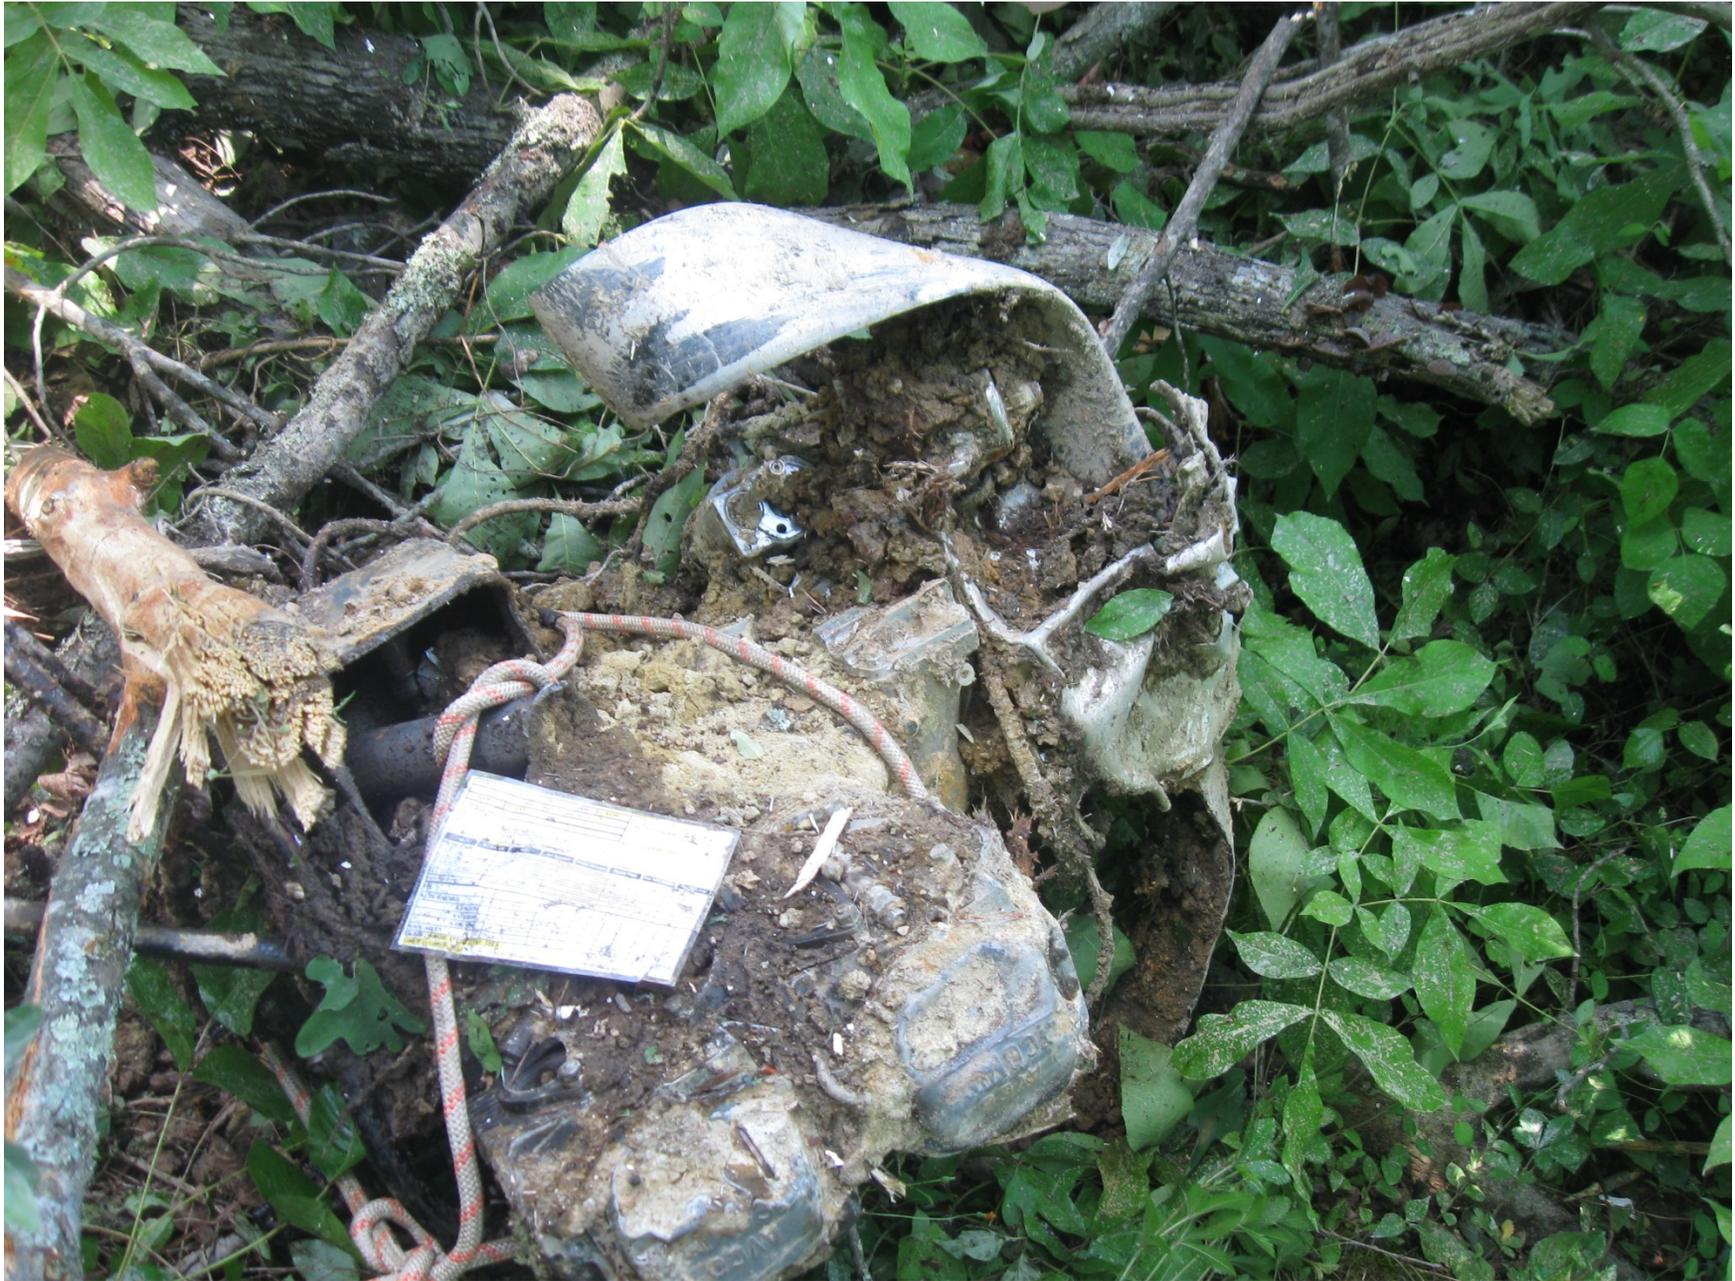
Photo 2 – Engine and propeller at accident site

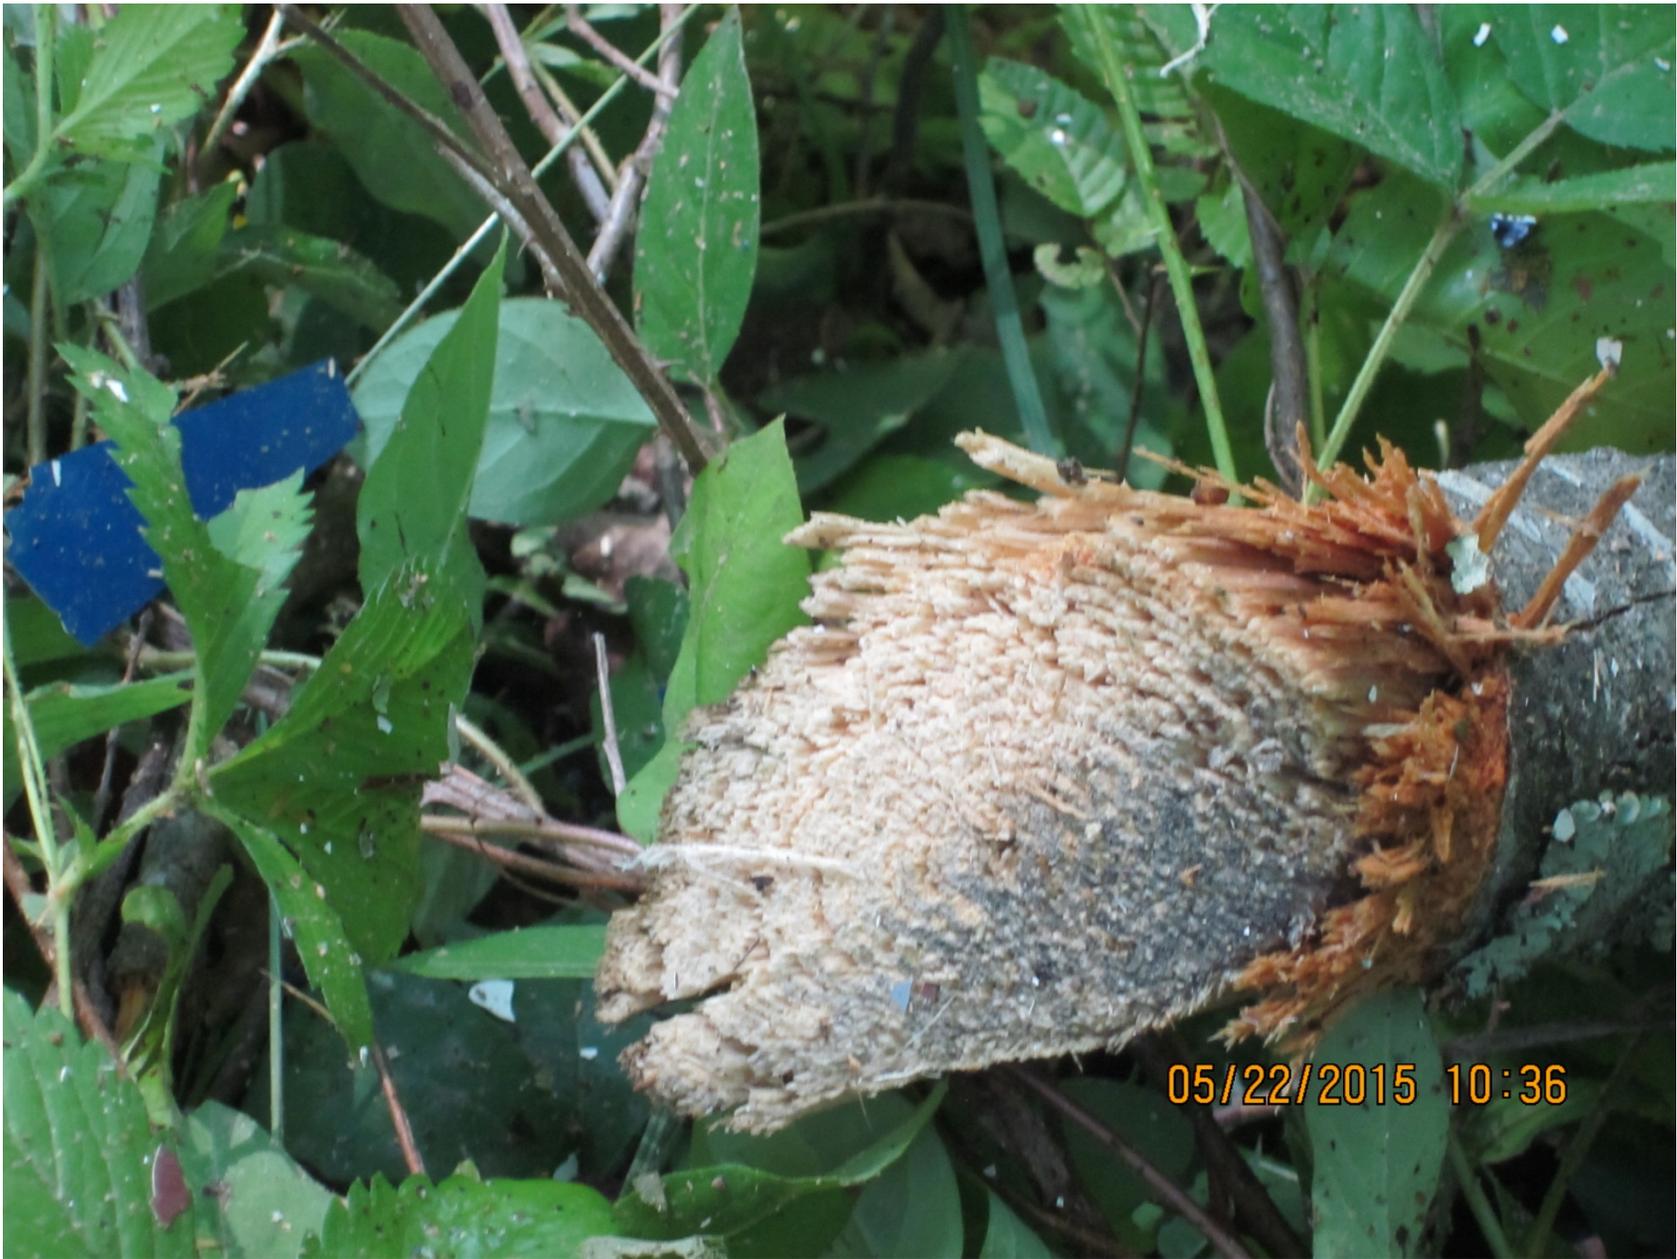
Photo 3 – Cut tree branch at accident site

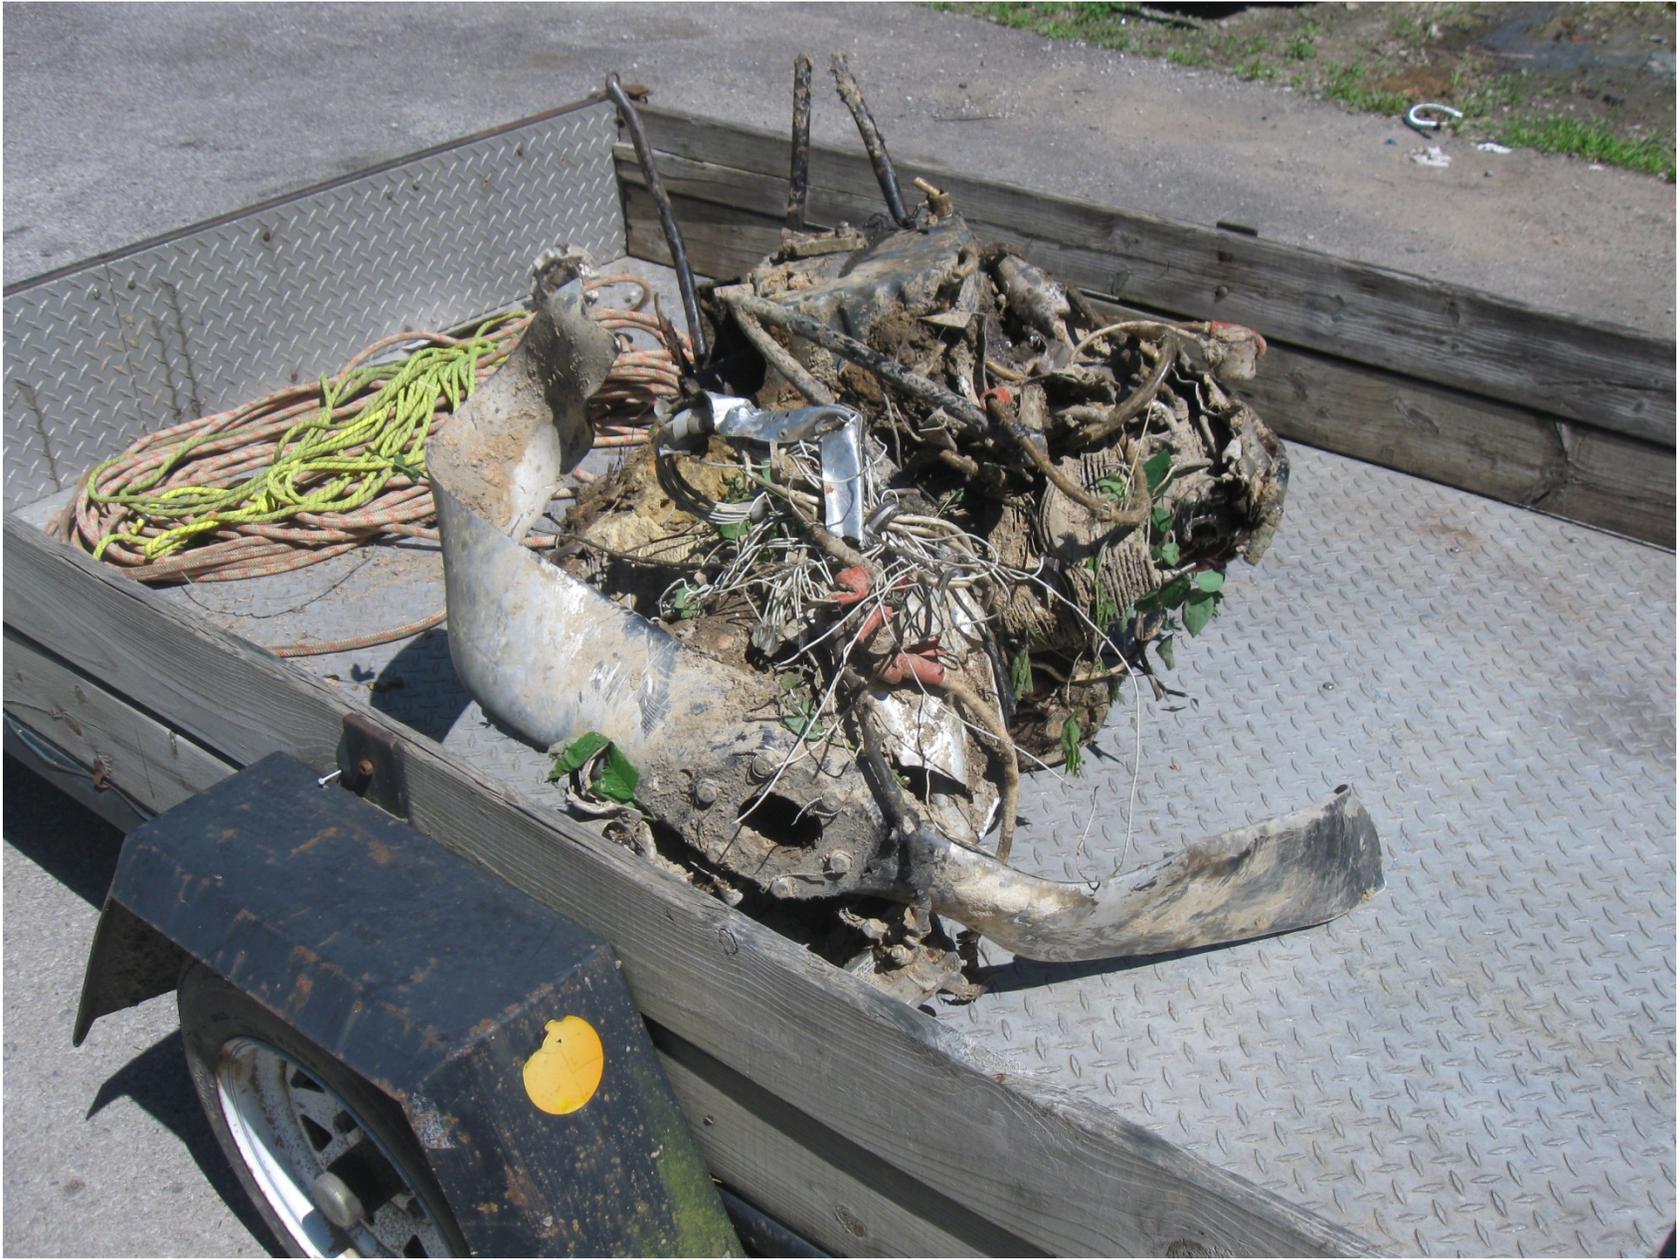
Photo 4 – Engine and propeller after recovery
