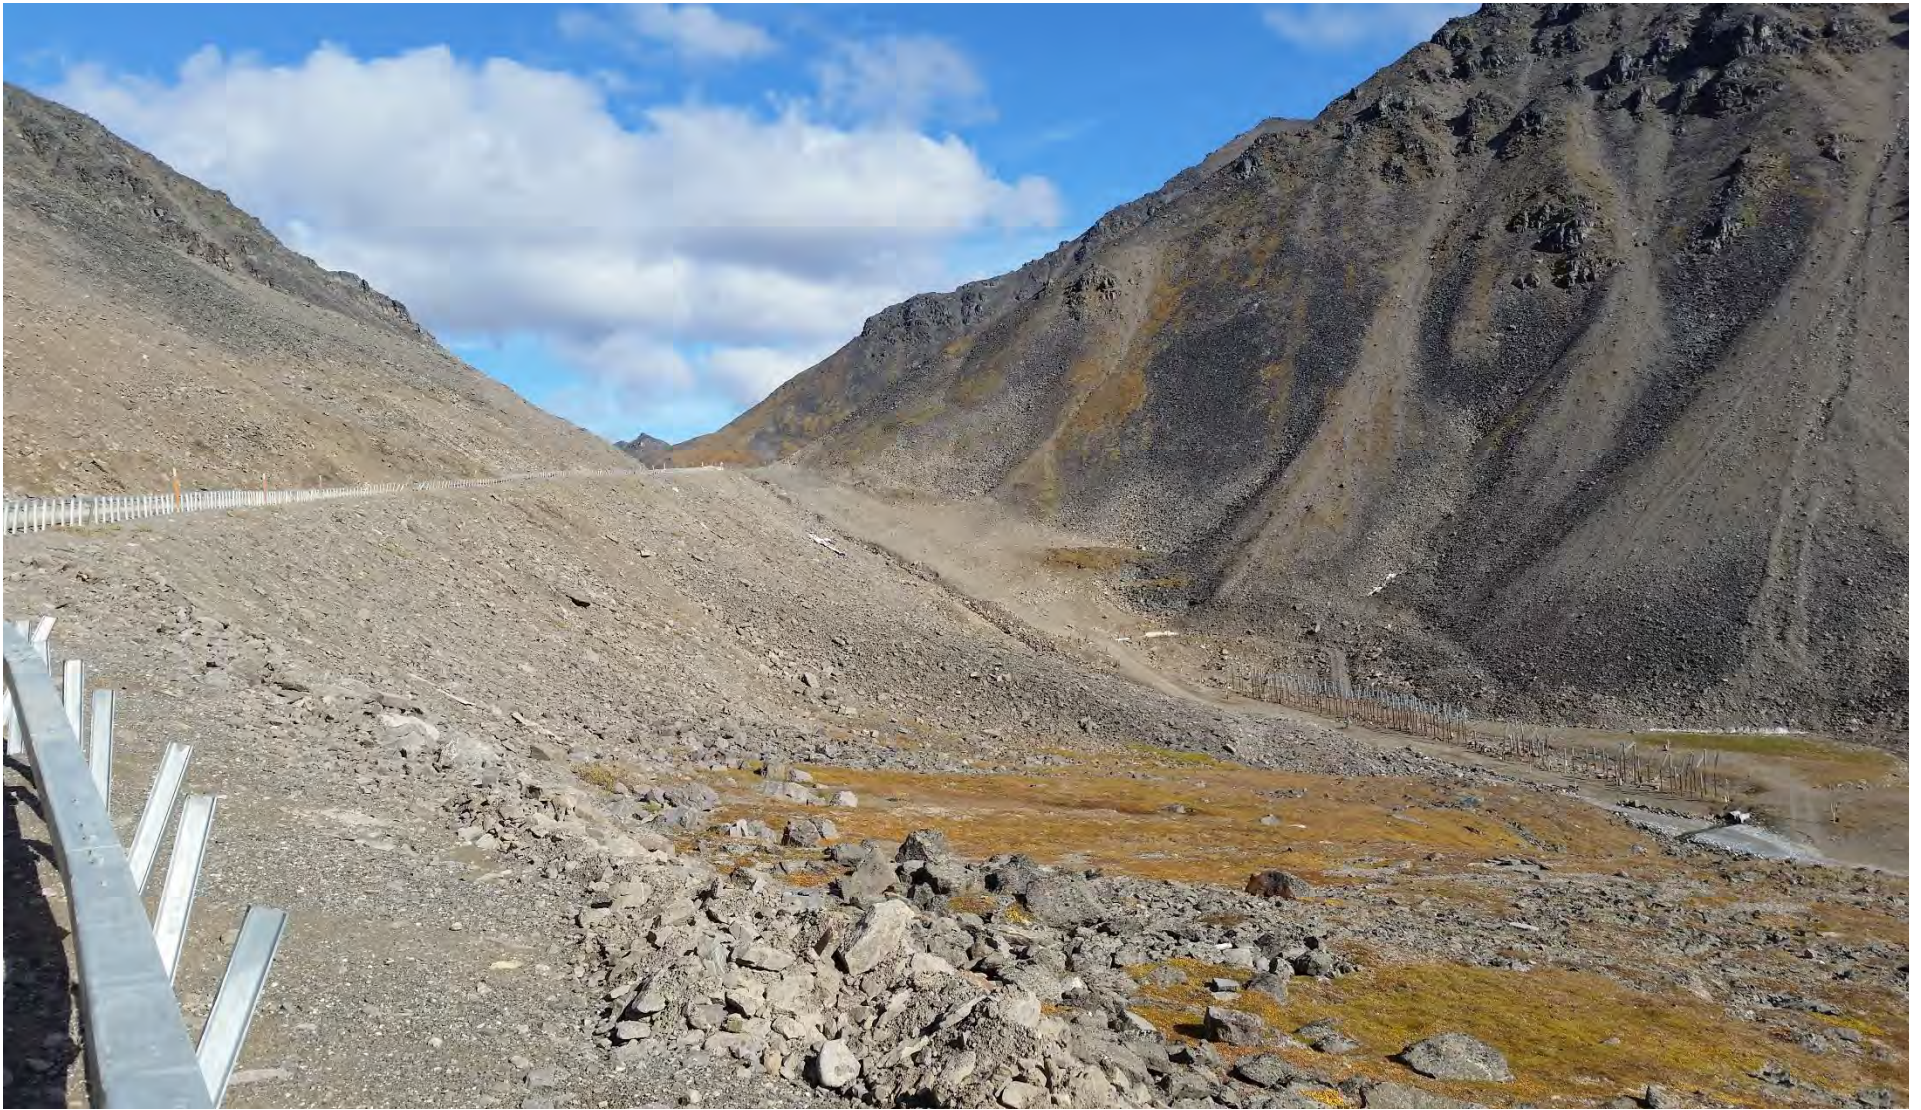
Photo 1 – Accident Location – Courtesy of FAA

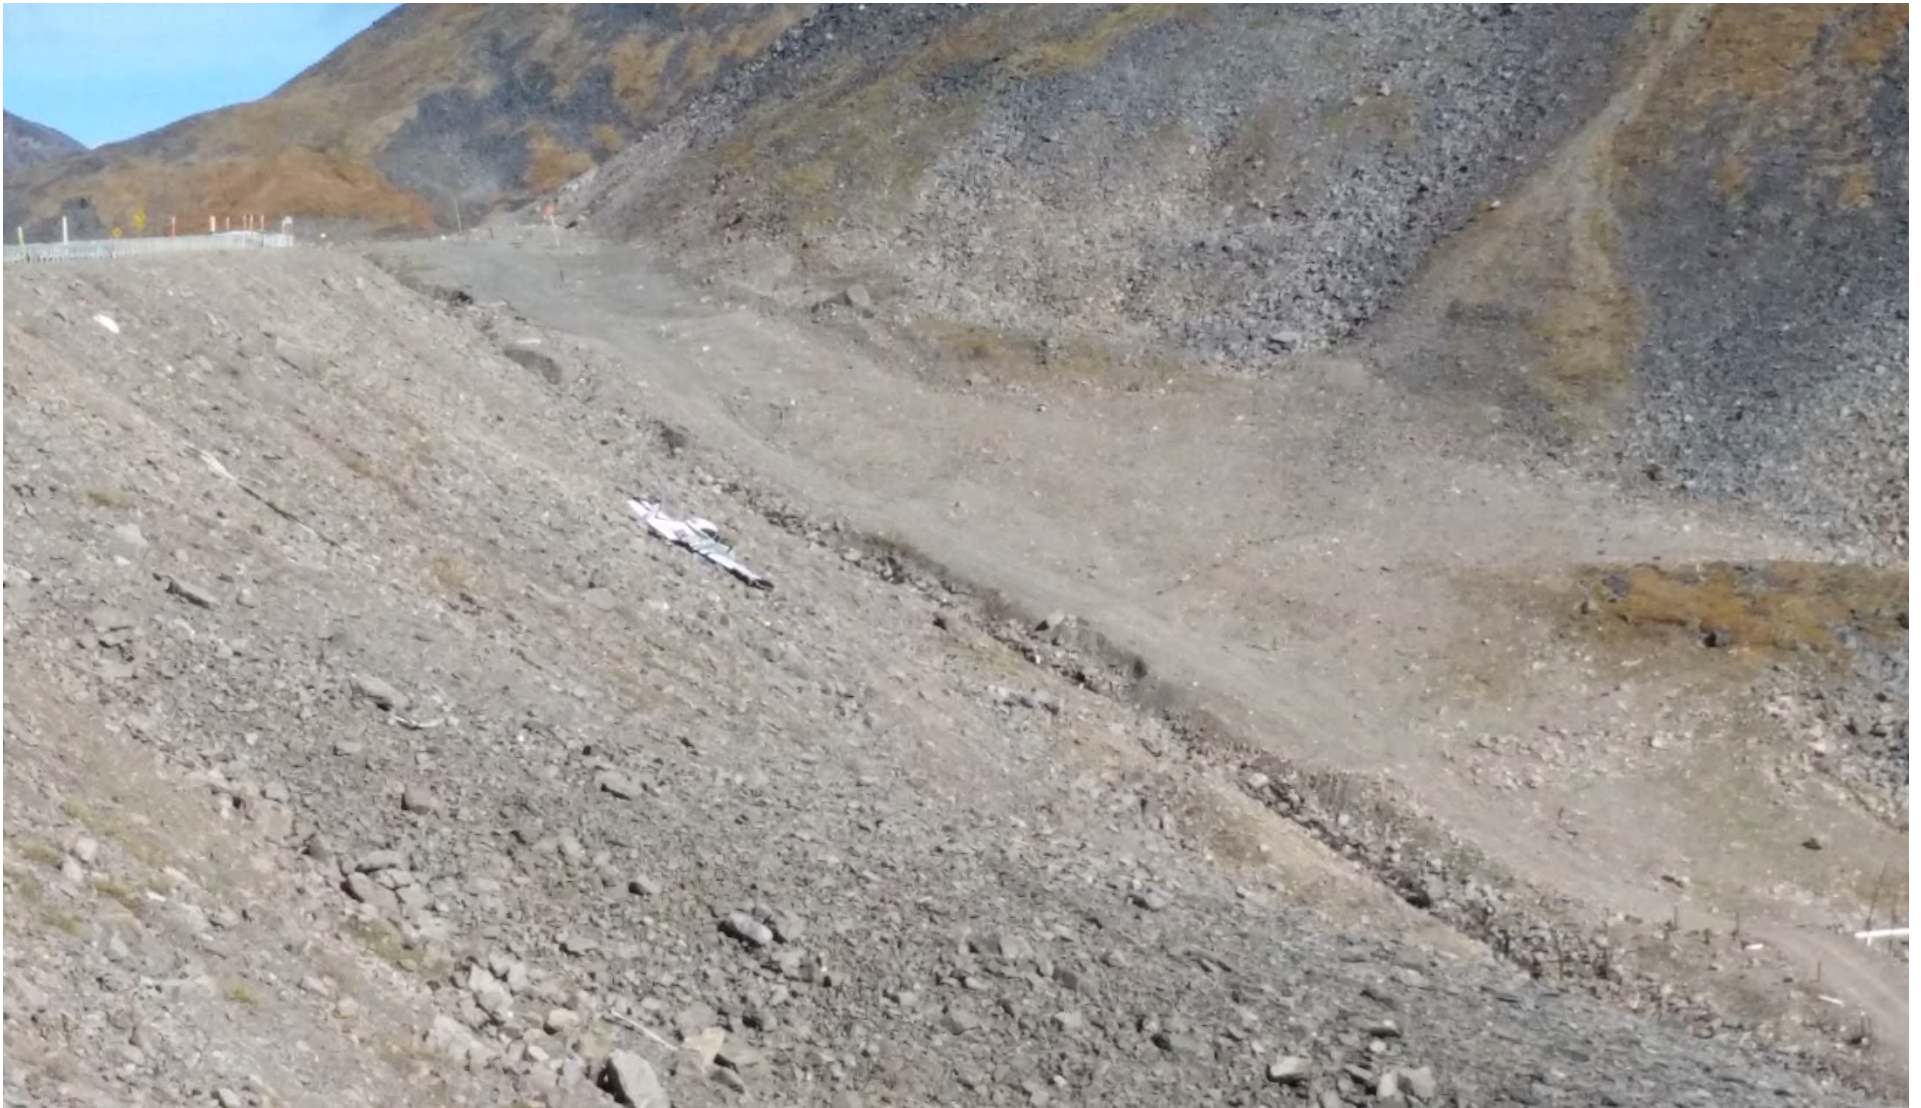
Photo 2 – Main Wreckage – Courtesy of FAA

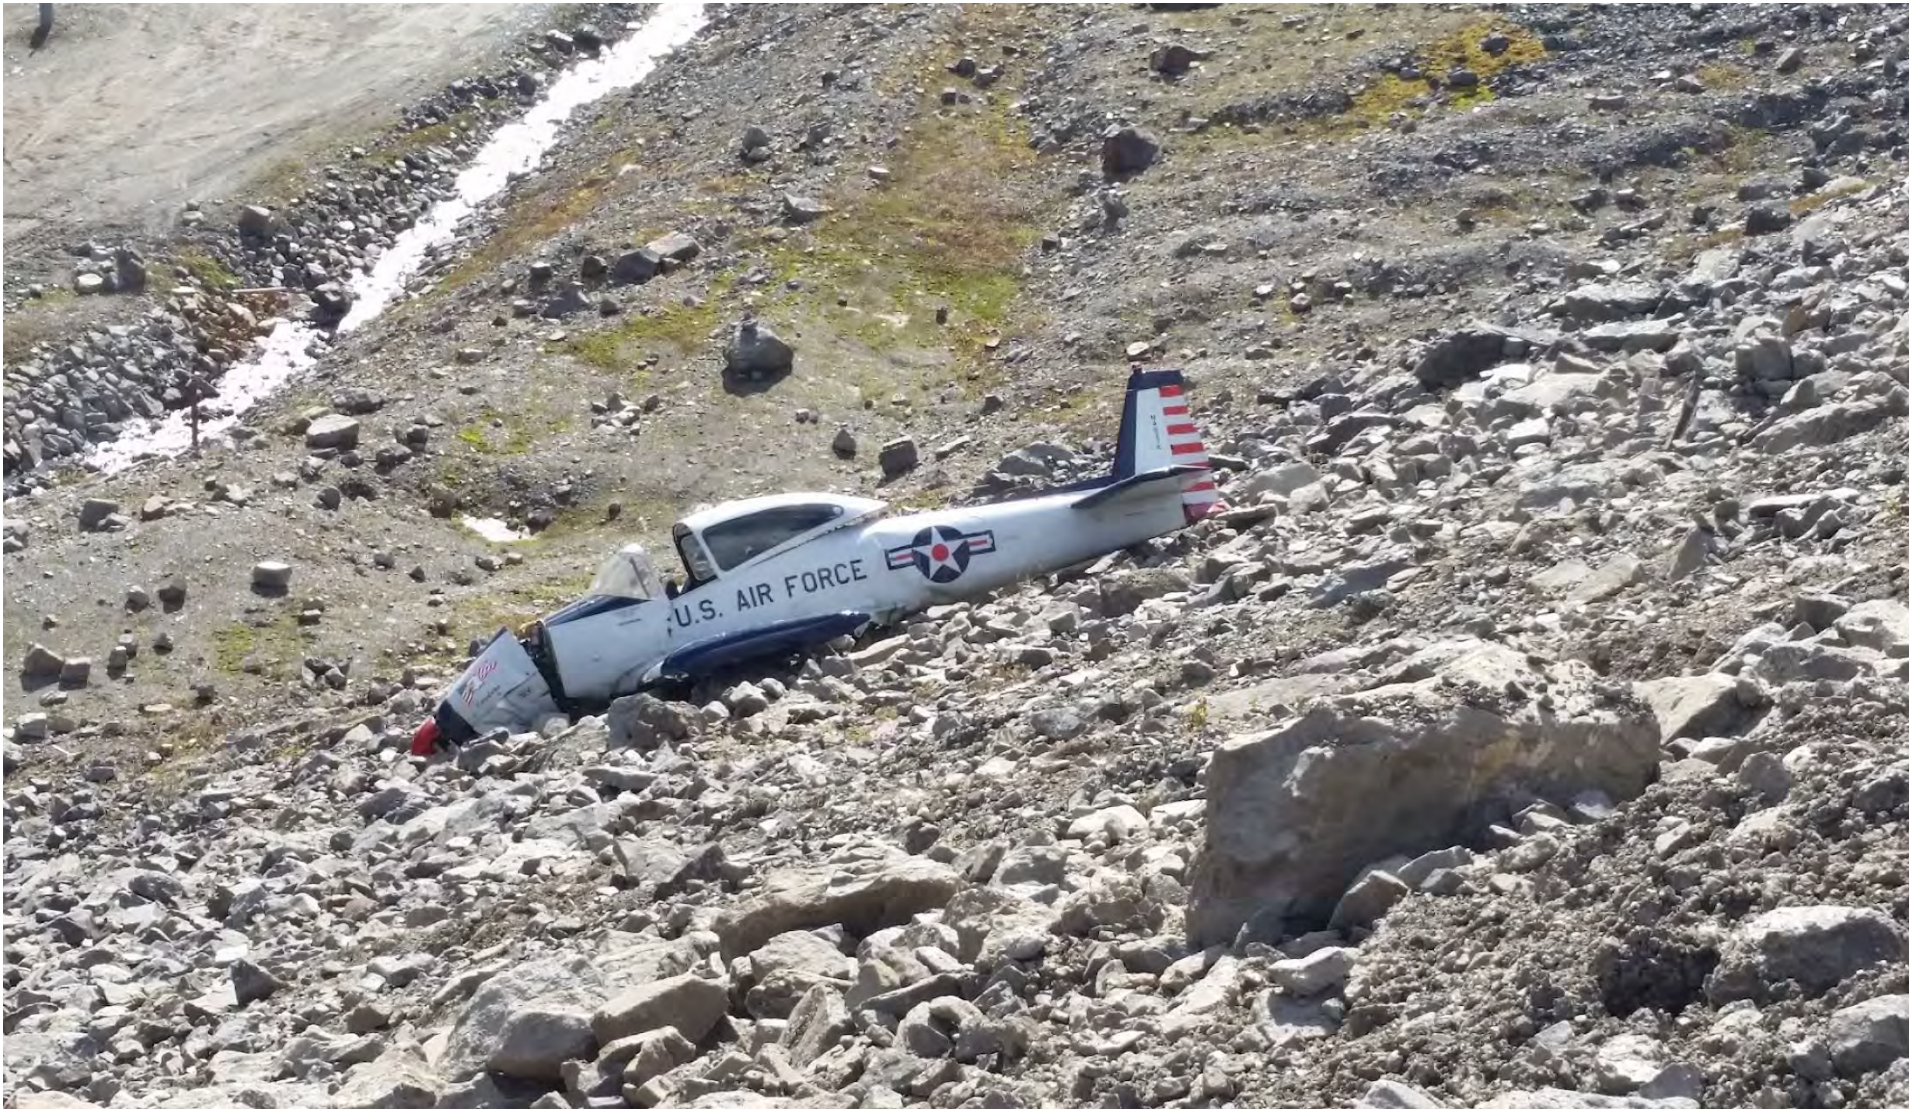
Photo 3 – View of Left Side of Main Wreckage – Courtesy of FAA

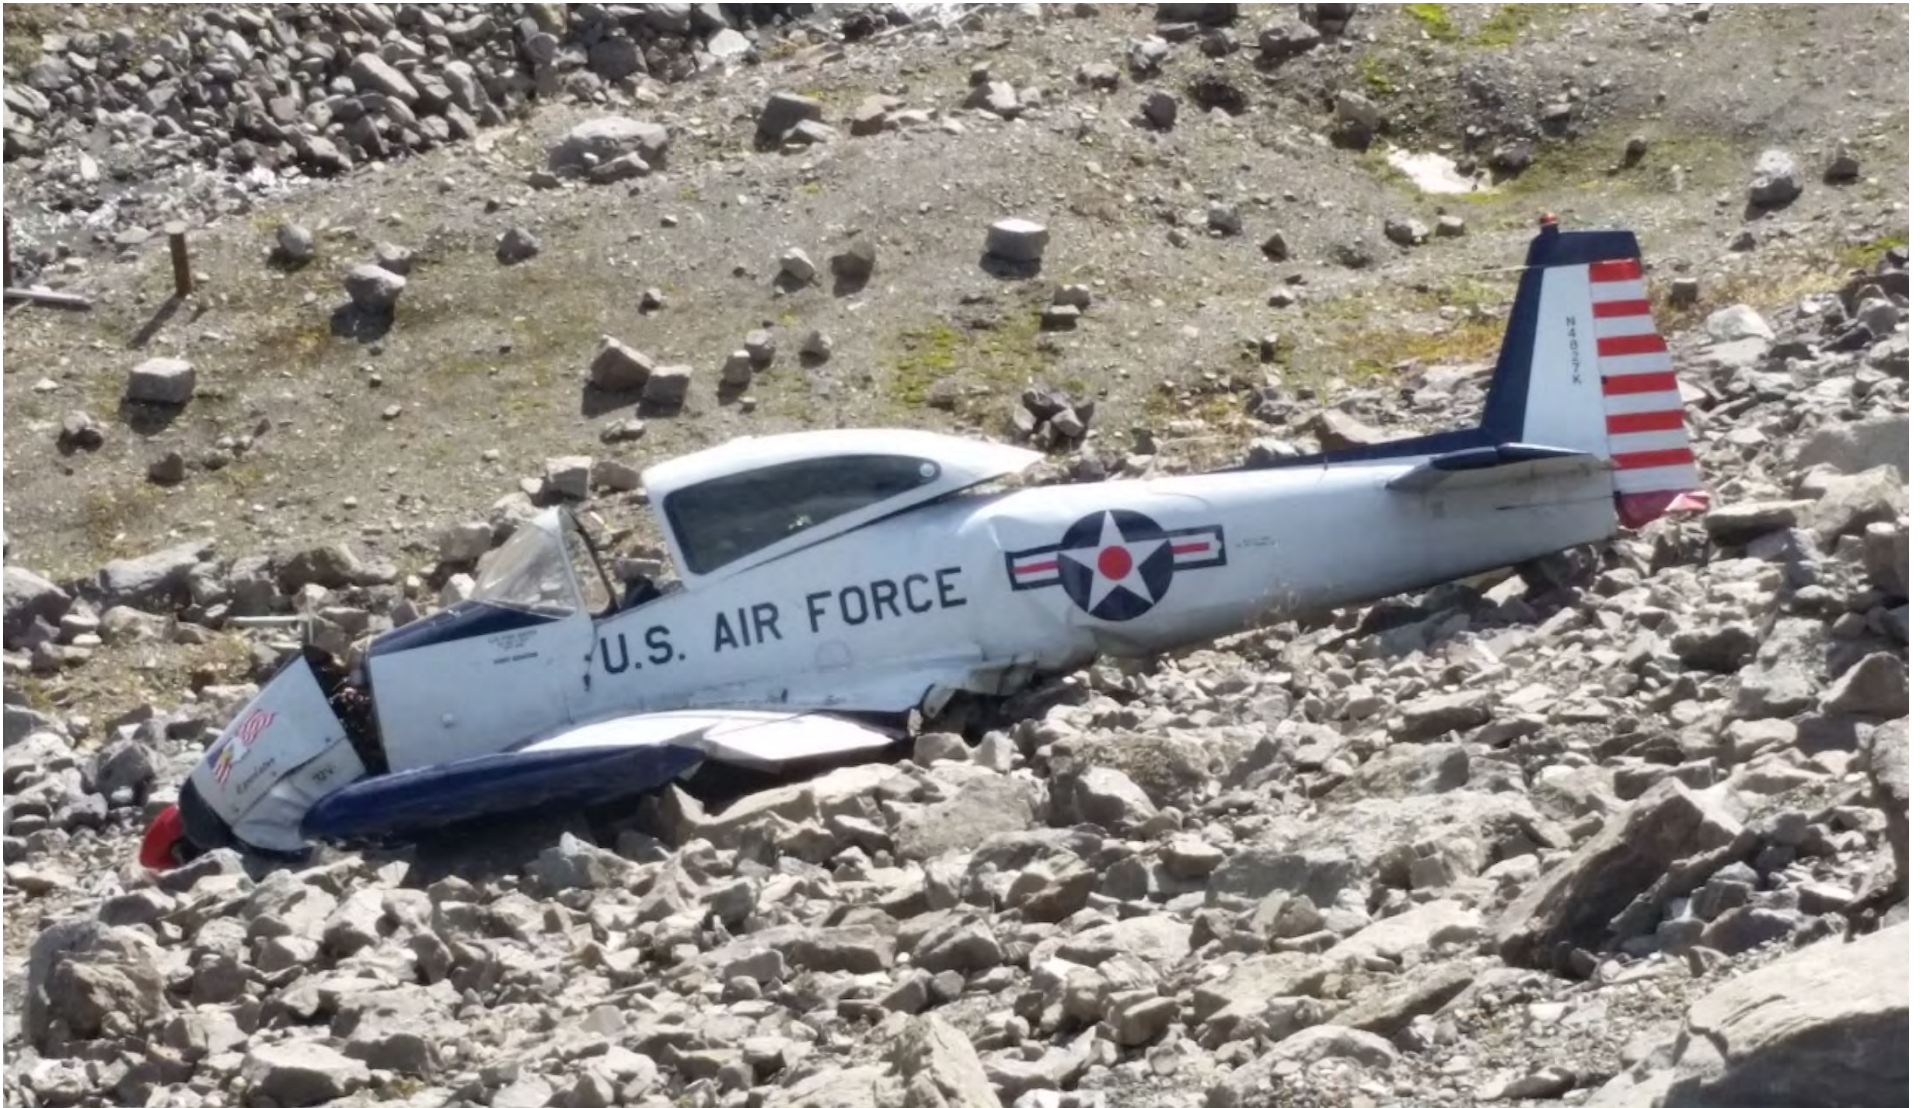
Photo 4 – Close Up of Main Wreckage – Courtesy of FAA

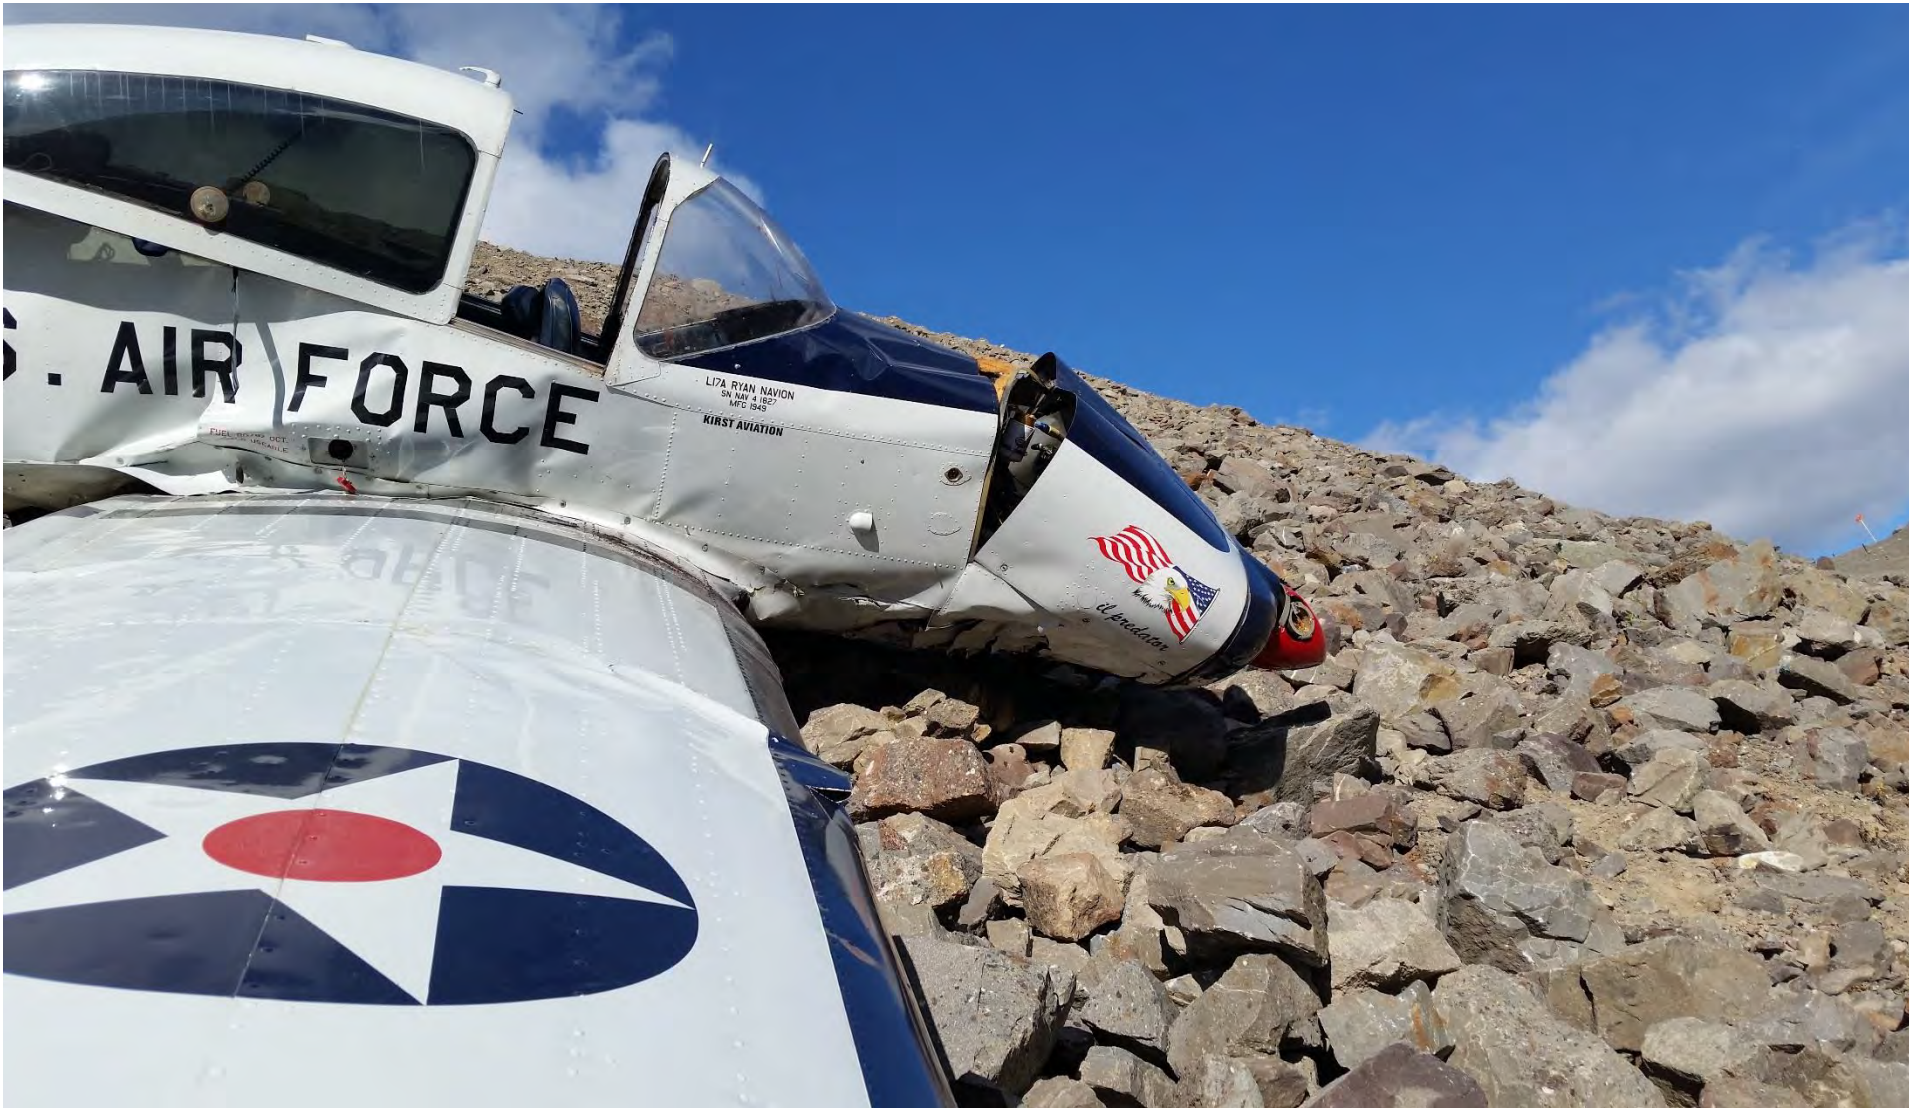
Photo 5 – Right Front Side of Main Wreckage – Courtesy of FAA

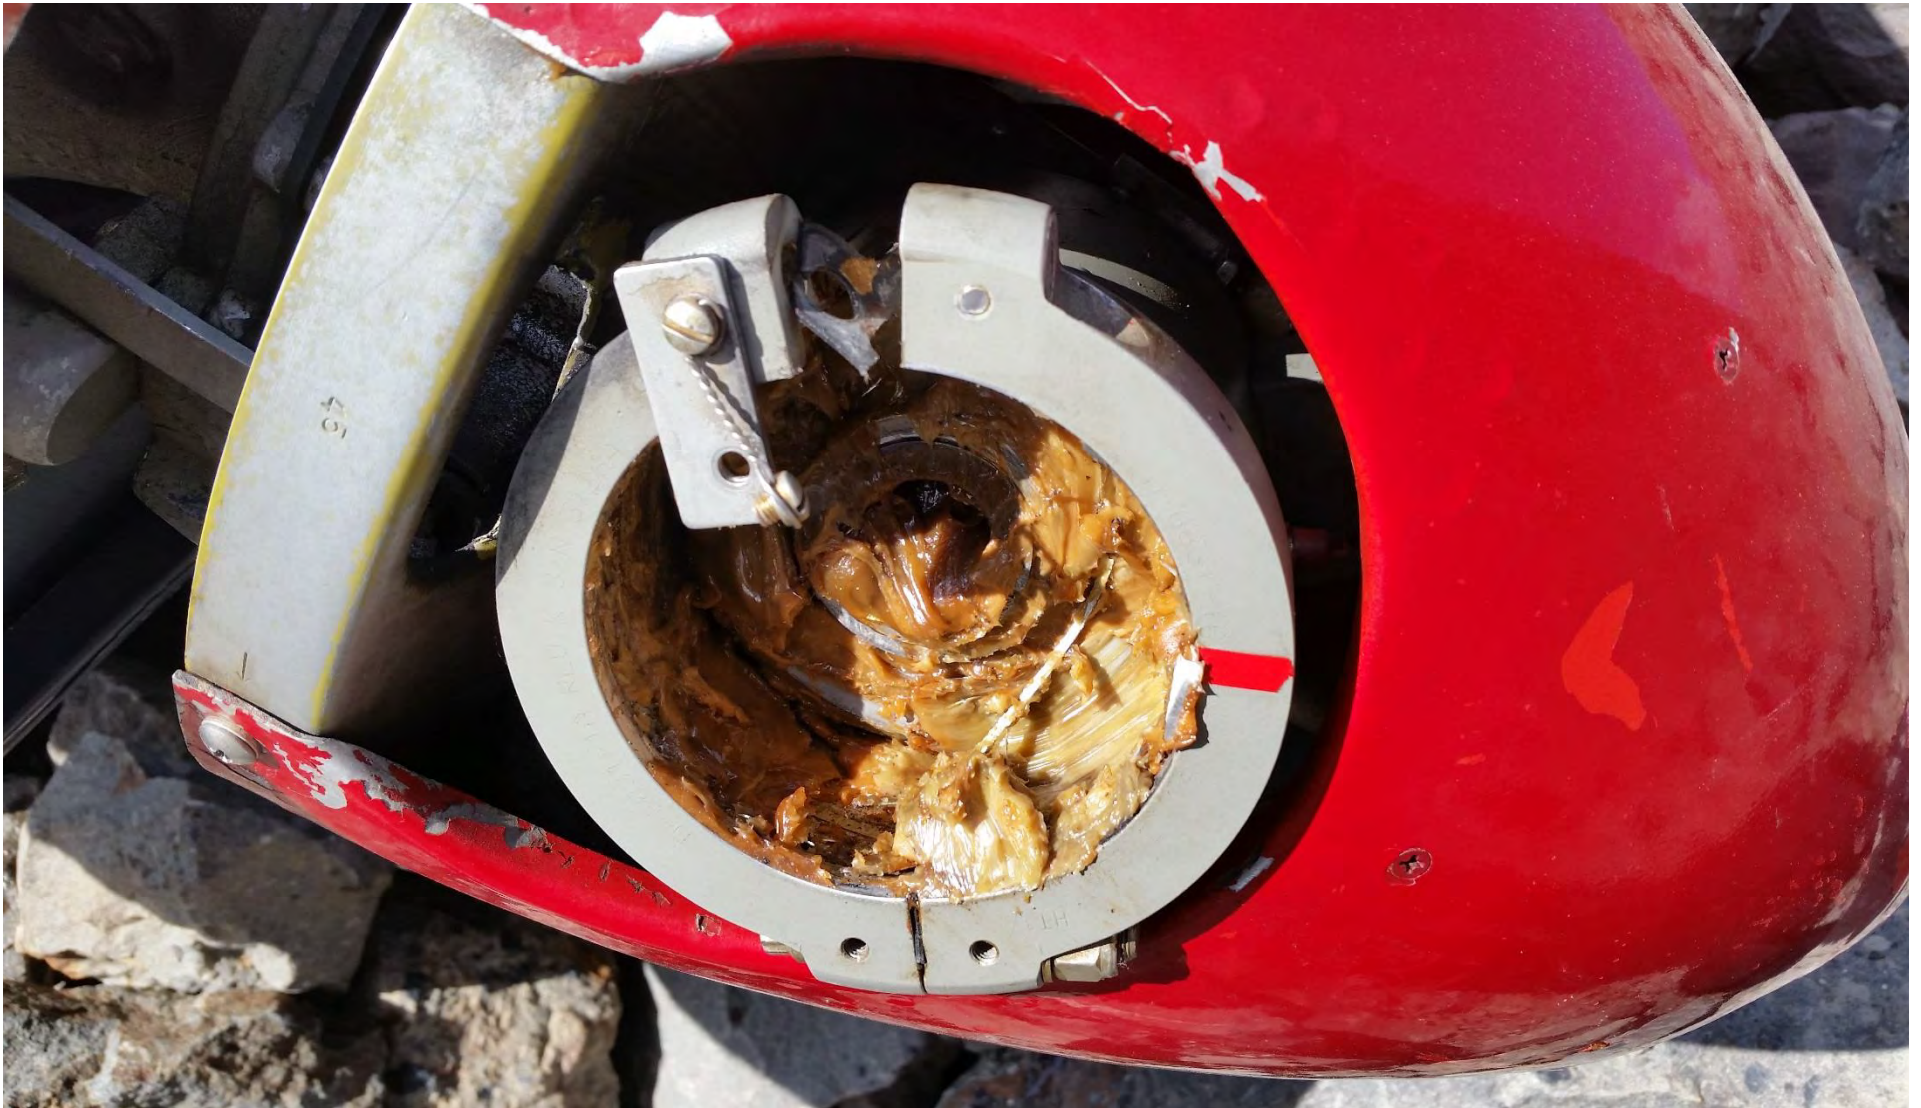
Photo 6 – Close Up of Propeller Hub – Courtesy of FAA

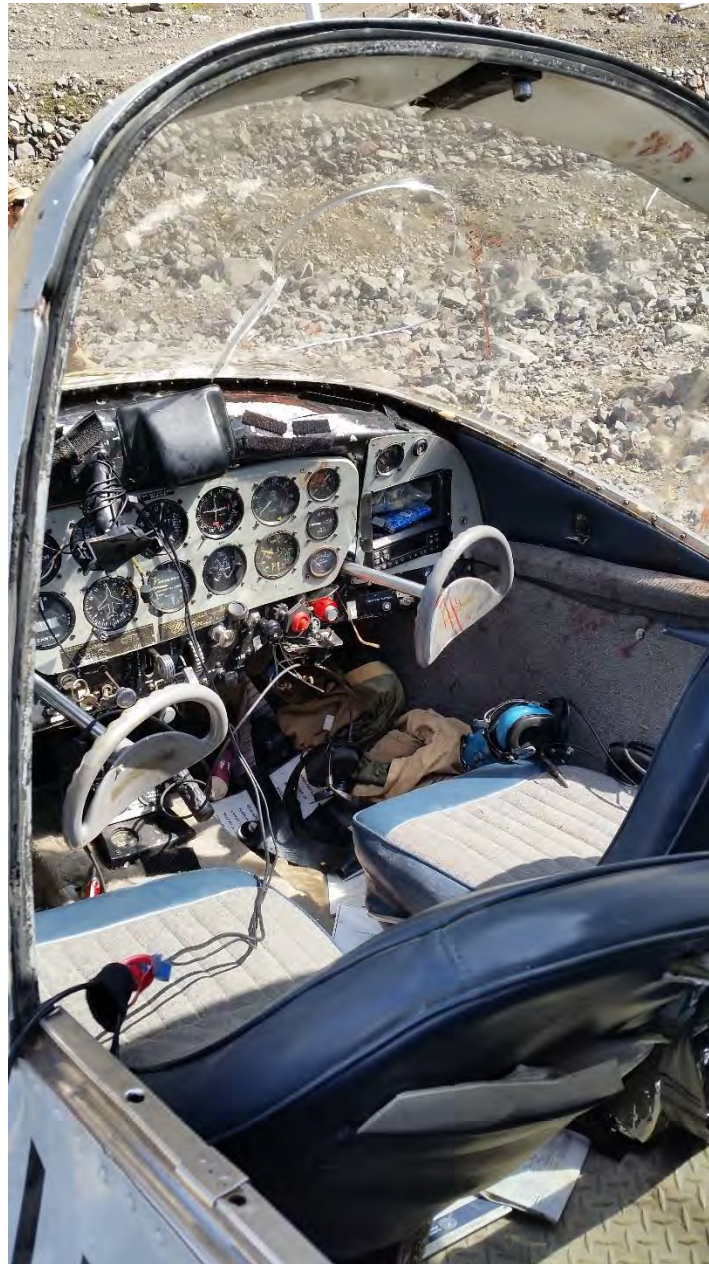
Photo 7 – Cockpit – Courtesy of FAA

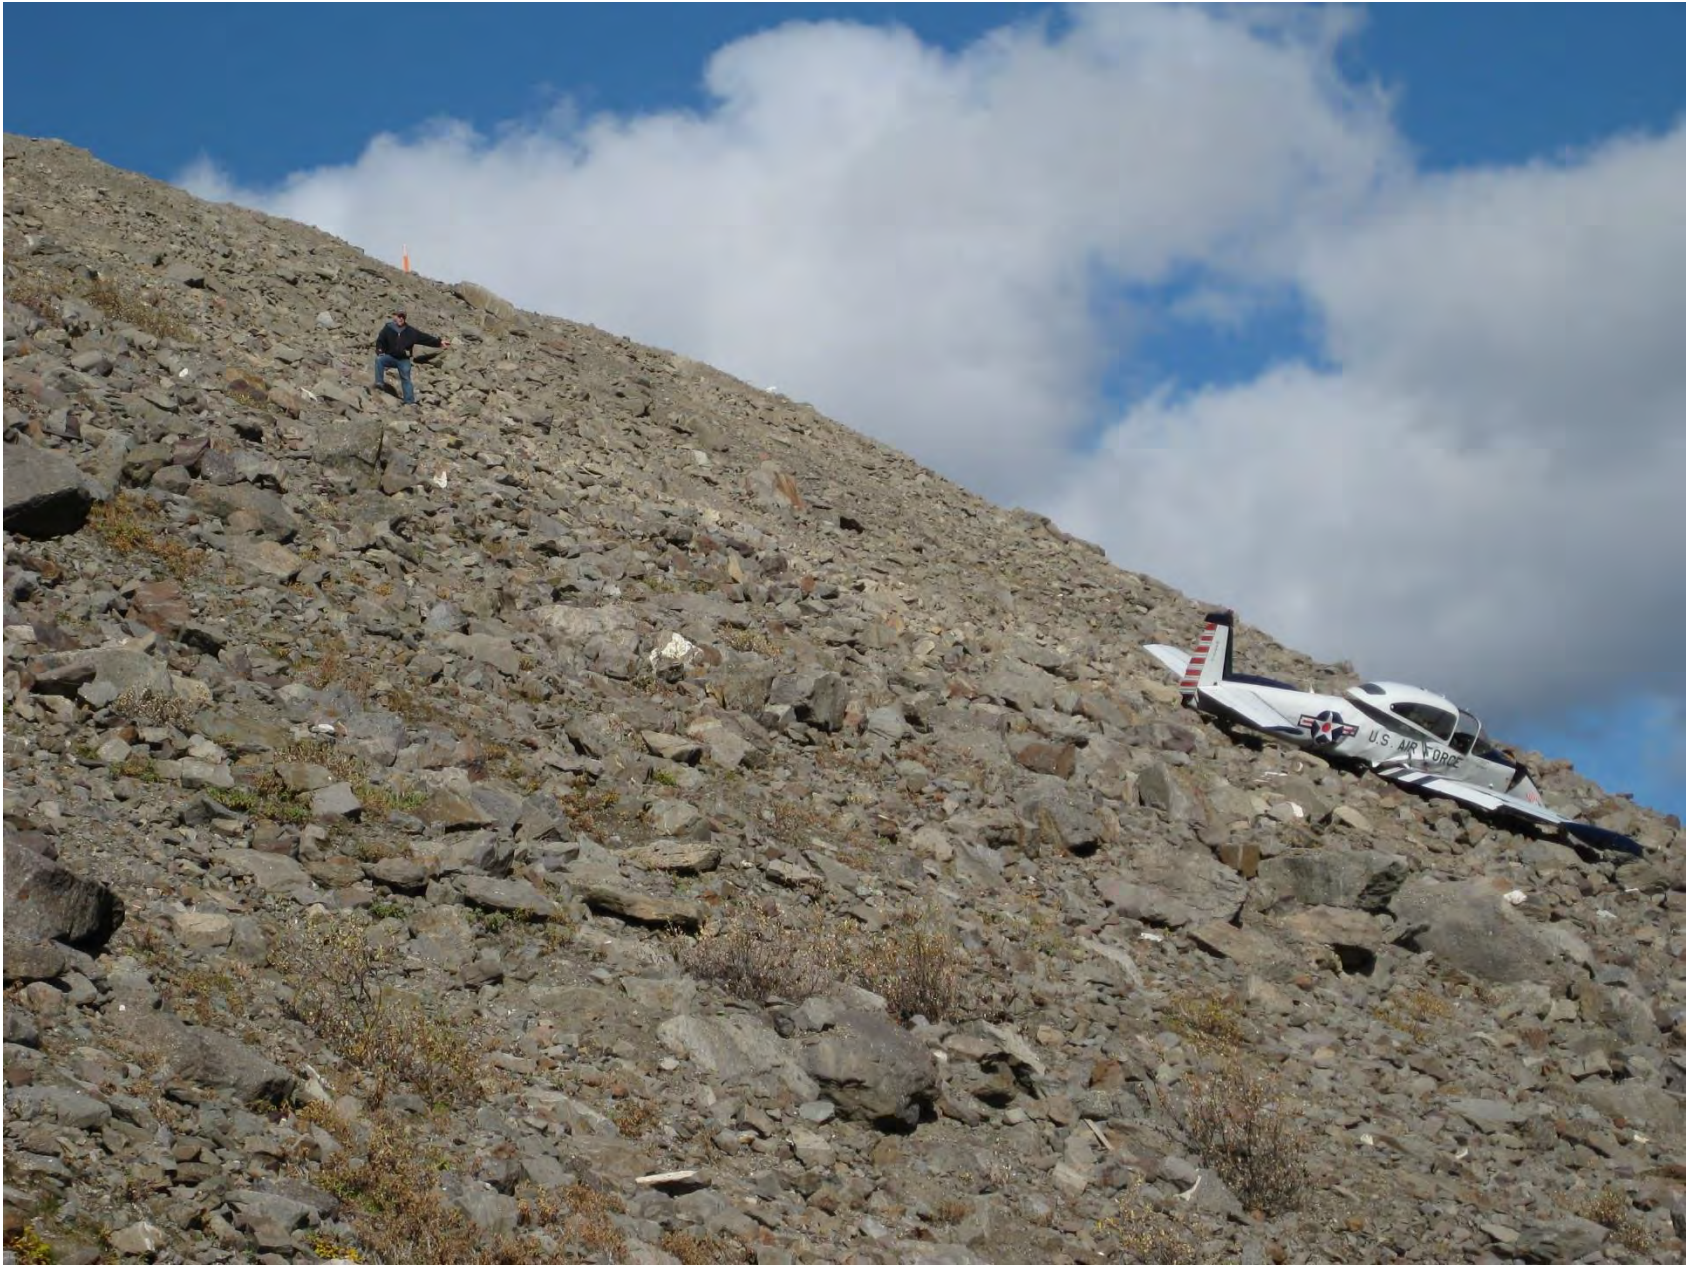
Photo 9 – Direction of Travel – Courtesy of FAA

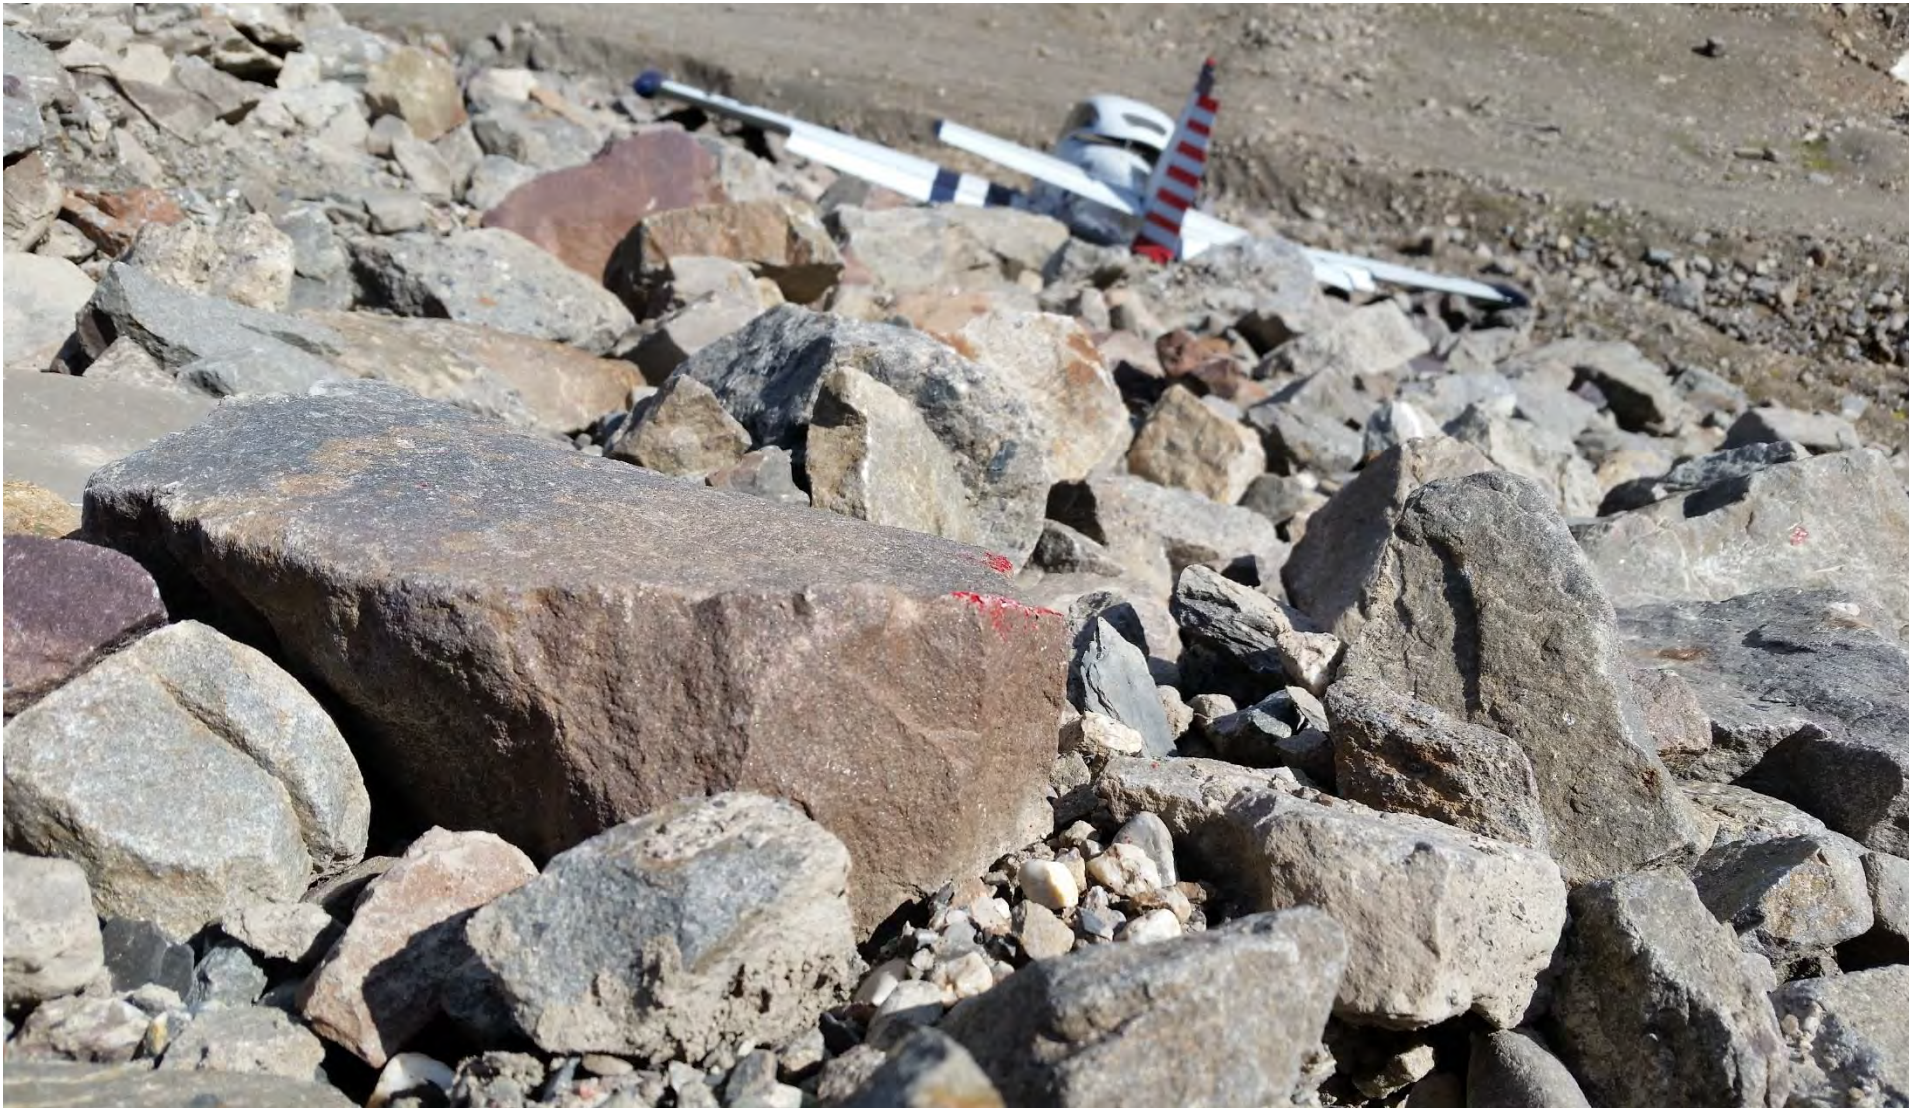
Photo 10 – Paint Transfer – Courtesy of FAA

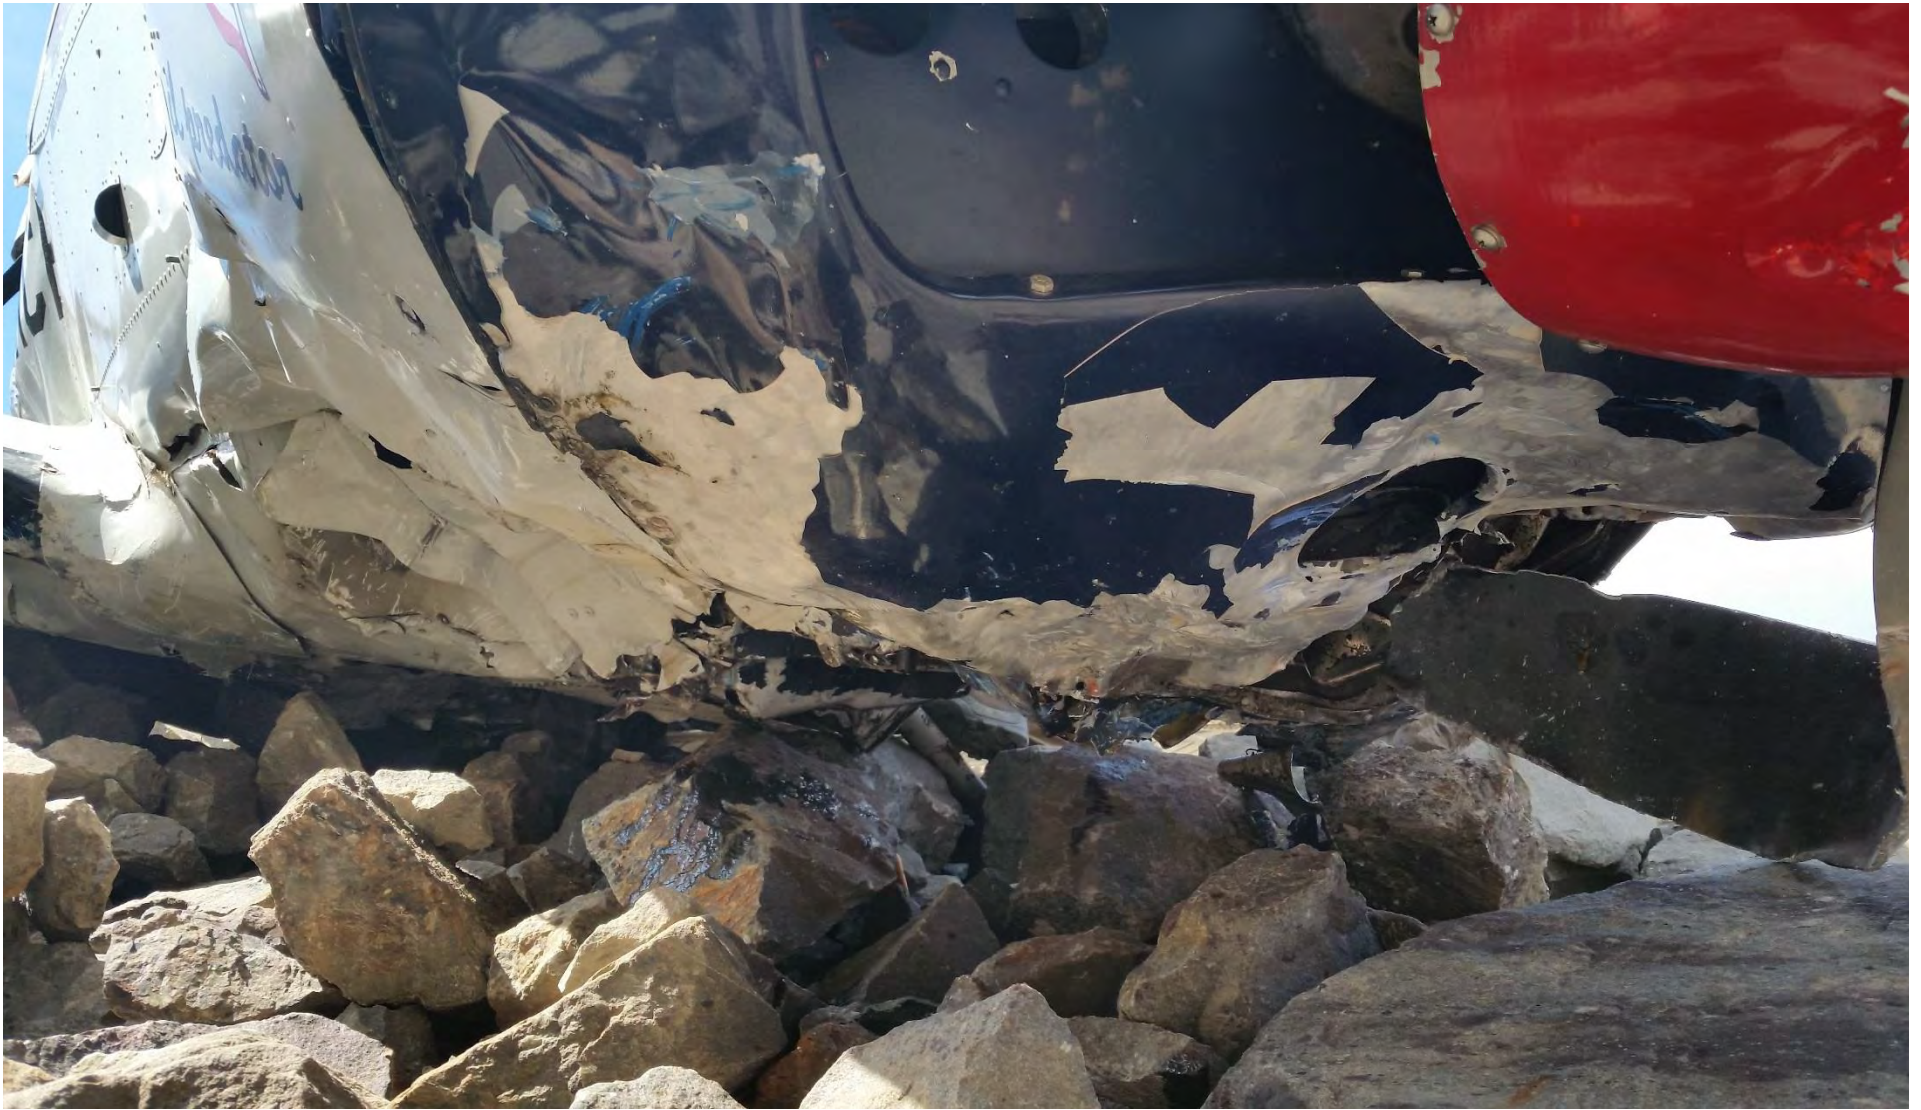
Photo 11 – Propeller Blade and Underside of Cowling – Courtesy of FAA

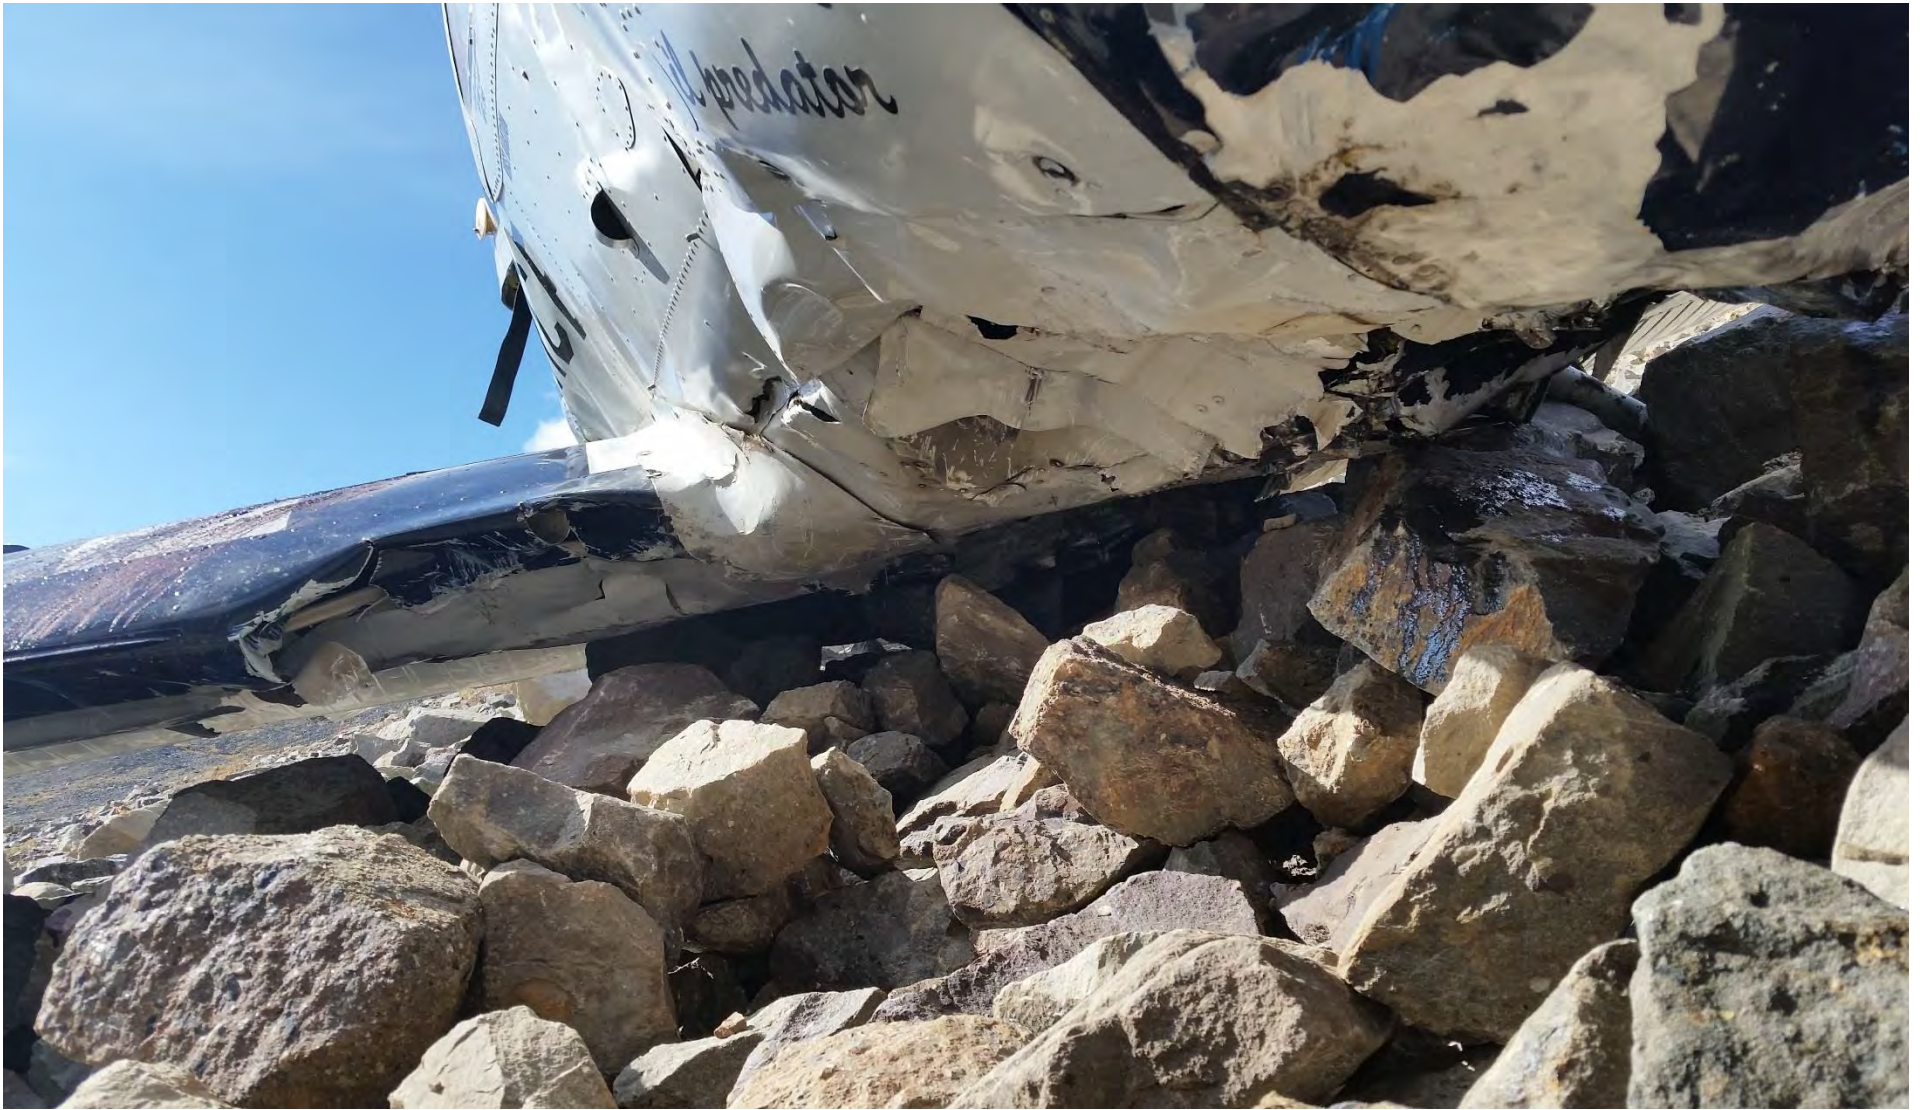
Photo 12 – Close Up of Underside of Cowling – Courtesy of FAA
