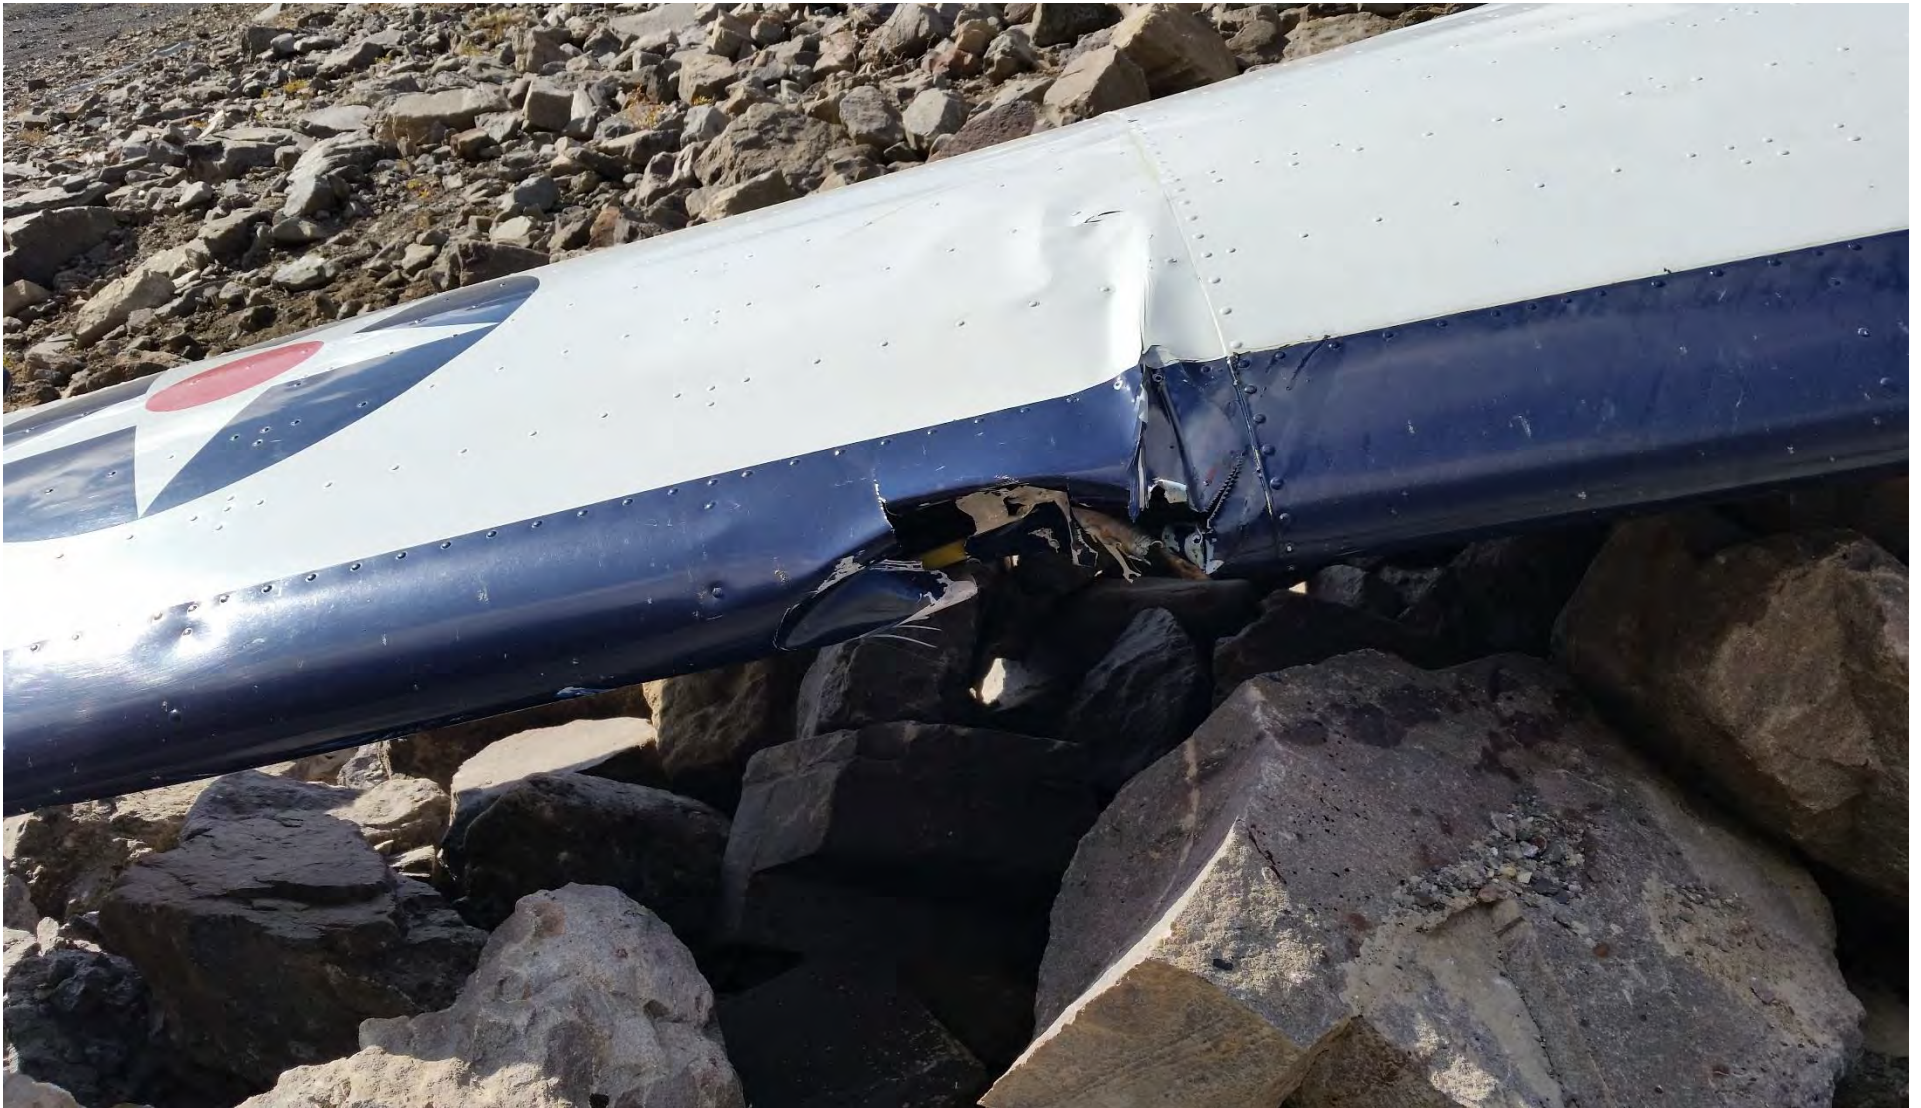
Photo 13 – Right Wing Leading Edge – Courtesy of FAA

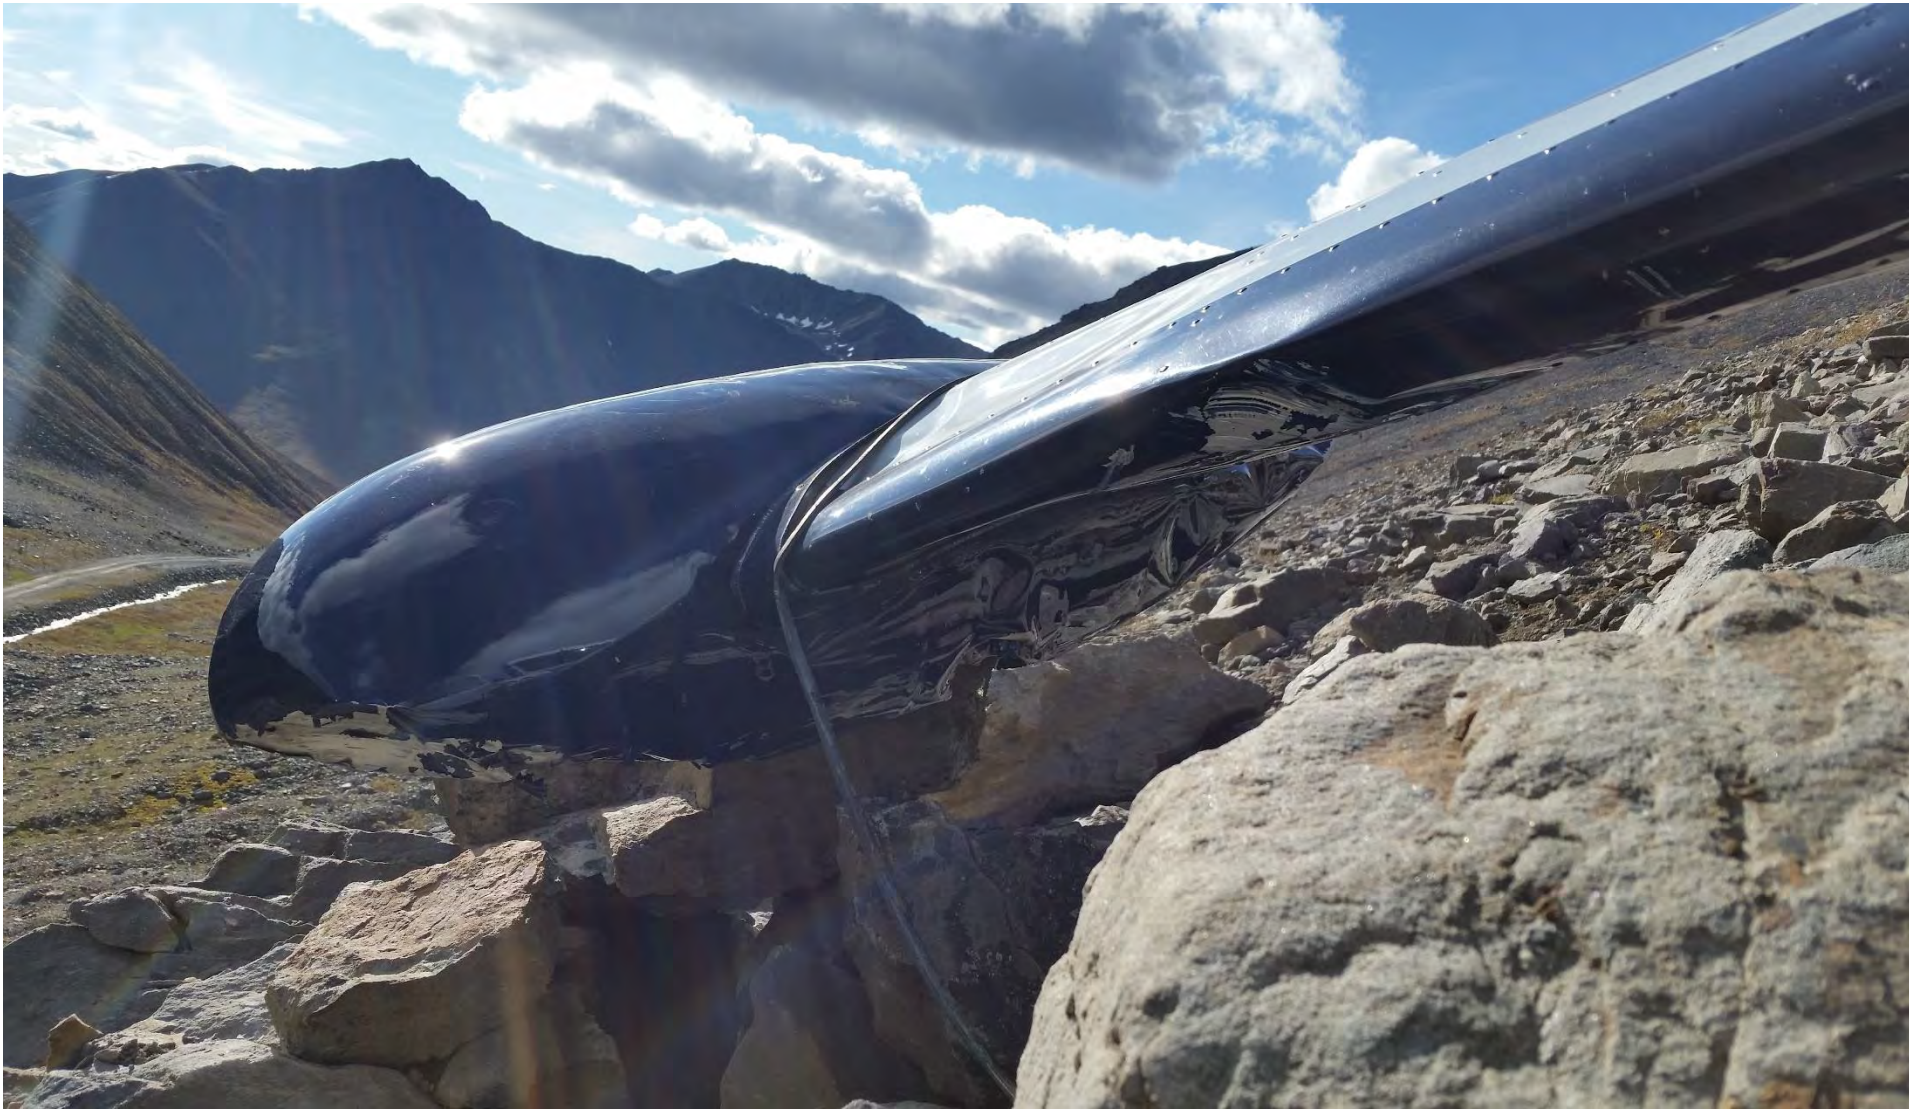
Photo 14 – Lower Portion of Right Tip Tank - Courtesy of FAA

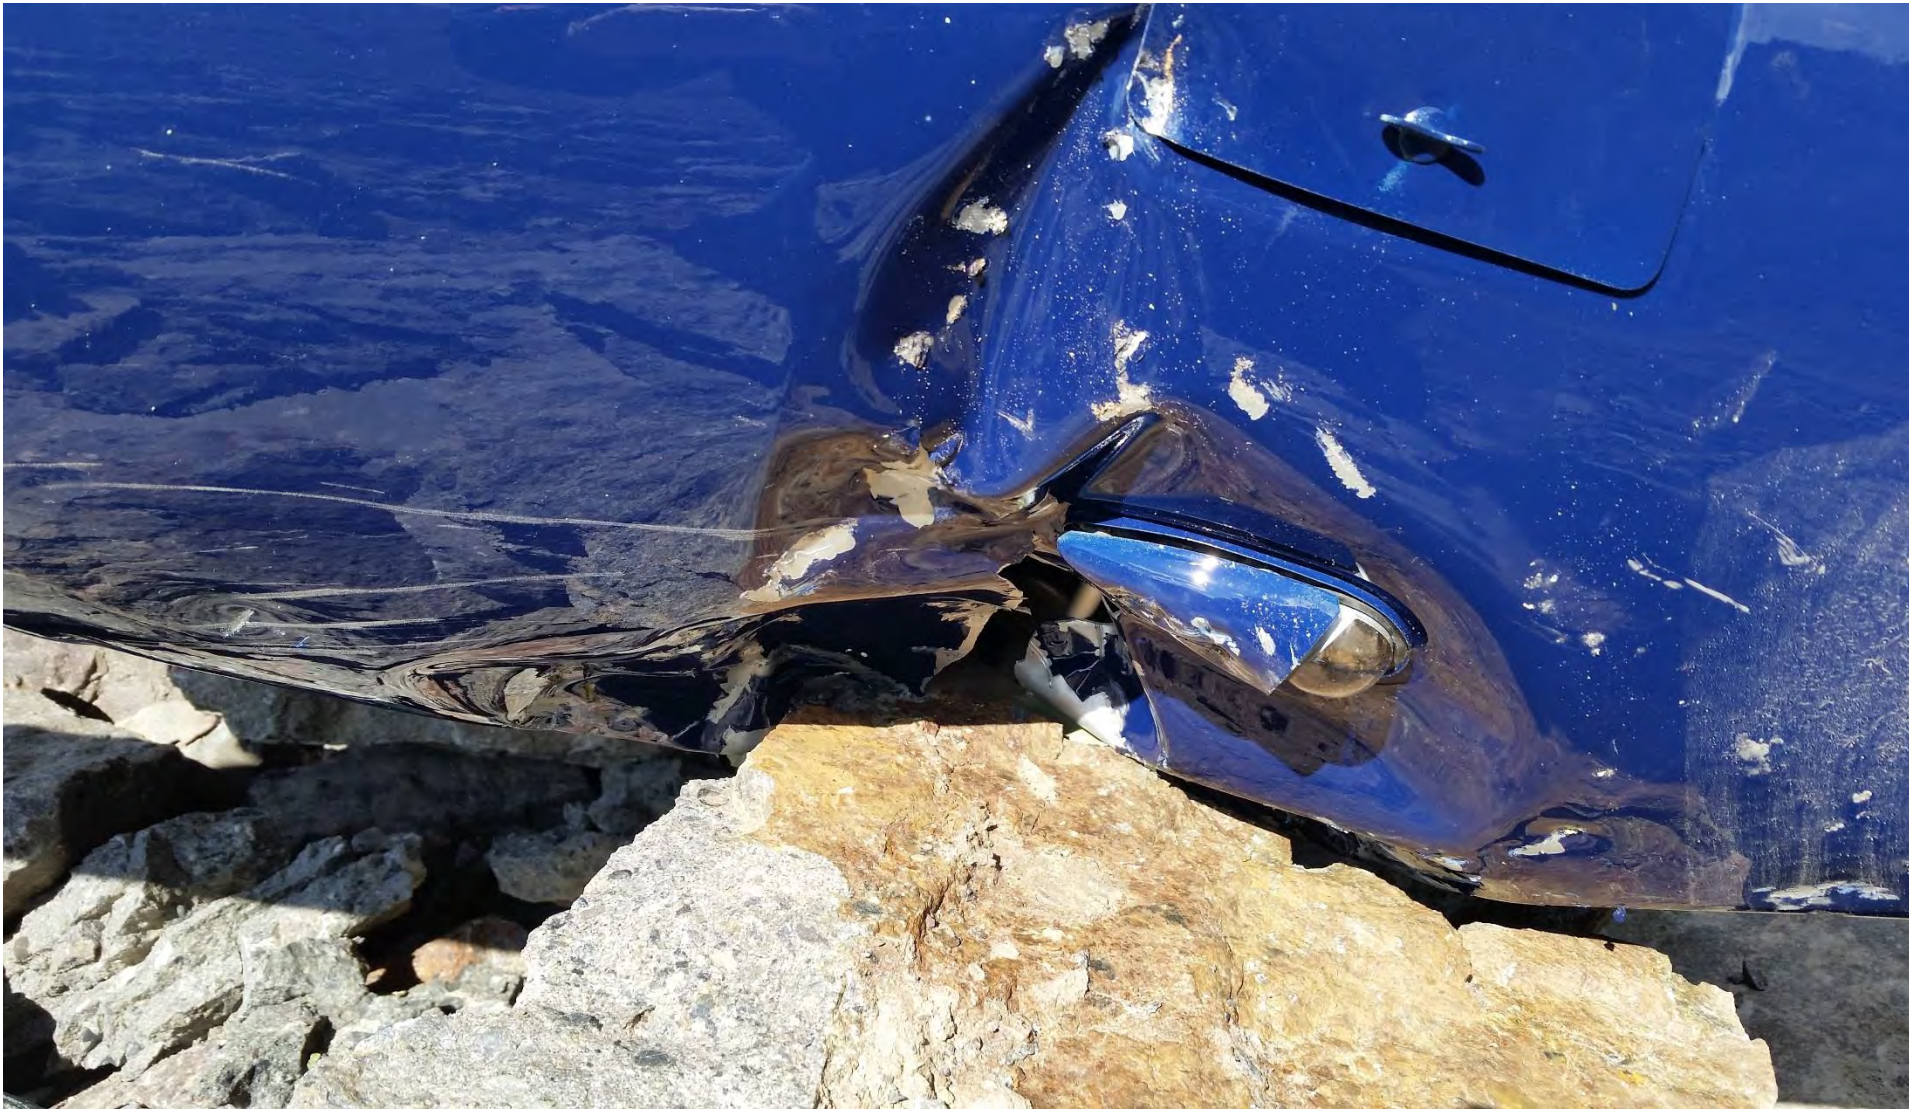
Photo 15 – Outboard Side of Right Tip Tank – Courtesy of FAA

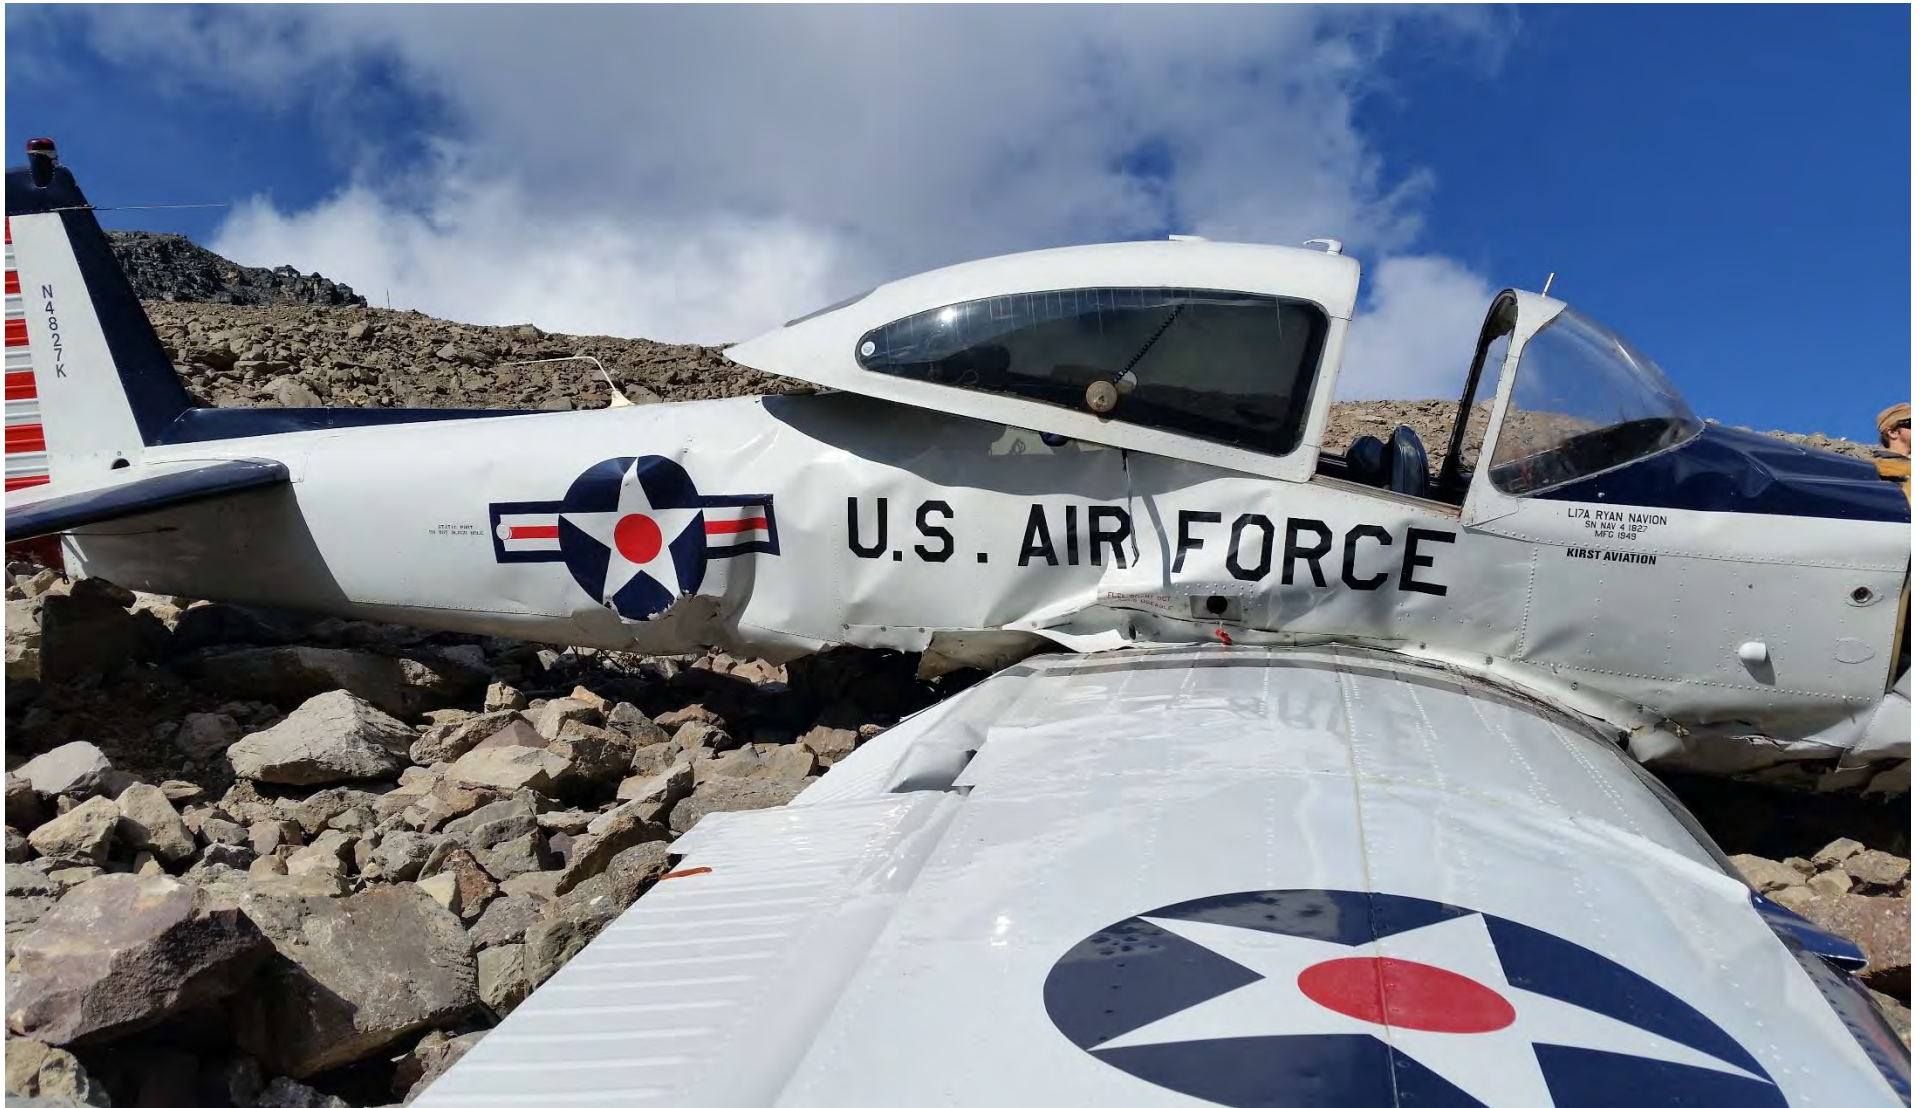
Photo 16 – Fuselage – Courtesy of FAA

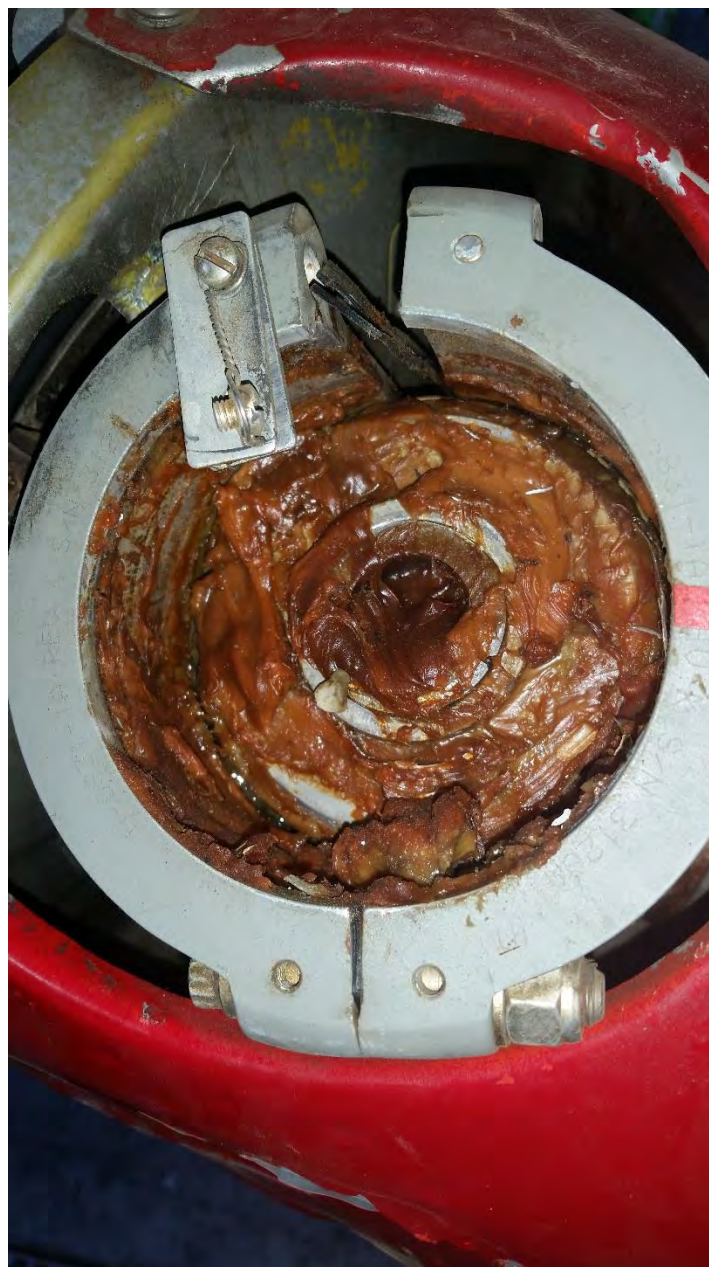
Photo 17 – Close Up of Blade Clamp After Recovery – Courtesy of FAA

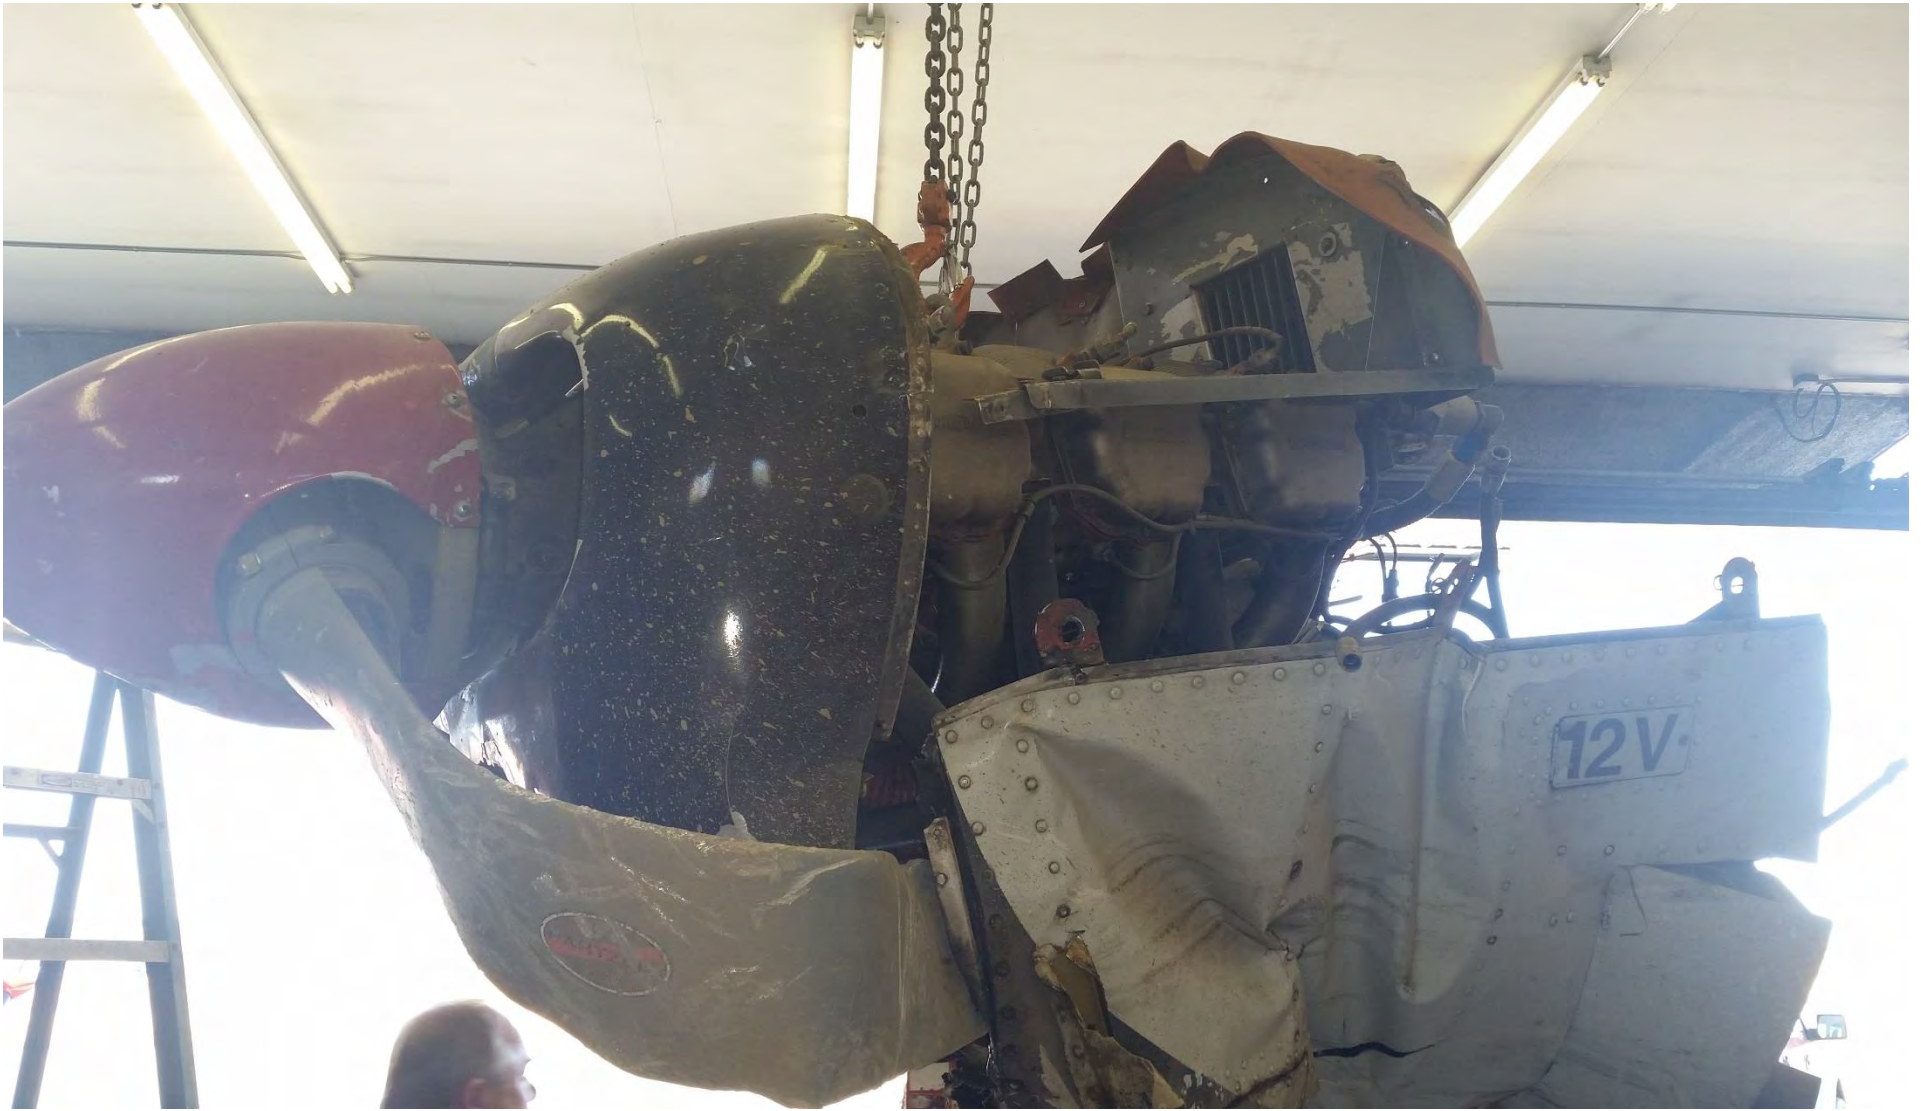
Photo 18 – Propeller Blade After Recovery – Courtesy of FAA

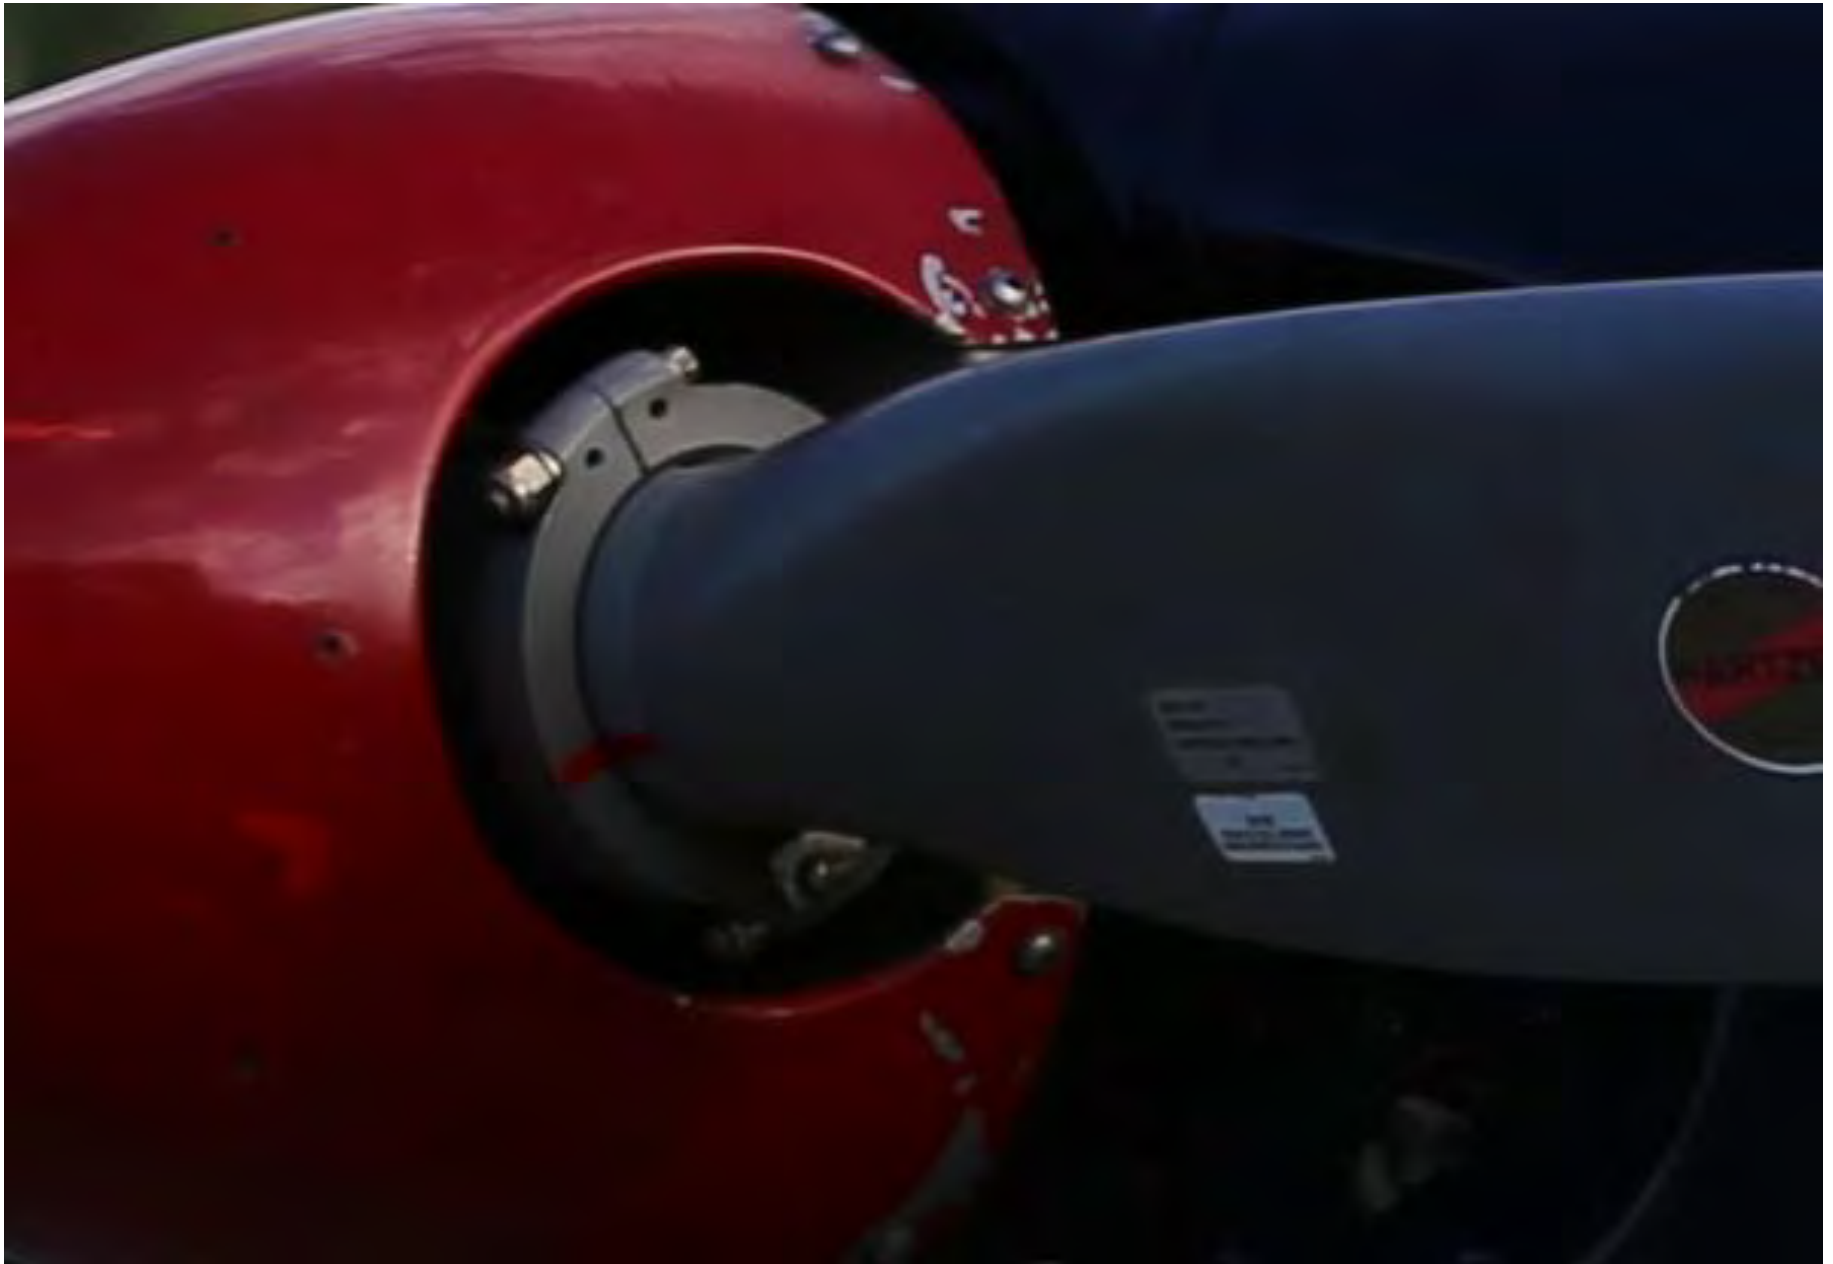
Photo 19 – Pre-Accident Photograph of the Missing Propeller Blade – Courtesy of FAA
