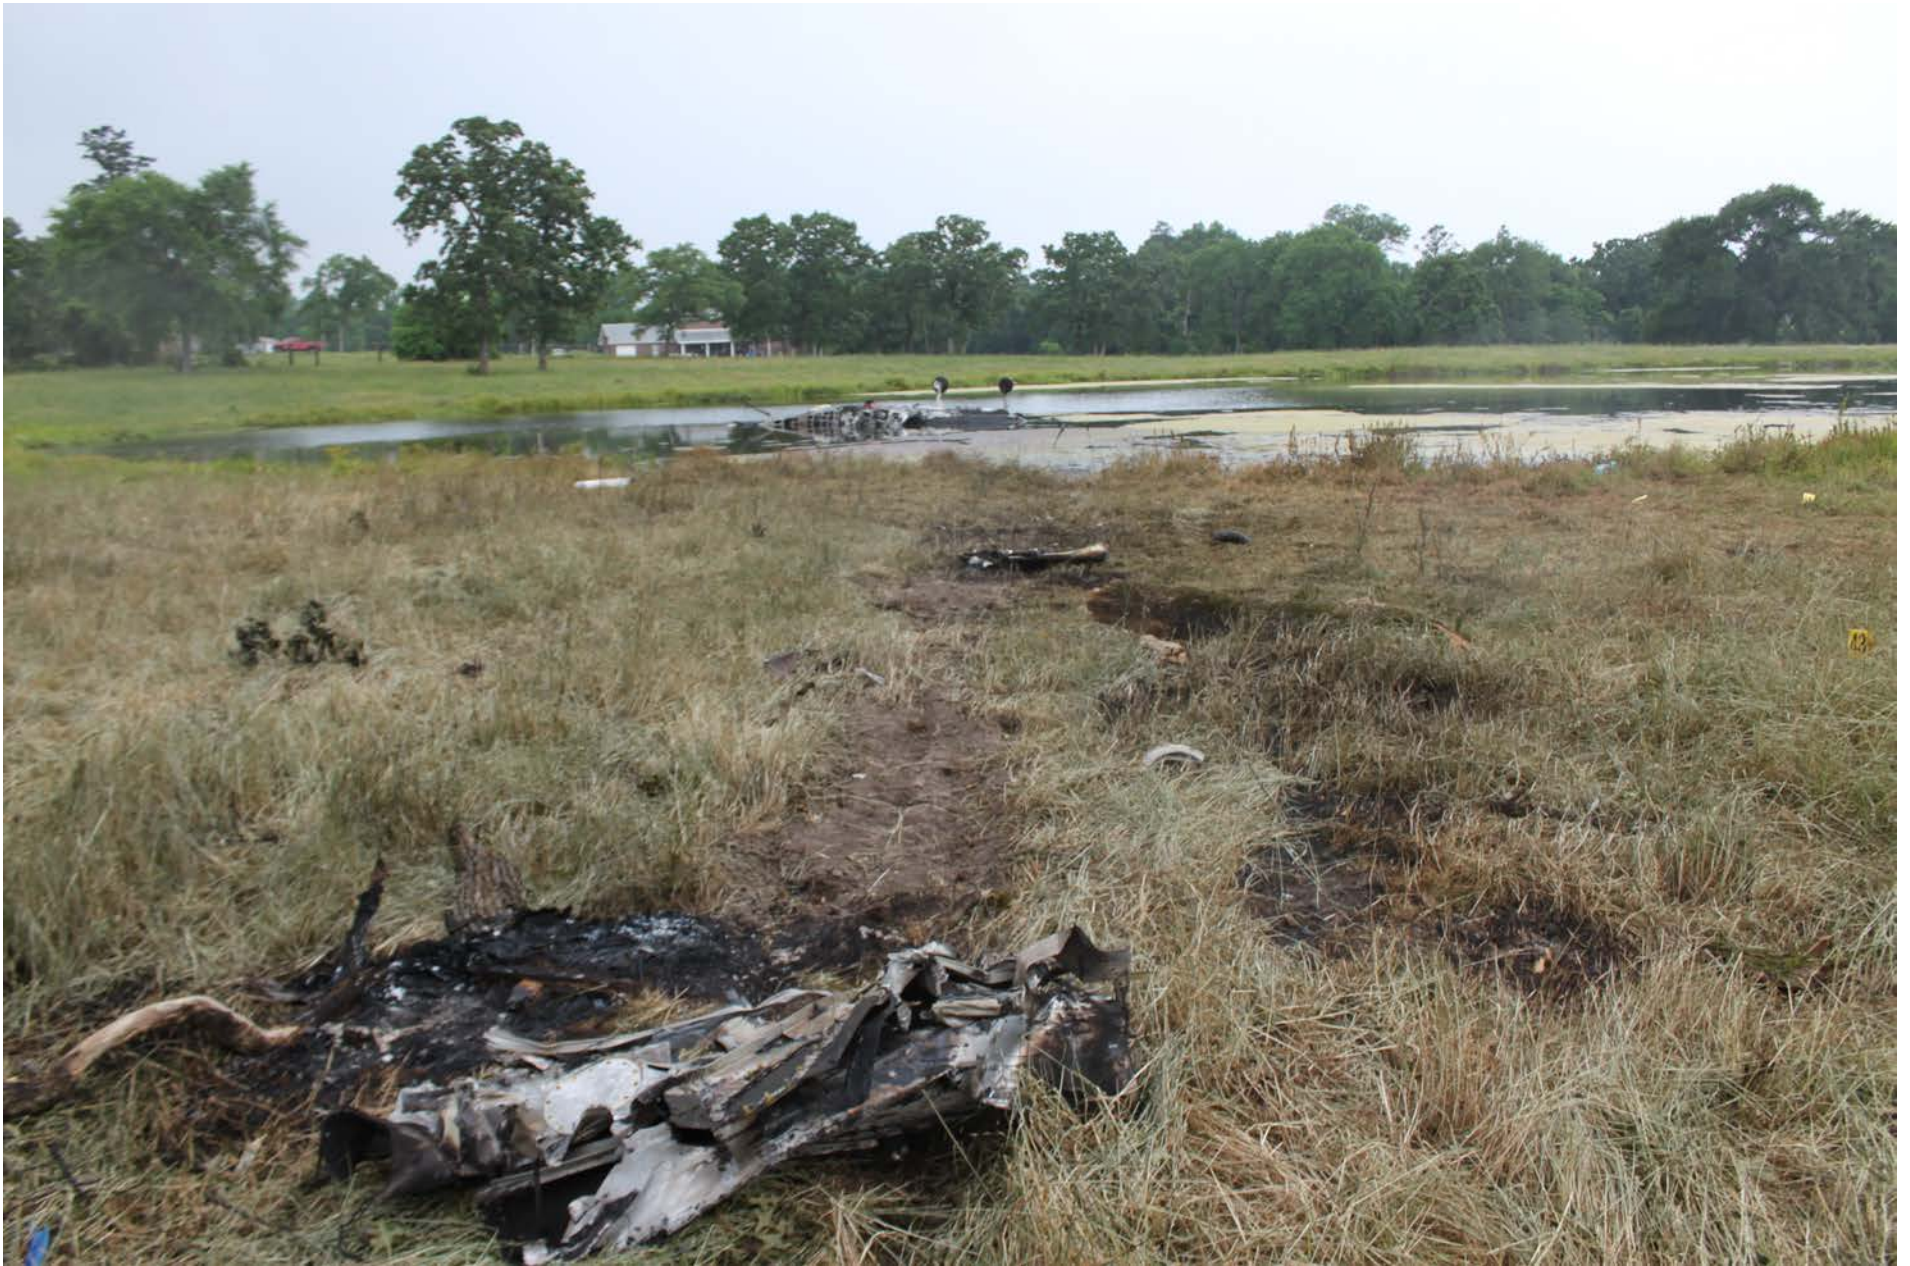
Photo 1 – Main wreckage path and main wreckage at accident site

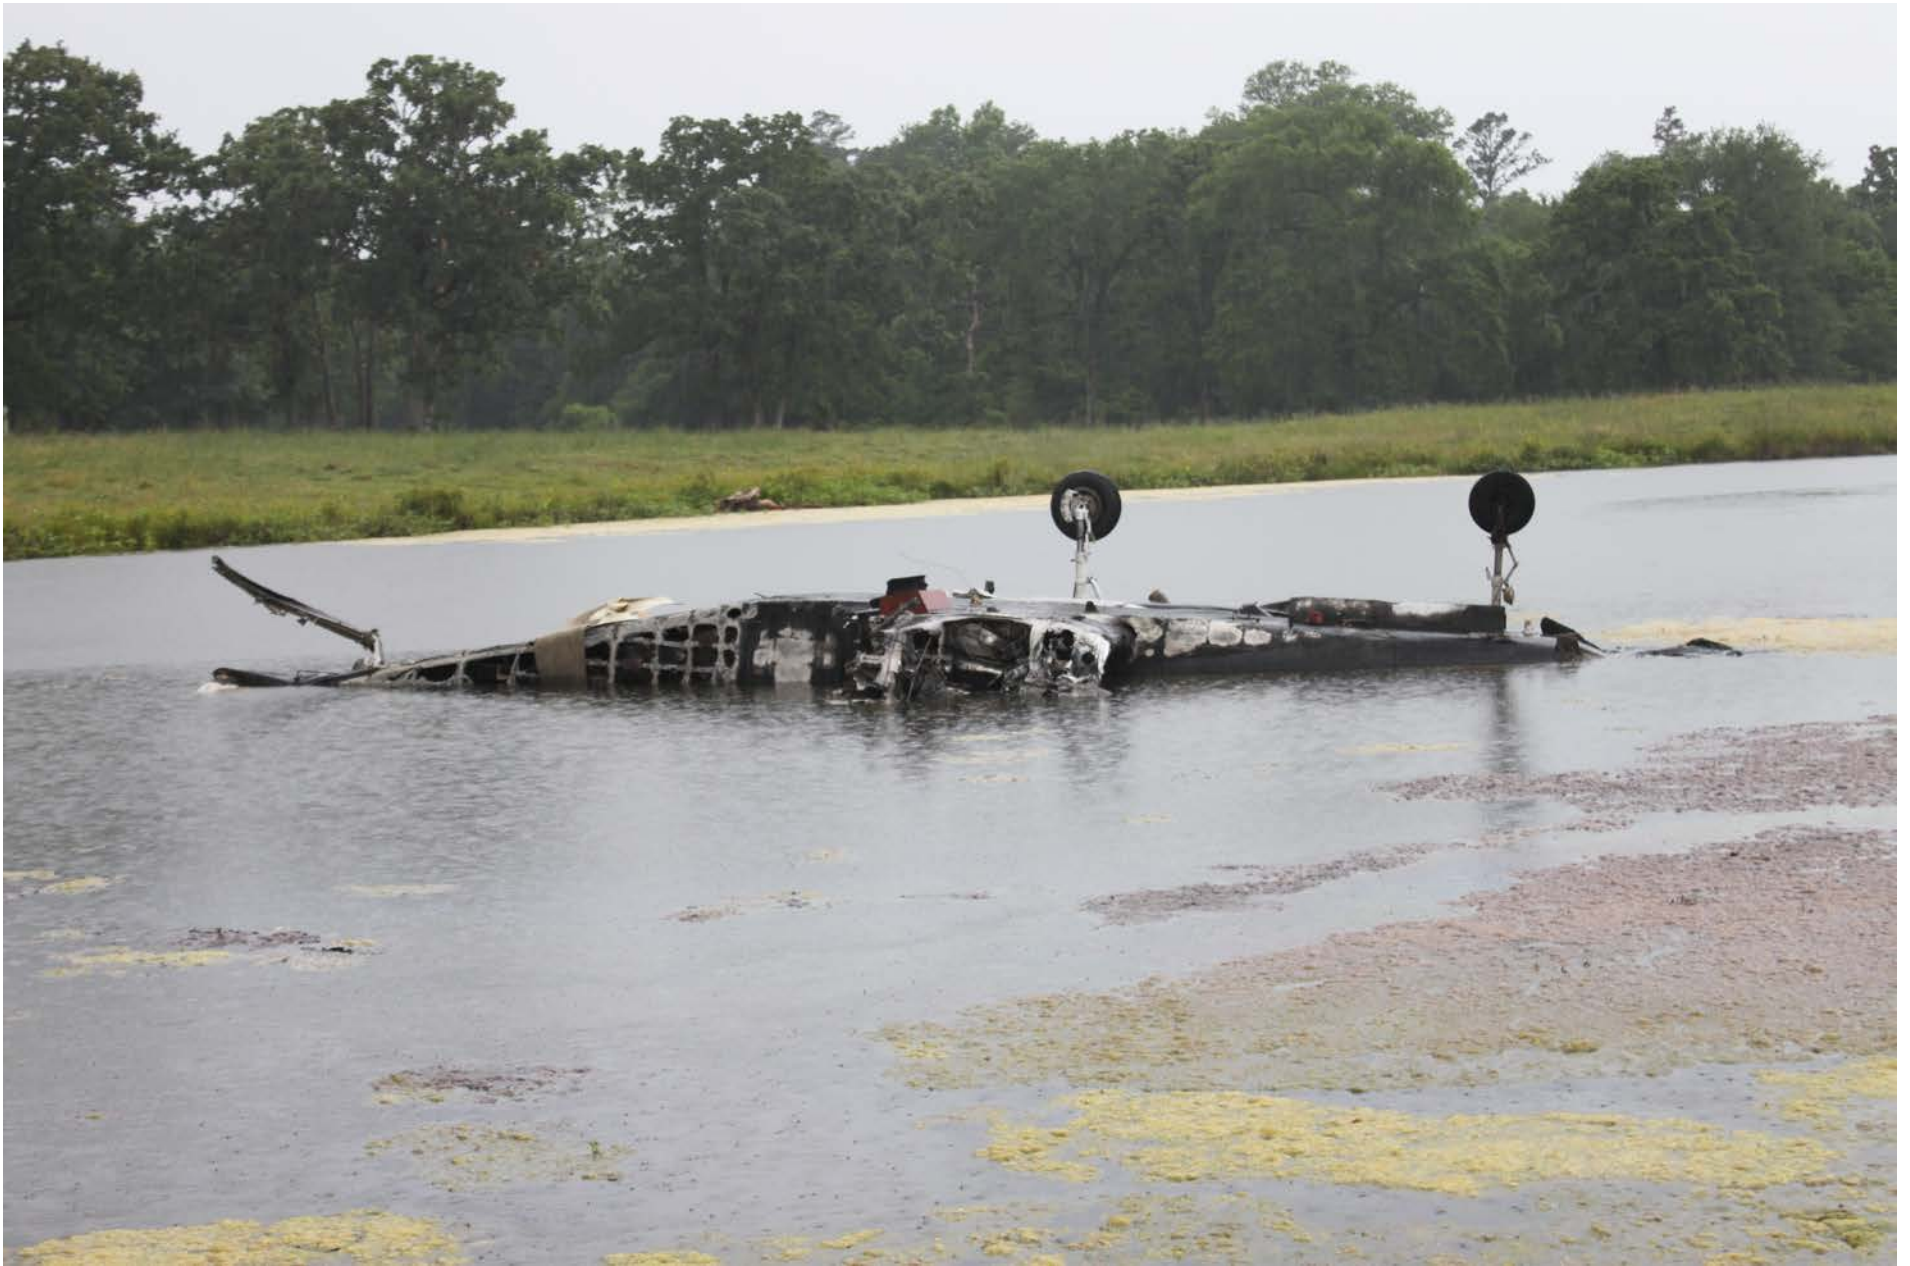
Photo 2 – Main wreckage at accident site

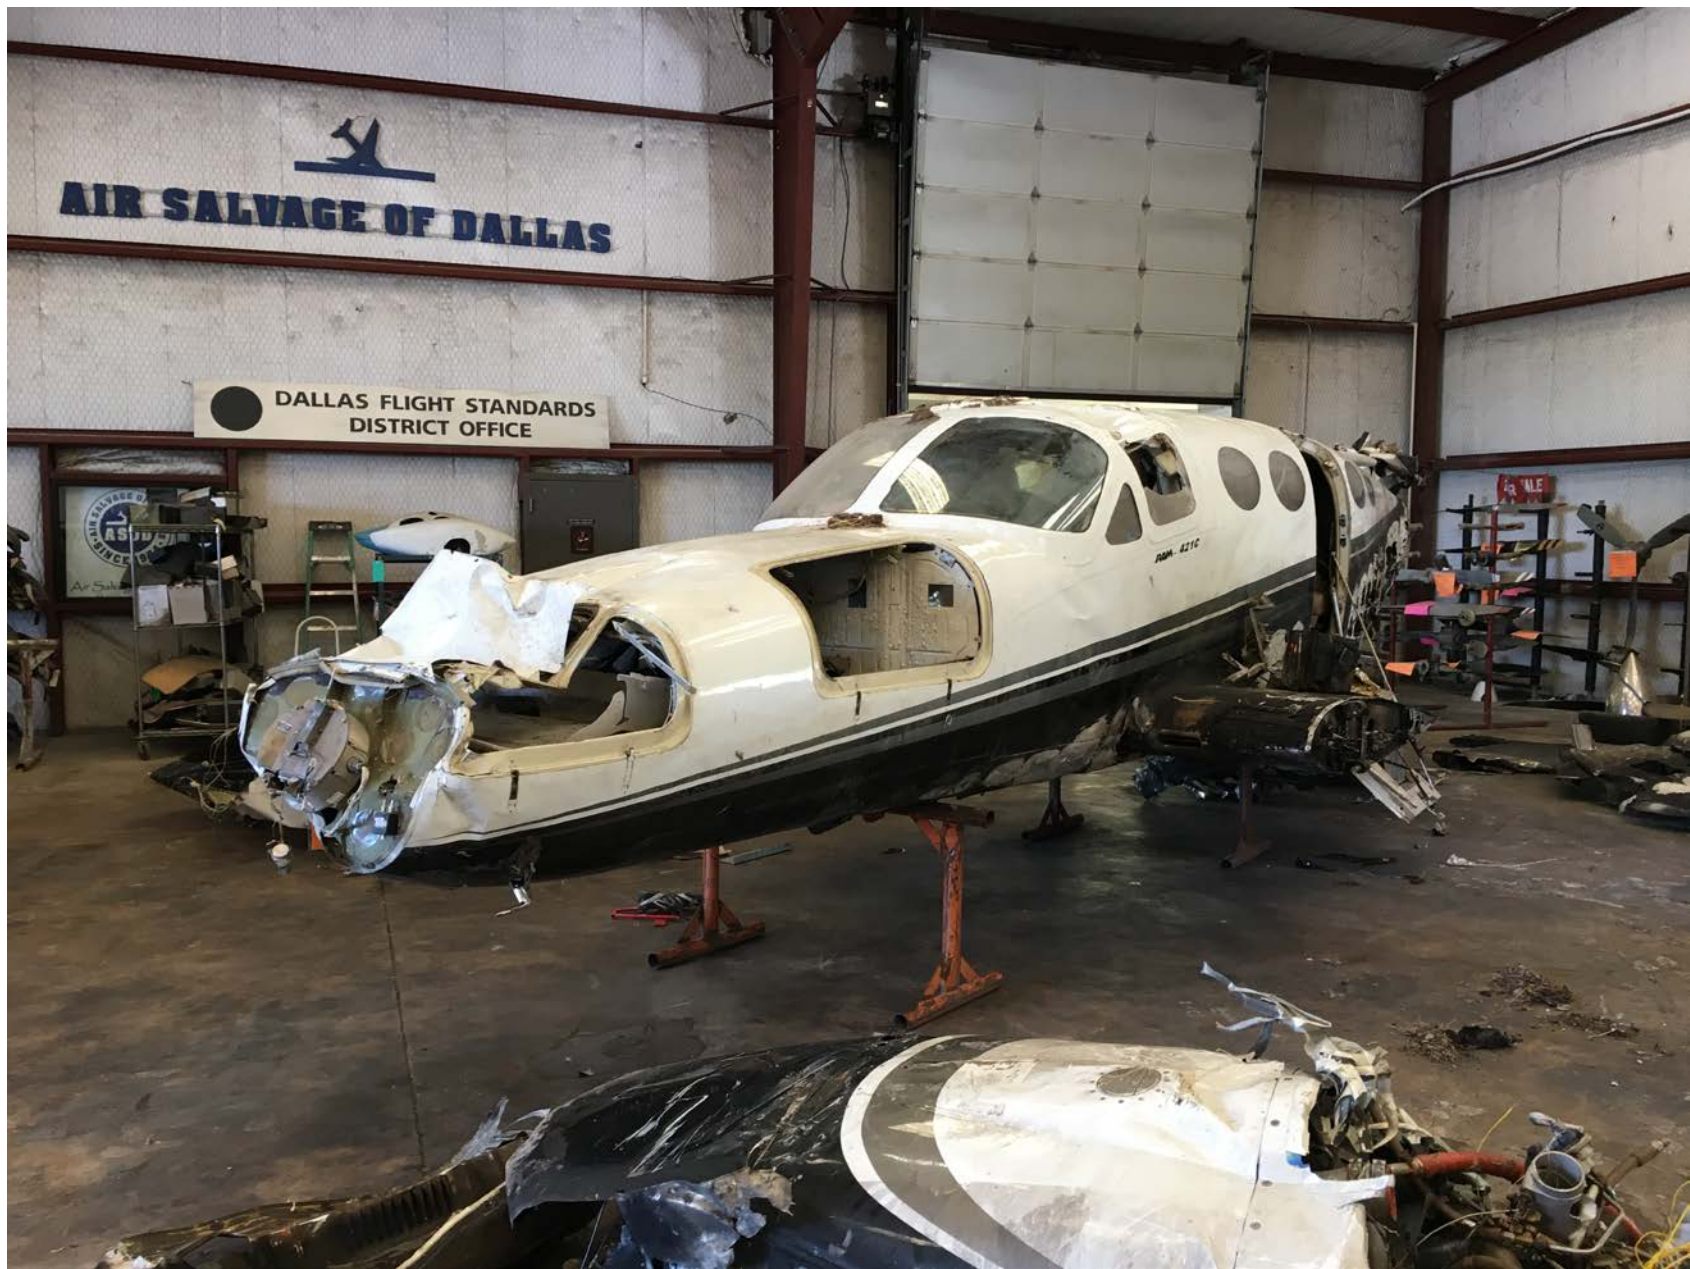
Photo 3 – Airplane fuselage during examination

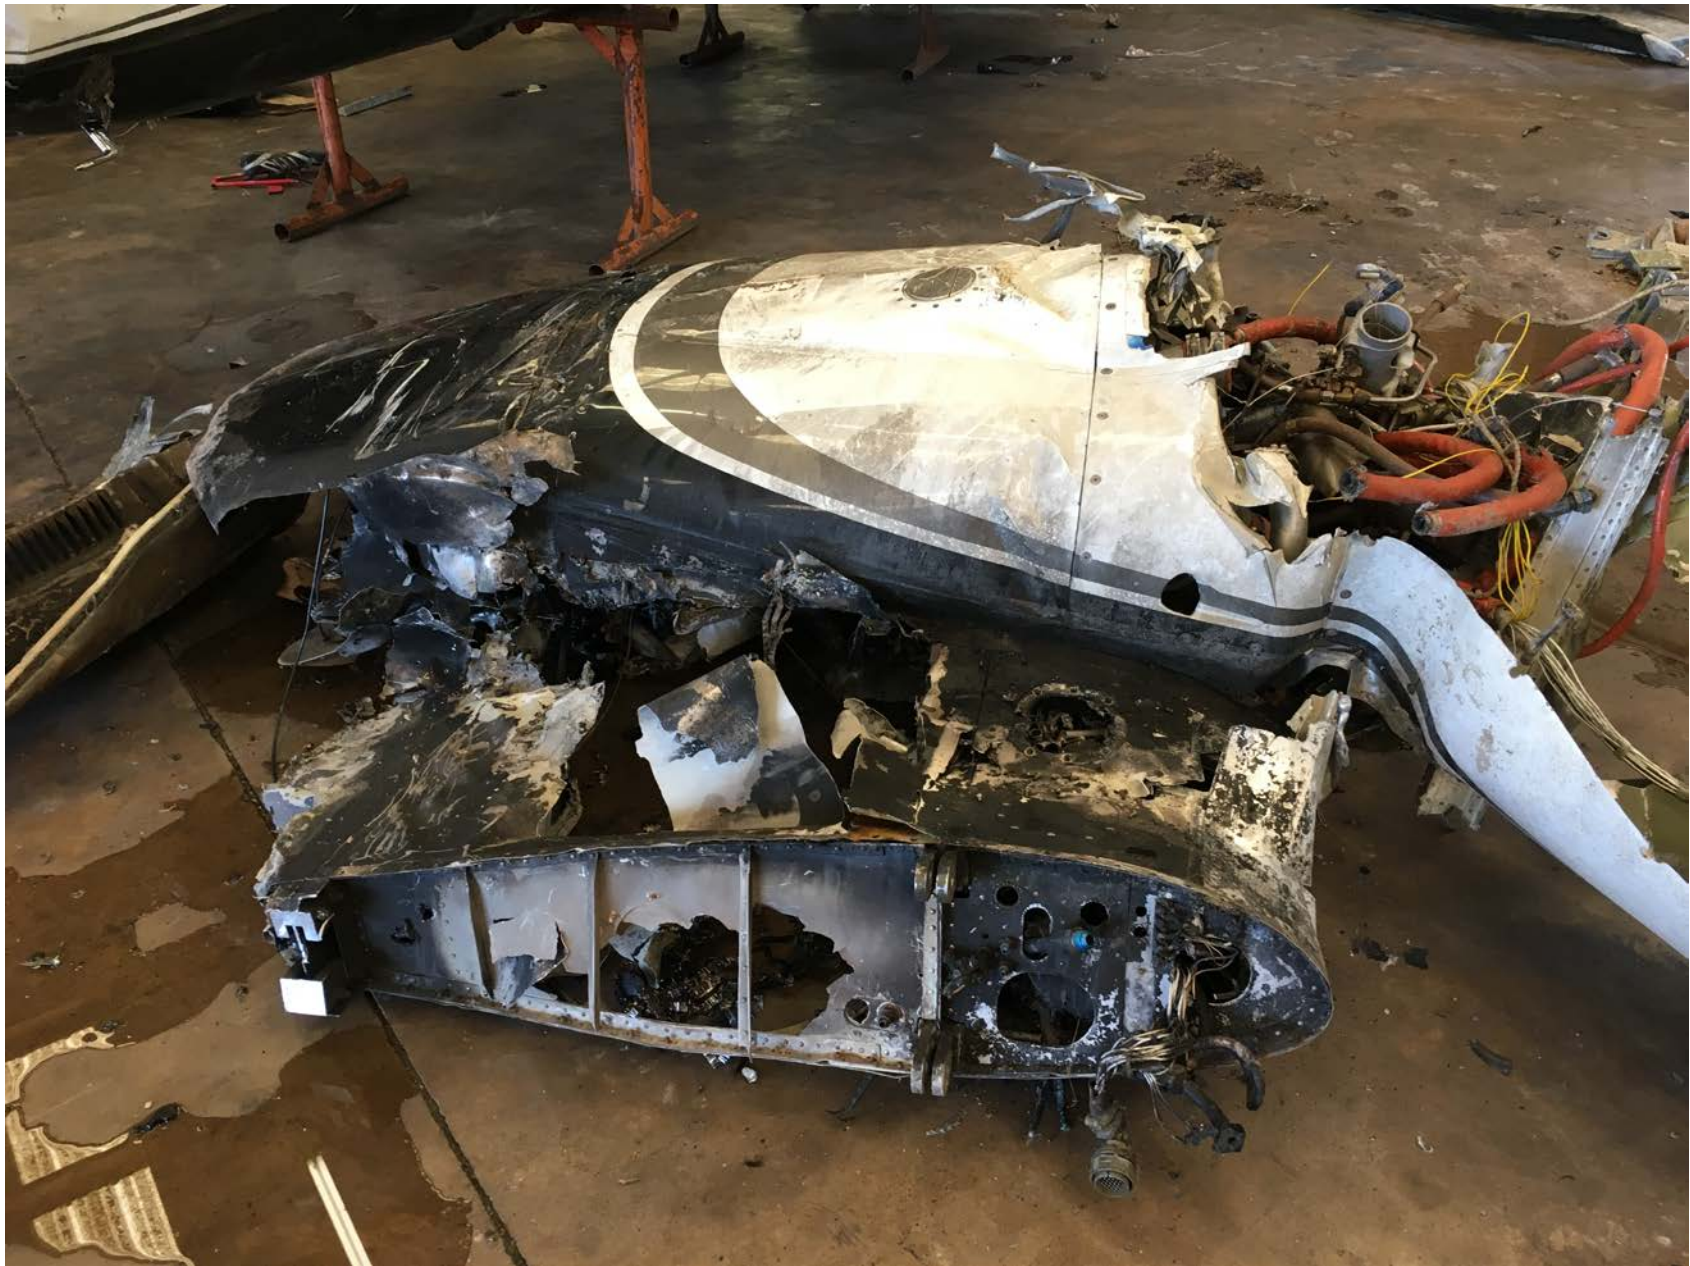
Photo 4 – Left engine nacelle during airframe examination

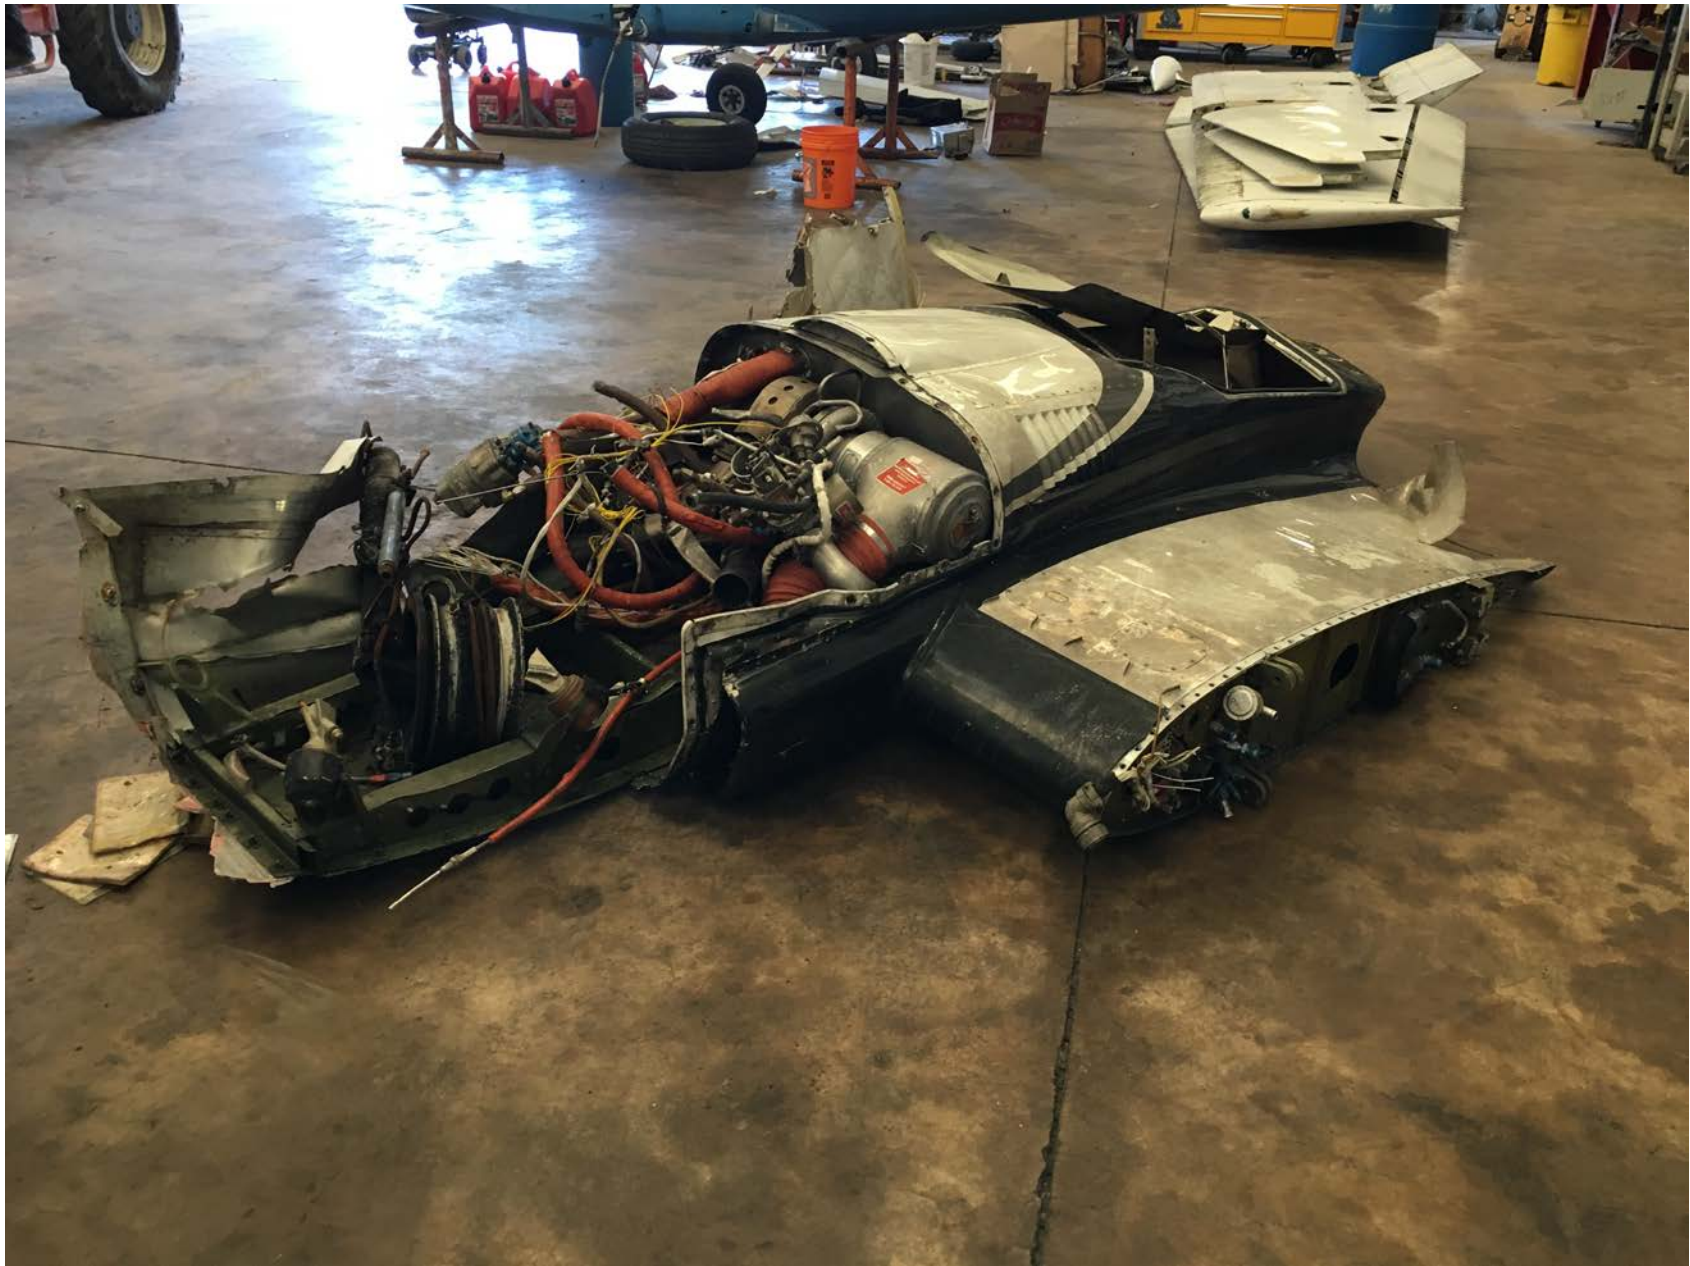
Photo 5 – Right engine nacelle during airframe examination

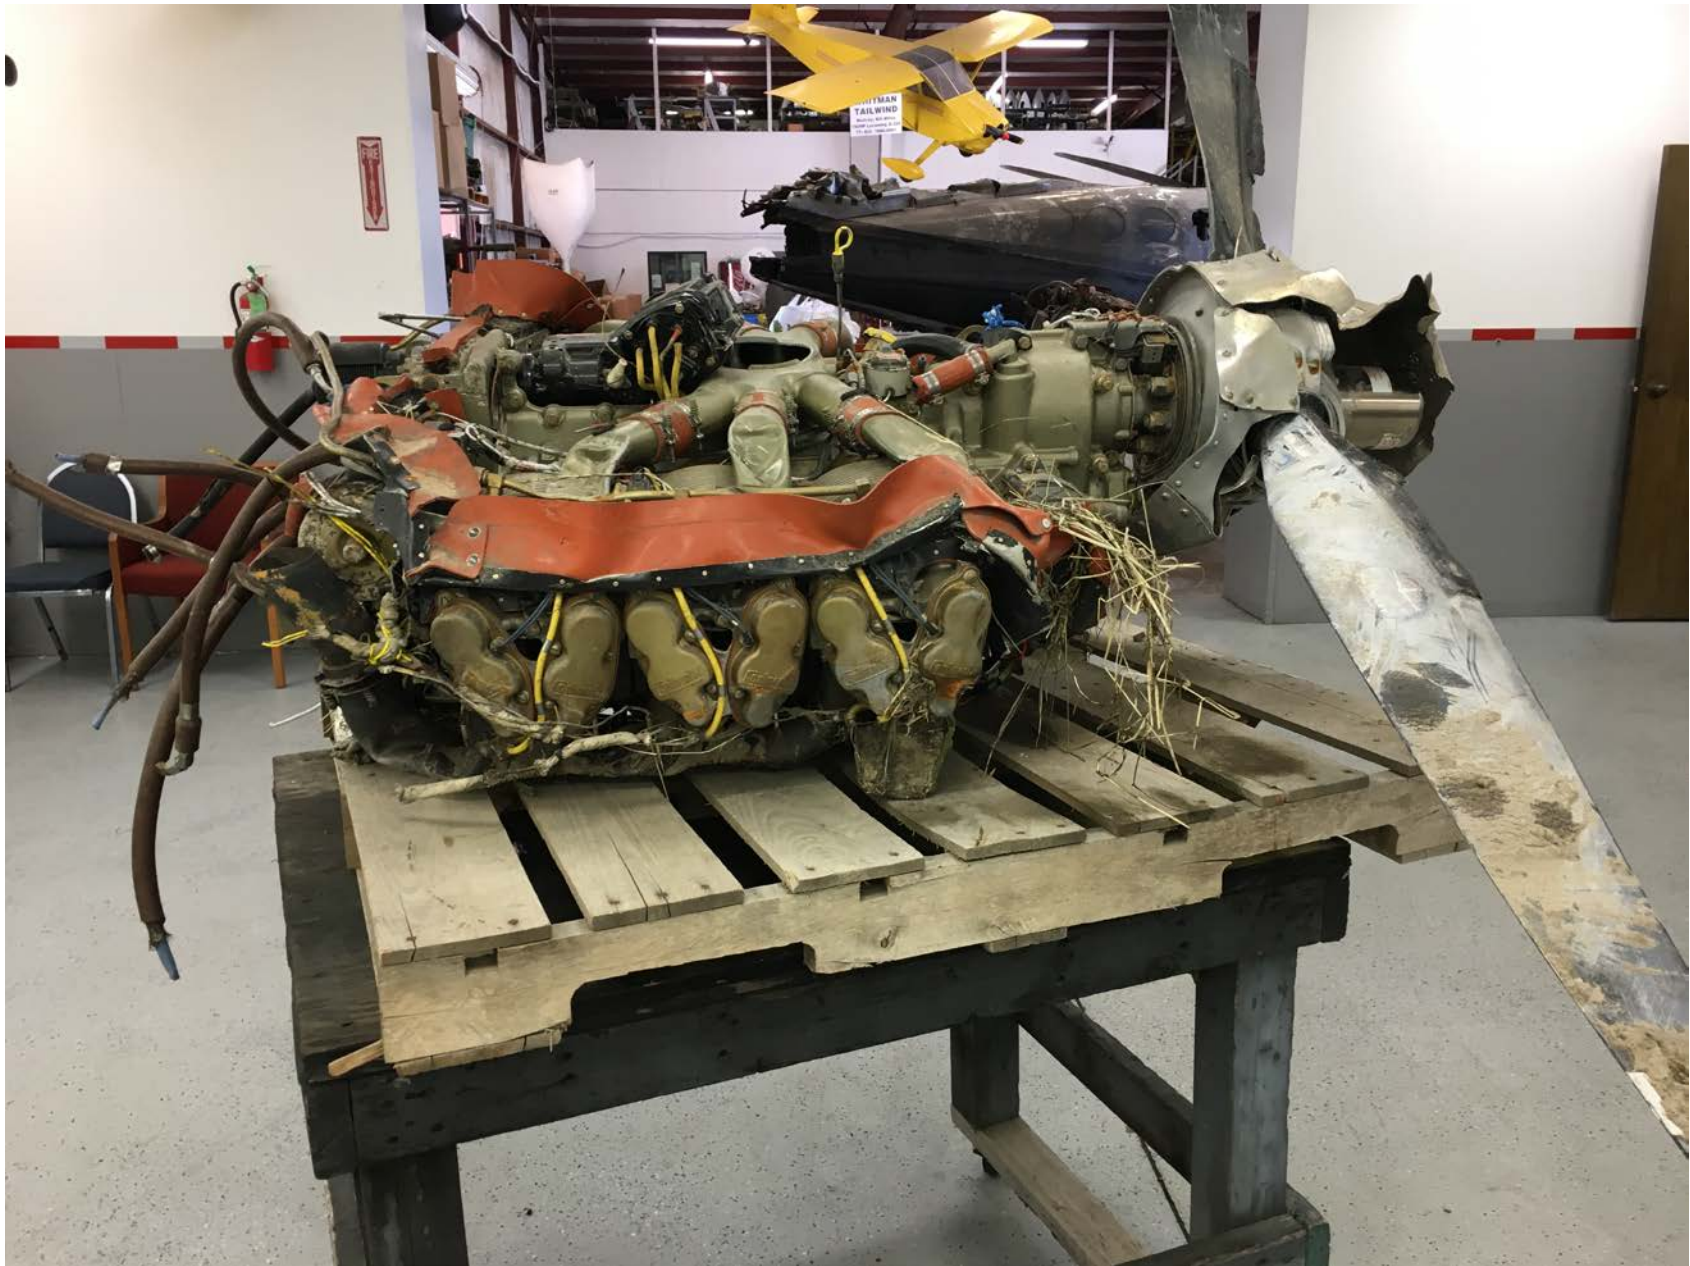
Photo 6 – Left engine during airframe examination

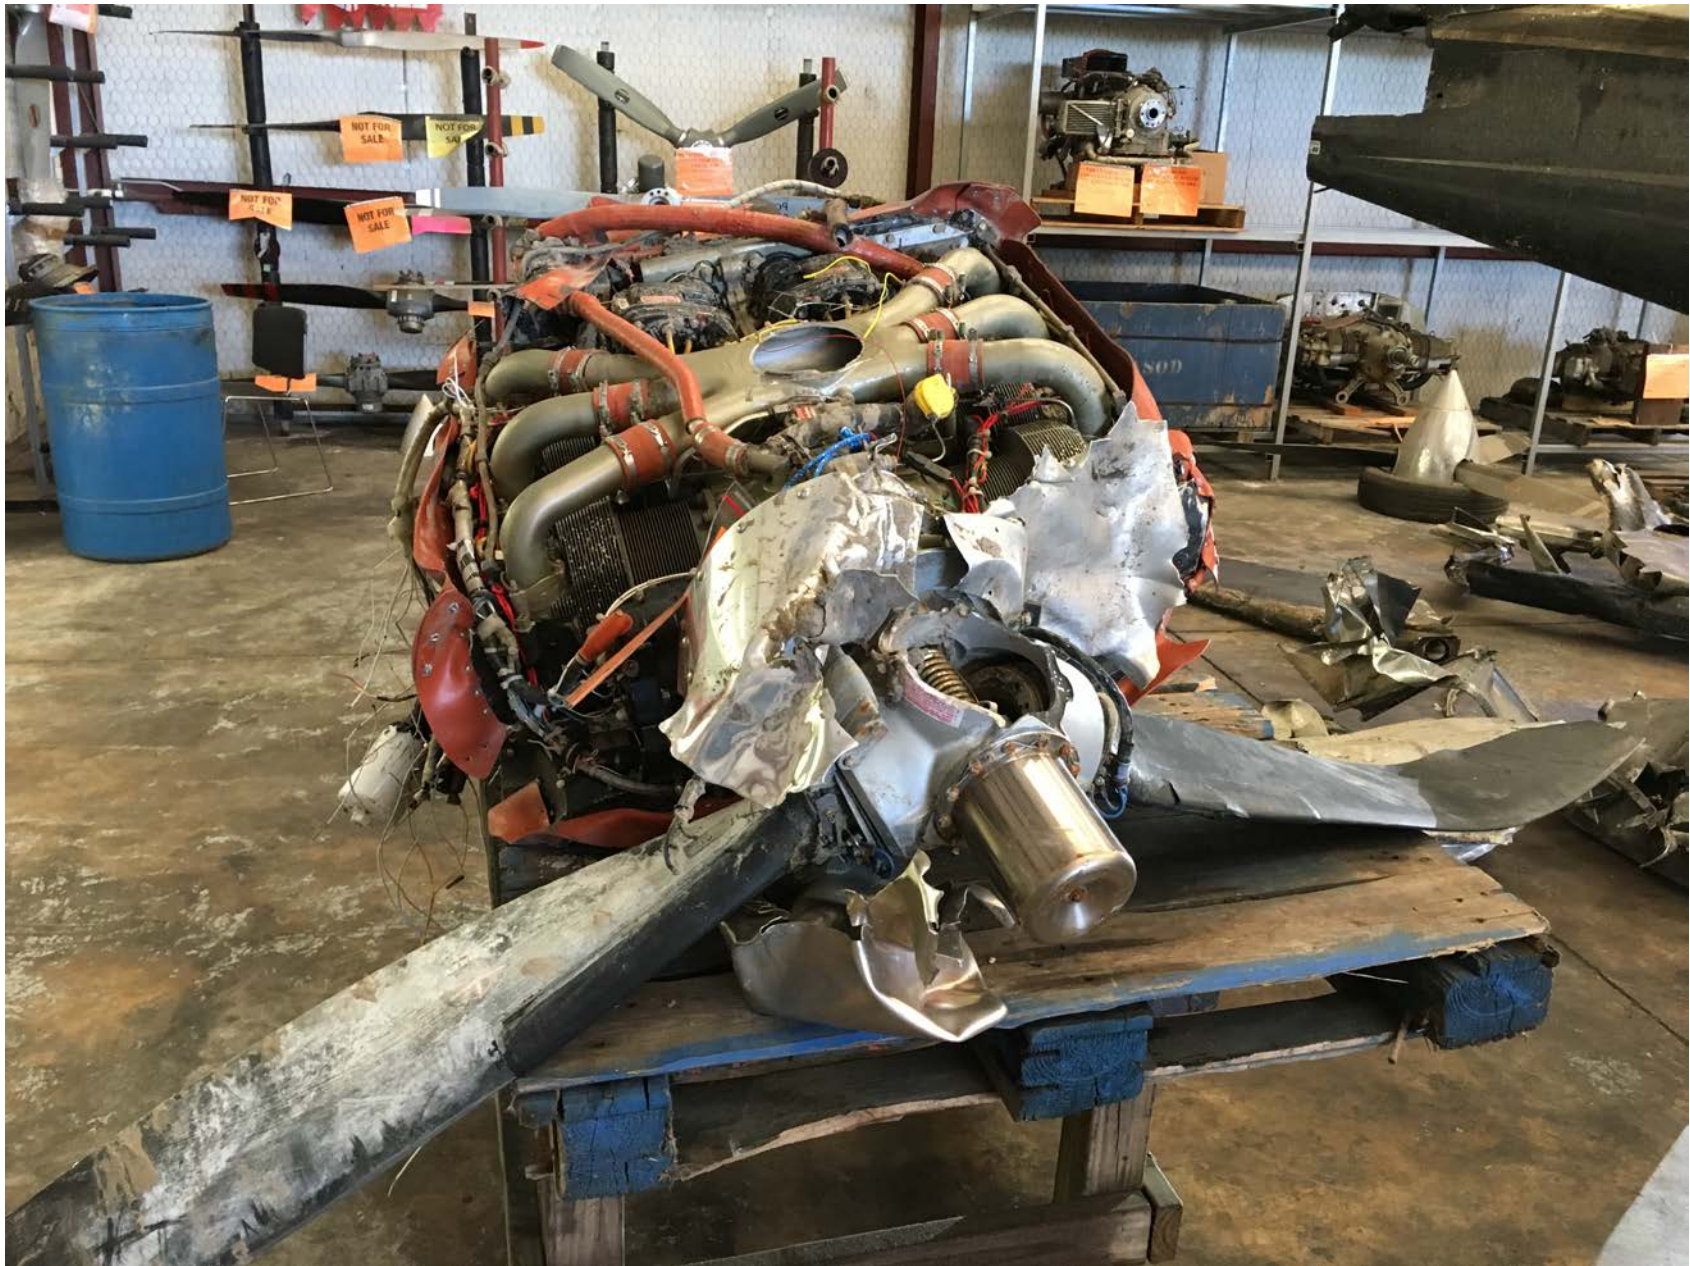
Photo 7 – Right engine during airframe examination

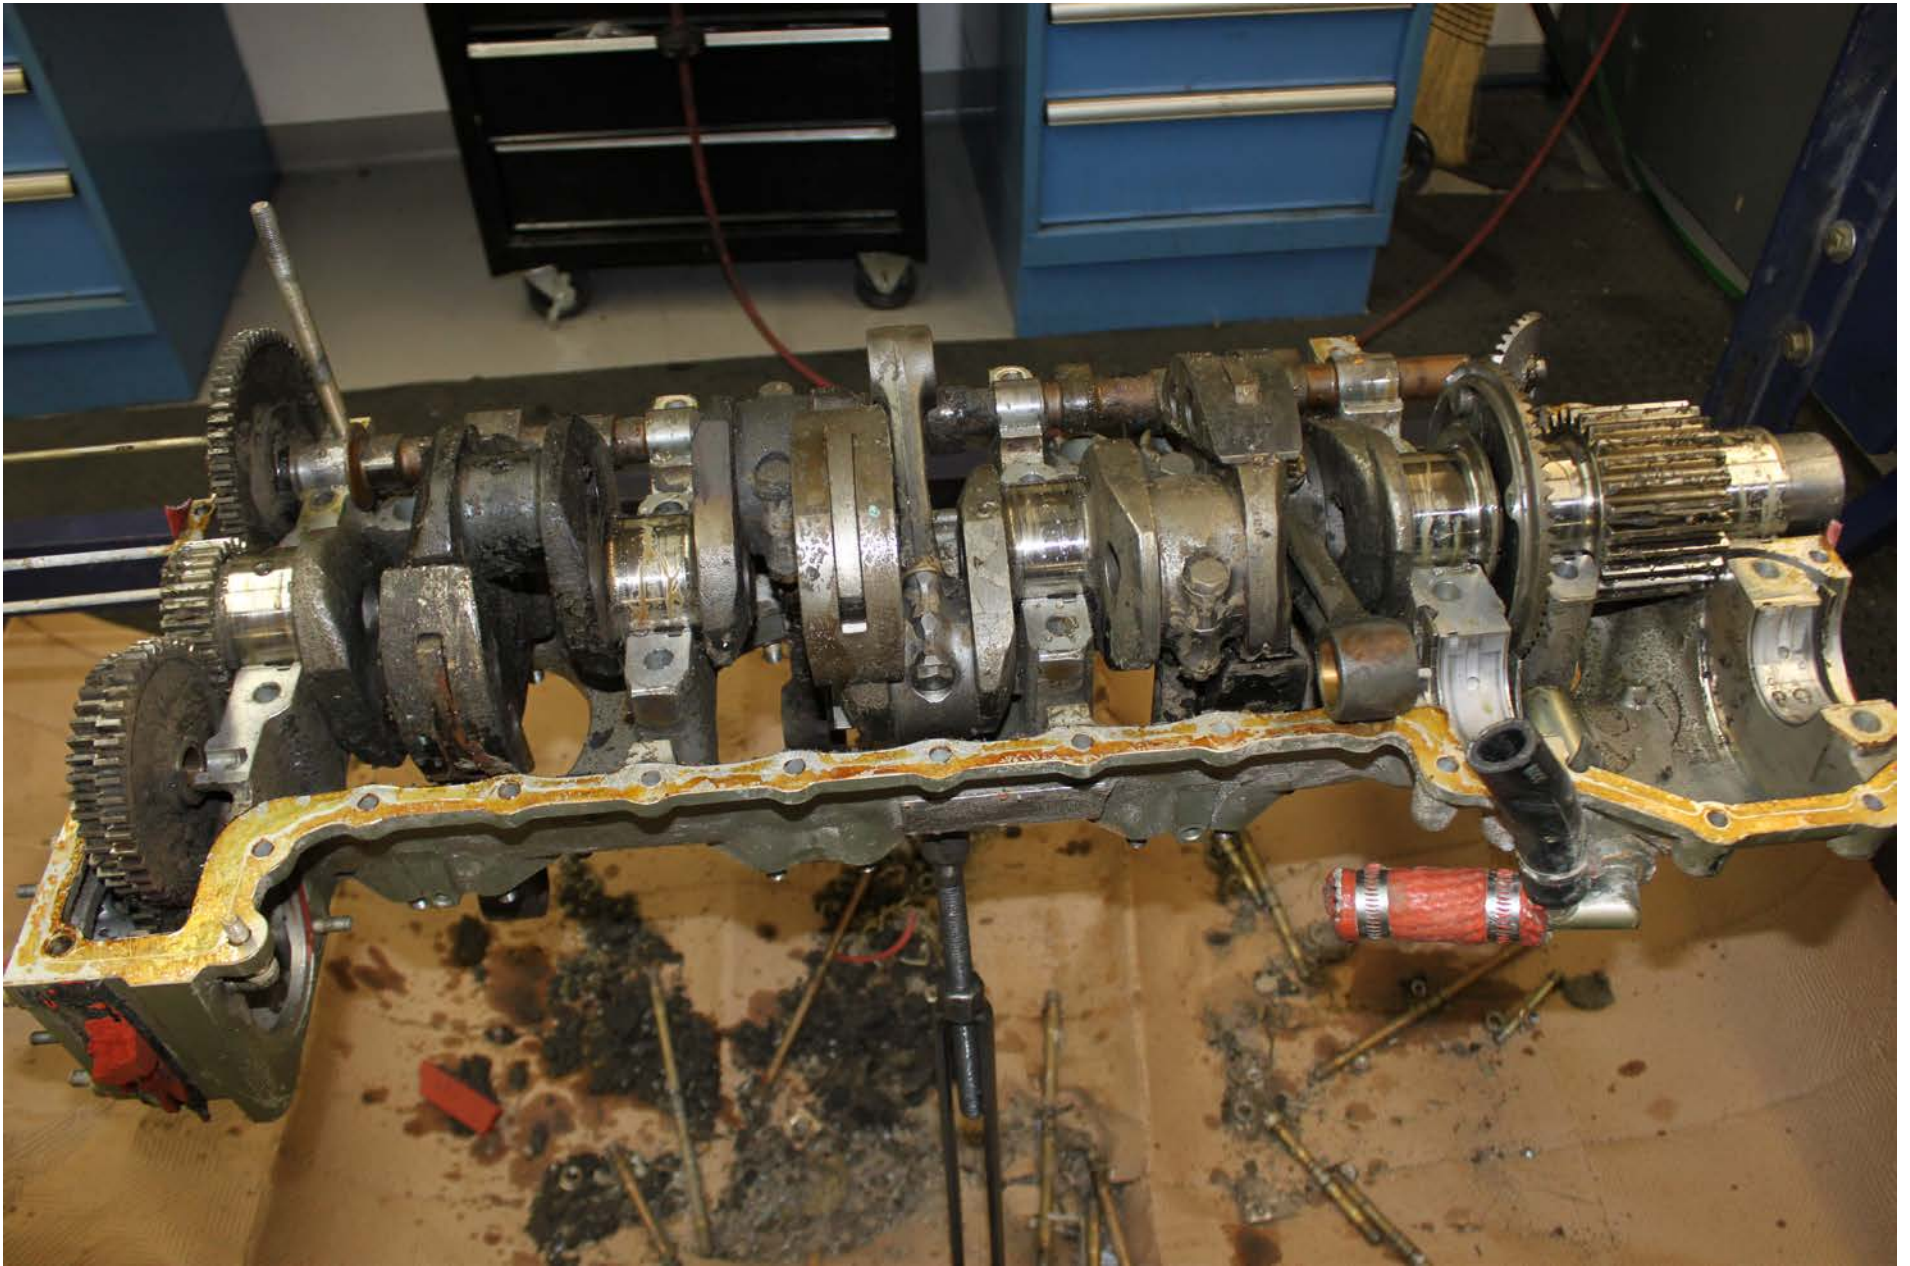
Photo 8 – Left engine during engine examination

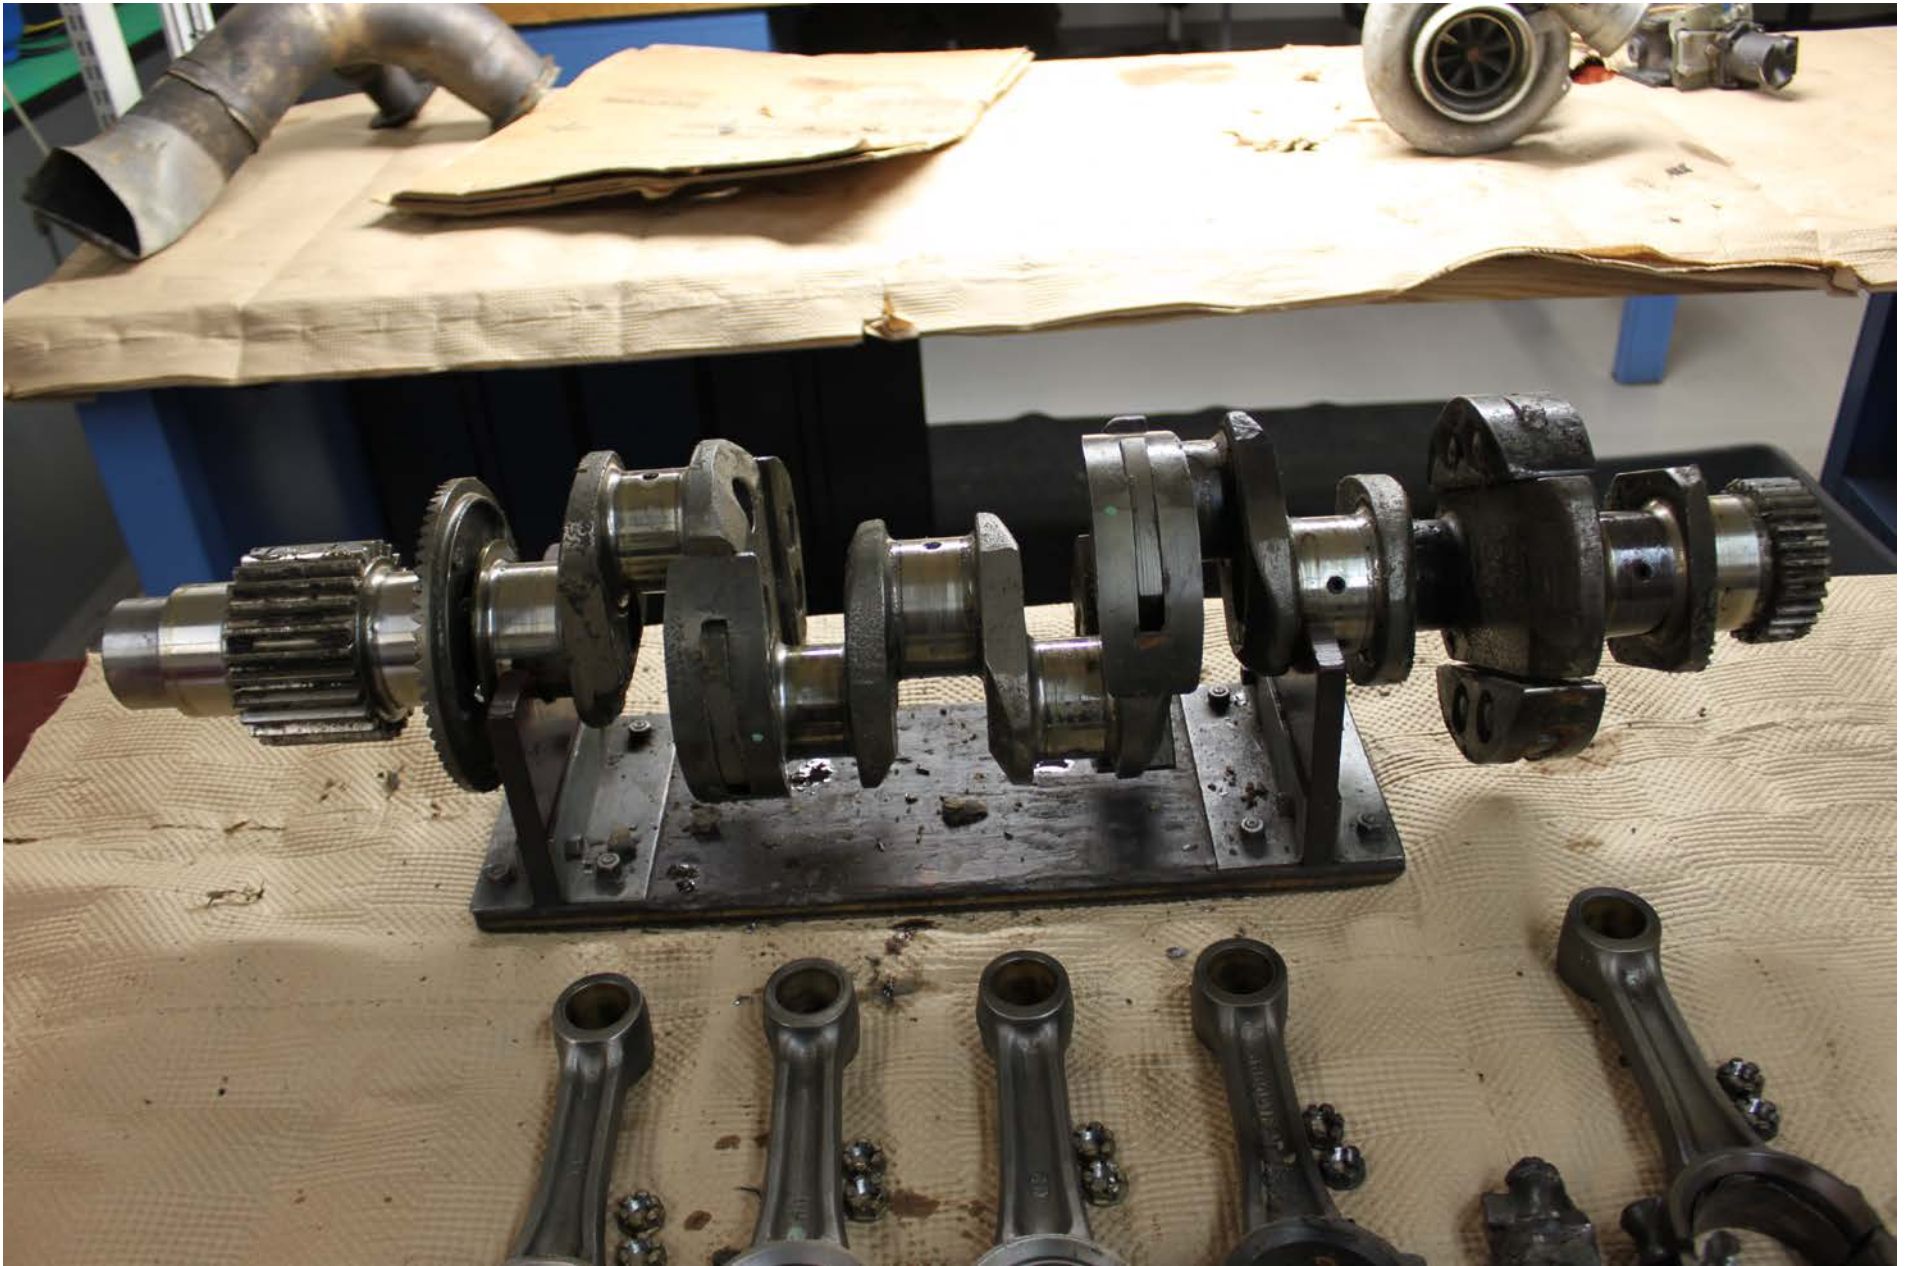
Photo 9 – Left engine crankshaft after removal from engine

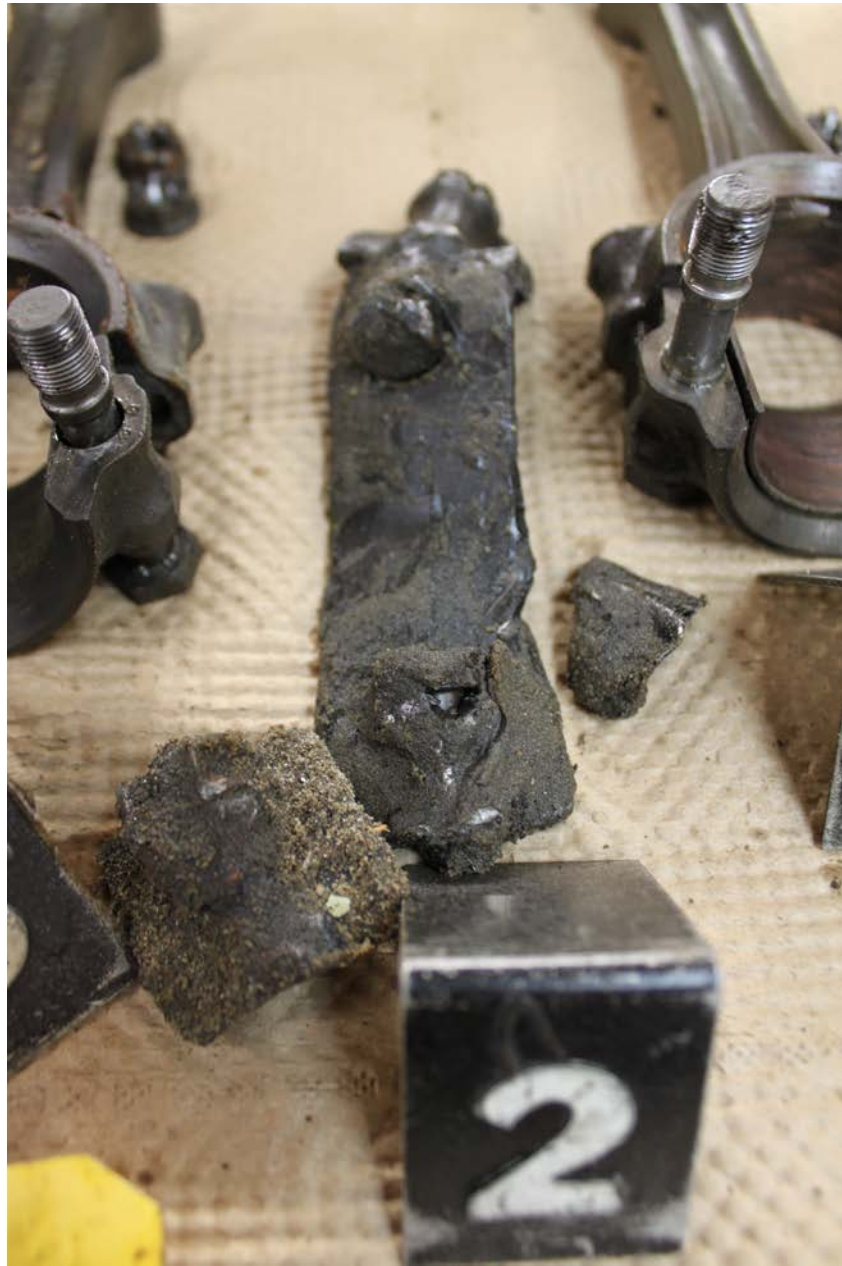
Photo 10 – Left engine number 2 connecting rod cap

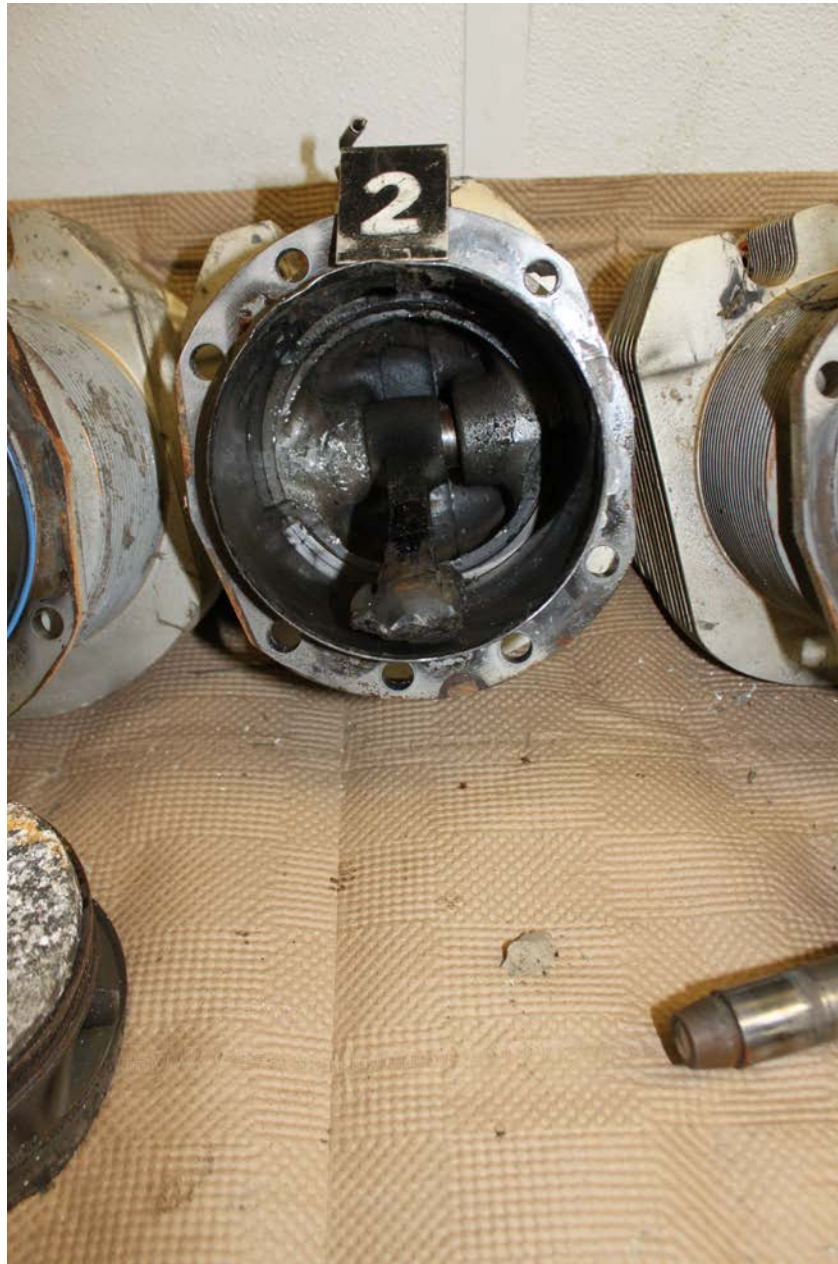
Photo 11 – Left engine number 2 piston, cylinder and connecting rod
