**Photo 1 – N88452 Bellanca Citabria 7GCBC wreckage**

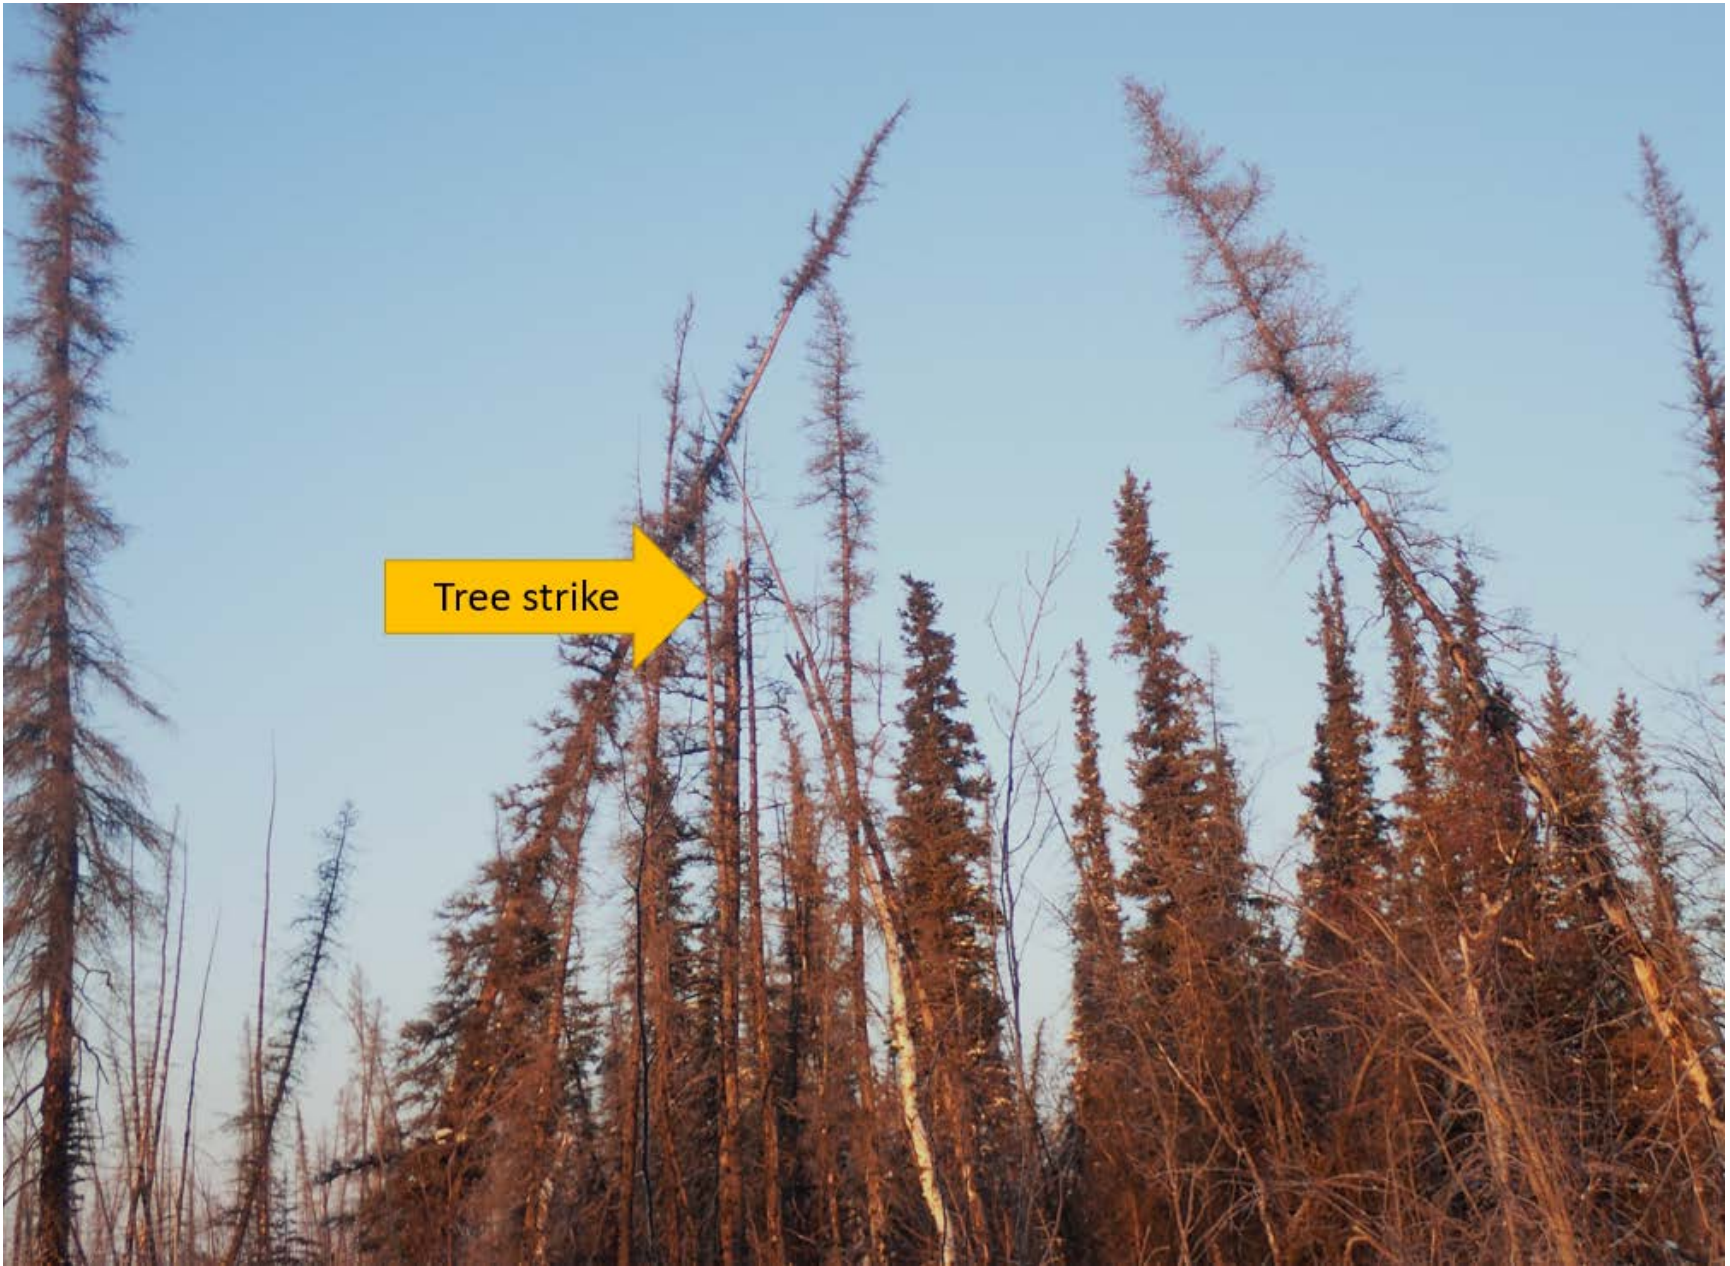
**Photo 2 - Fractured tree top**

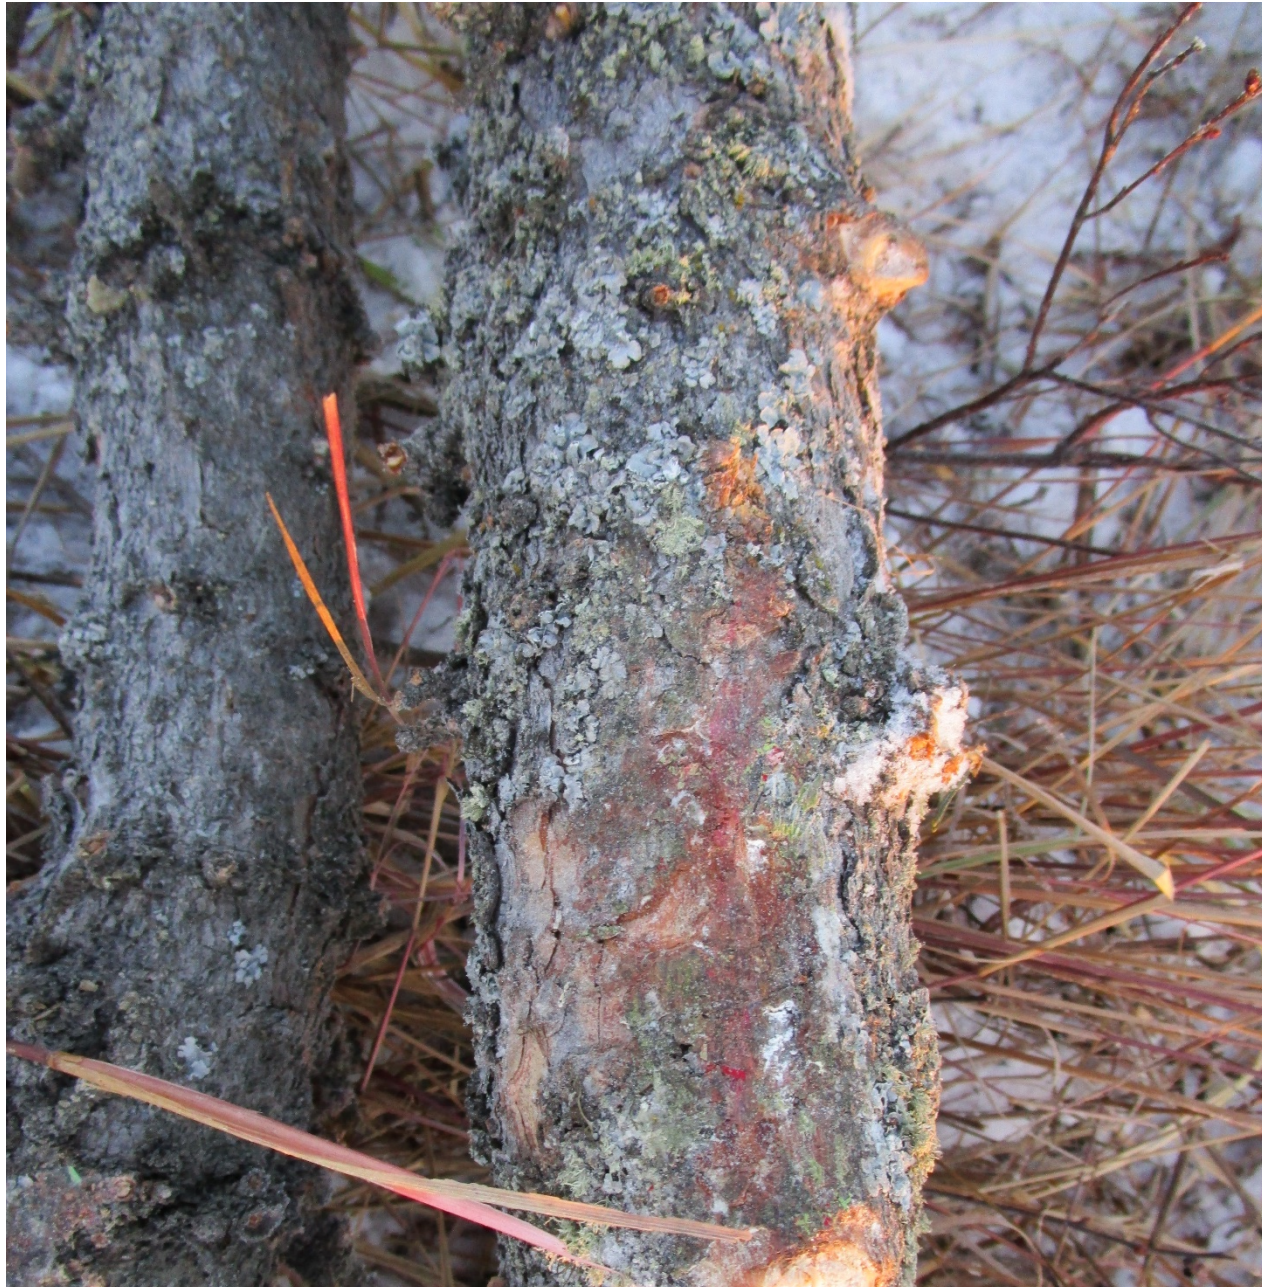
**Photo 3 - Red paint transfer on broken tree section**

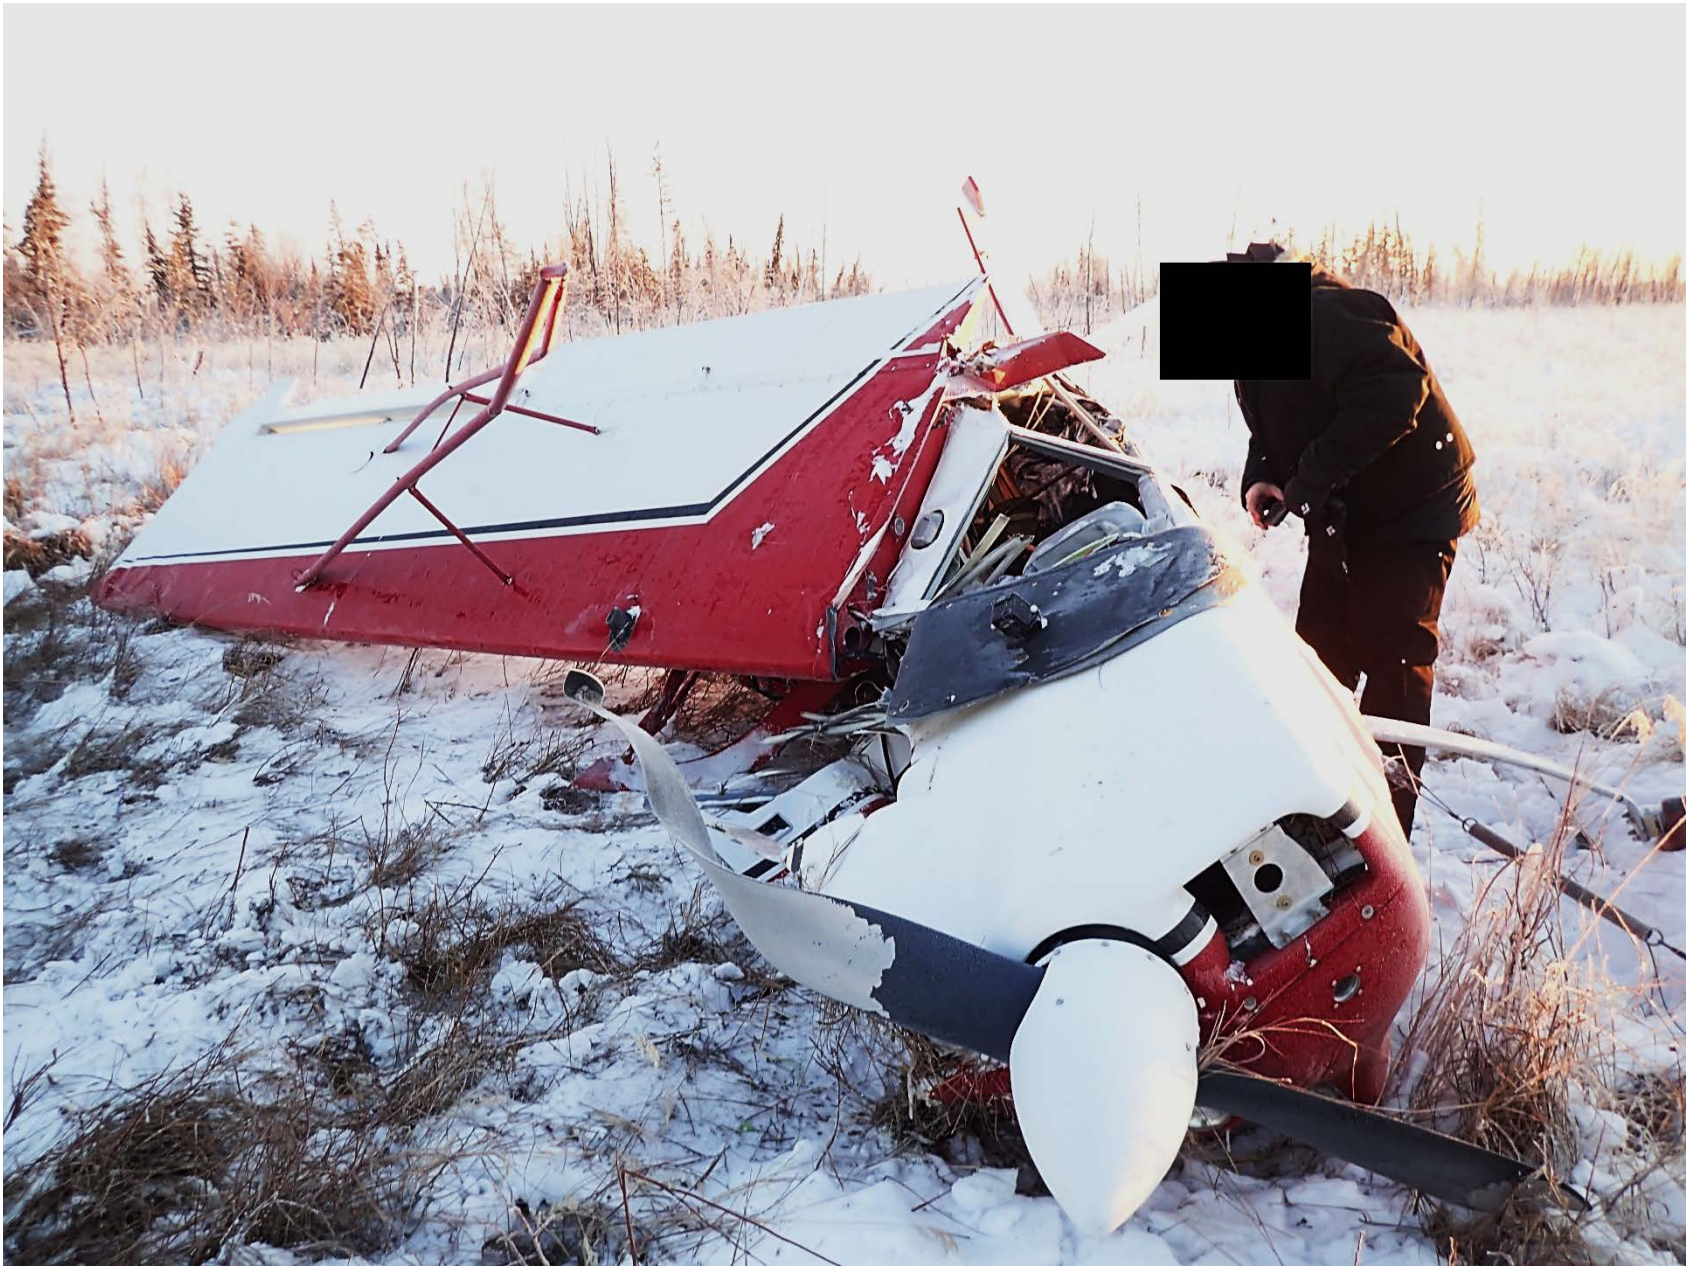
**Photo 4 - Front view of airplane at the accident scene**

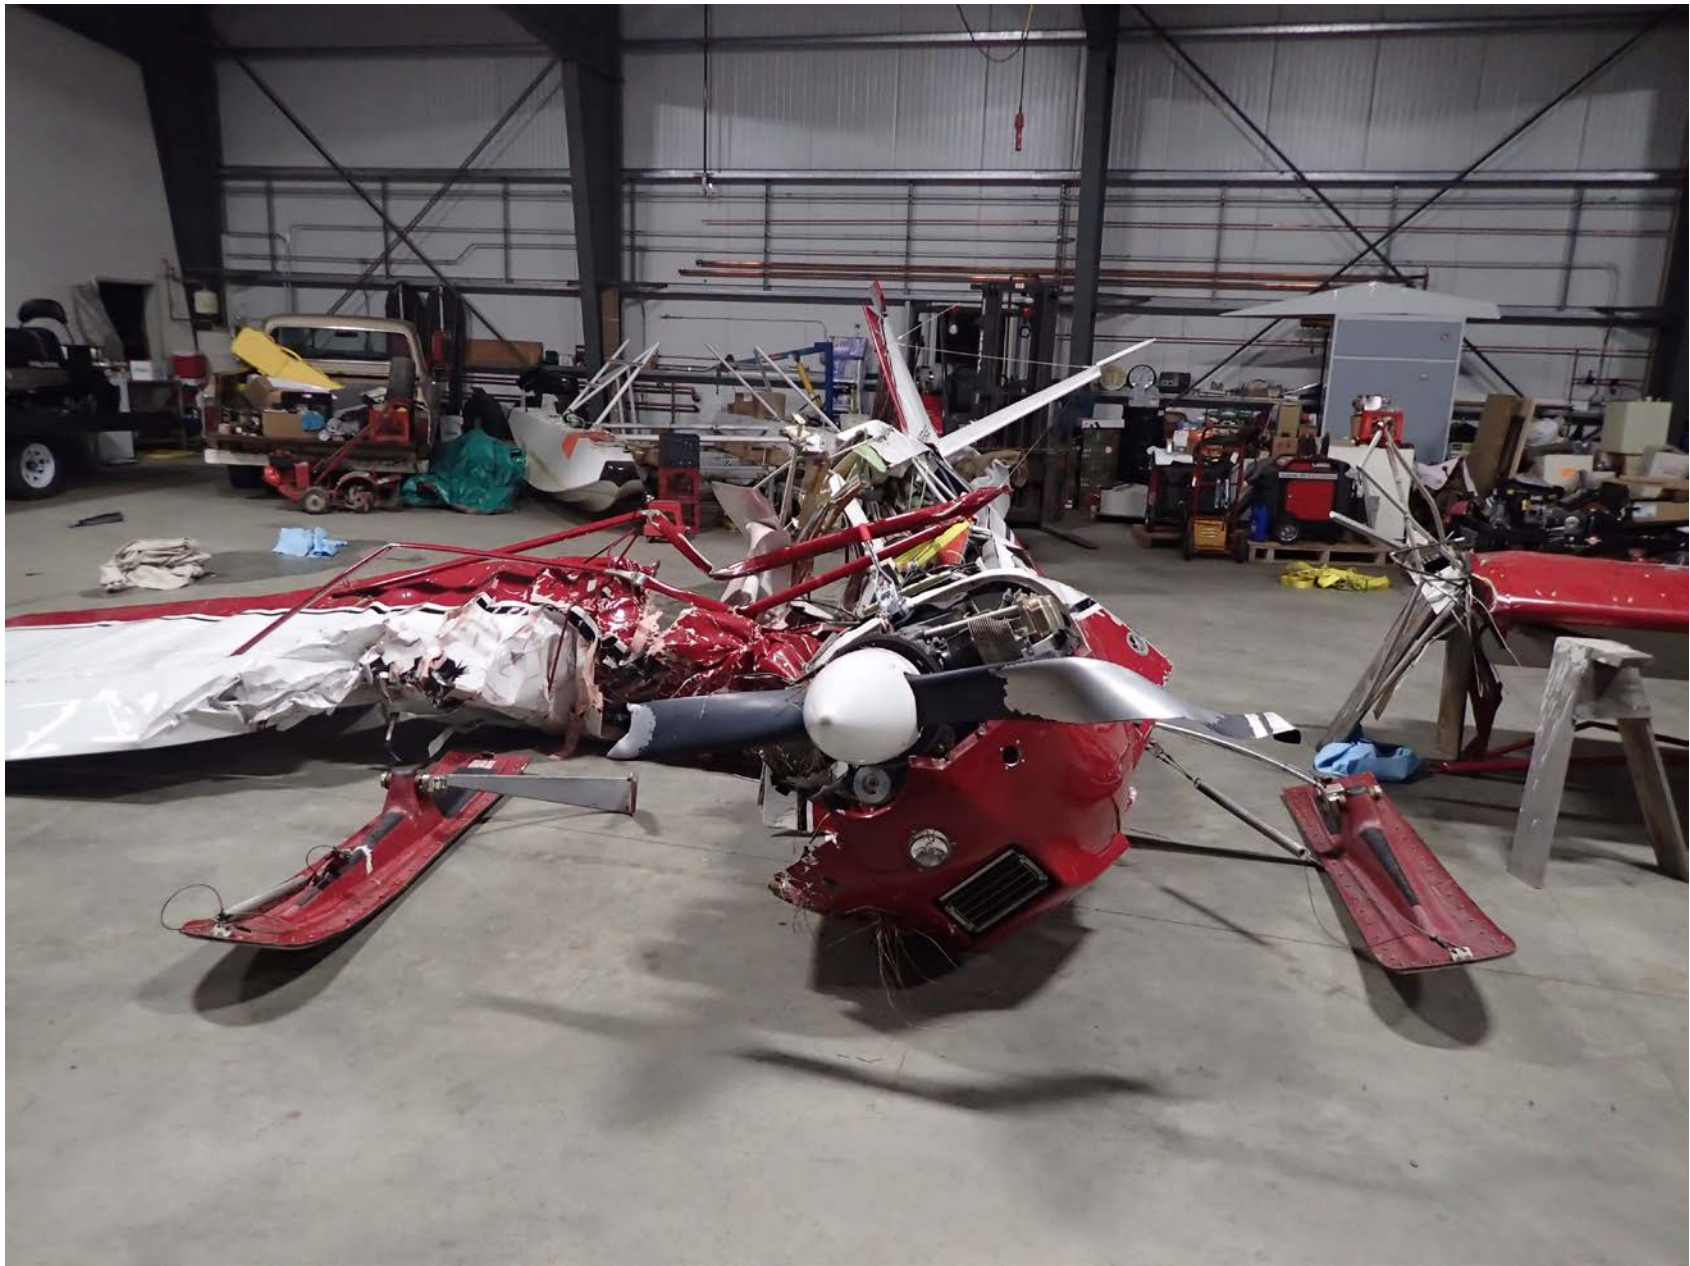
**Photo 5 - Detailed examination in a hangar**

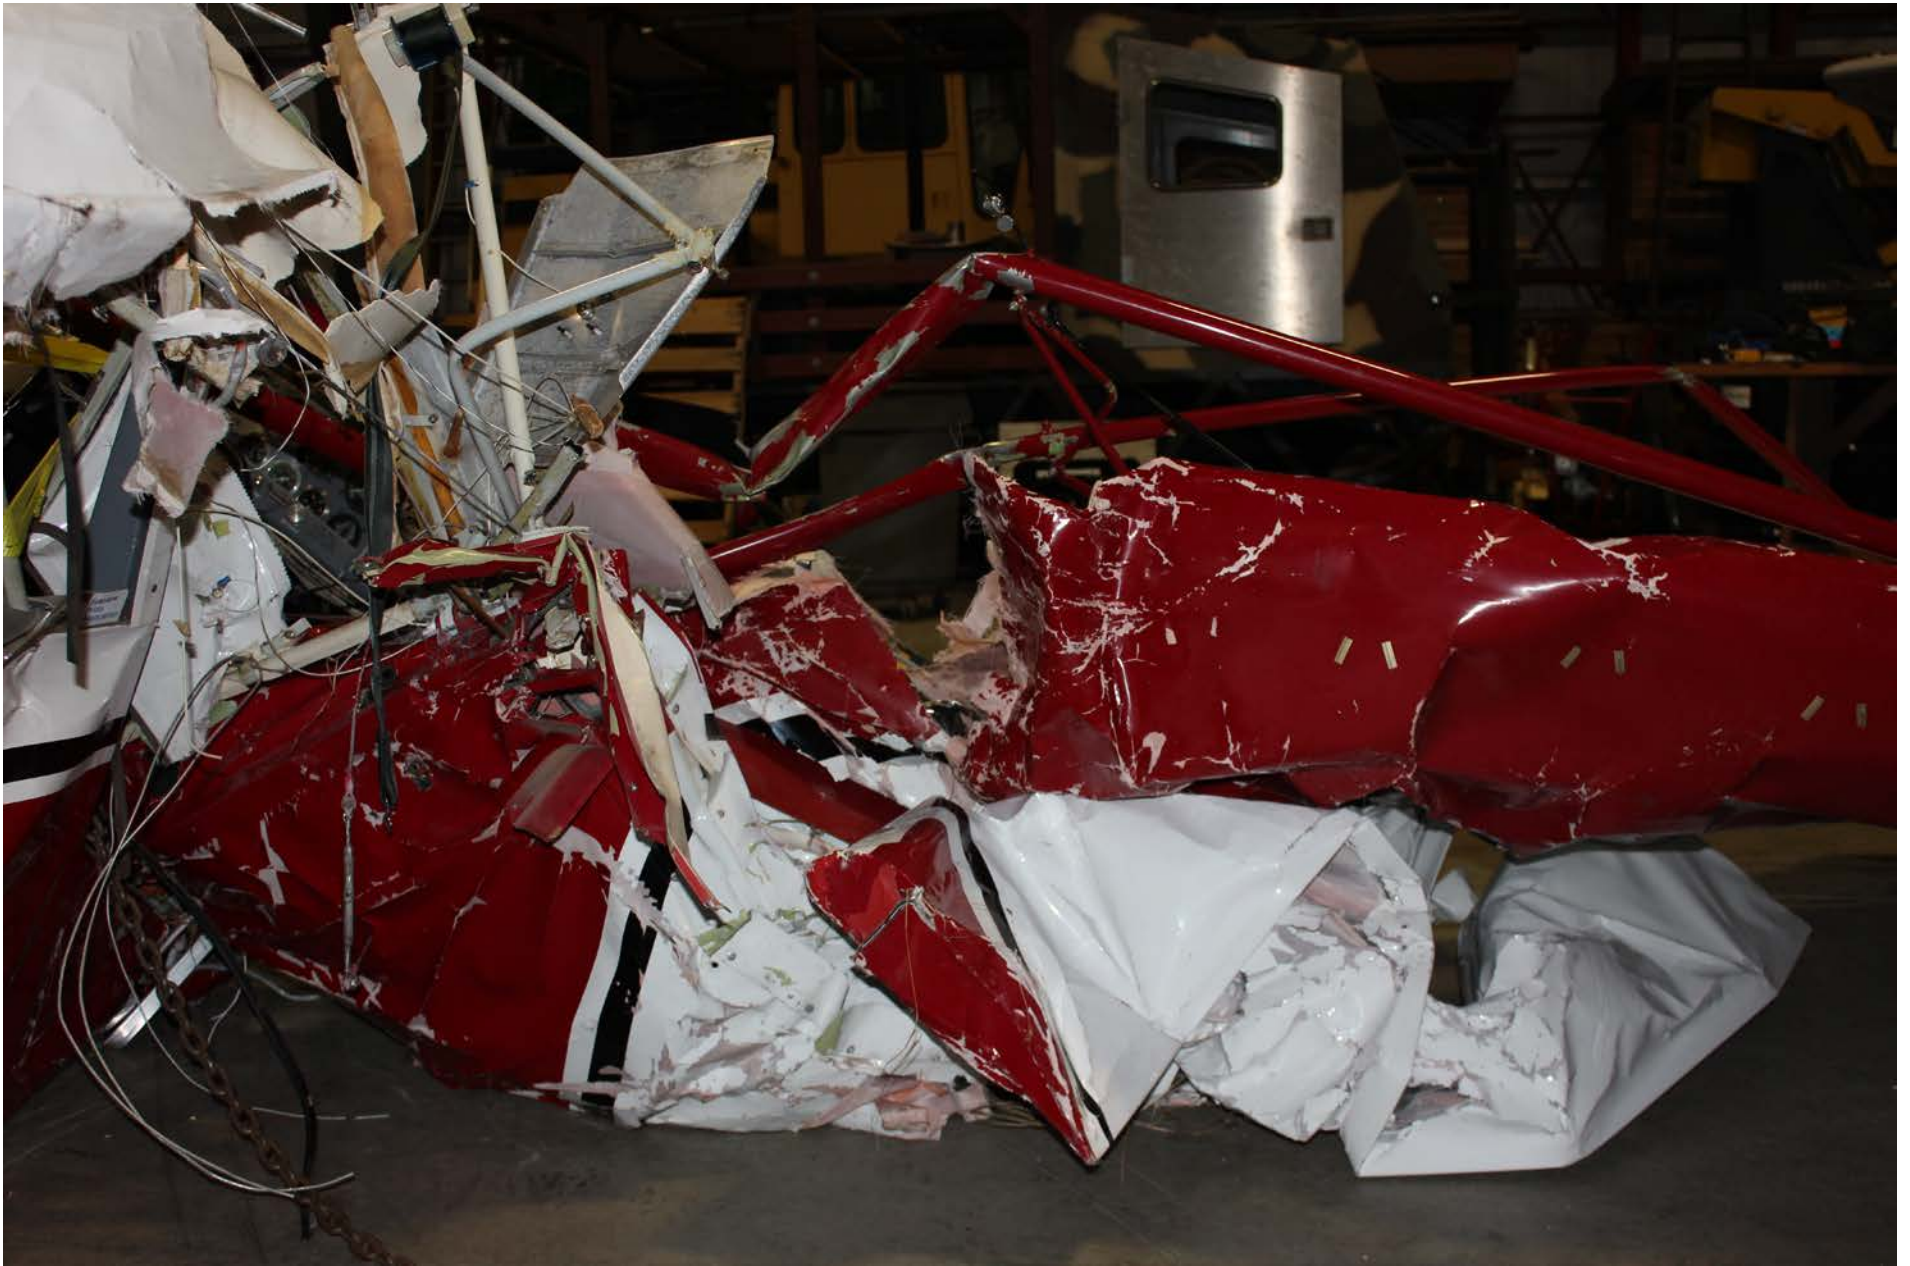
**Photo 6 - Right wing root damage**

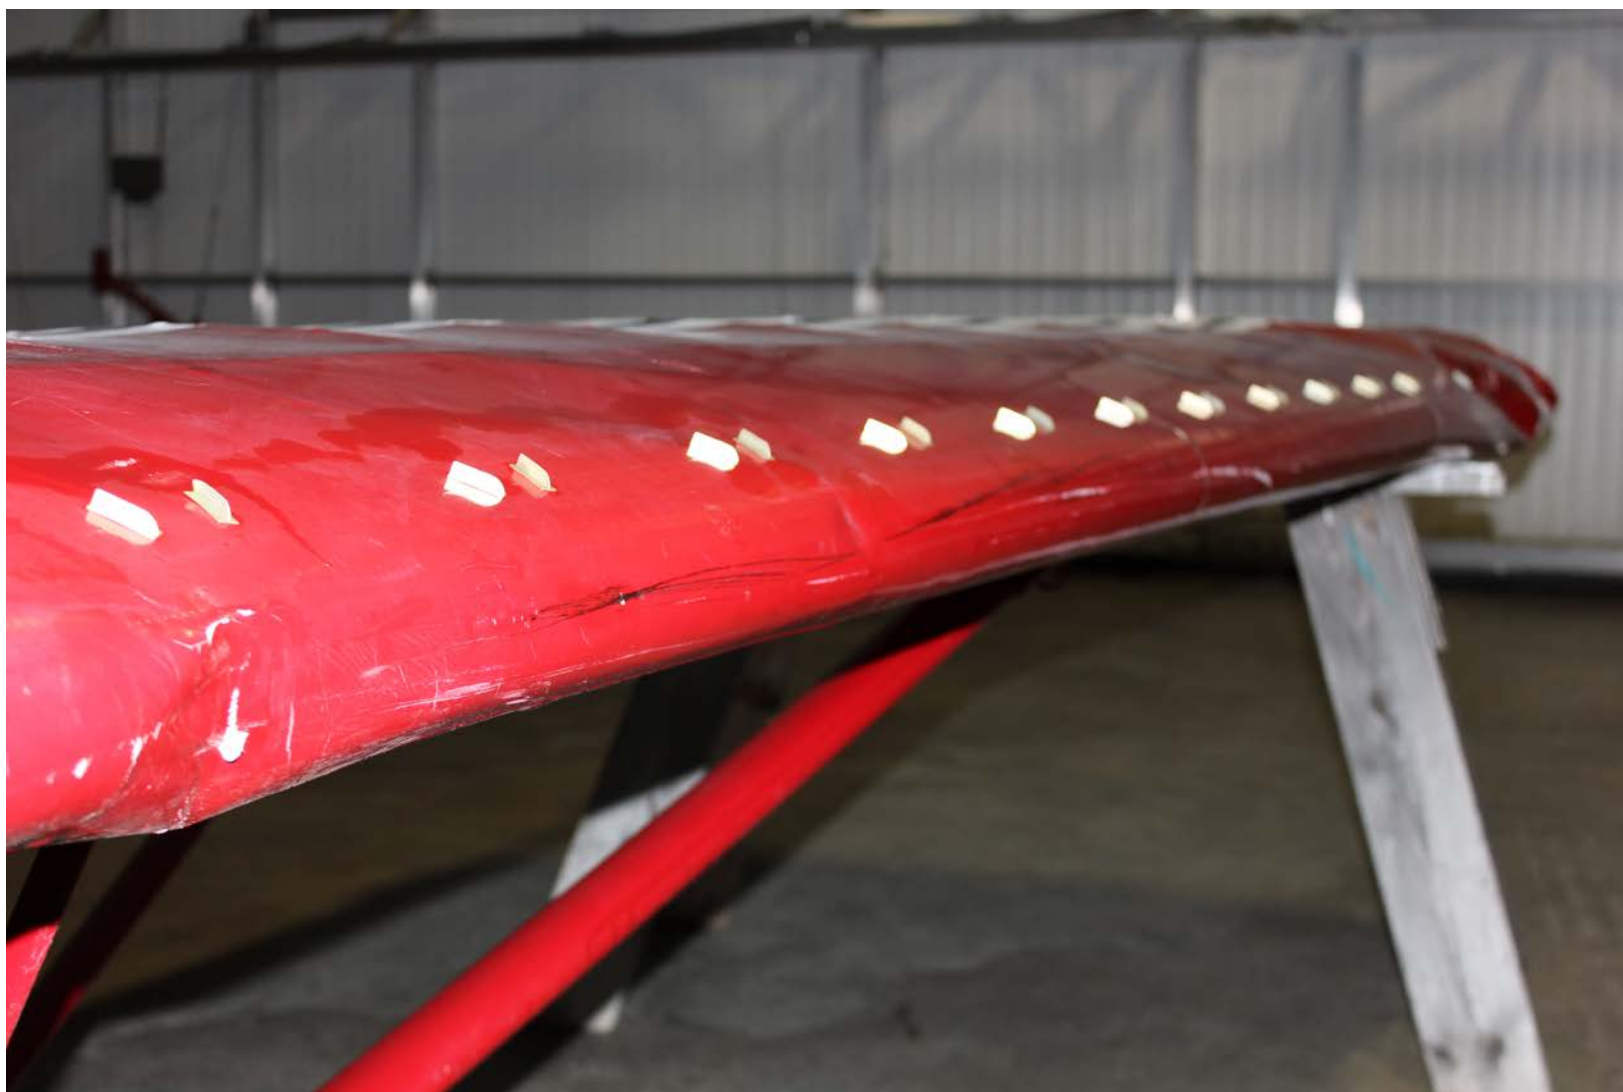
**Photo 7 - Left wing with vortex generators**

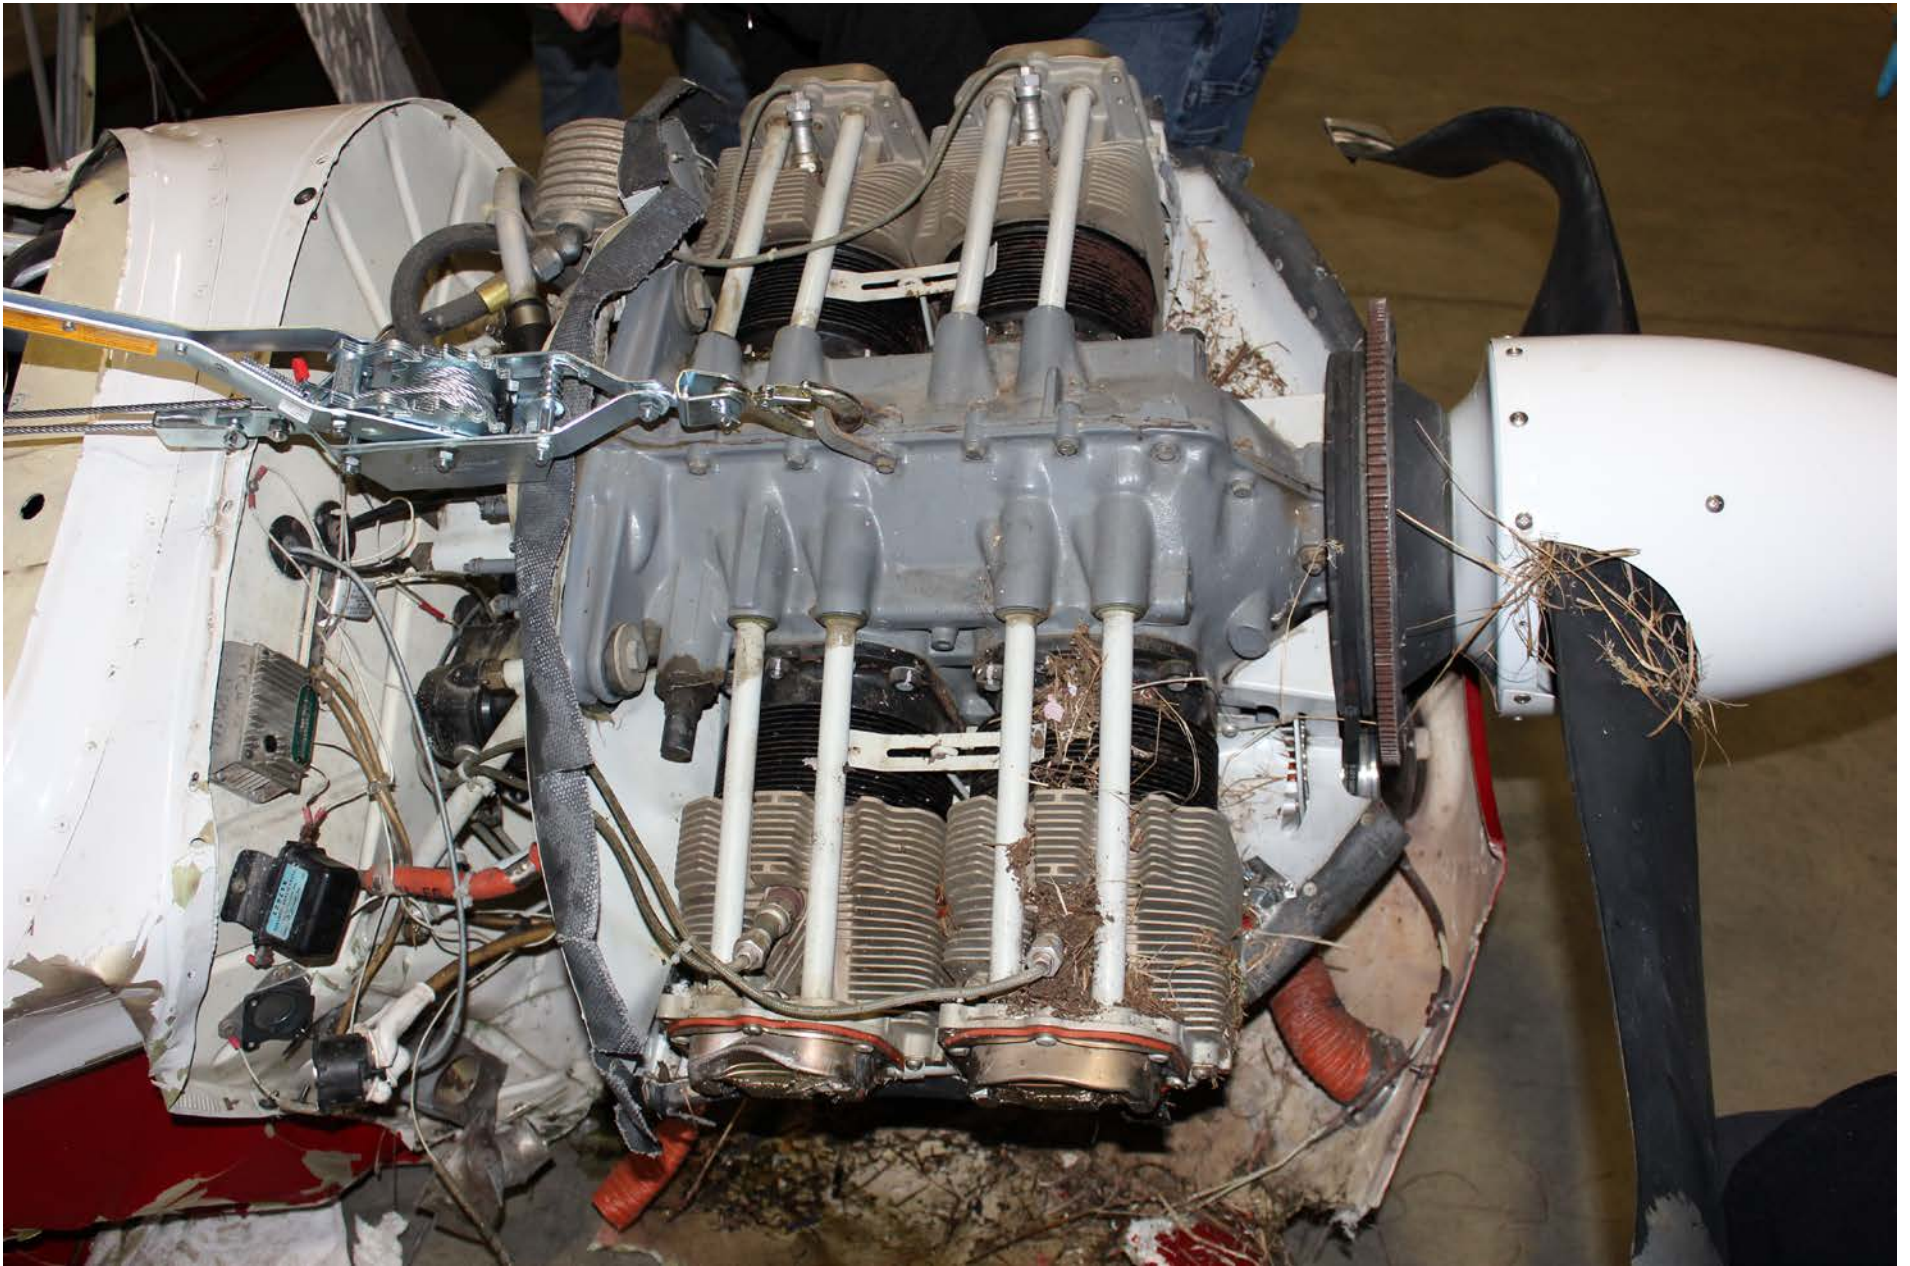
**Photo 8 - Lycoming O-320 engine with right side damage**

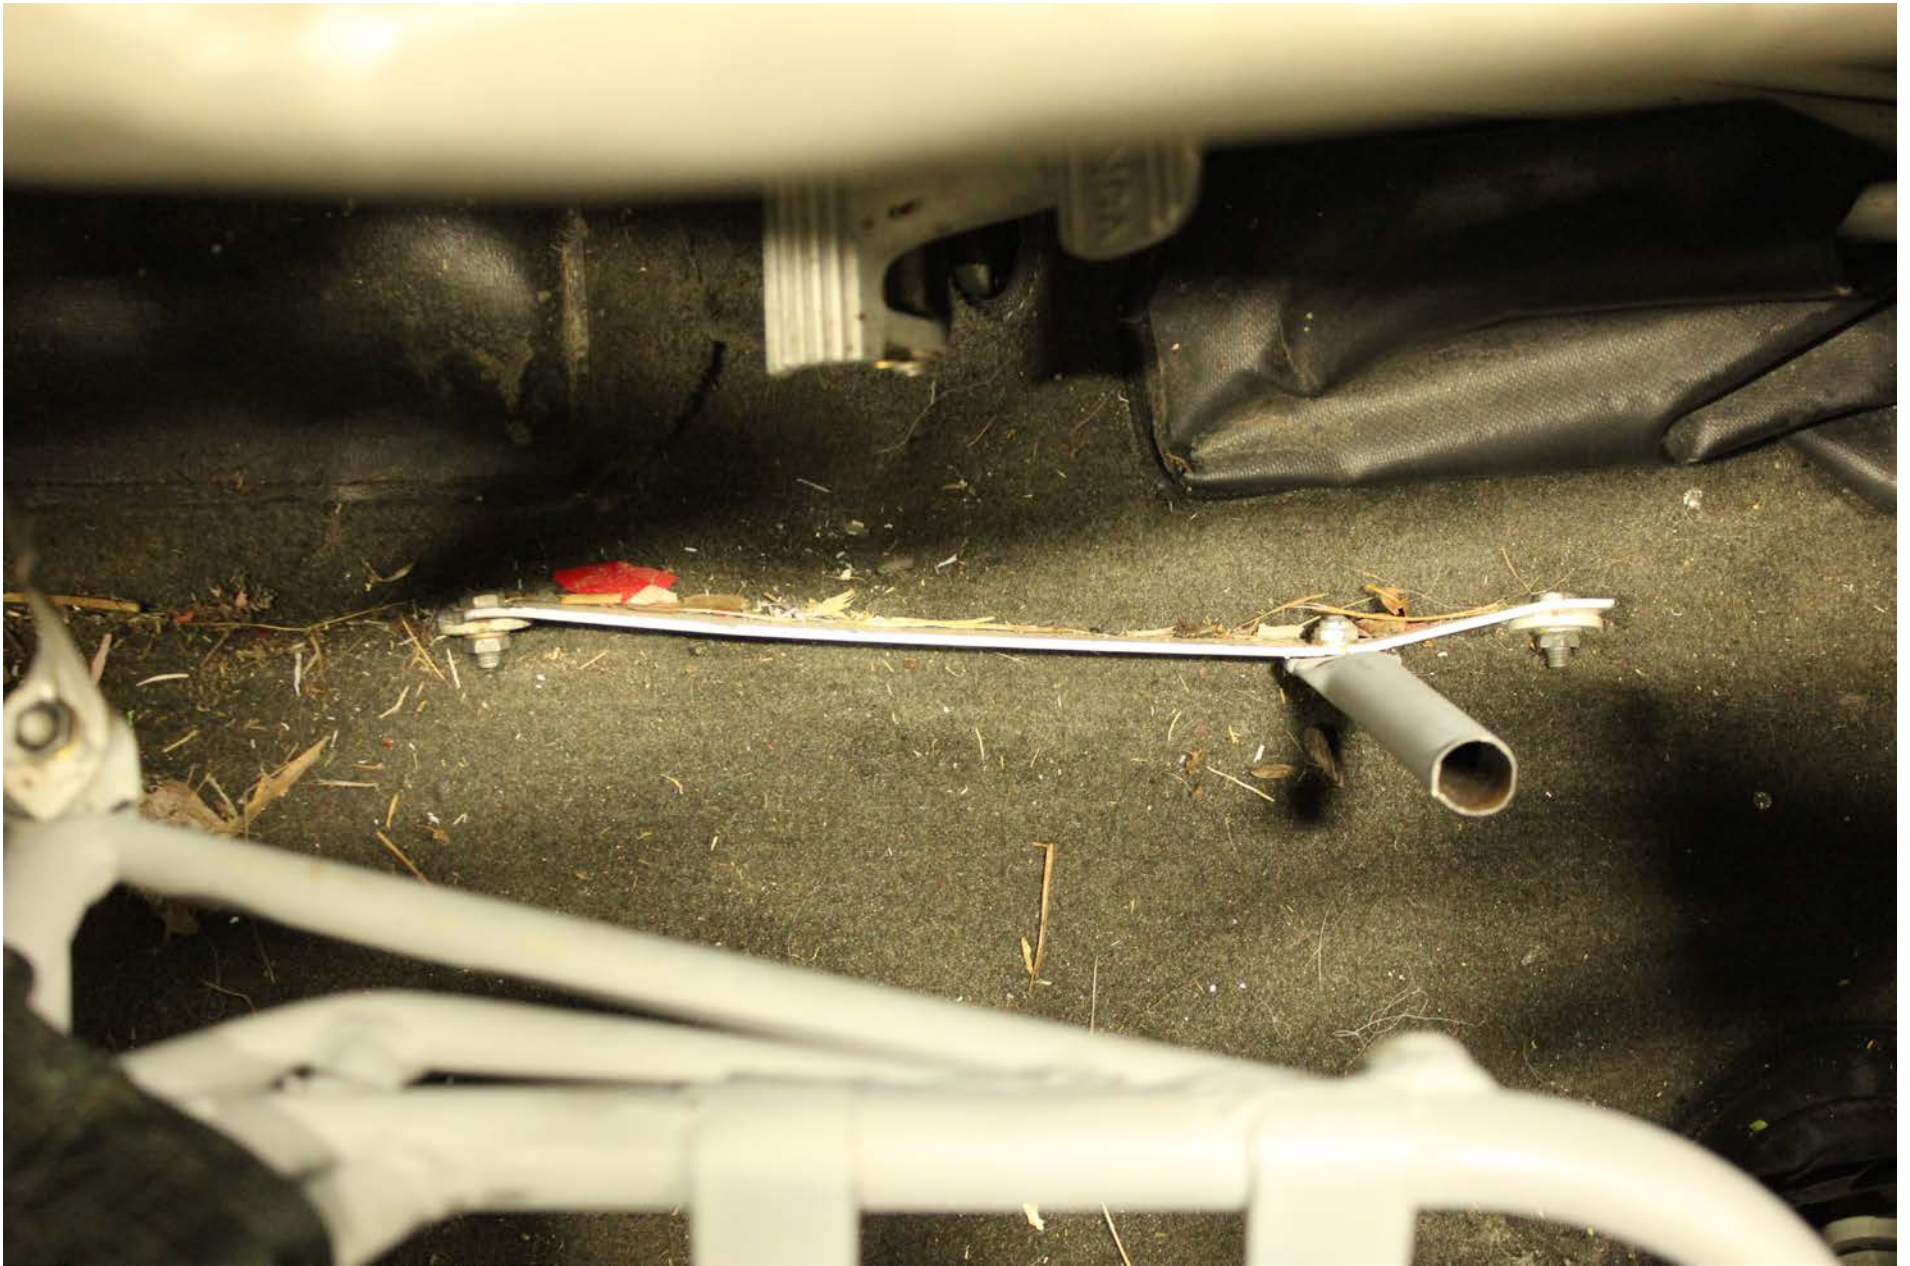
**Photo 9 - Left side pilot seat leg fractures and modified bracket**
