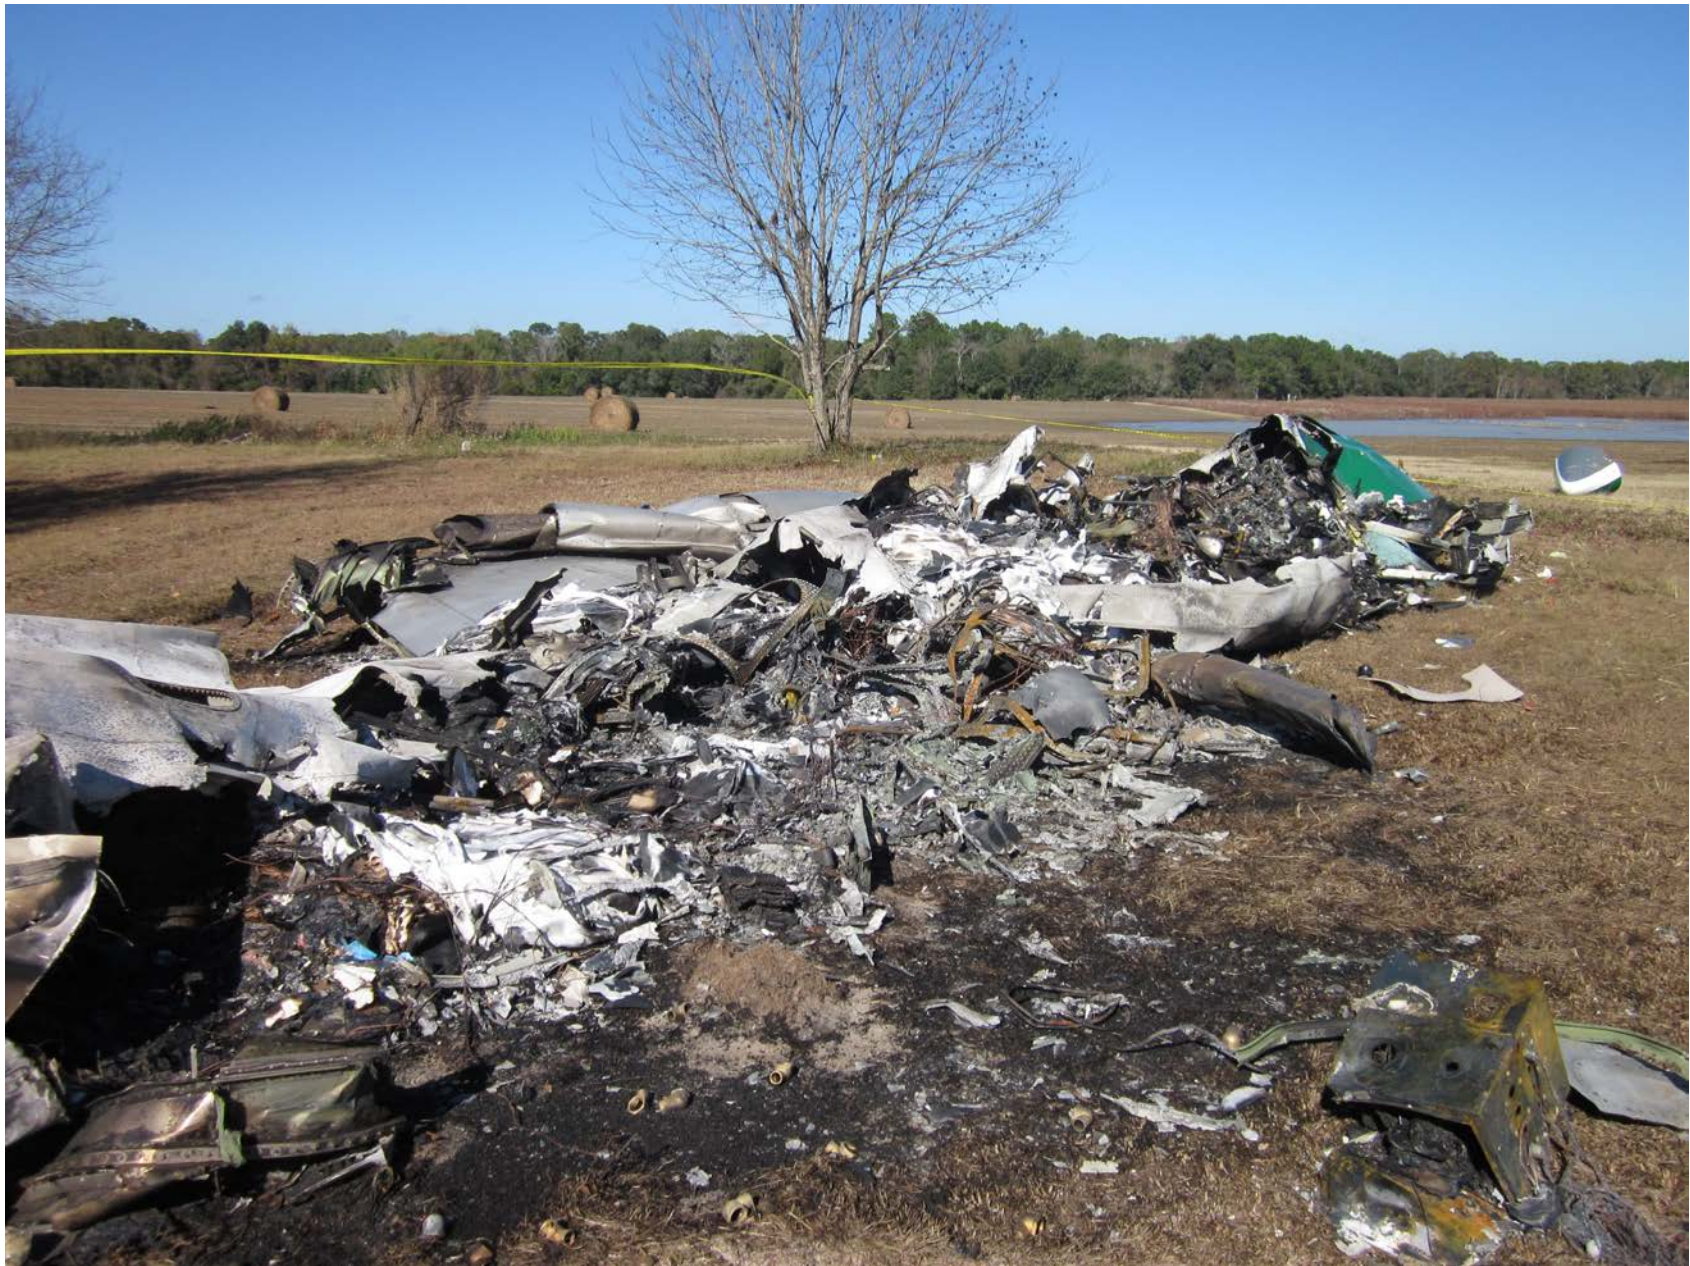
**Photo 1 – View of main wreckage showing fire damaged fuselage**

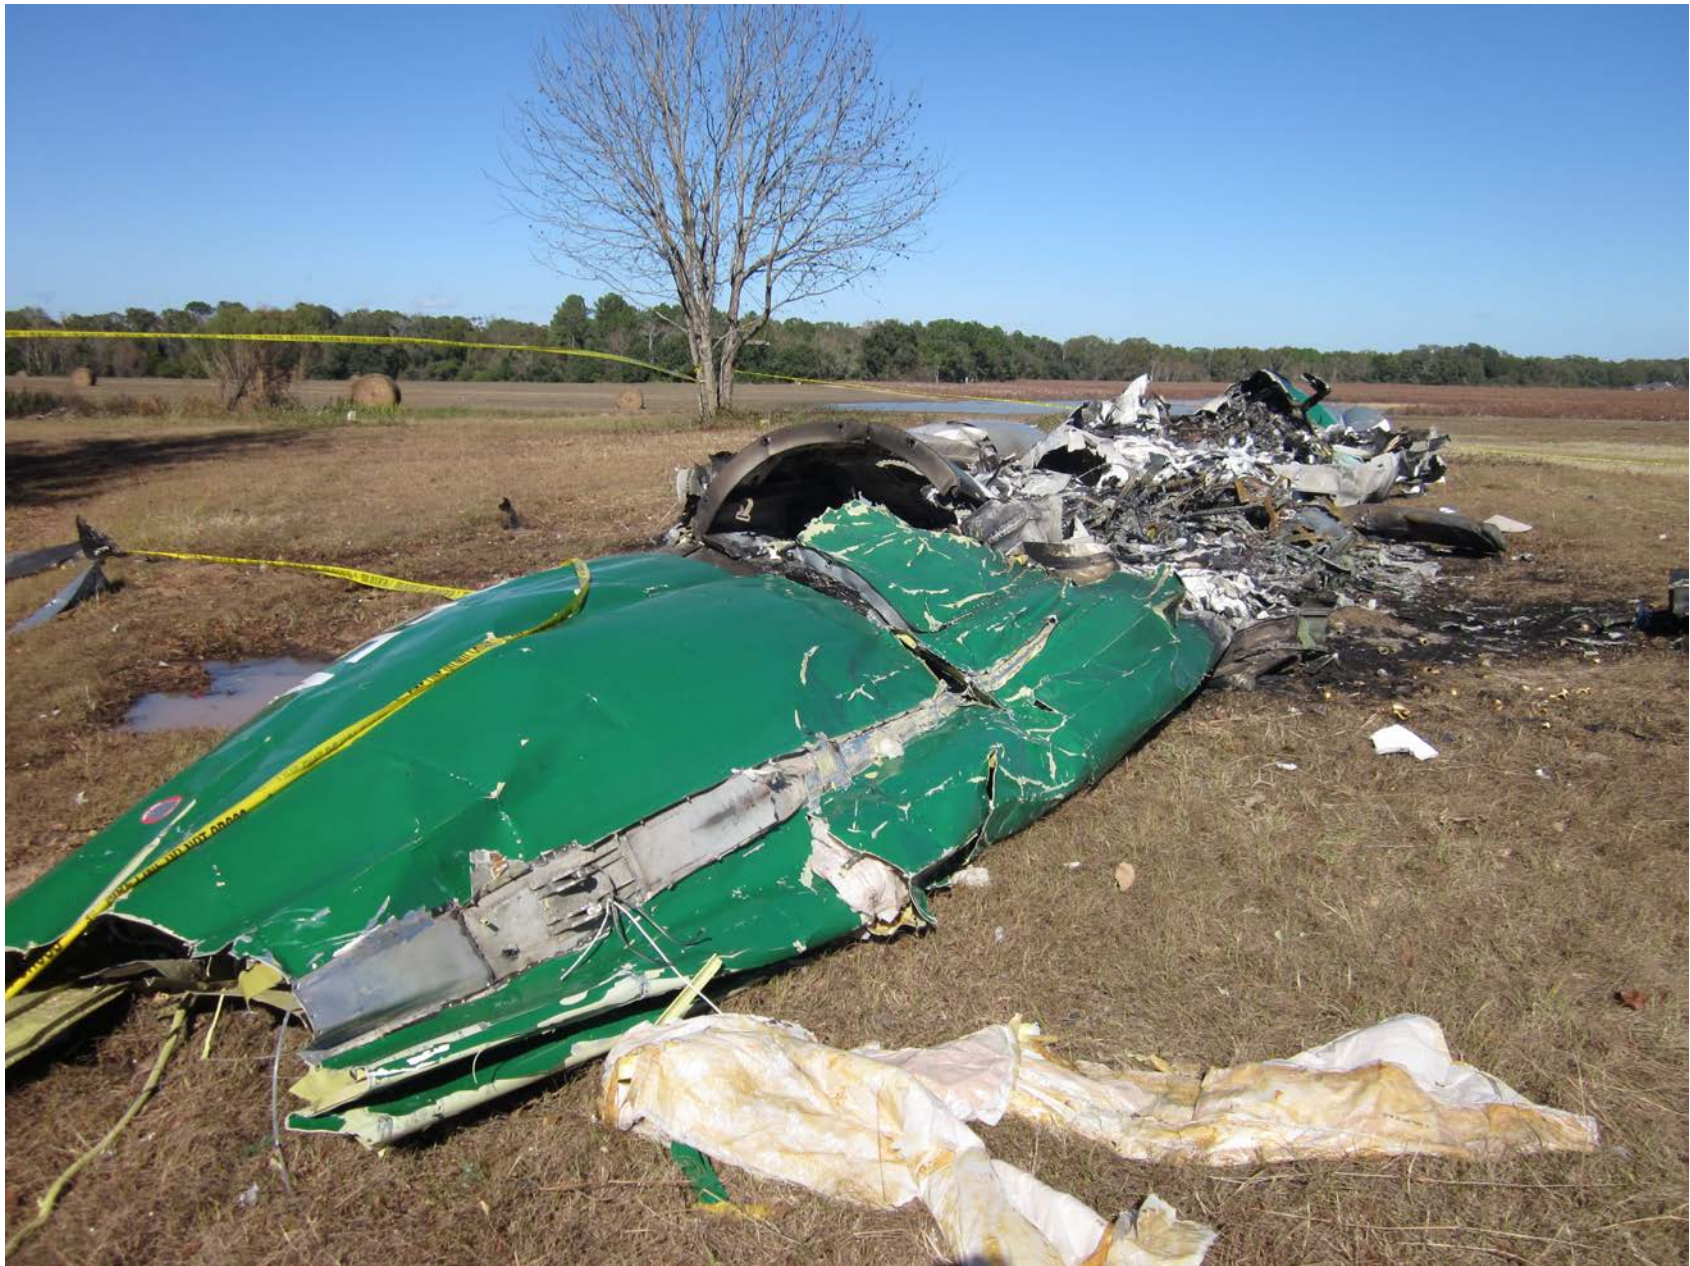
**Photo 2 – View of aft section of fuselage showing crush damage**

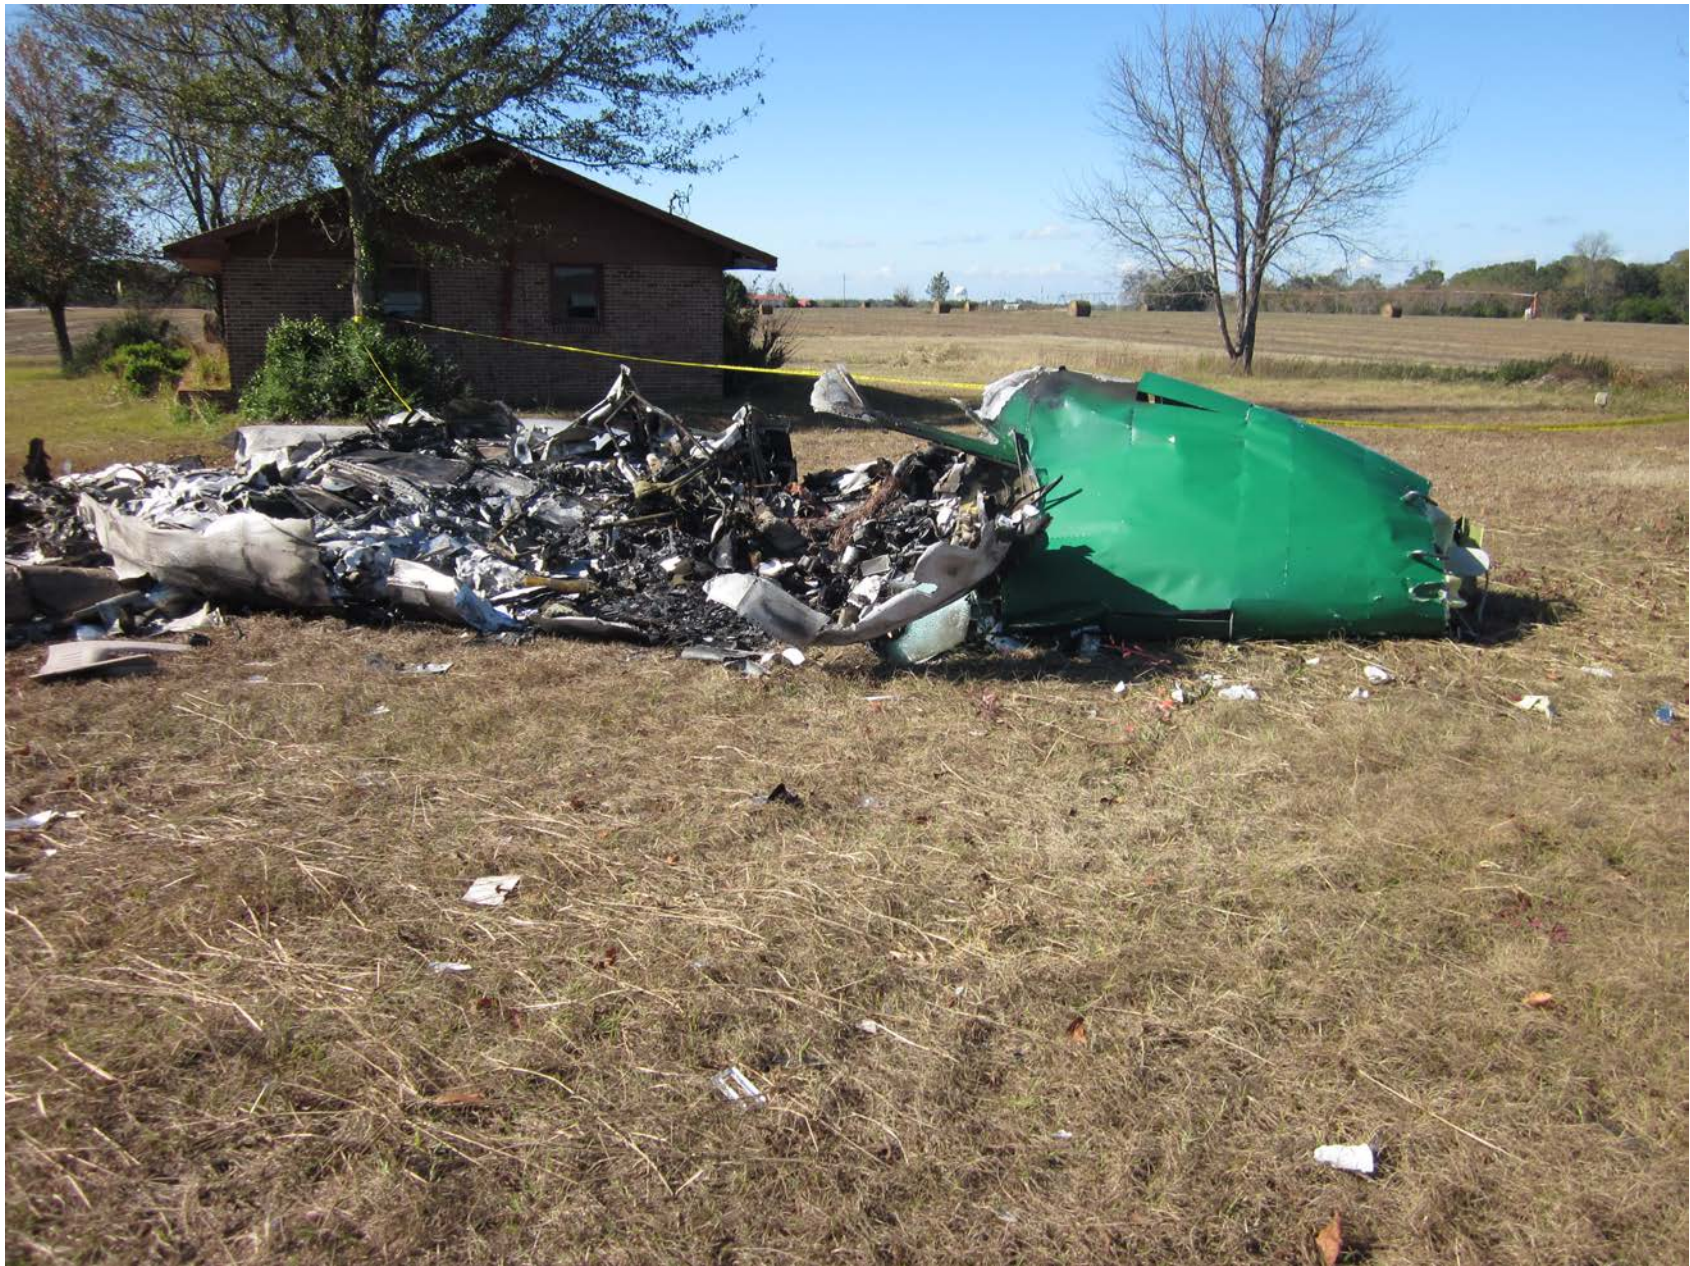
**Photo 3 – Right side view of cockpit and nose fire damaged**

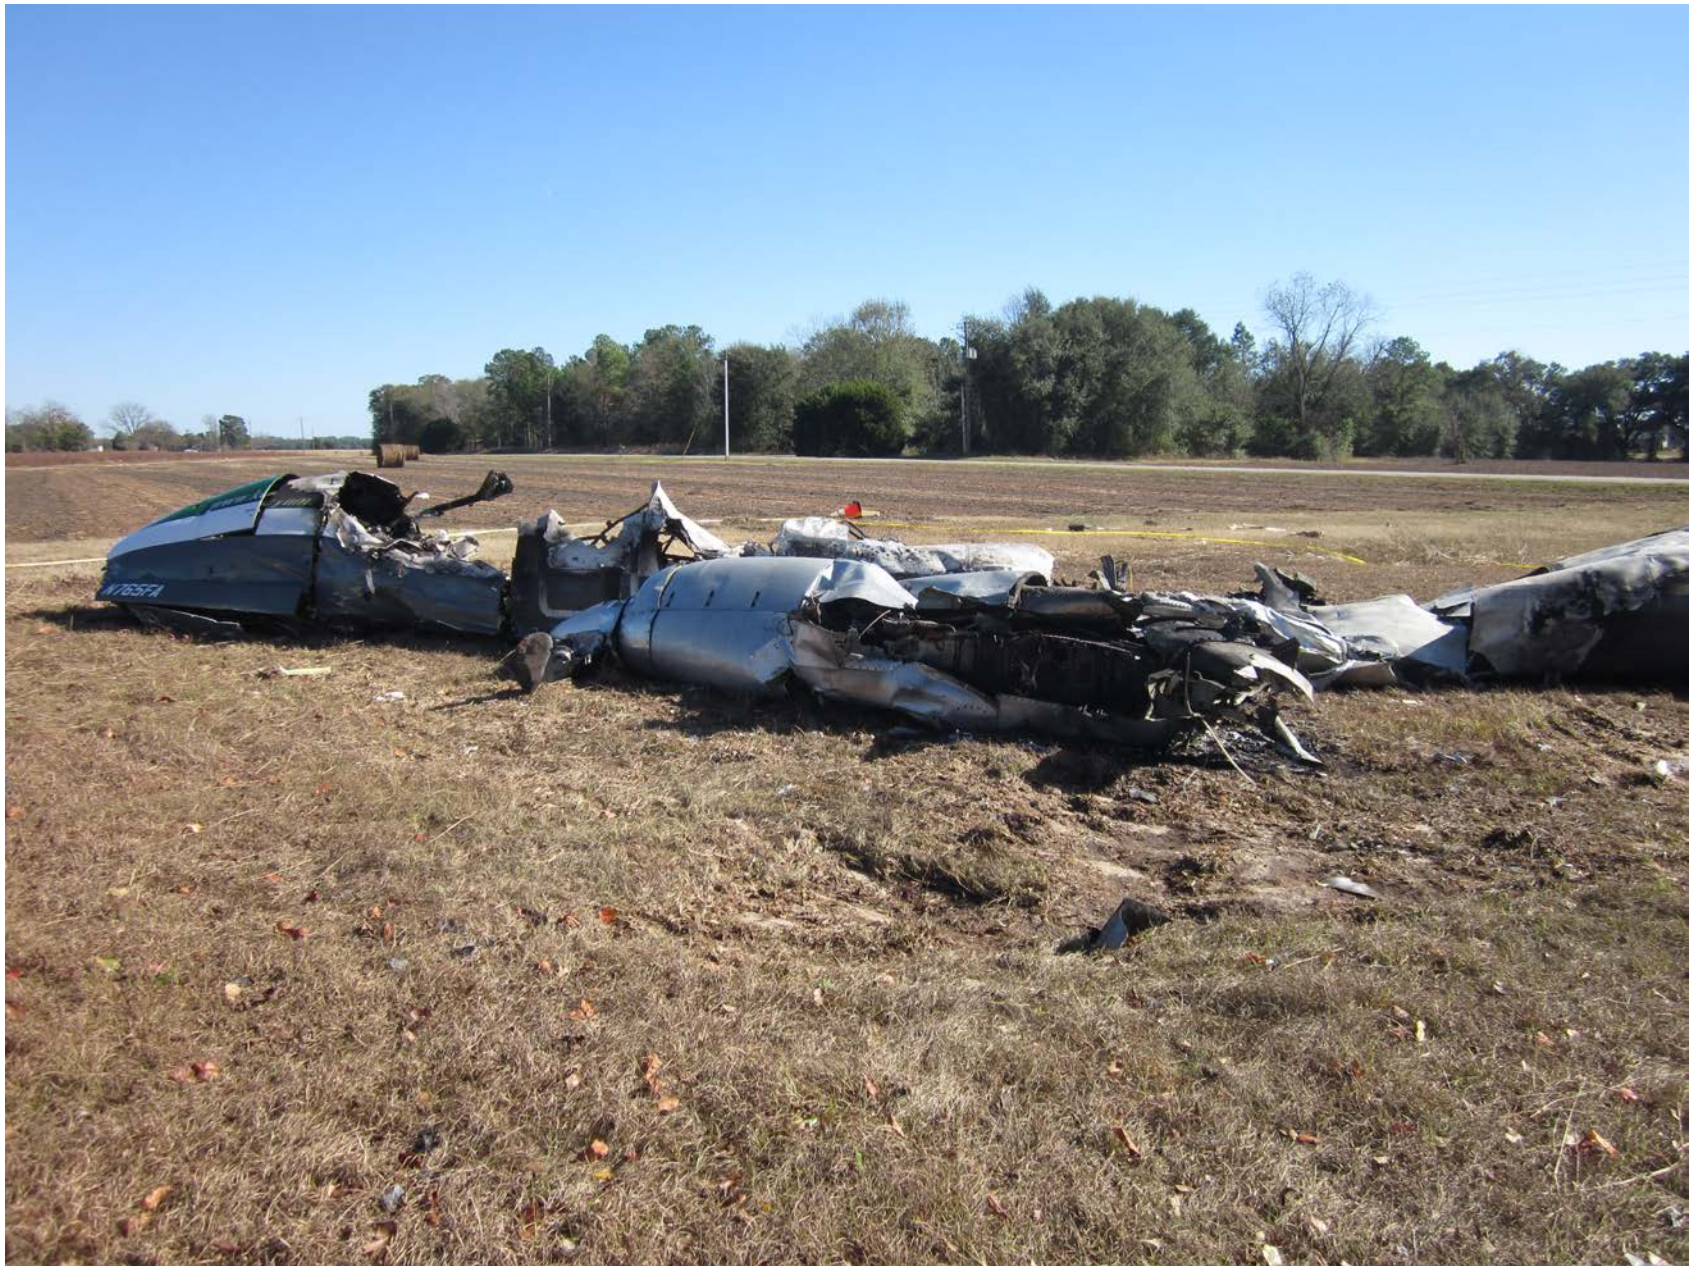
**Photo 4 – View of left side of fuselage and left engine fire damaged and crushed**

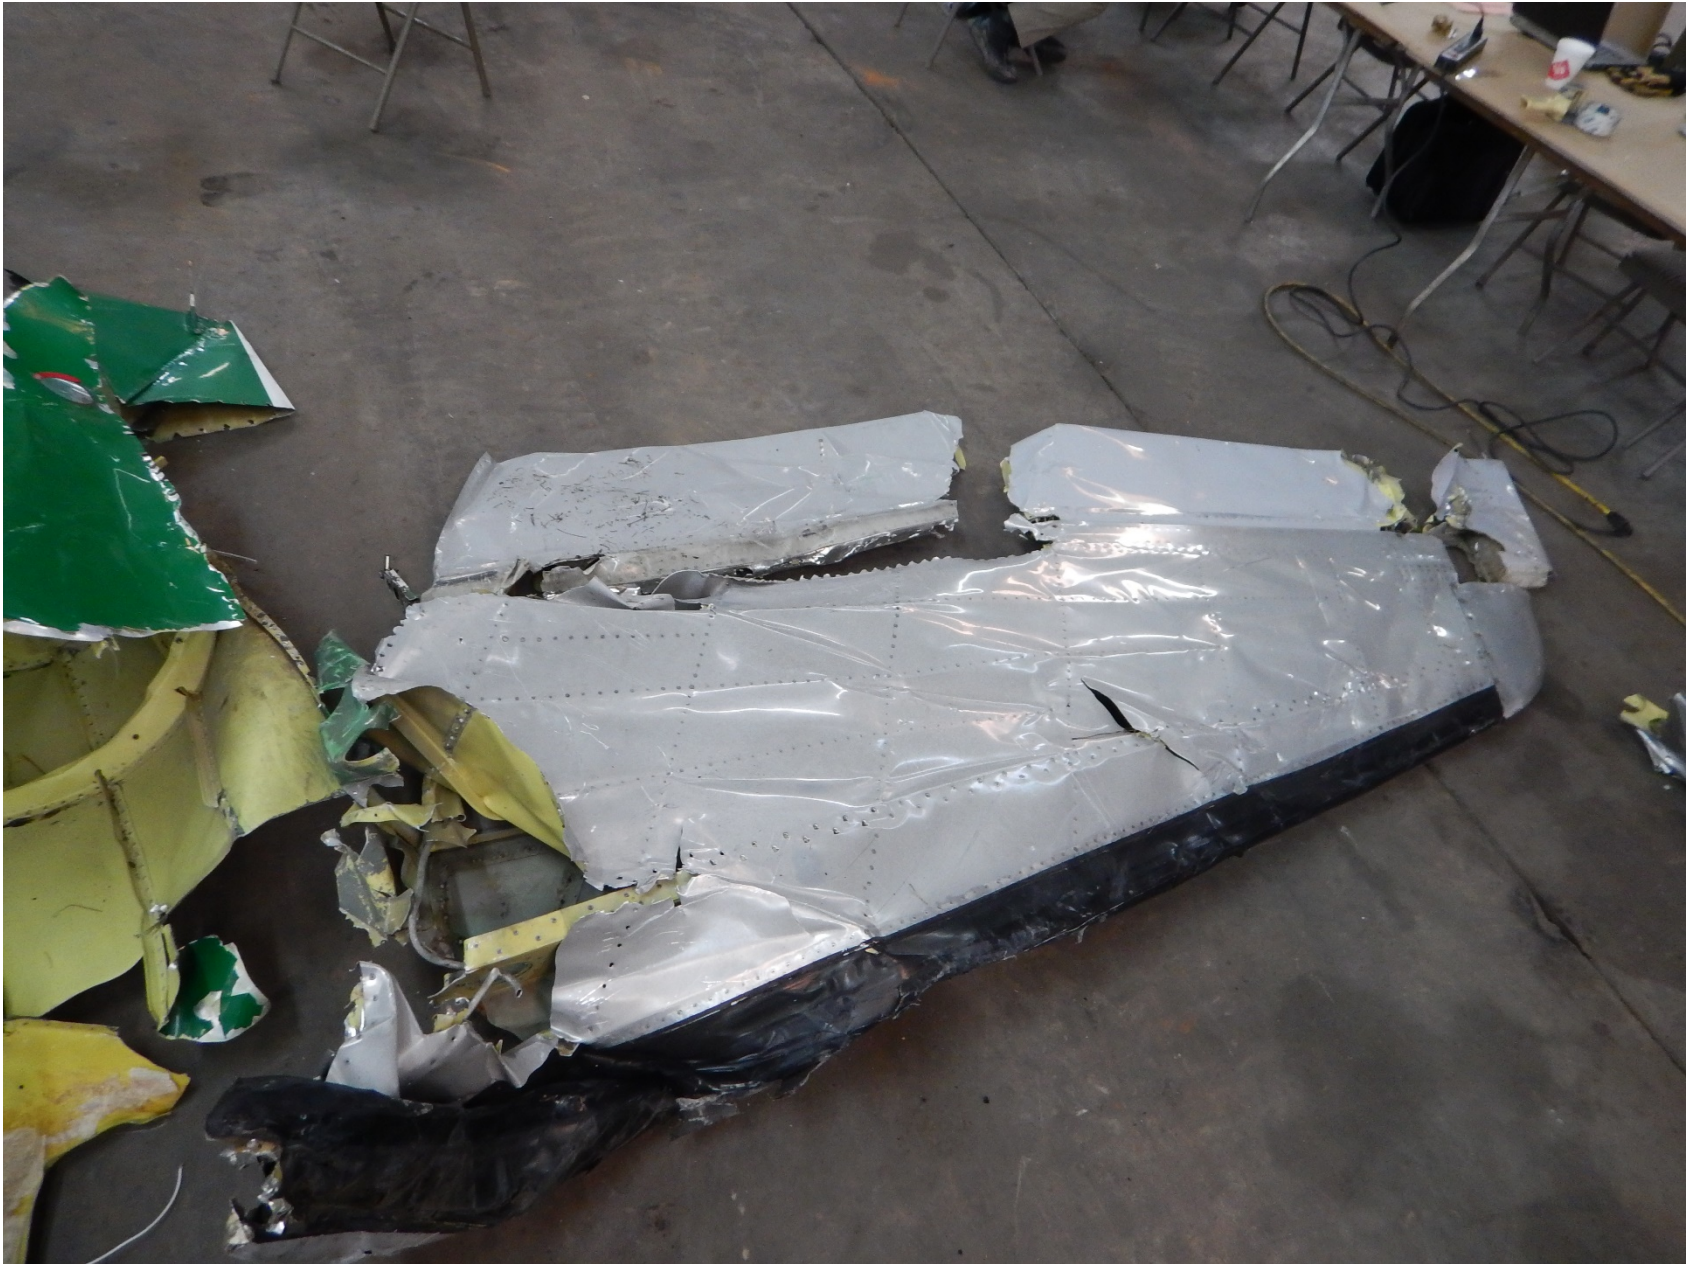
**Photo 9 – View of a left side section of the horizontal stabilizer and damaged elevator sections**

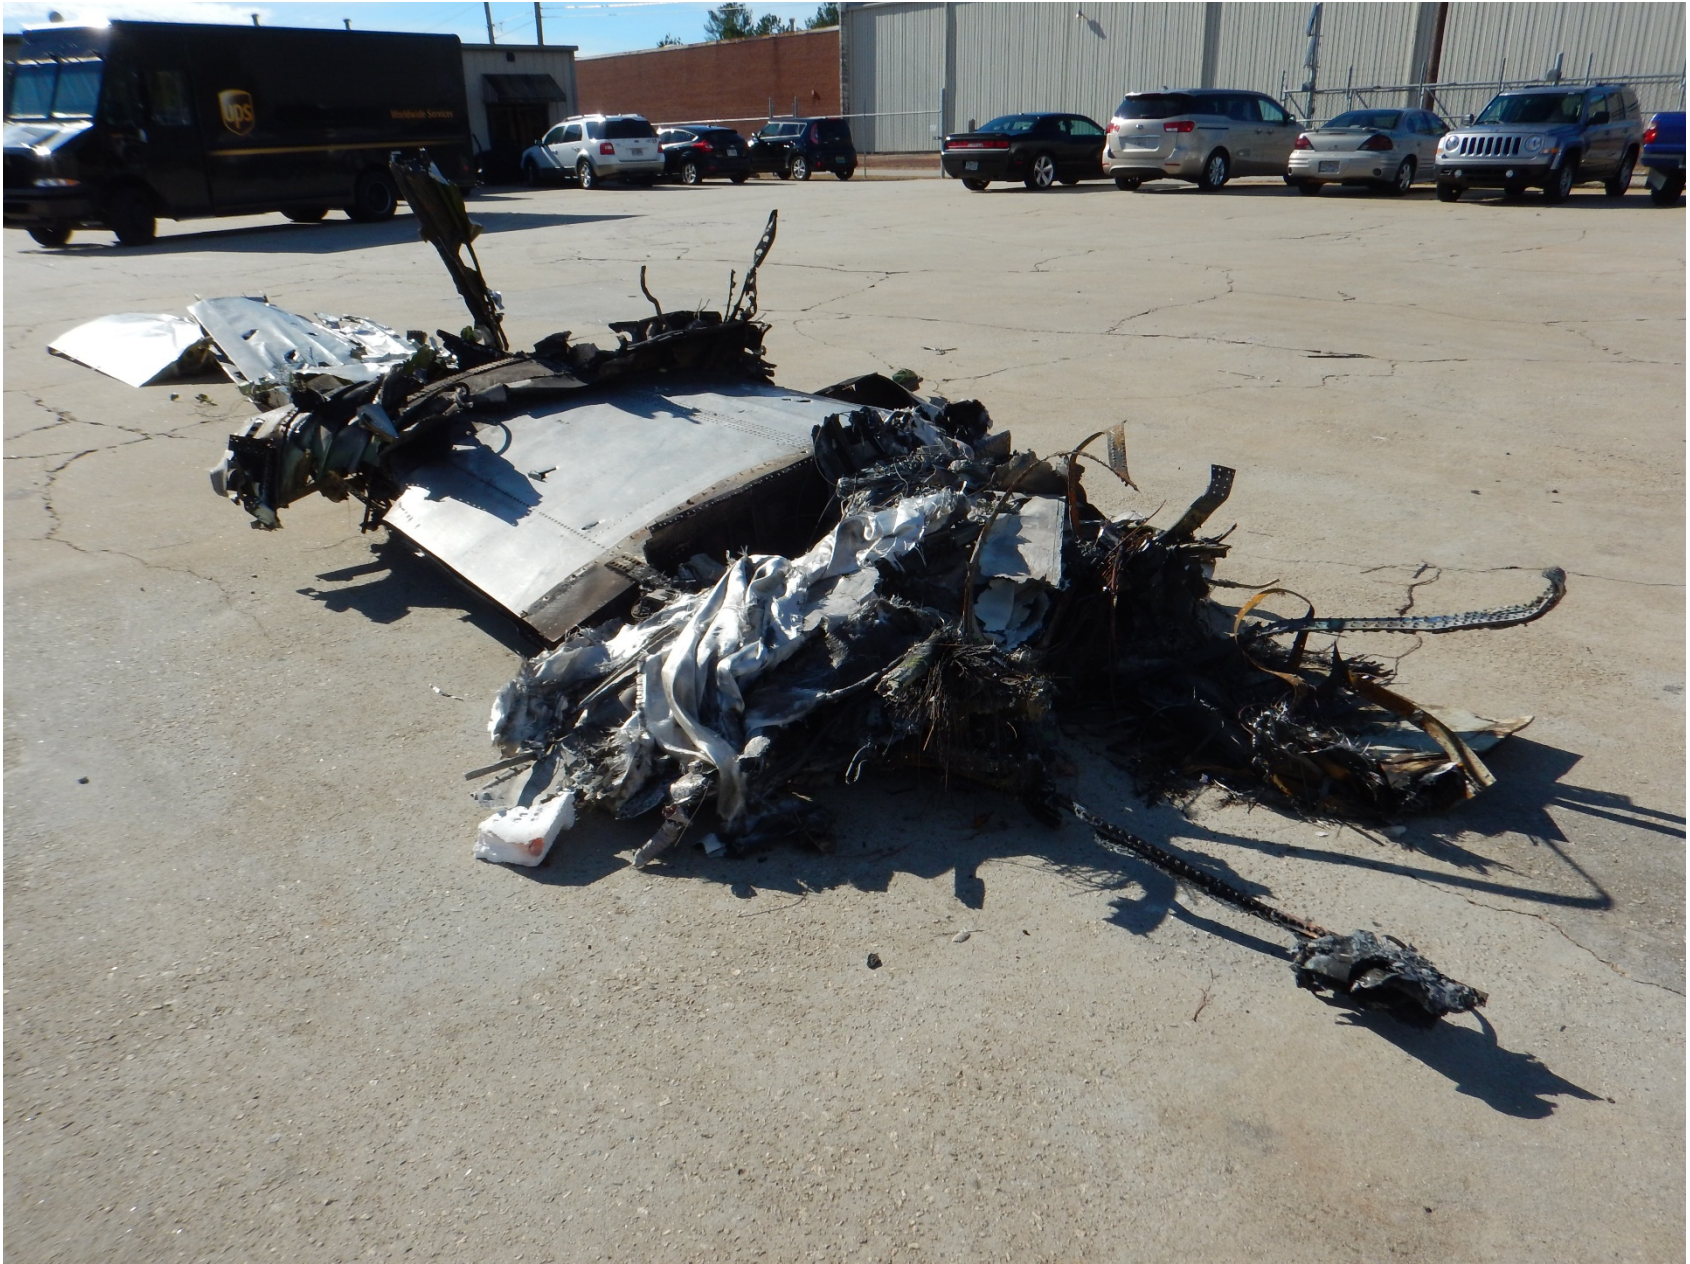
**Photo 10 – View of left wing section damaged**

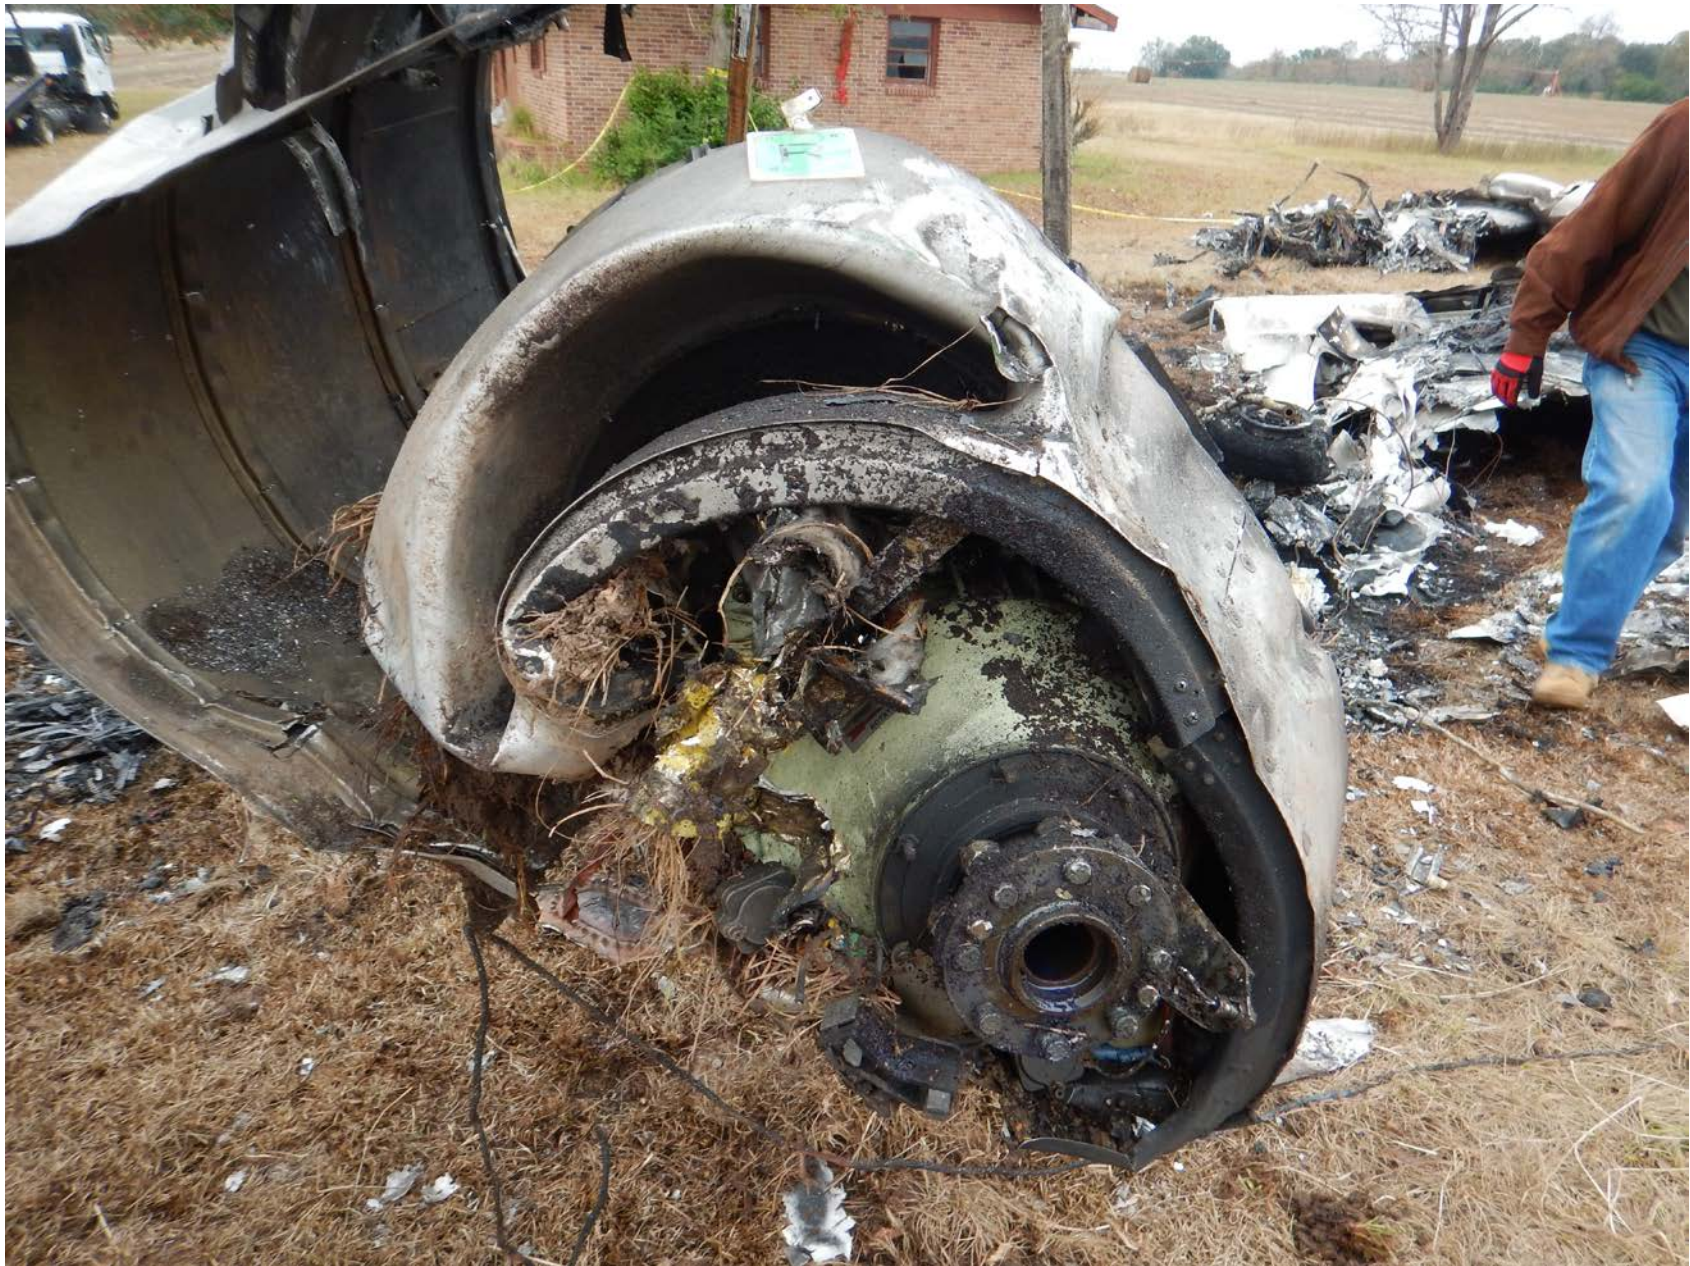
**Photo 14 – View of damaged right engine**

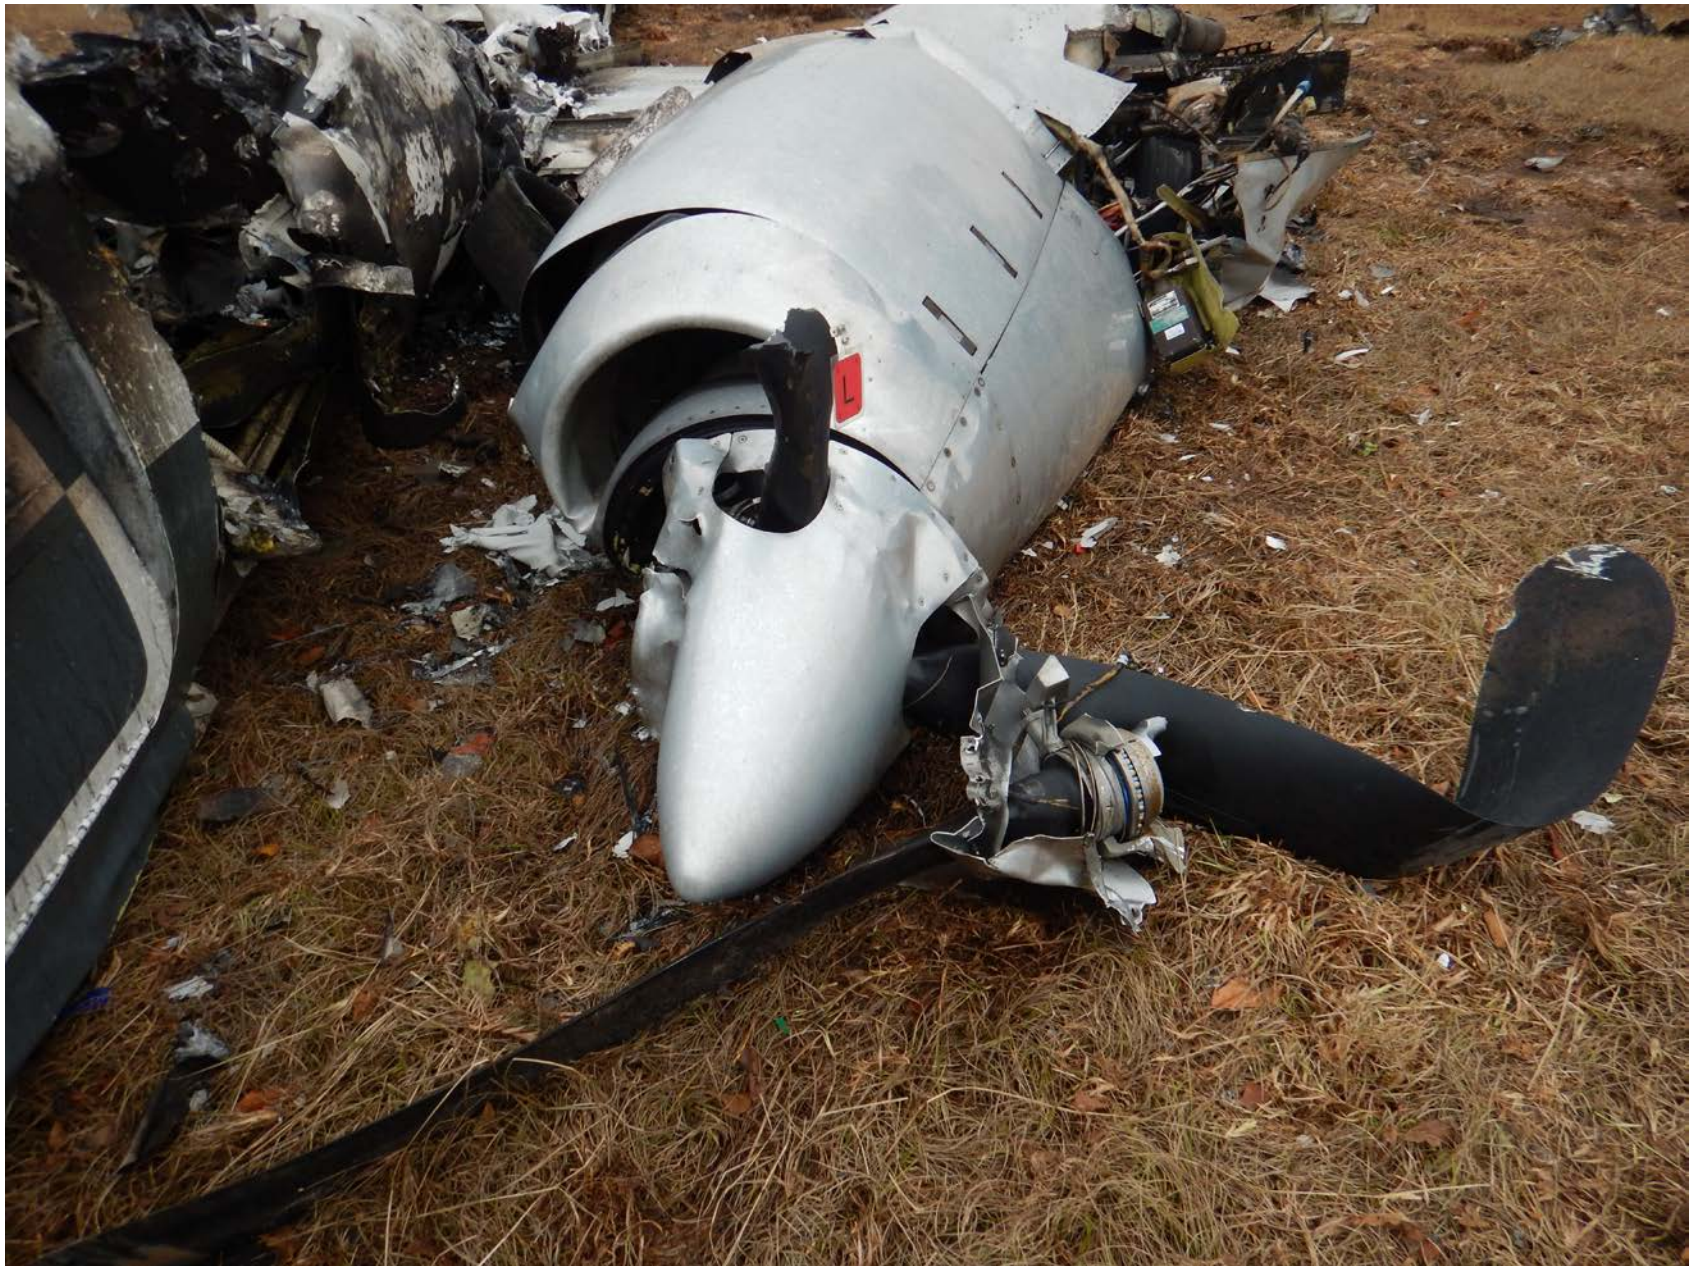
**Photo 15 – View of damaged left engine**
