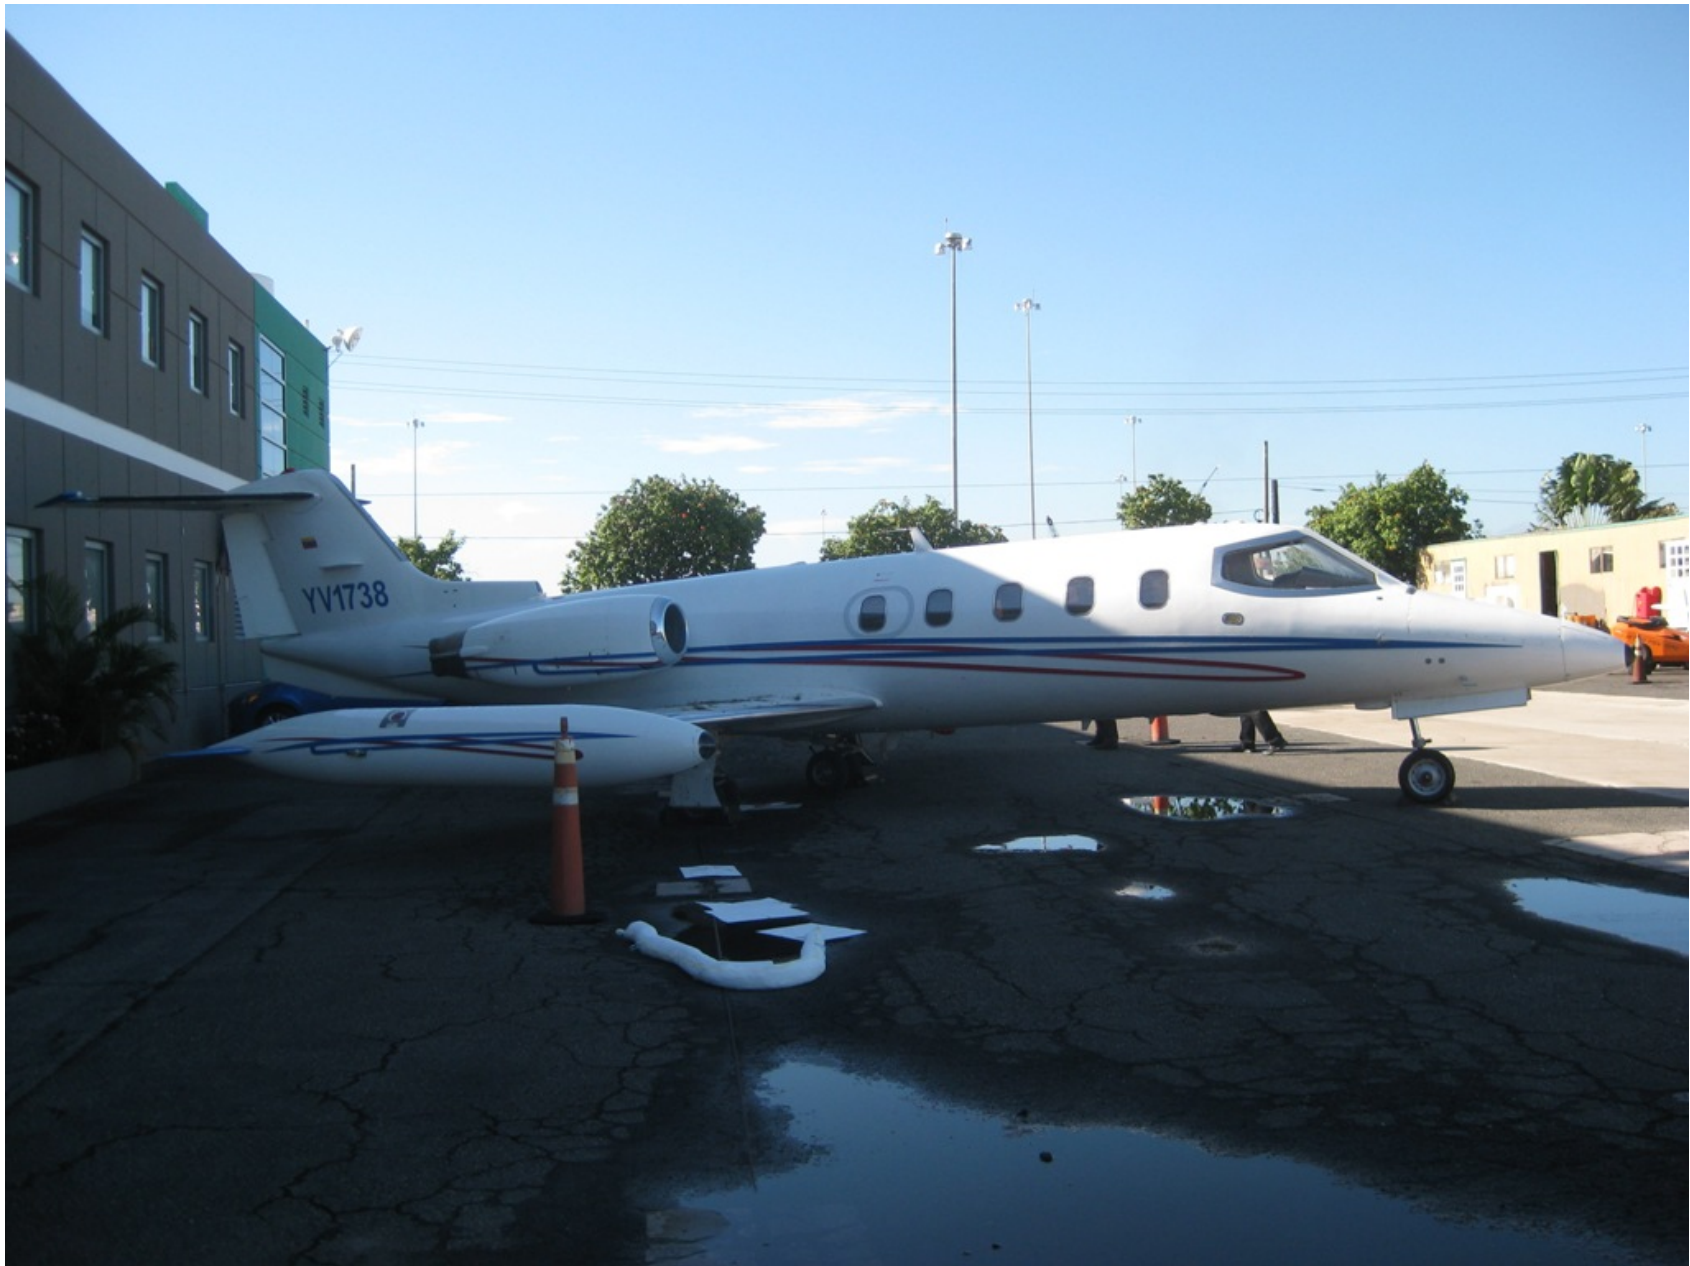
Photo 1 – View of YV1738 (FAA Photo)

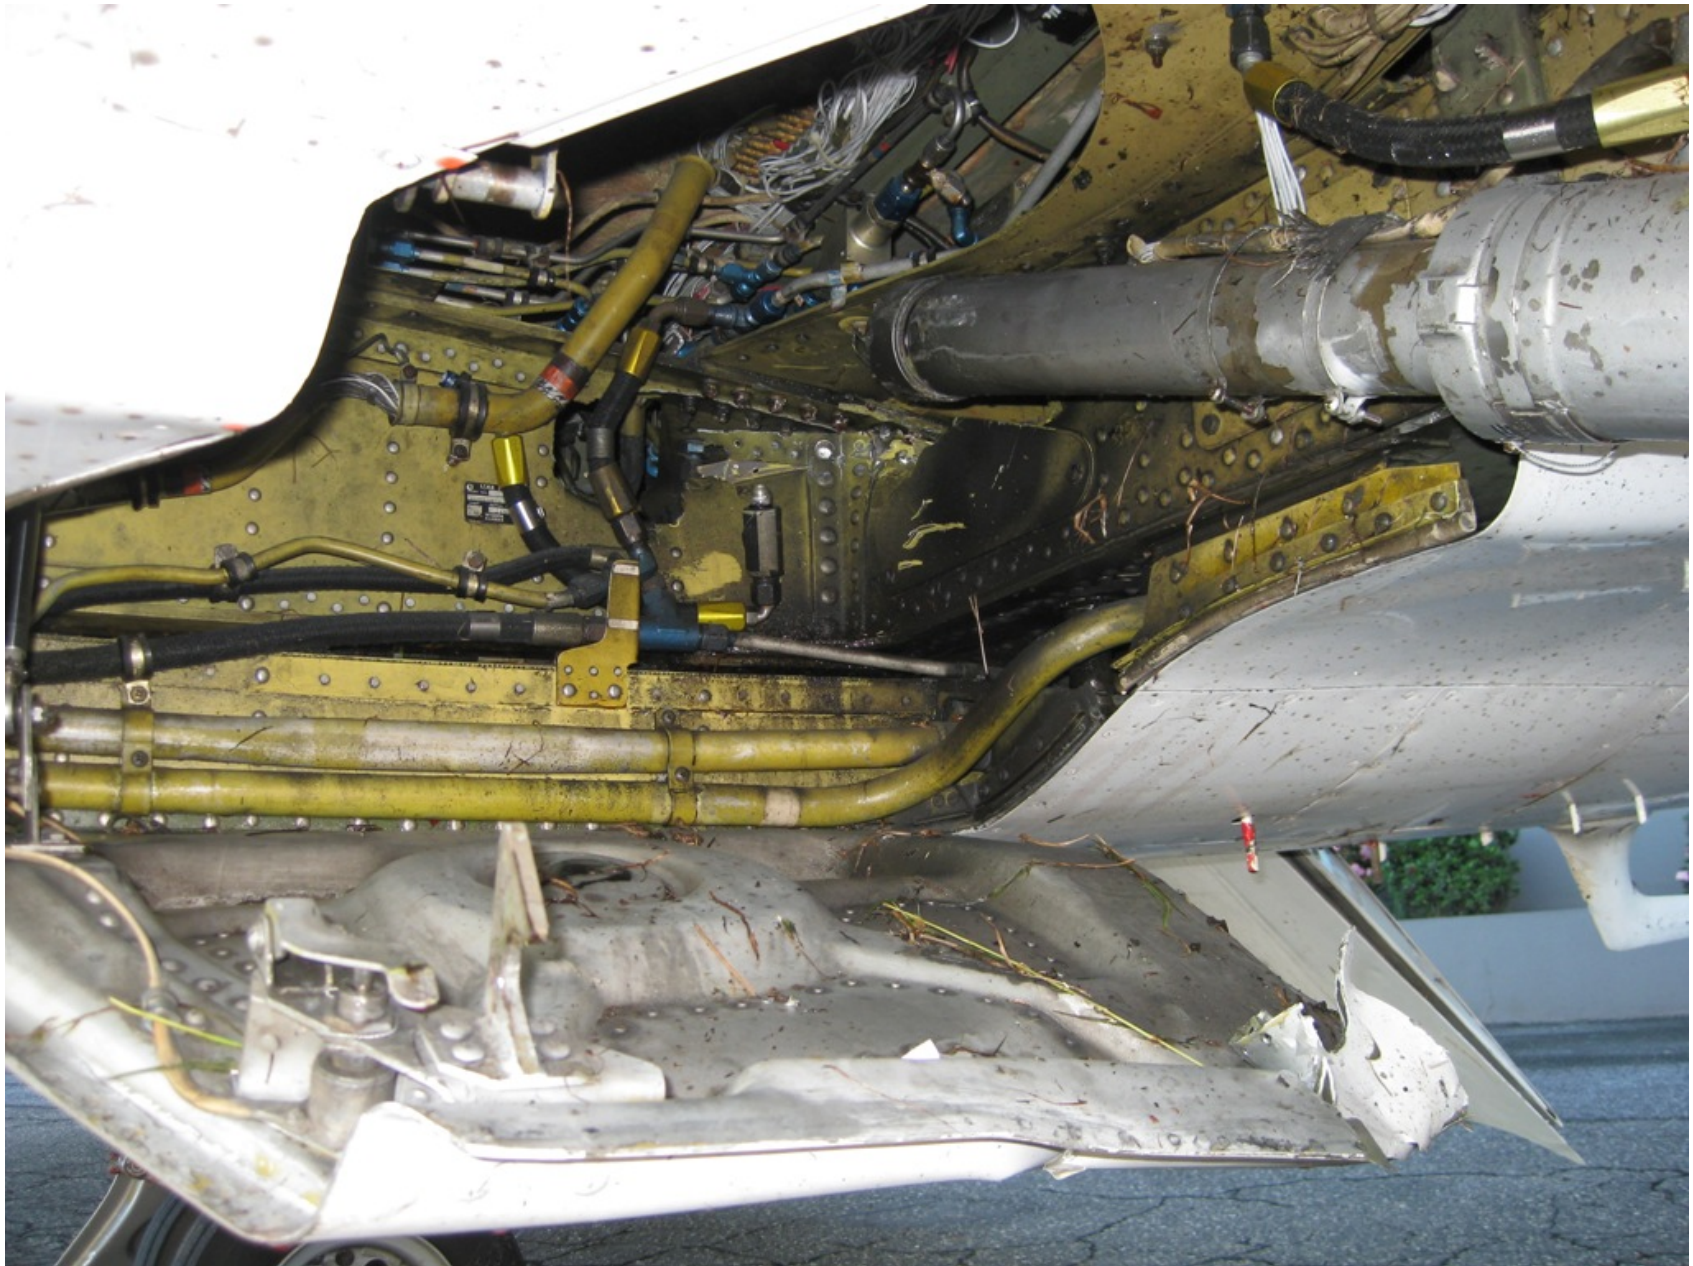
Photo 2 – Left Main Wheel Well Structural Damage (FAA Photo)

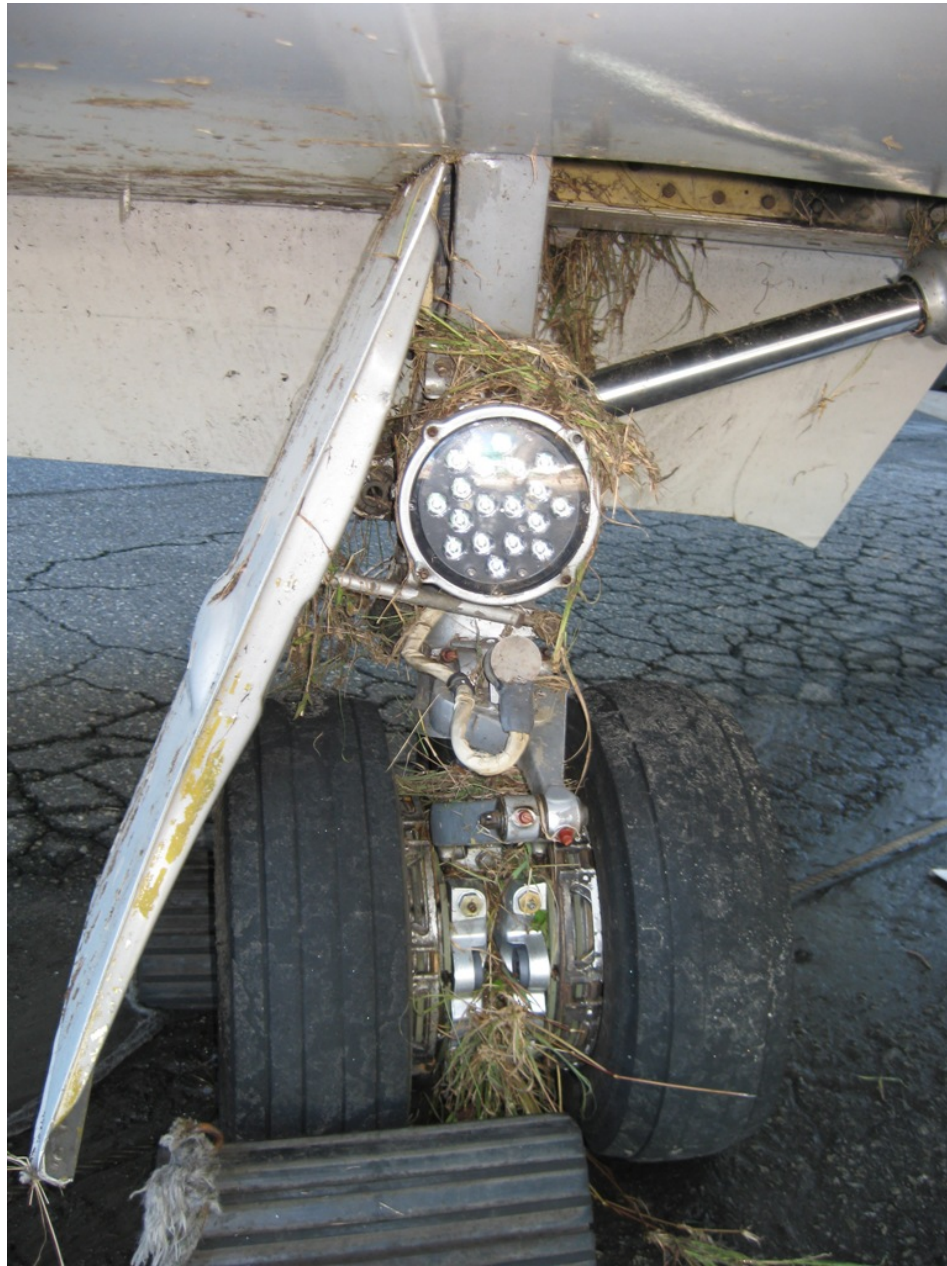
Photo 3 – Right Main Landing Gear (FAA Photo)

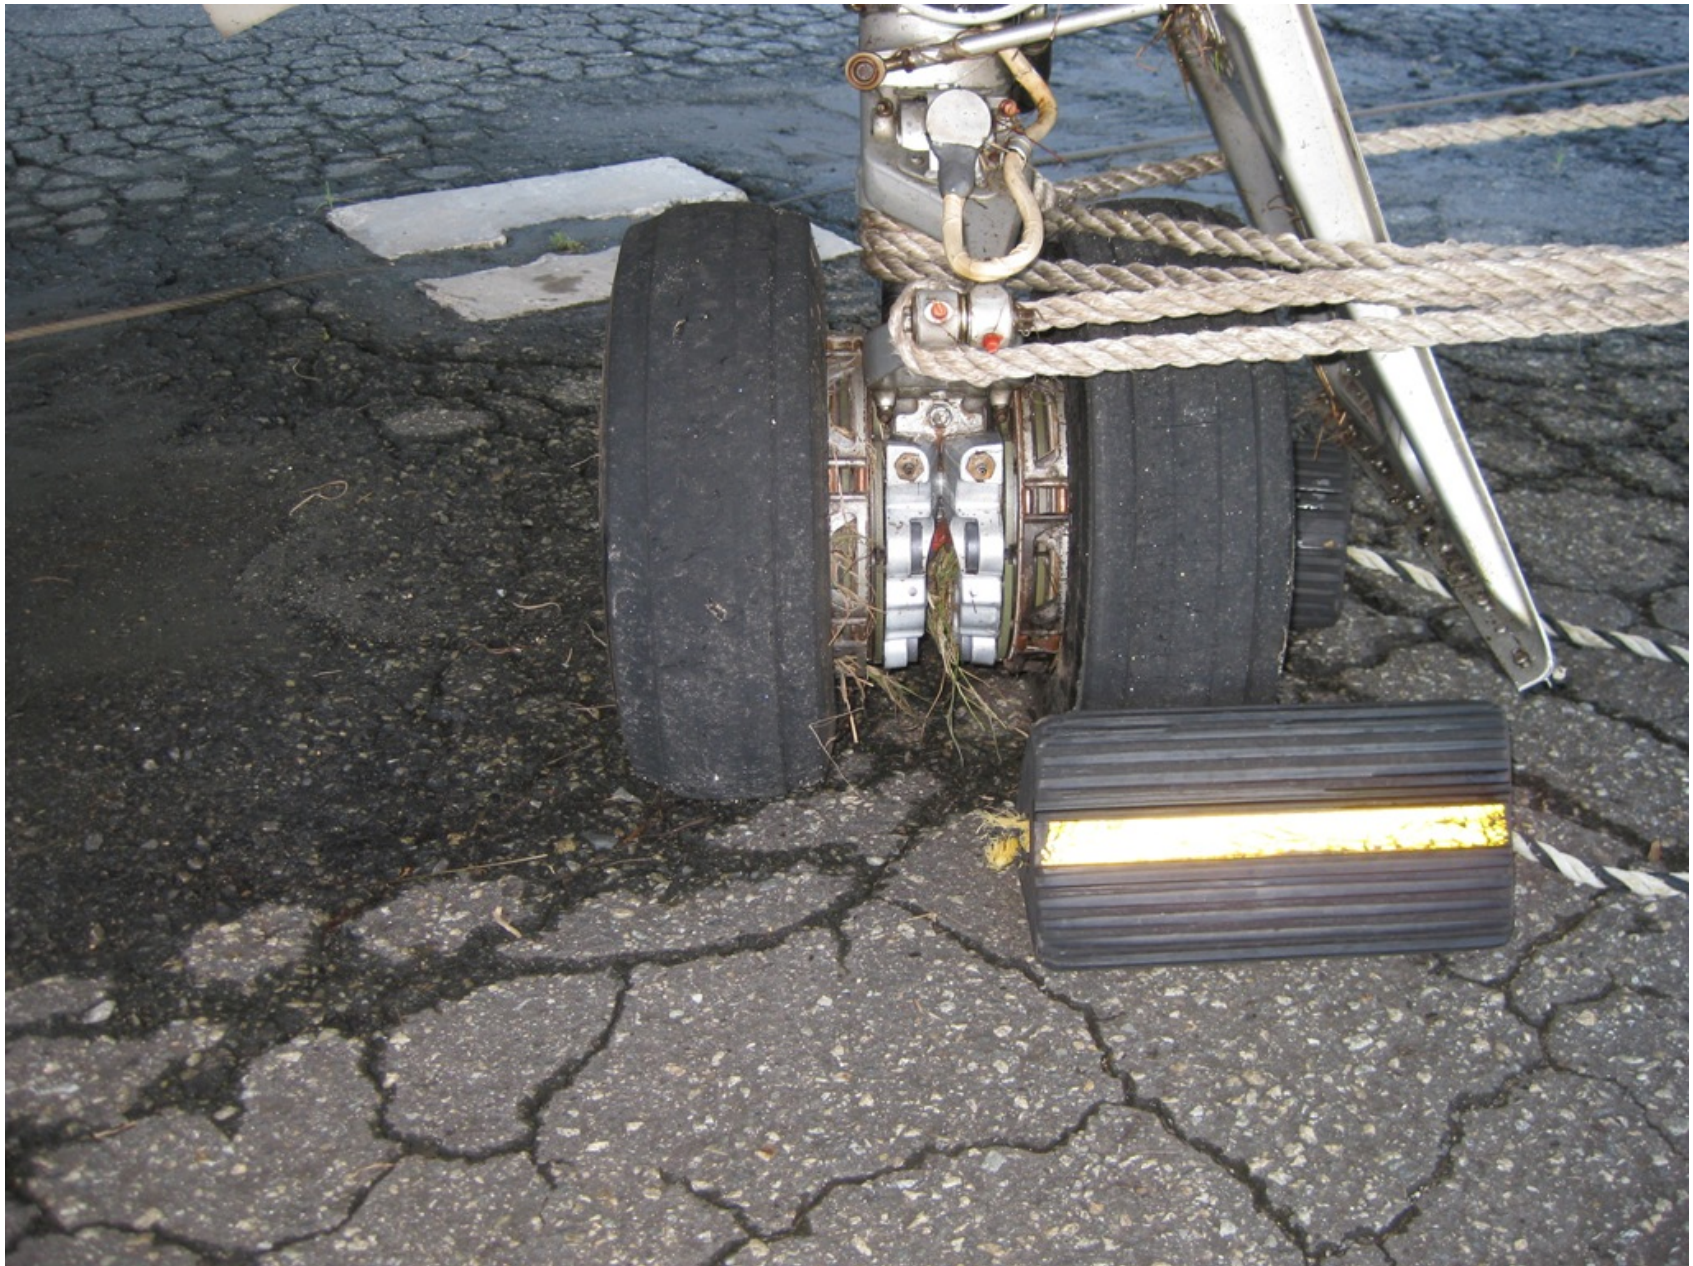
Photo 4 – Left Main Landing Gear (FAA Photo)

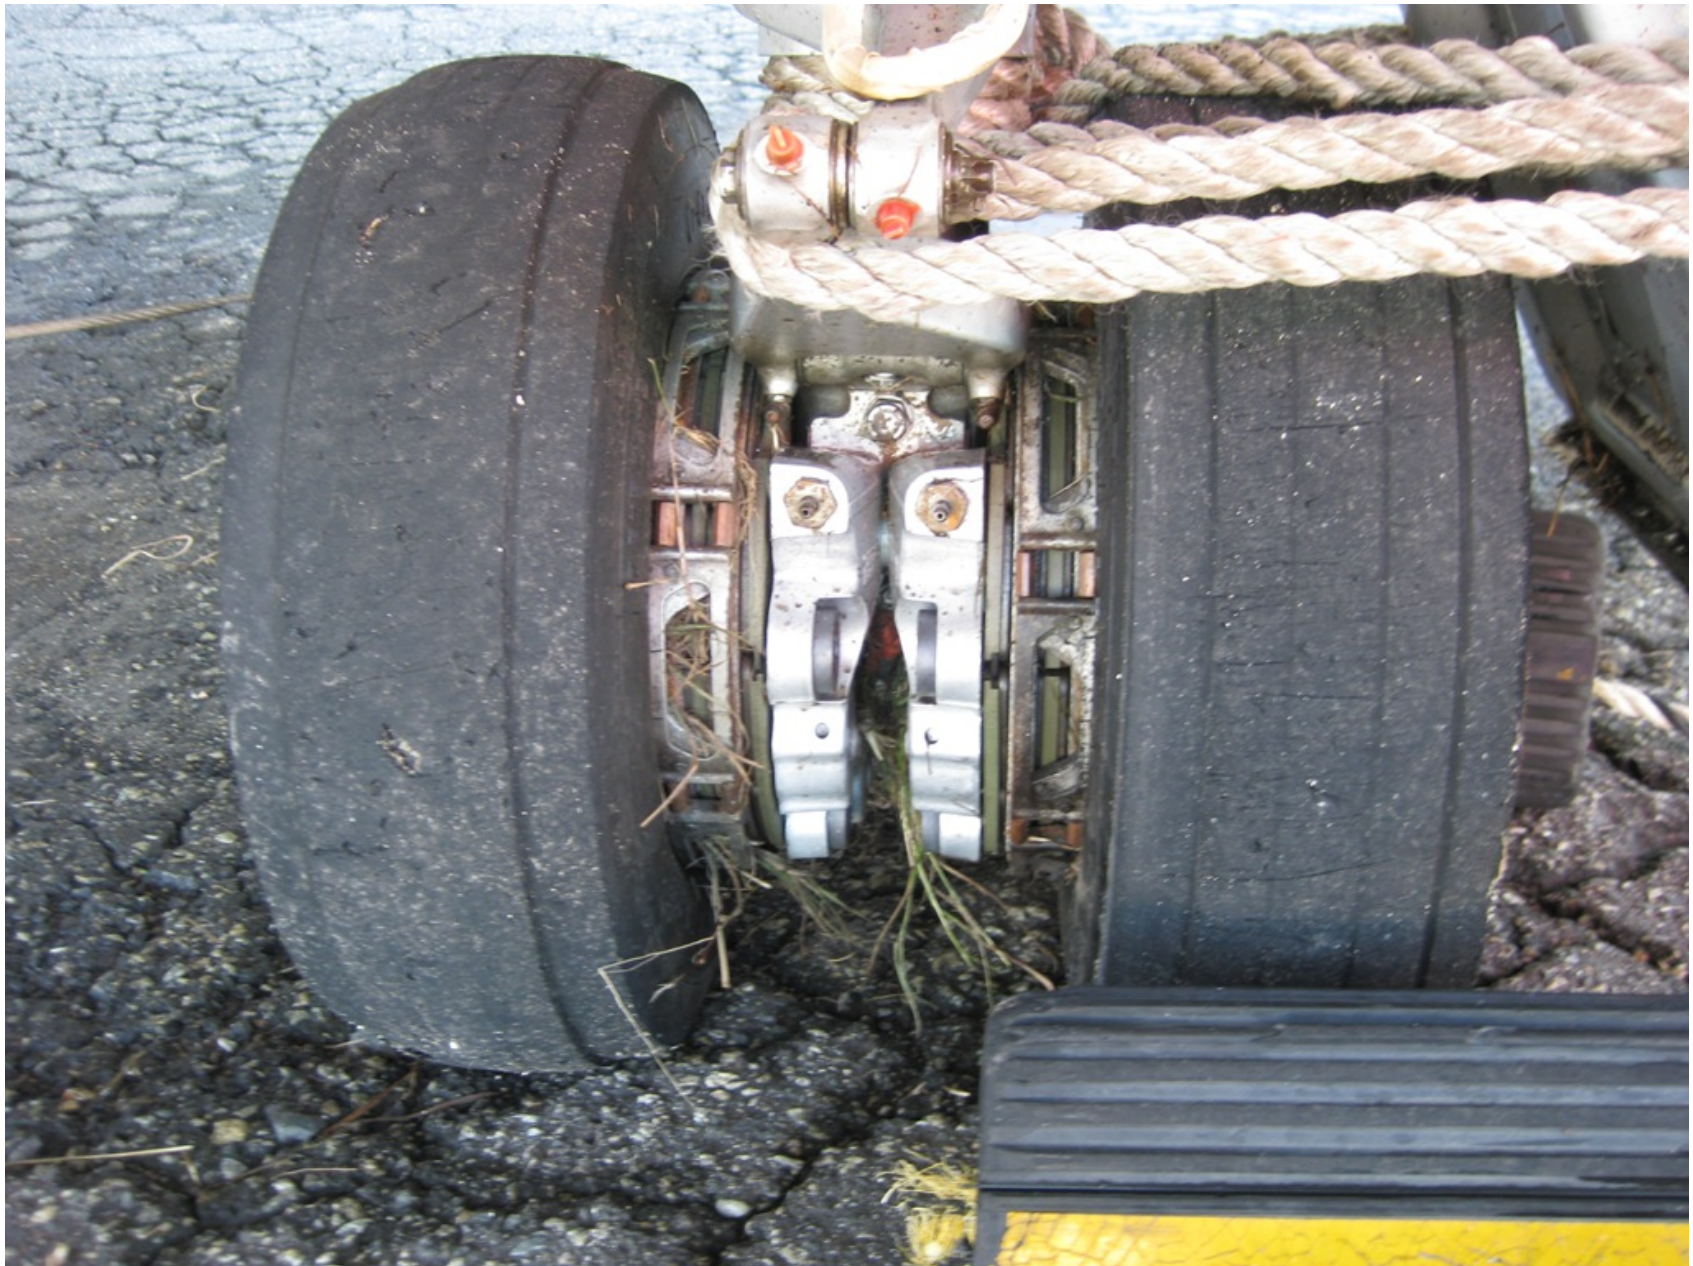
Photo 5 – Left Main Landing Gear (FAA Photo)

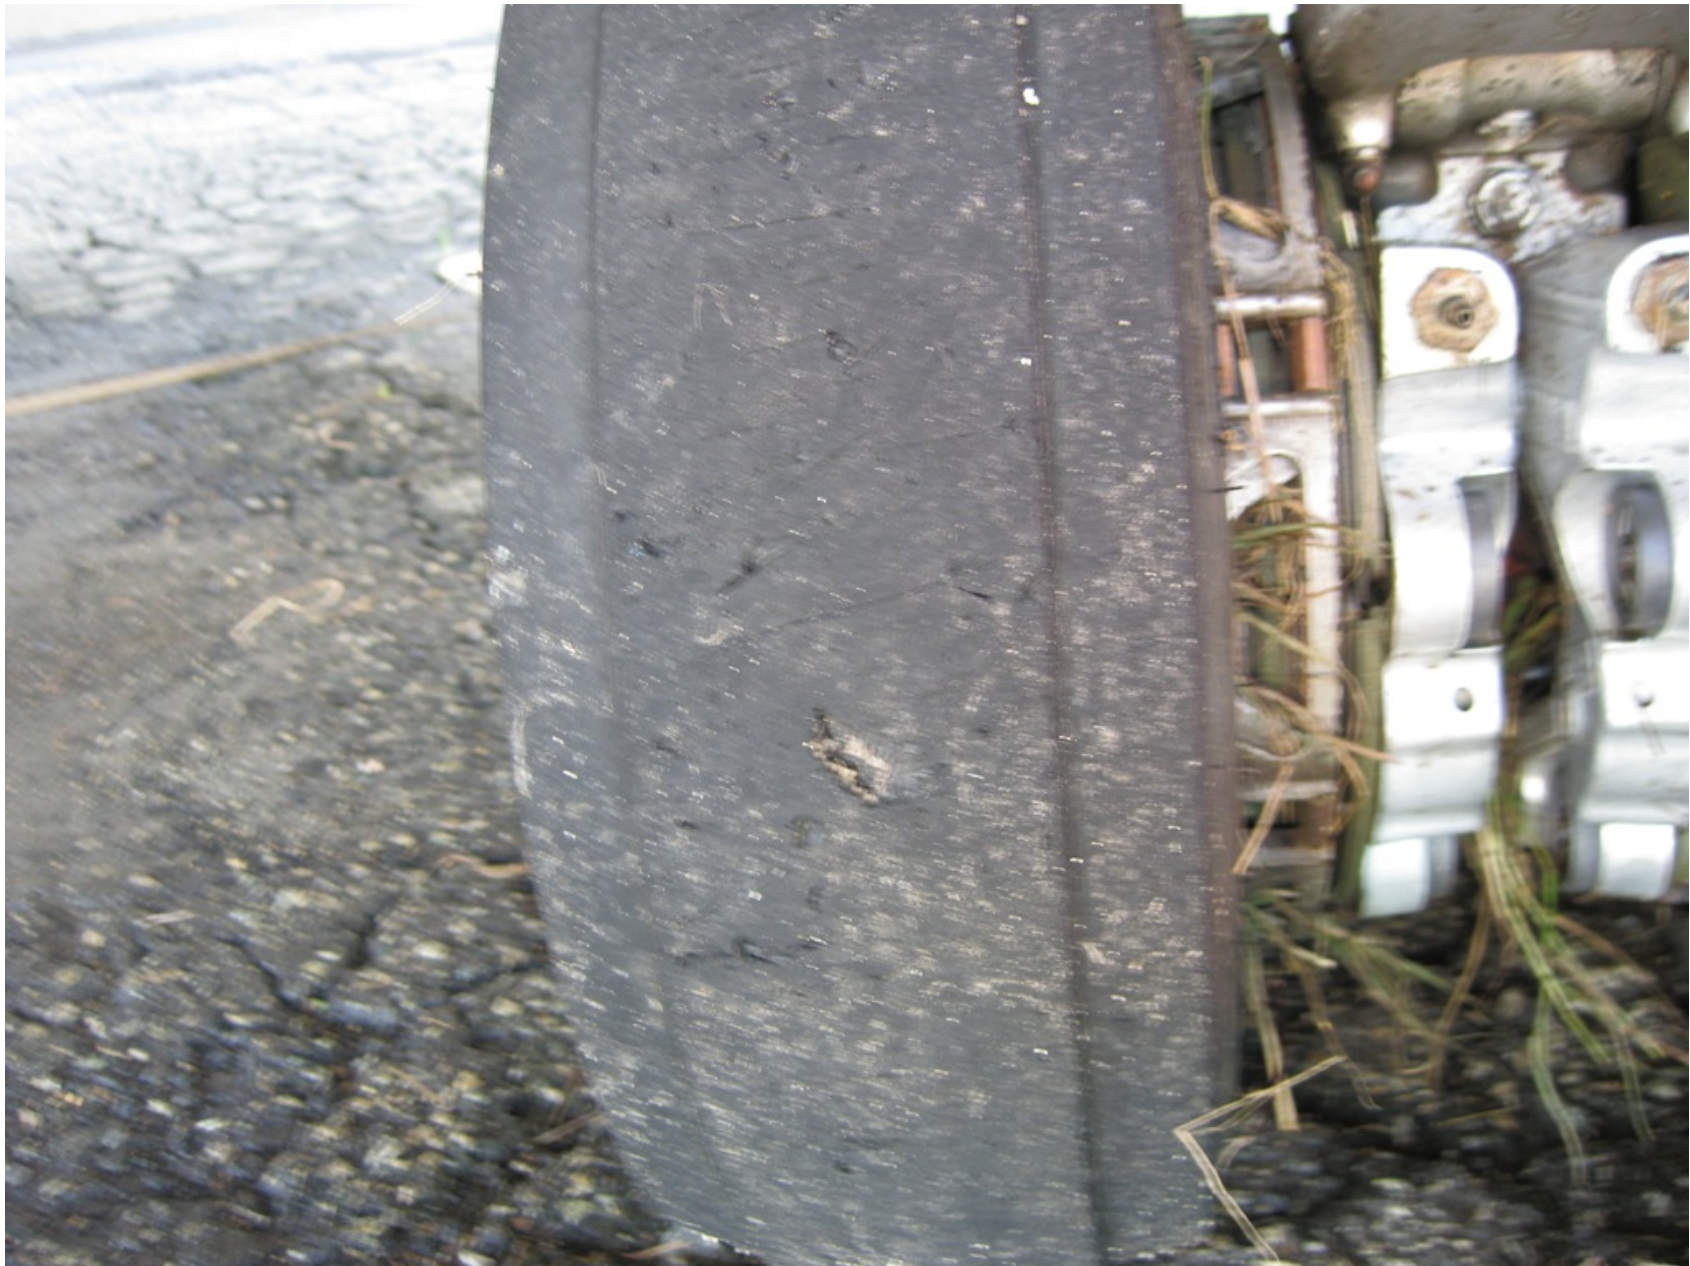
Photo 6 – Left Main Outboard Tire (FAA Photo)
