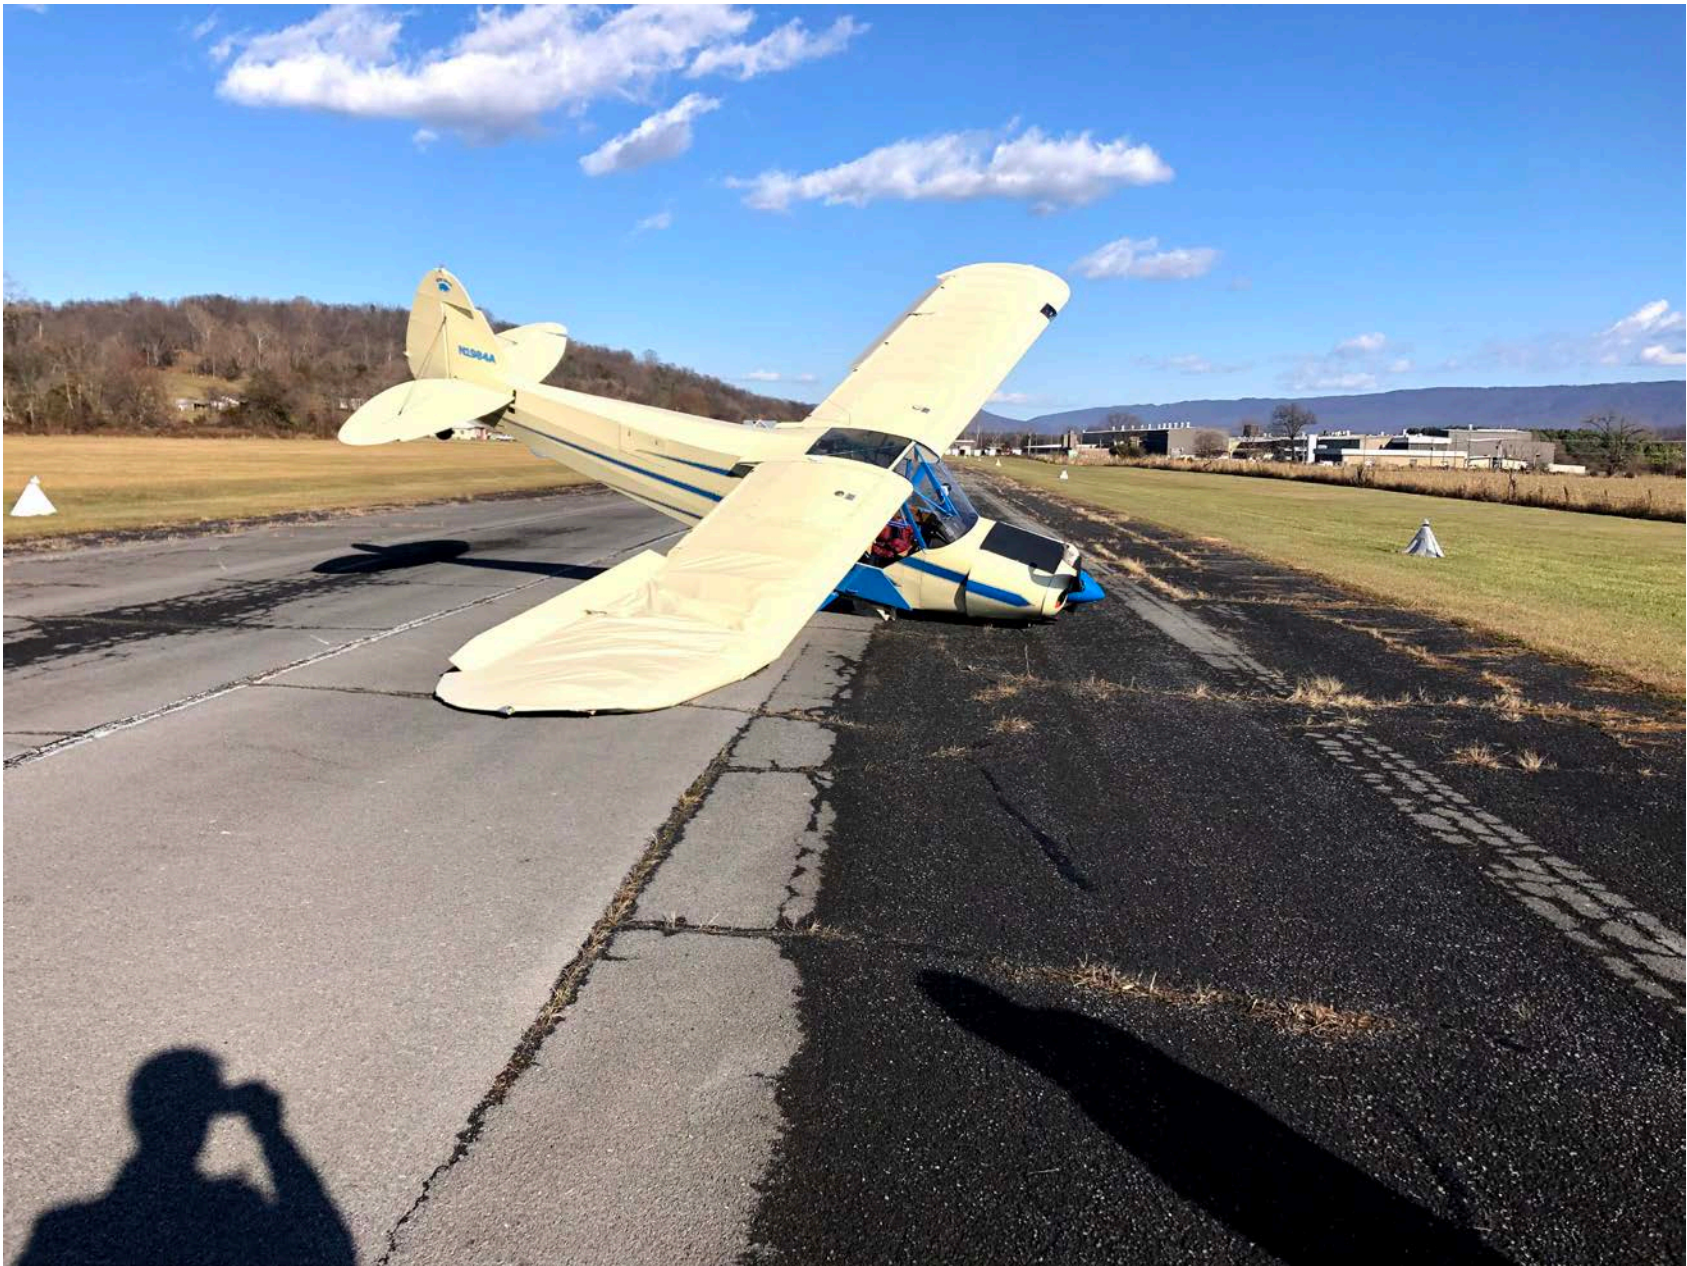
Photo 1 – View of Airplane as Found (FAA)

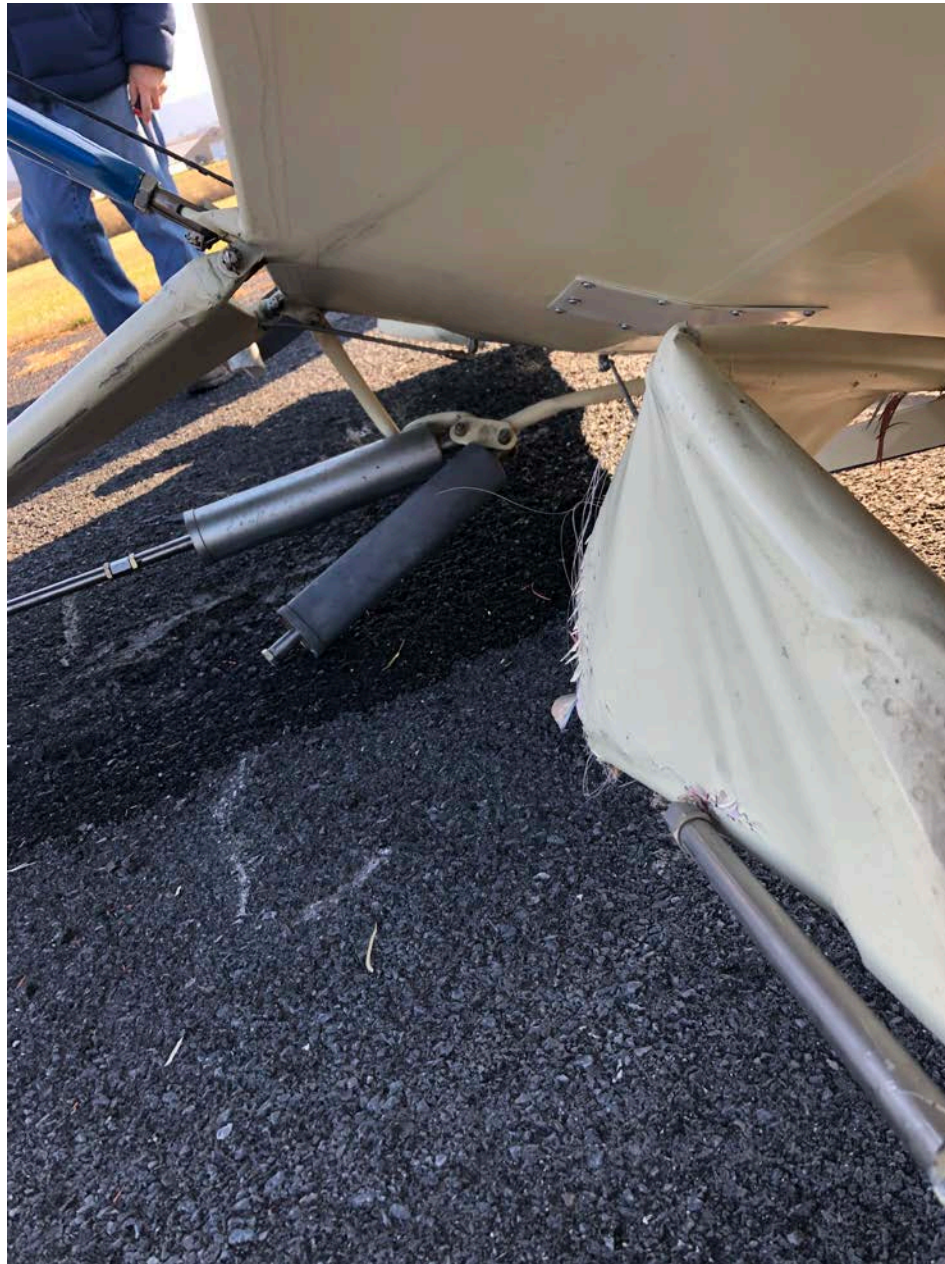
Photo 3 – View of Both Dampeners at the Accident Site (FAA)

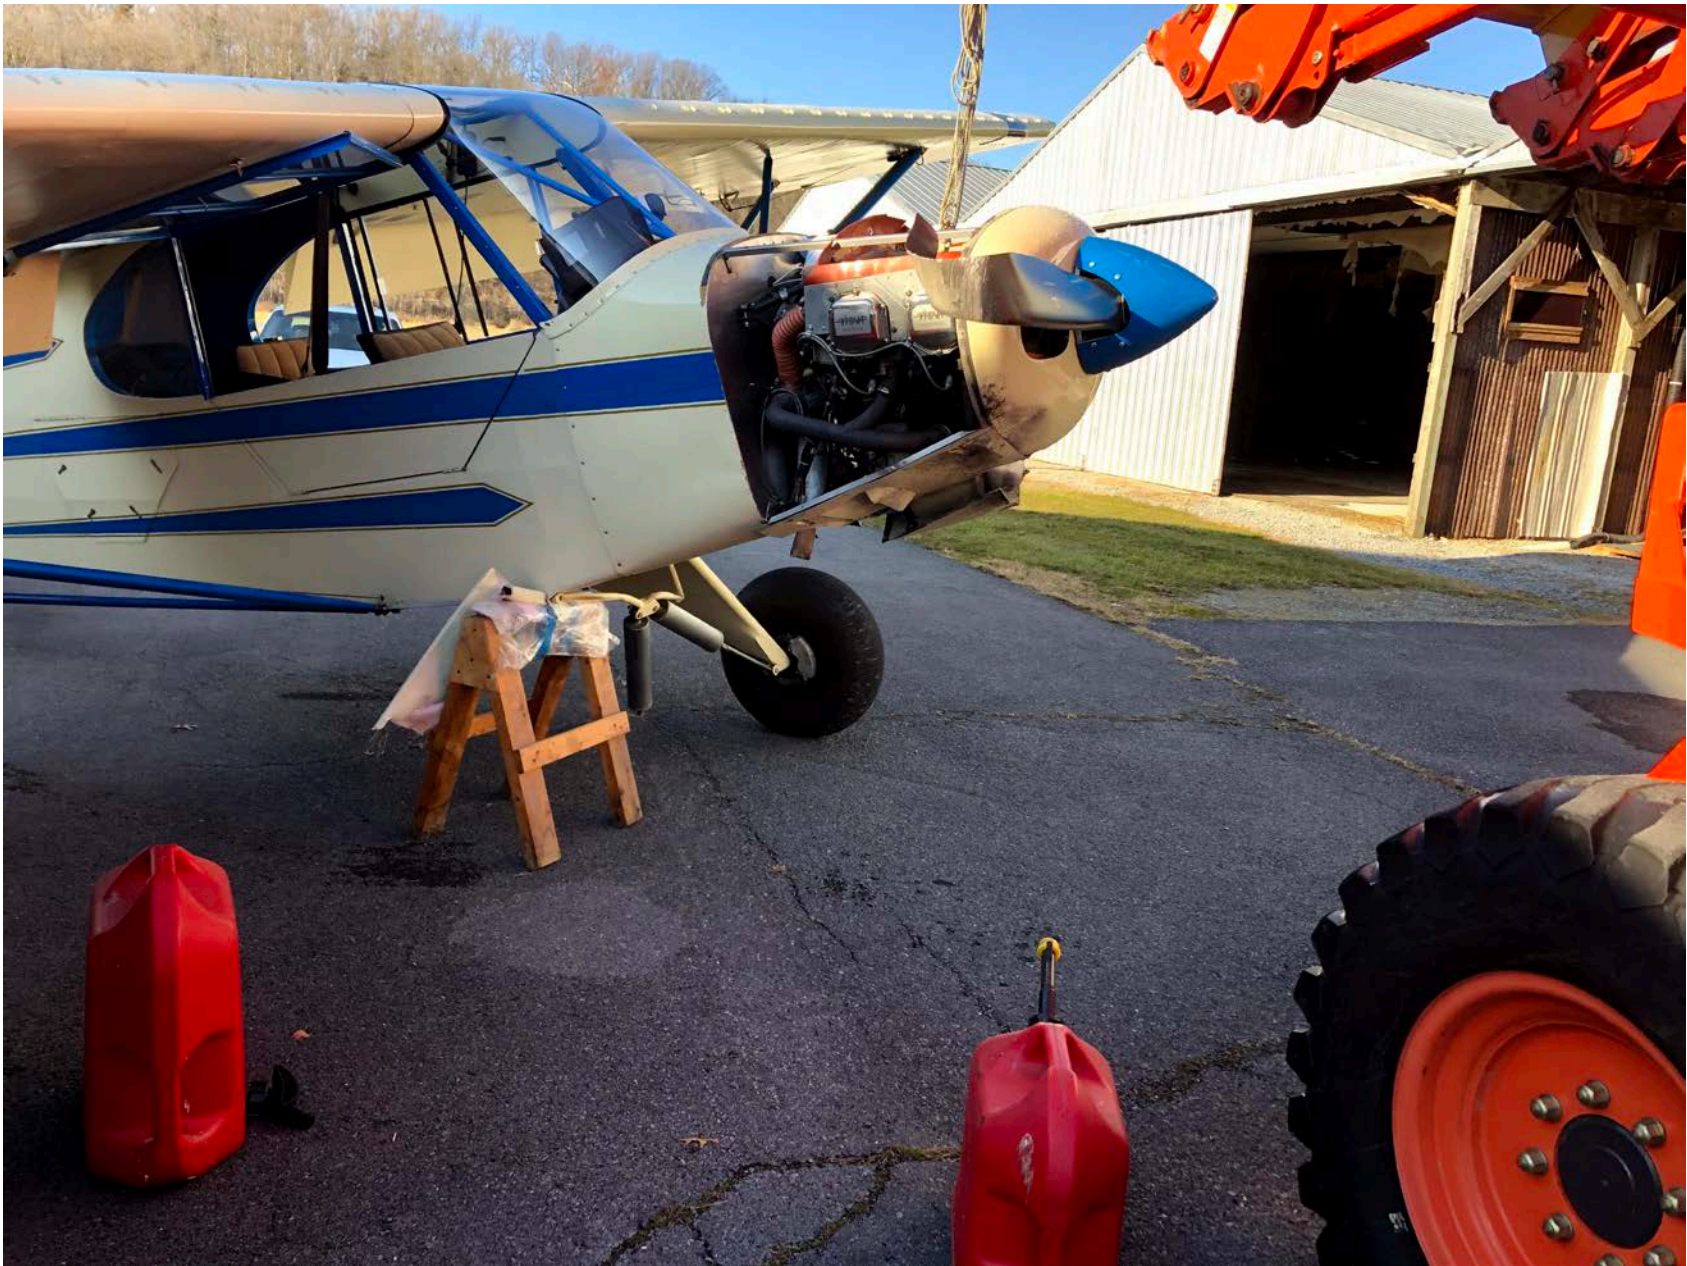
Photo 4 – View of Landing Gear Dampeners and Deformed Dampener Mounts after Recovery (FAA)

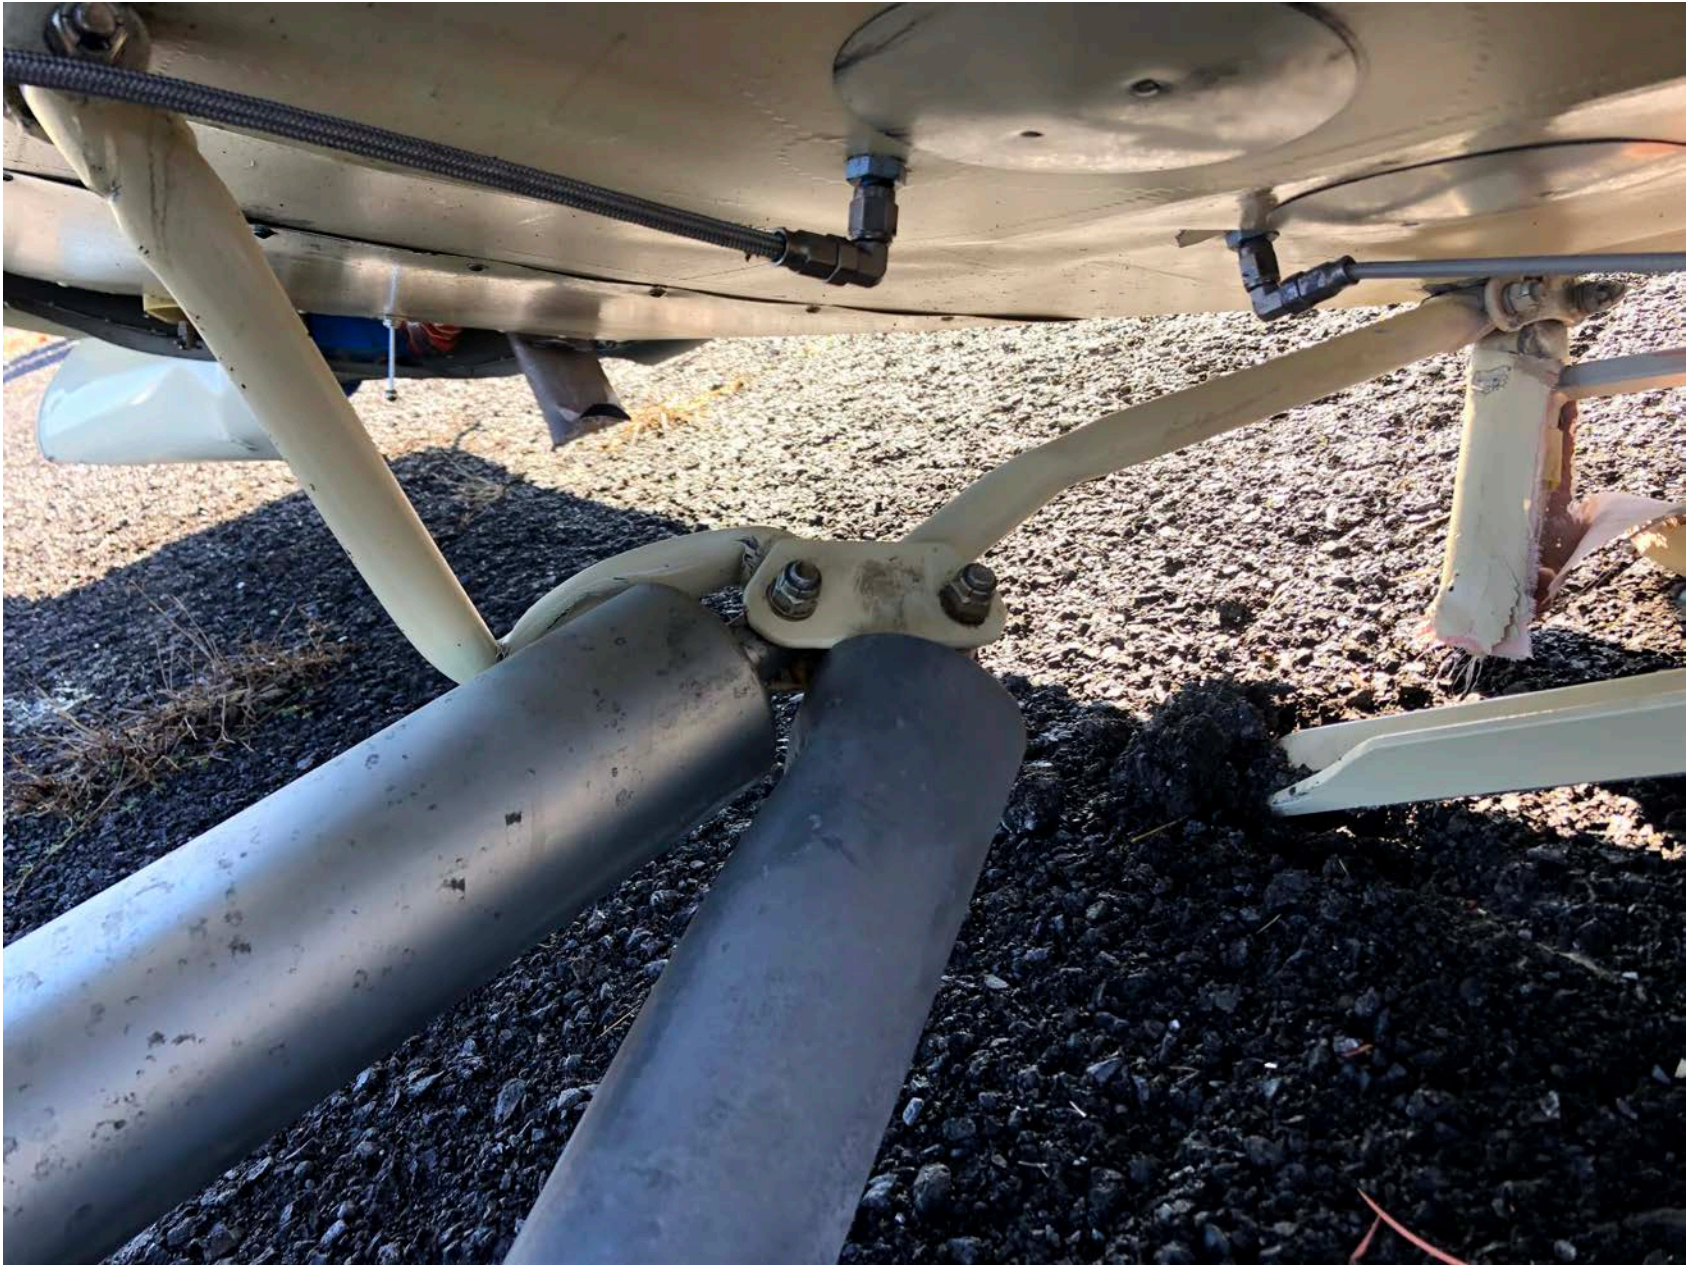
Photo 5 – View of Fractured Right Main Landing Gear Leg (FAA)
