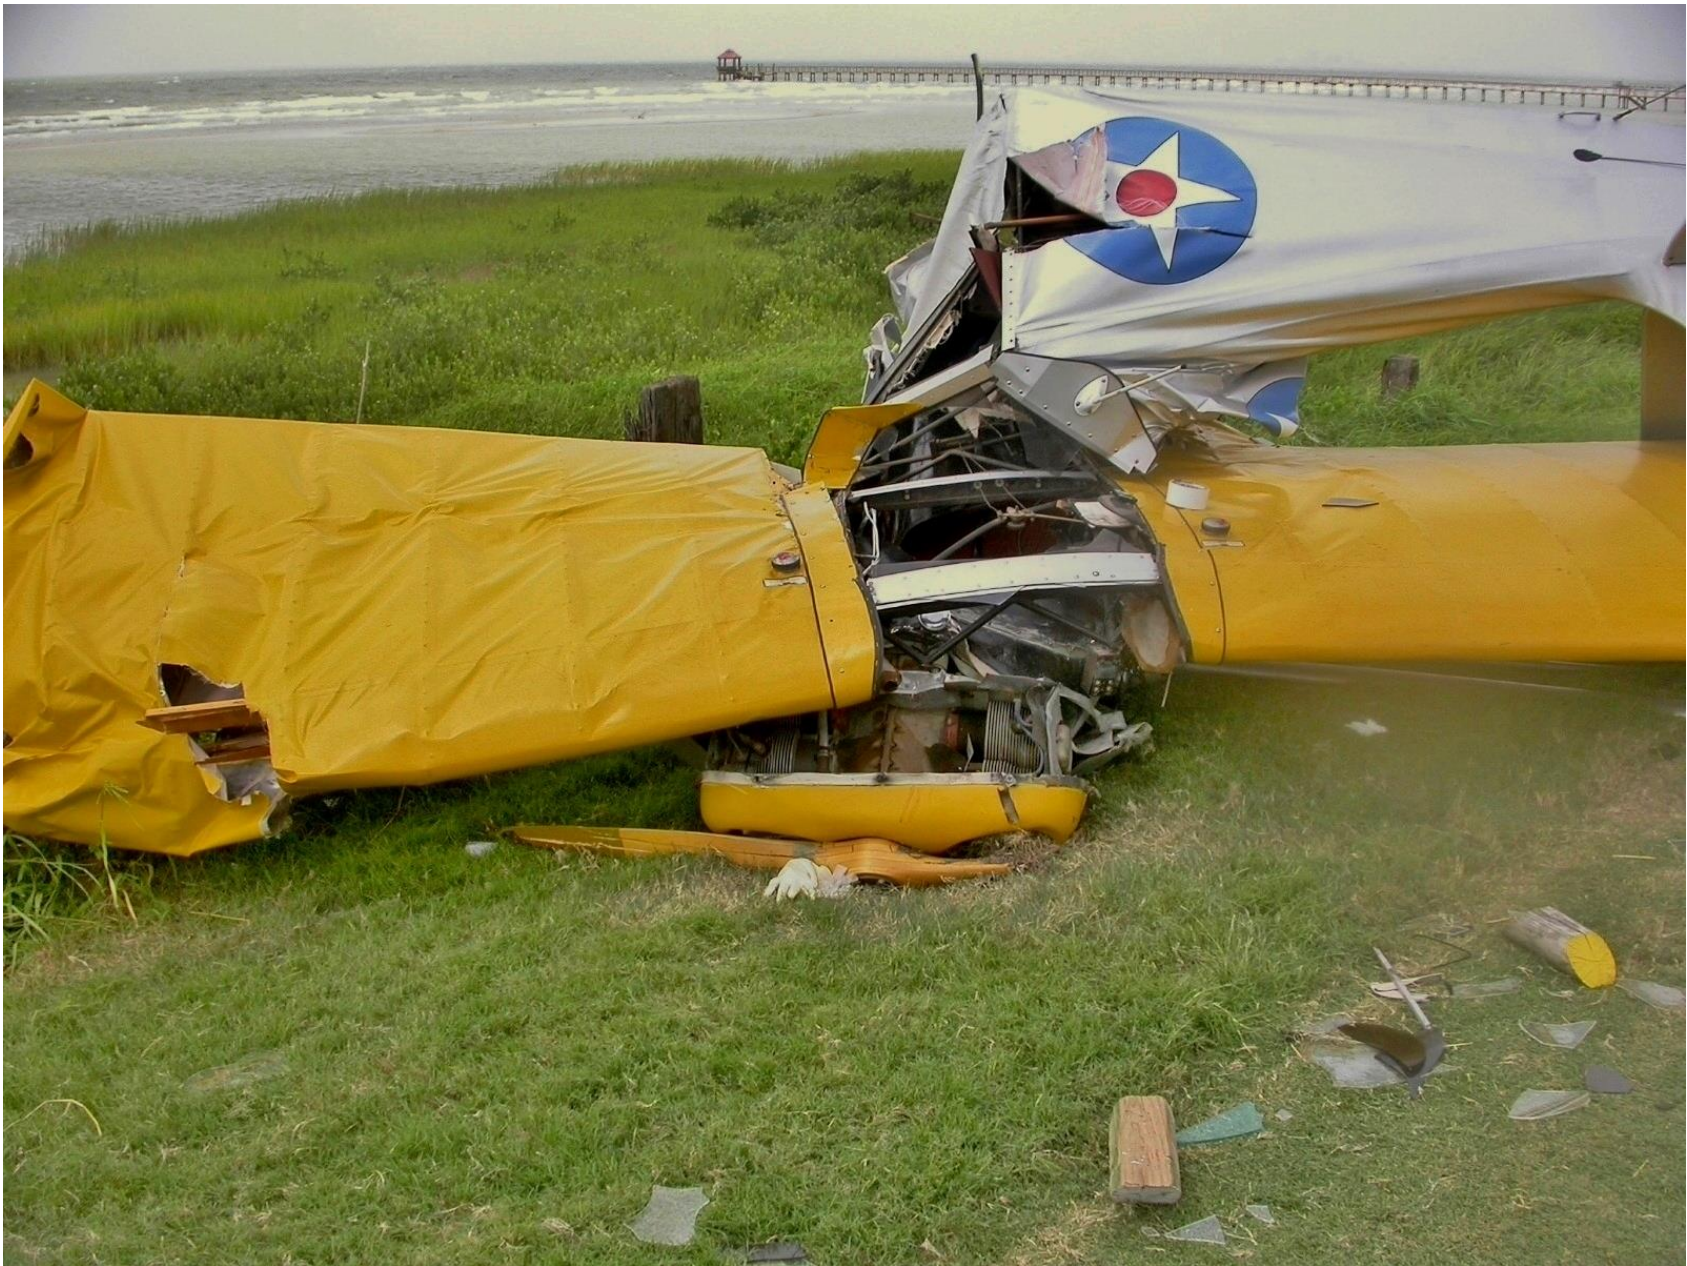
Photo 1 – View for the airplane from the front

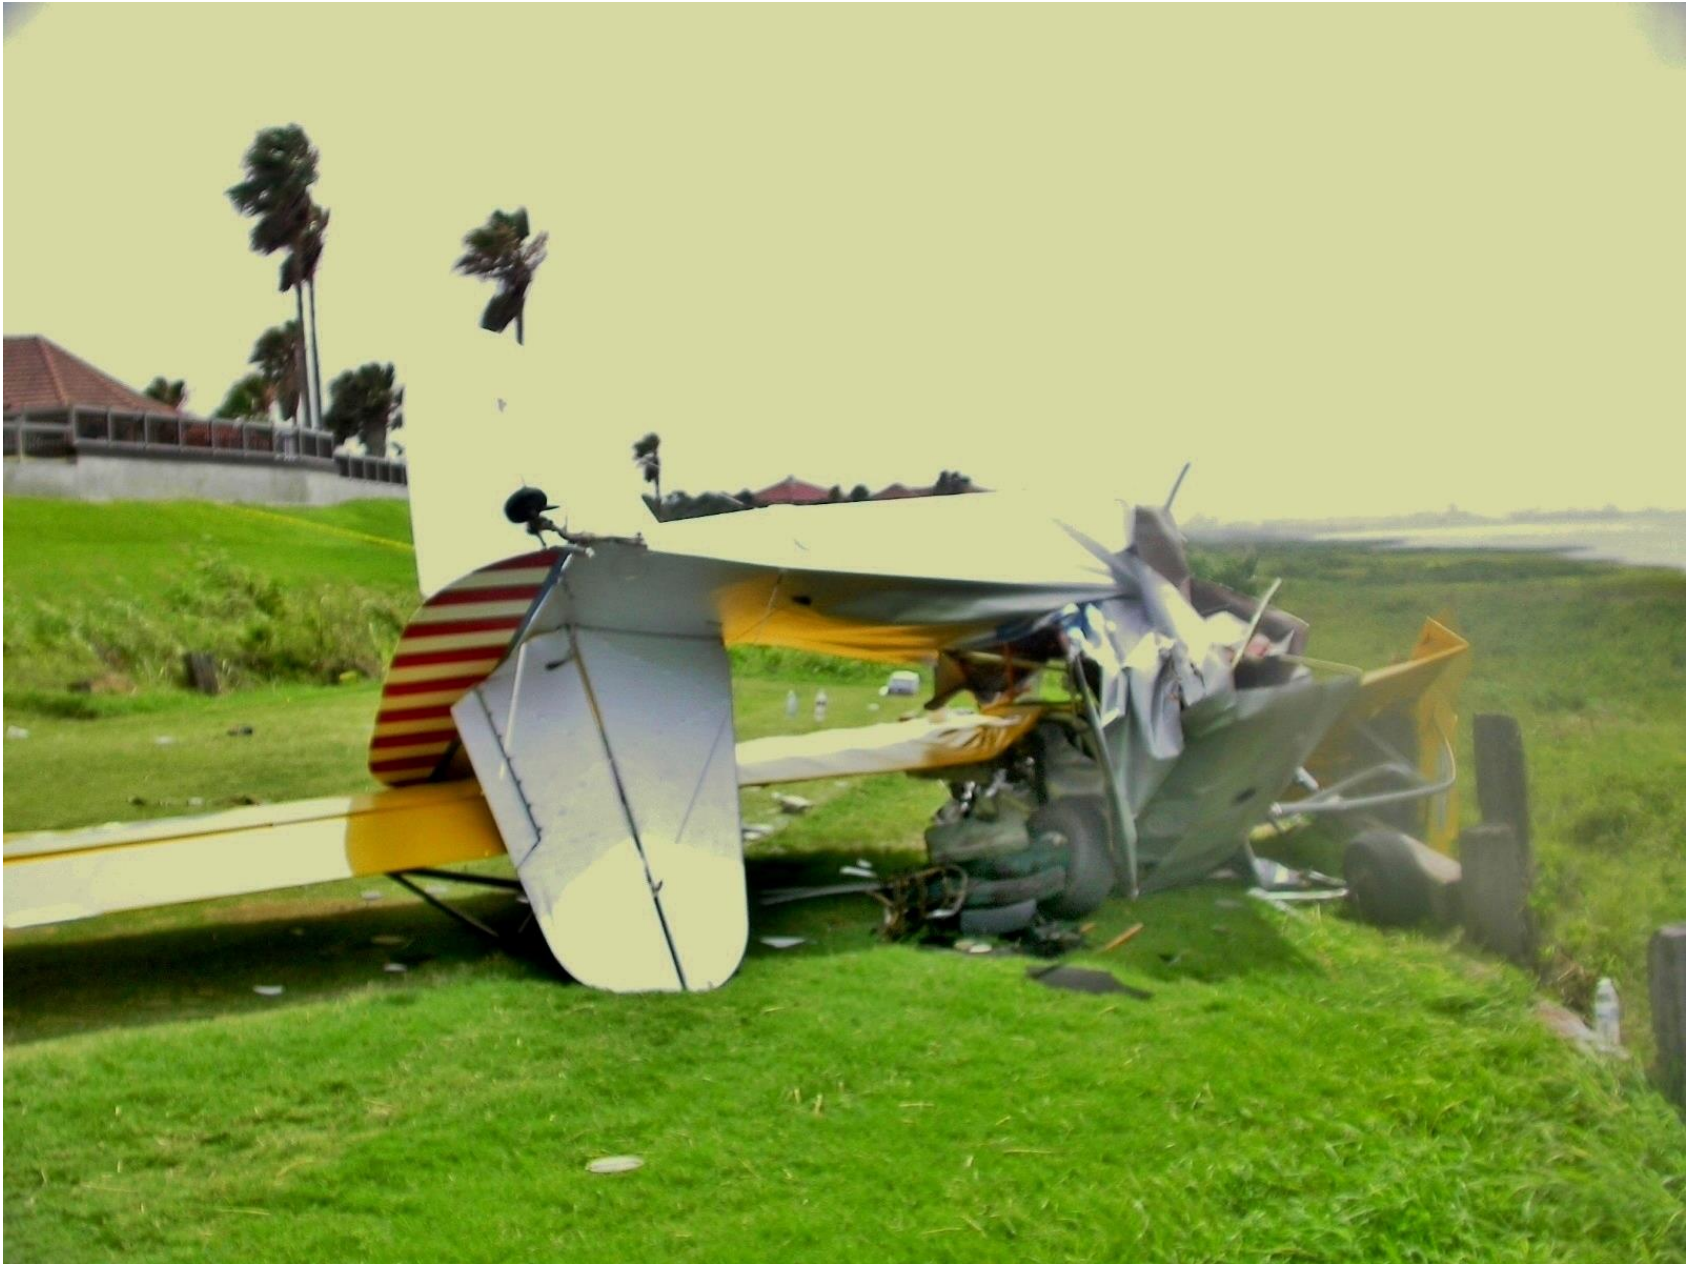
Photo 2 – View of the airplane from the rear

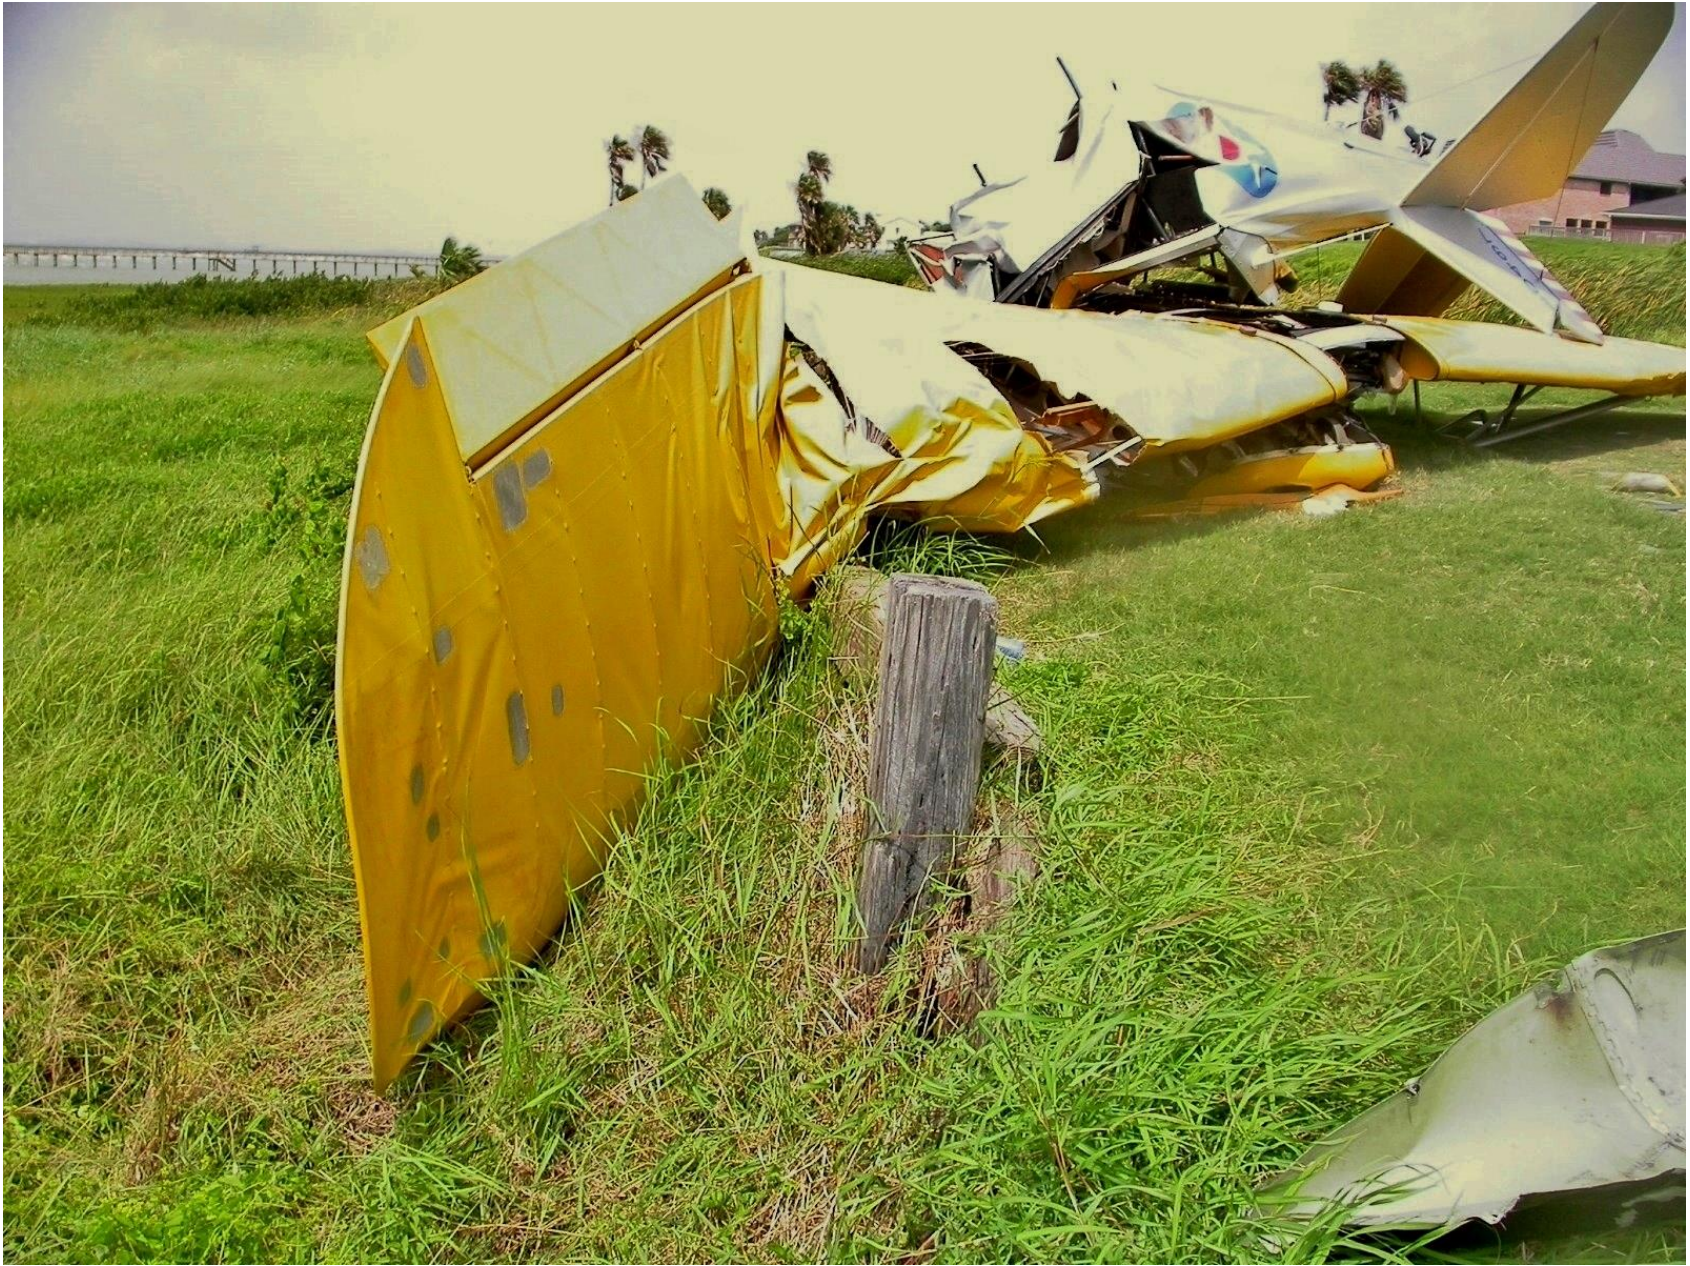
Photo 3 – View of the wreckage taken from the tip of the right wing

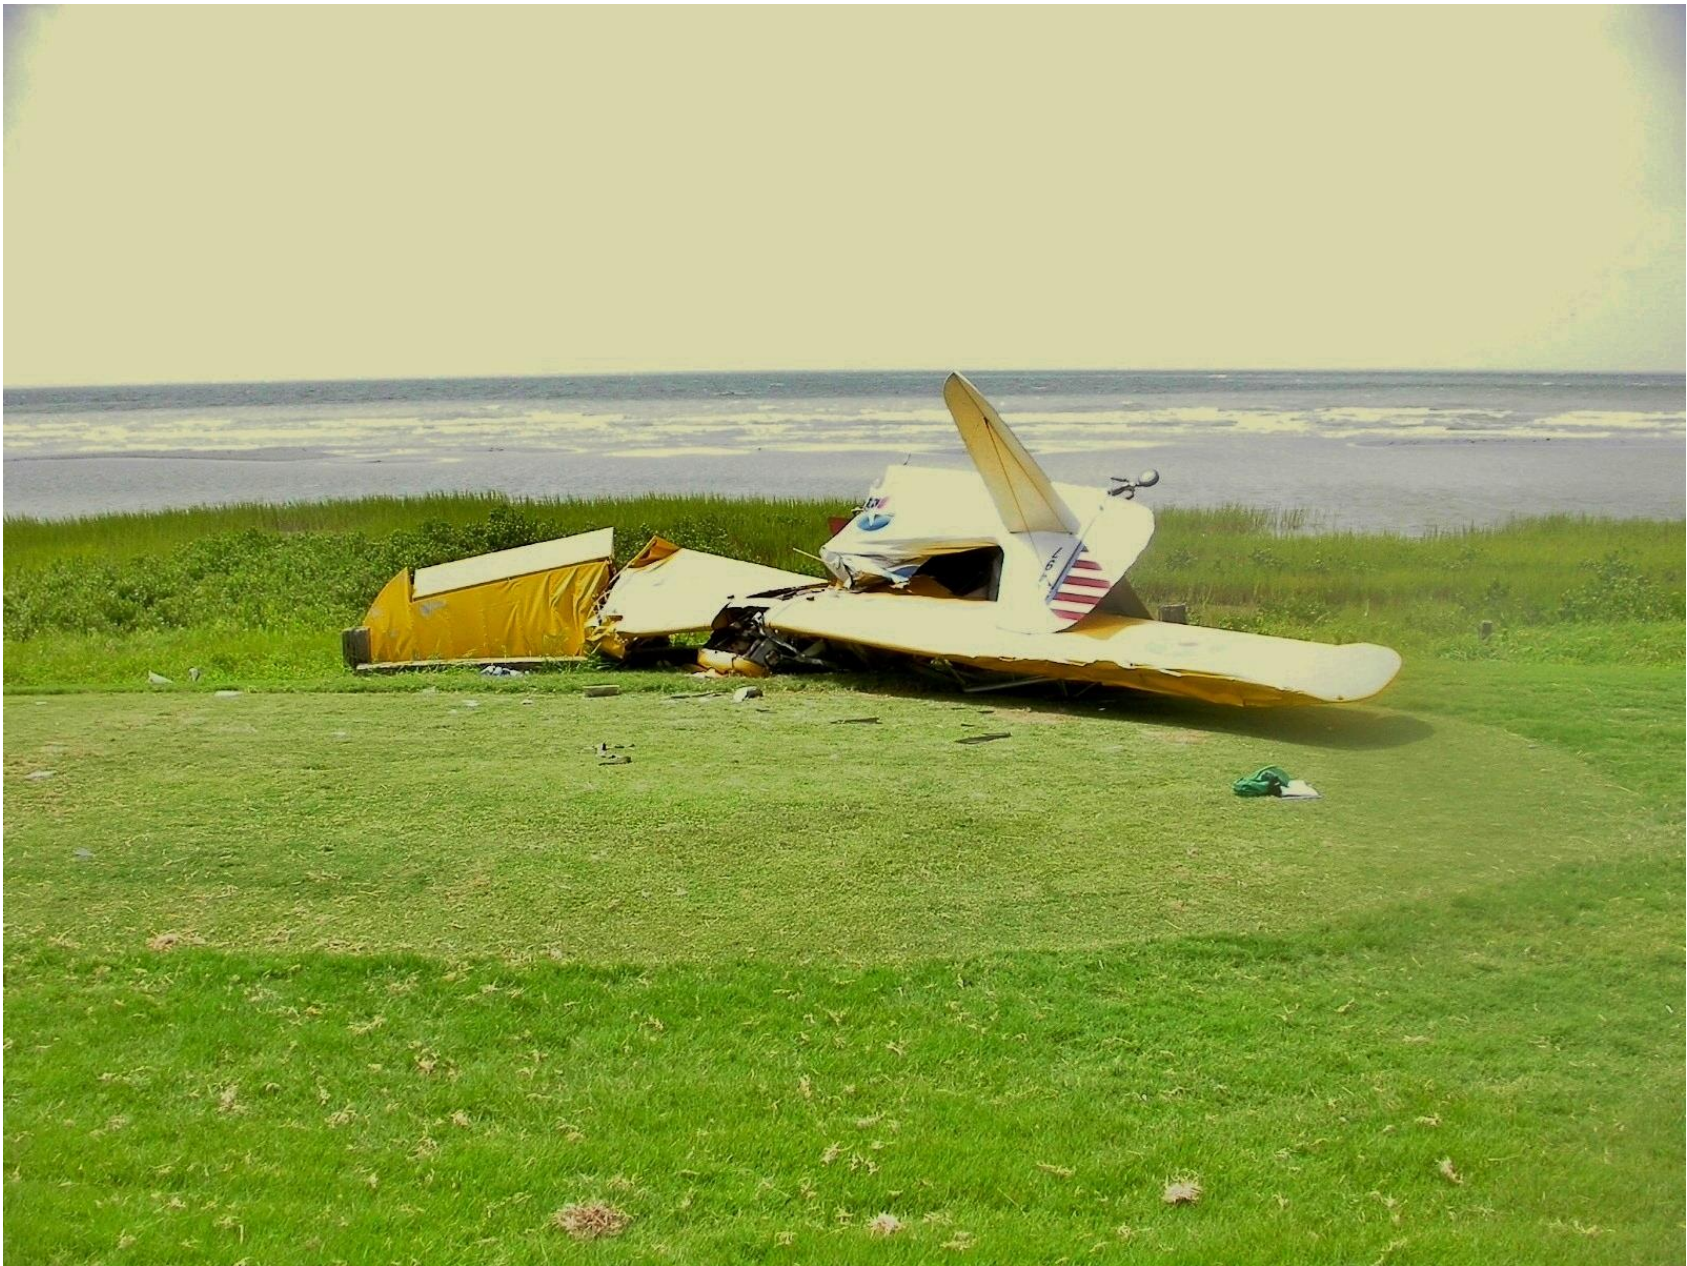
Photo 4 – View of the airplane on the 16th T-box with the bay in the background

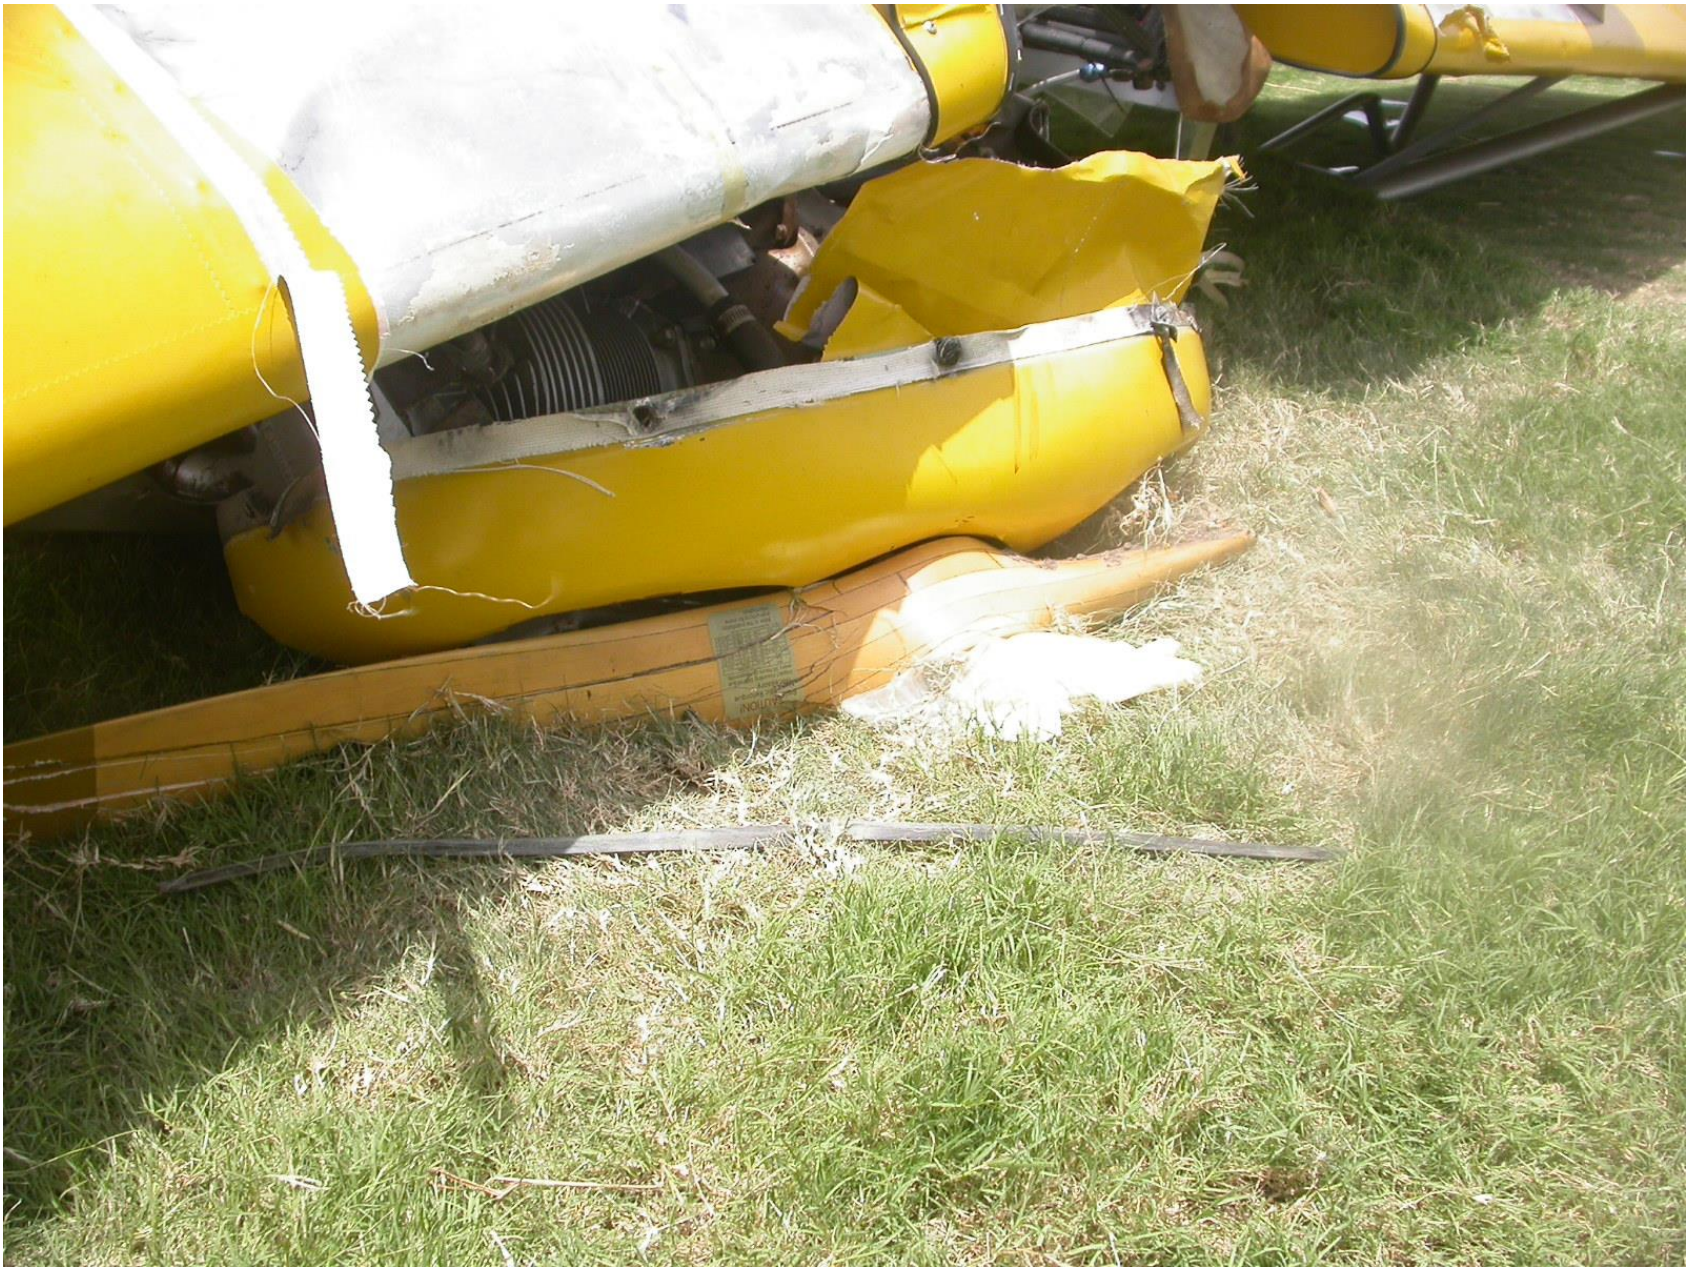
Photo 5 – View of the propeller at the accident site

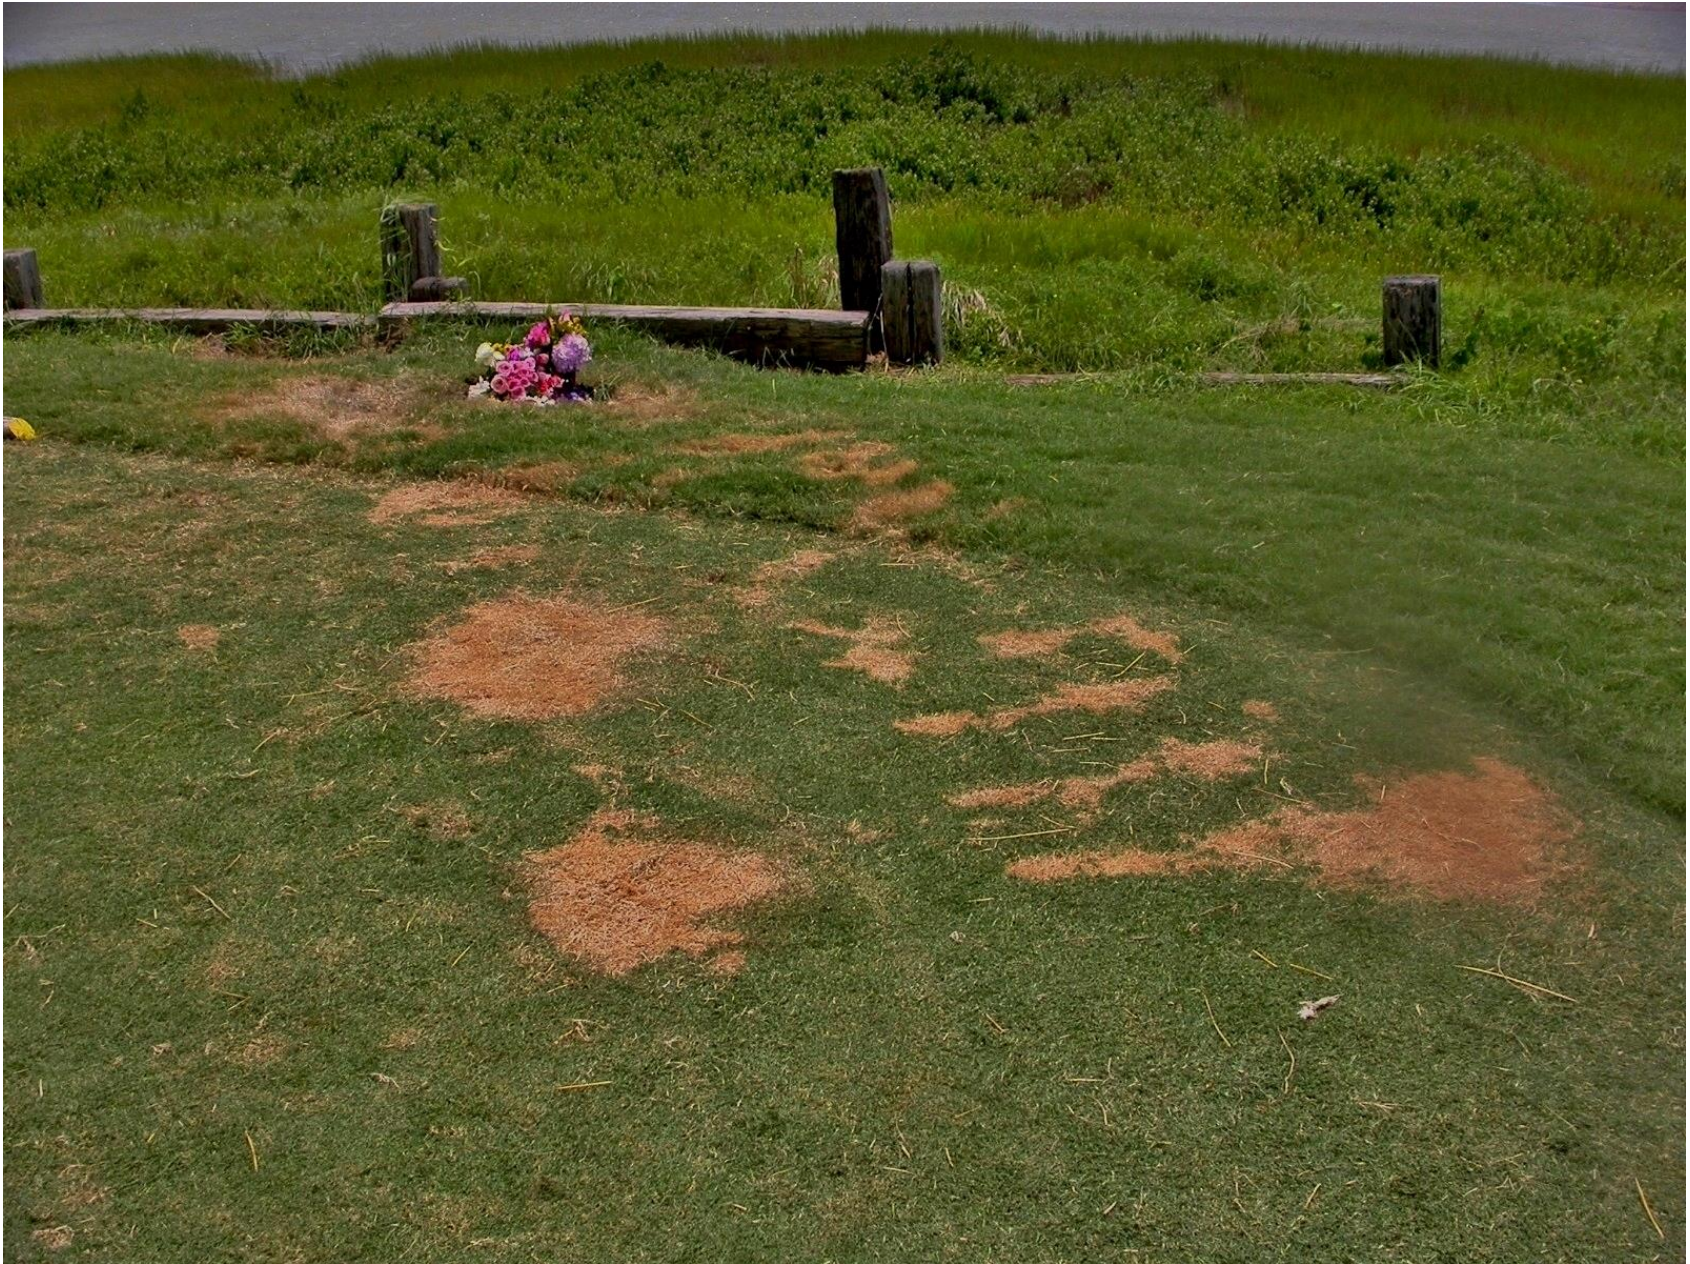
Photo 6 – View of the grass at the accident site two days after the accident occurred

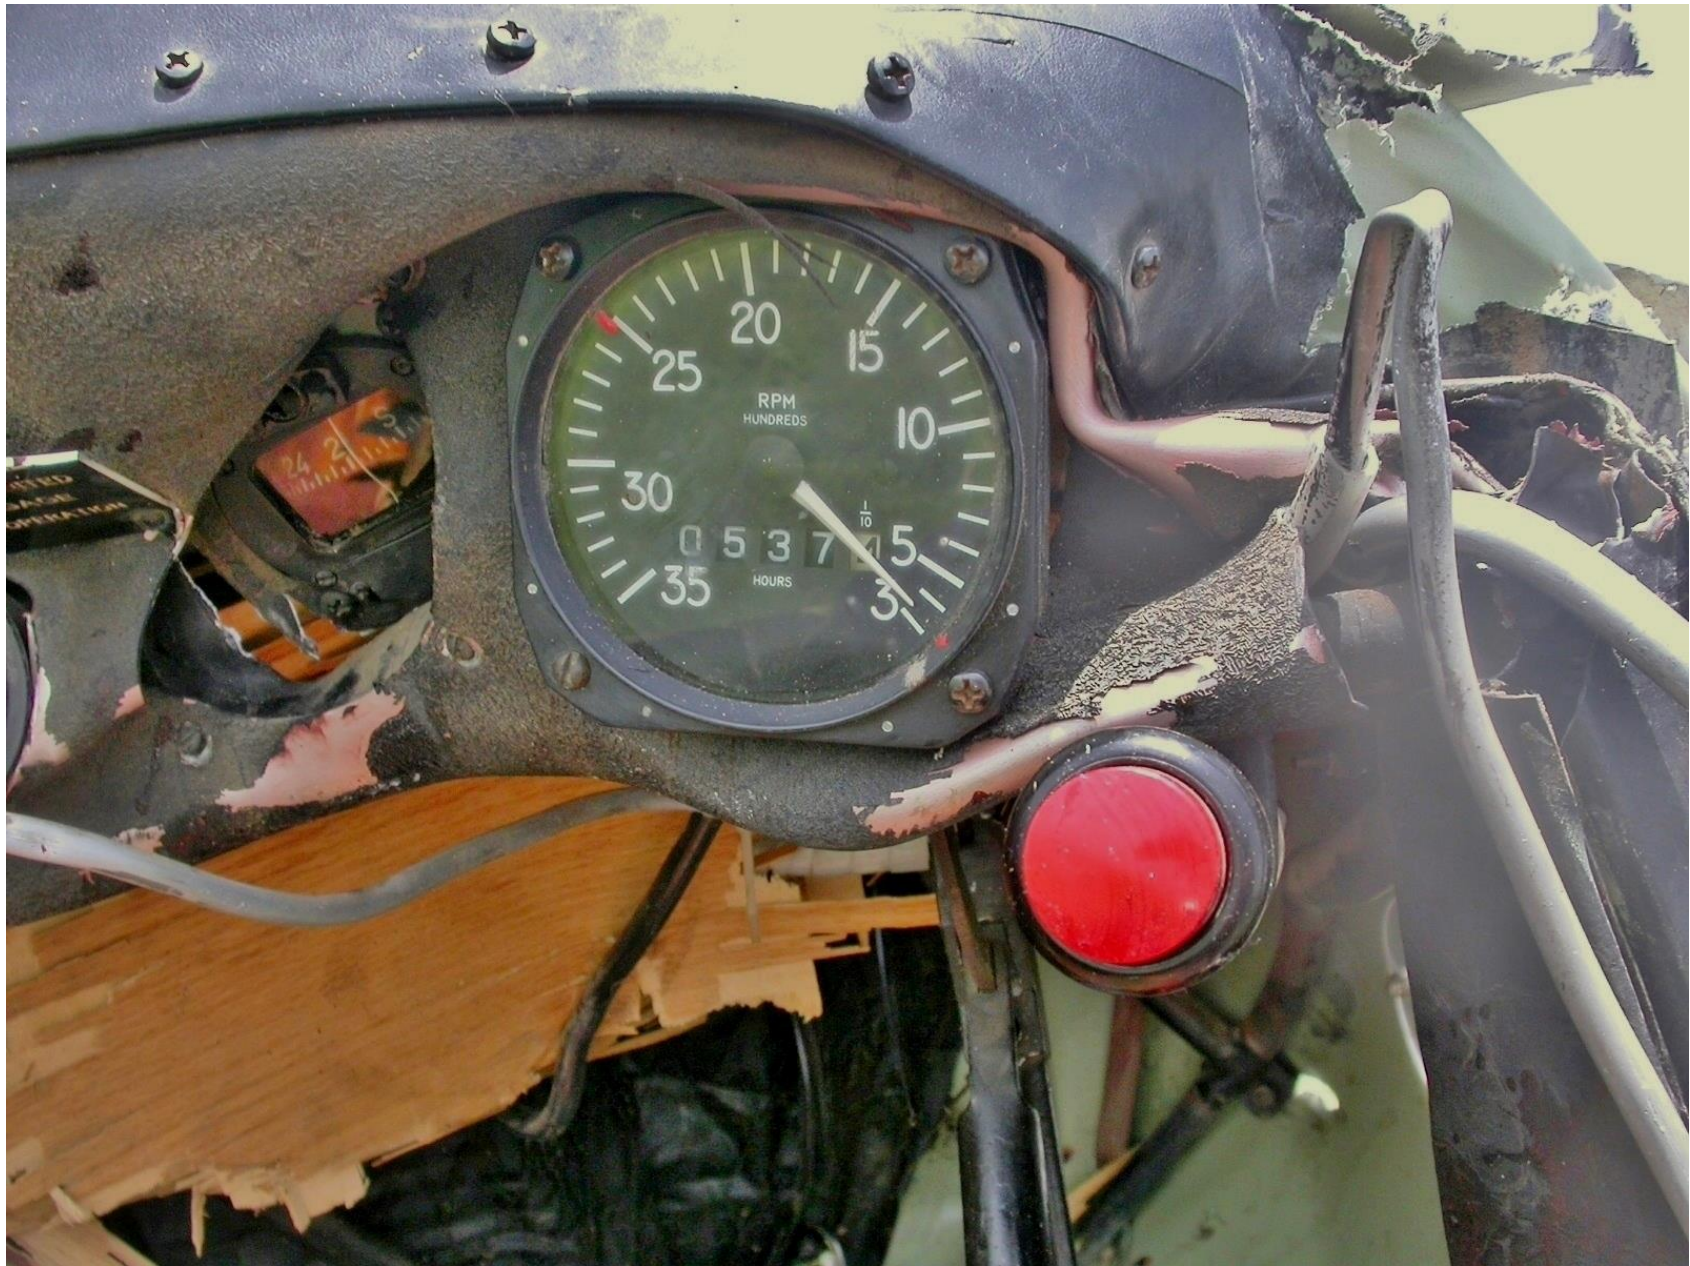
Photo 7 – View of the airplane’s tachometer

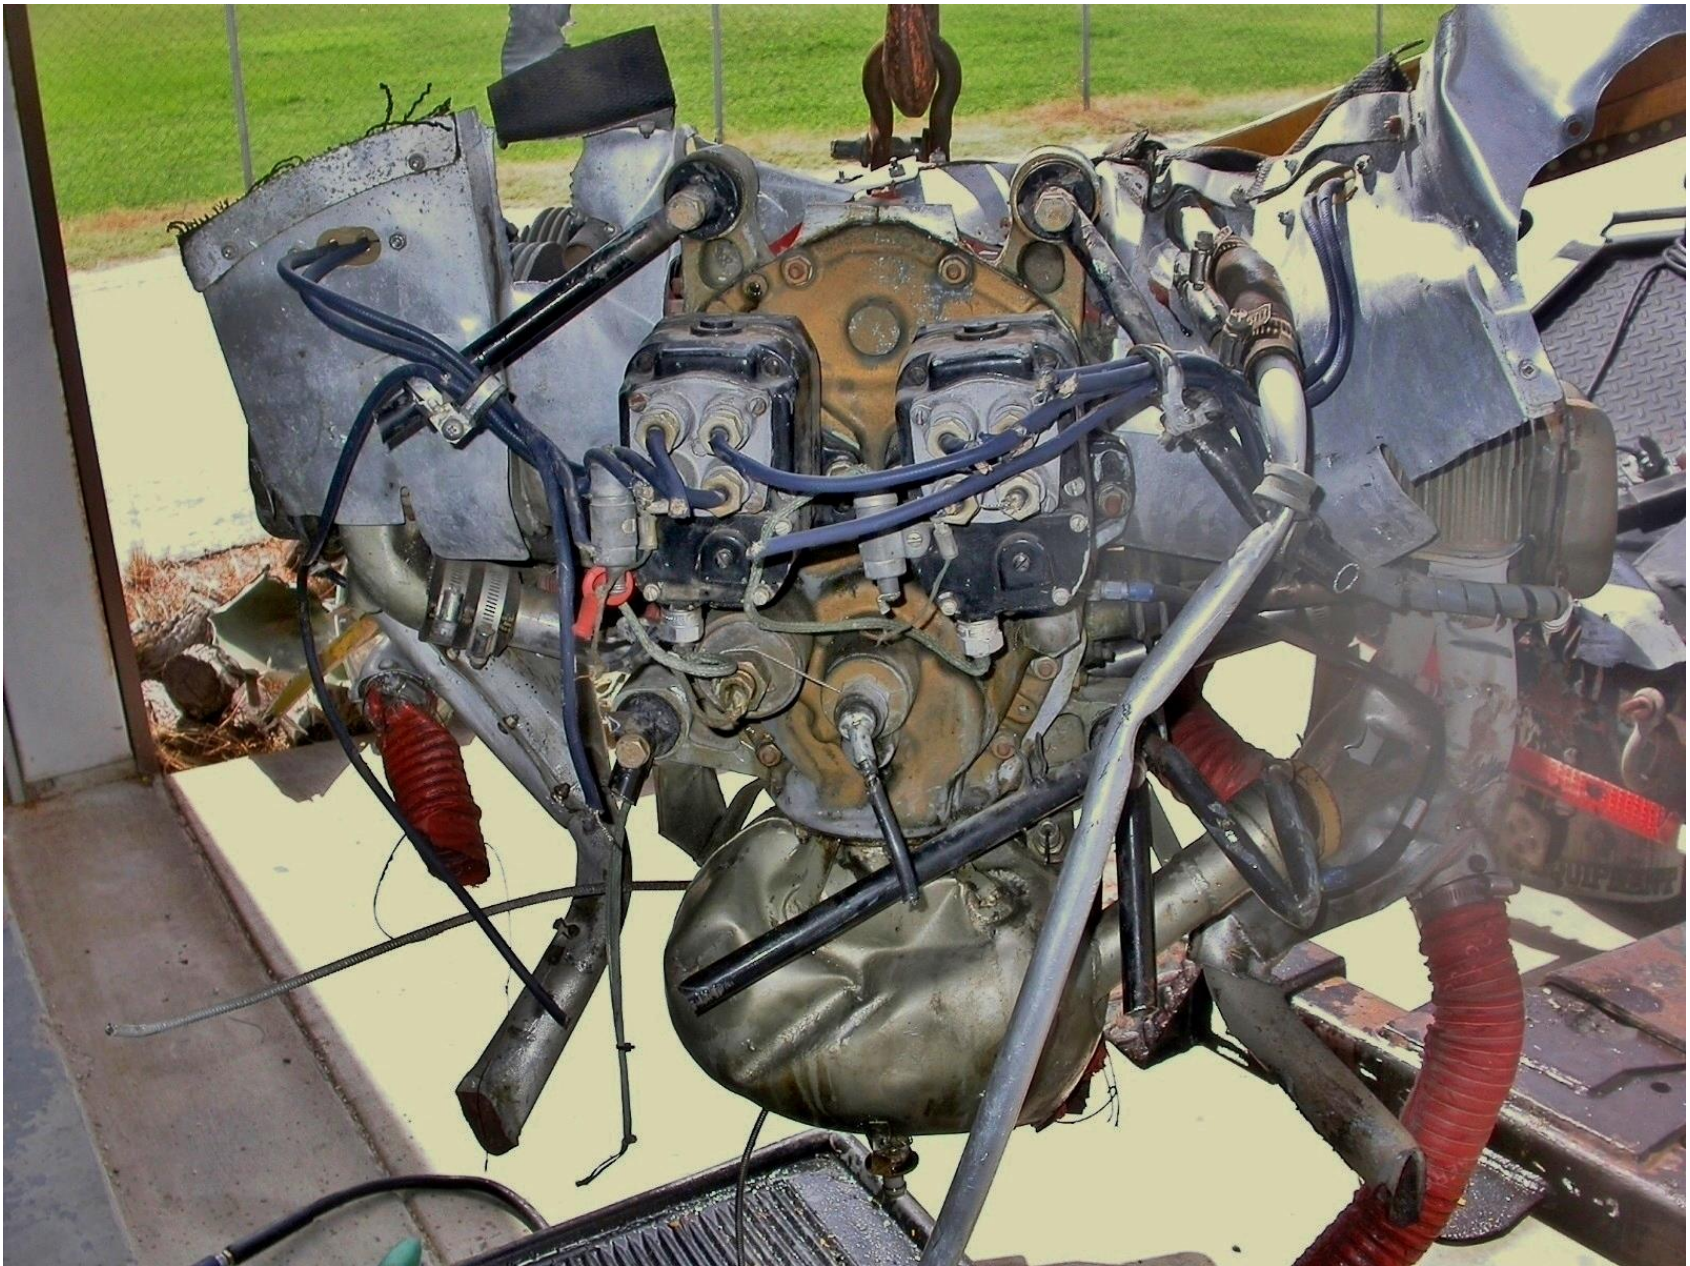
Photo 8 – View of the back of the engine during the engine exam

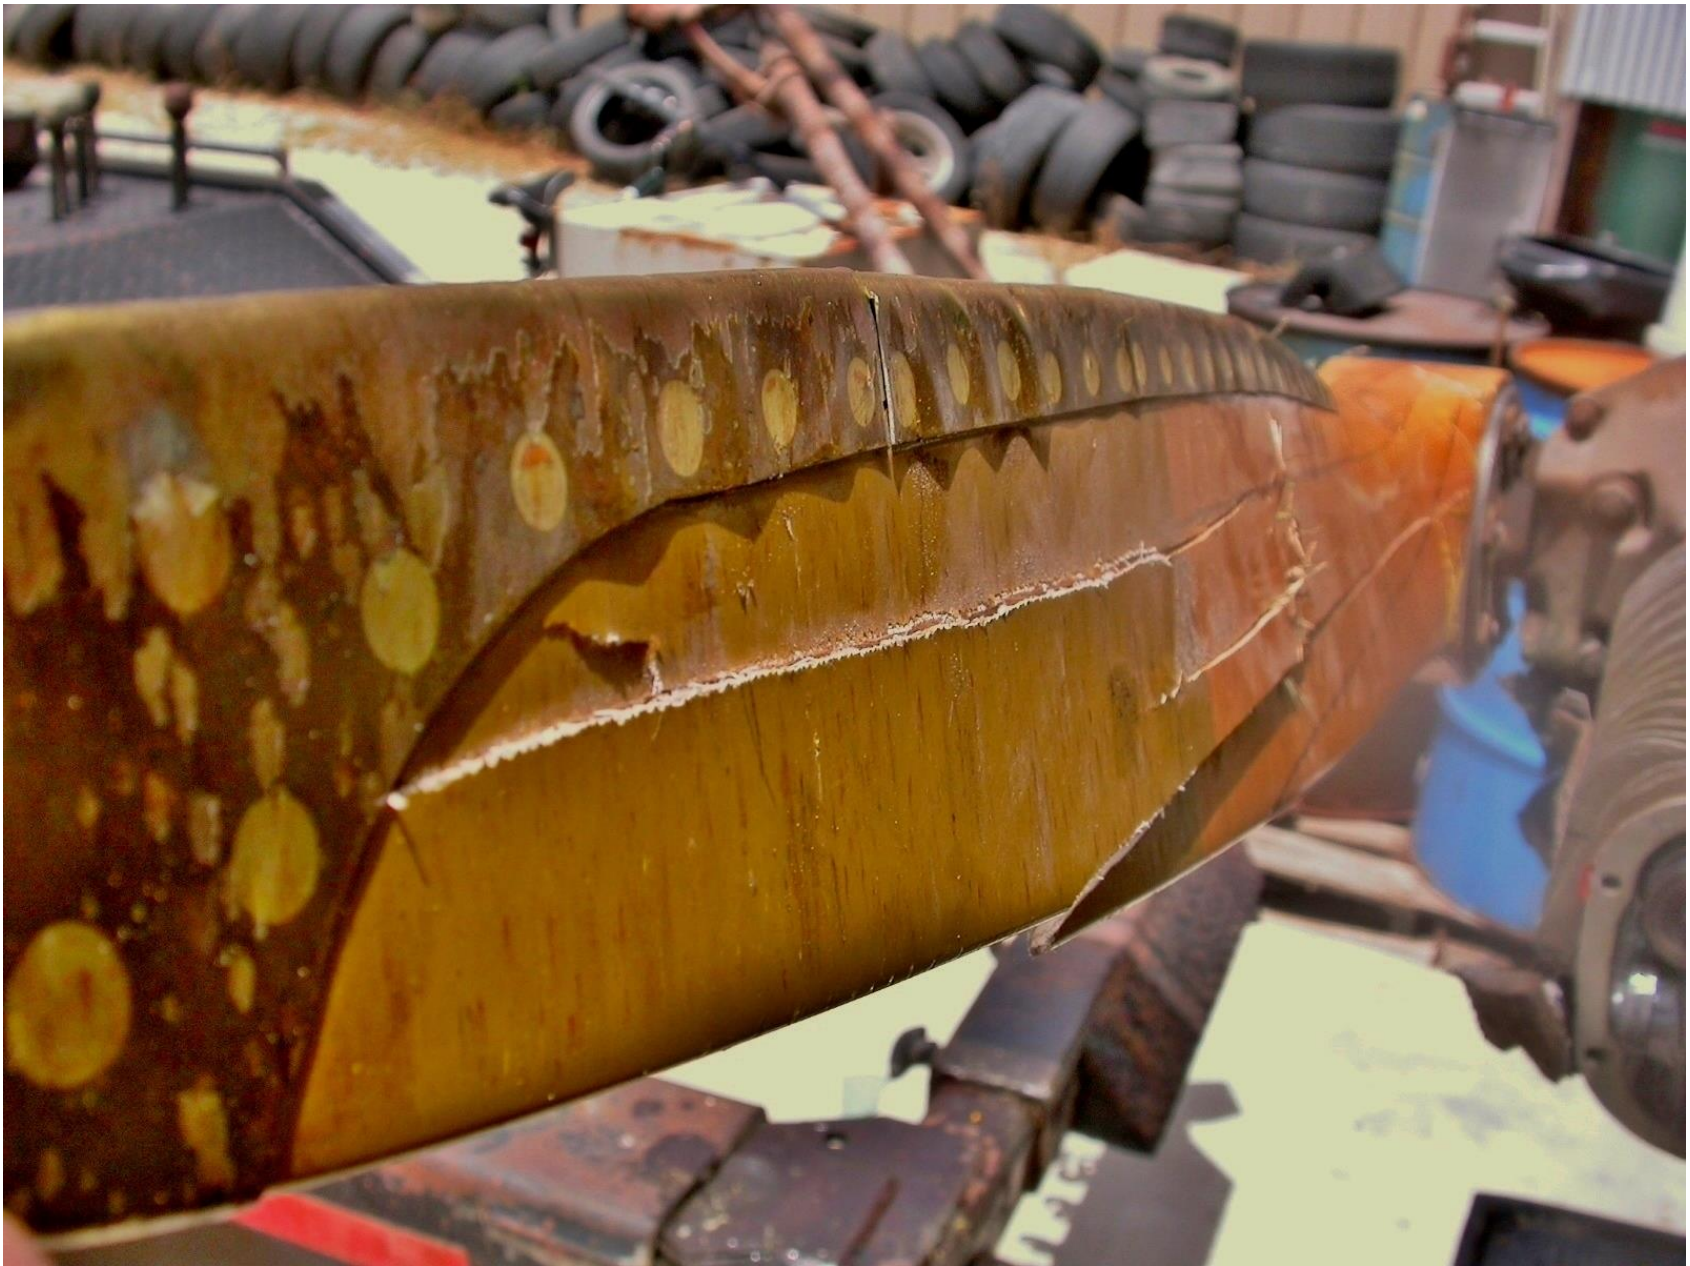
Photo 9 – View of one of the wooden propeller blades

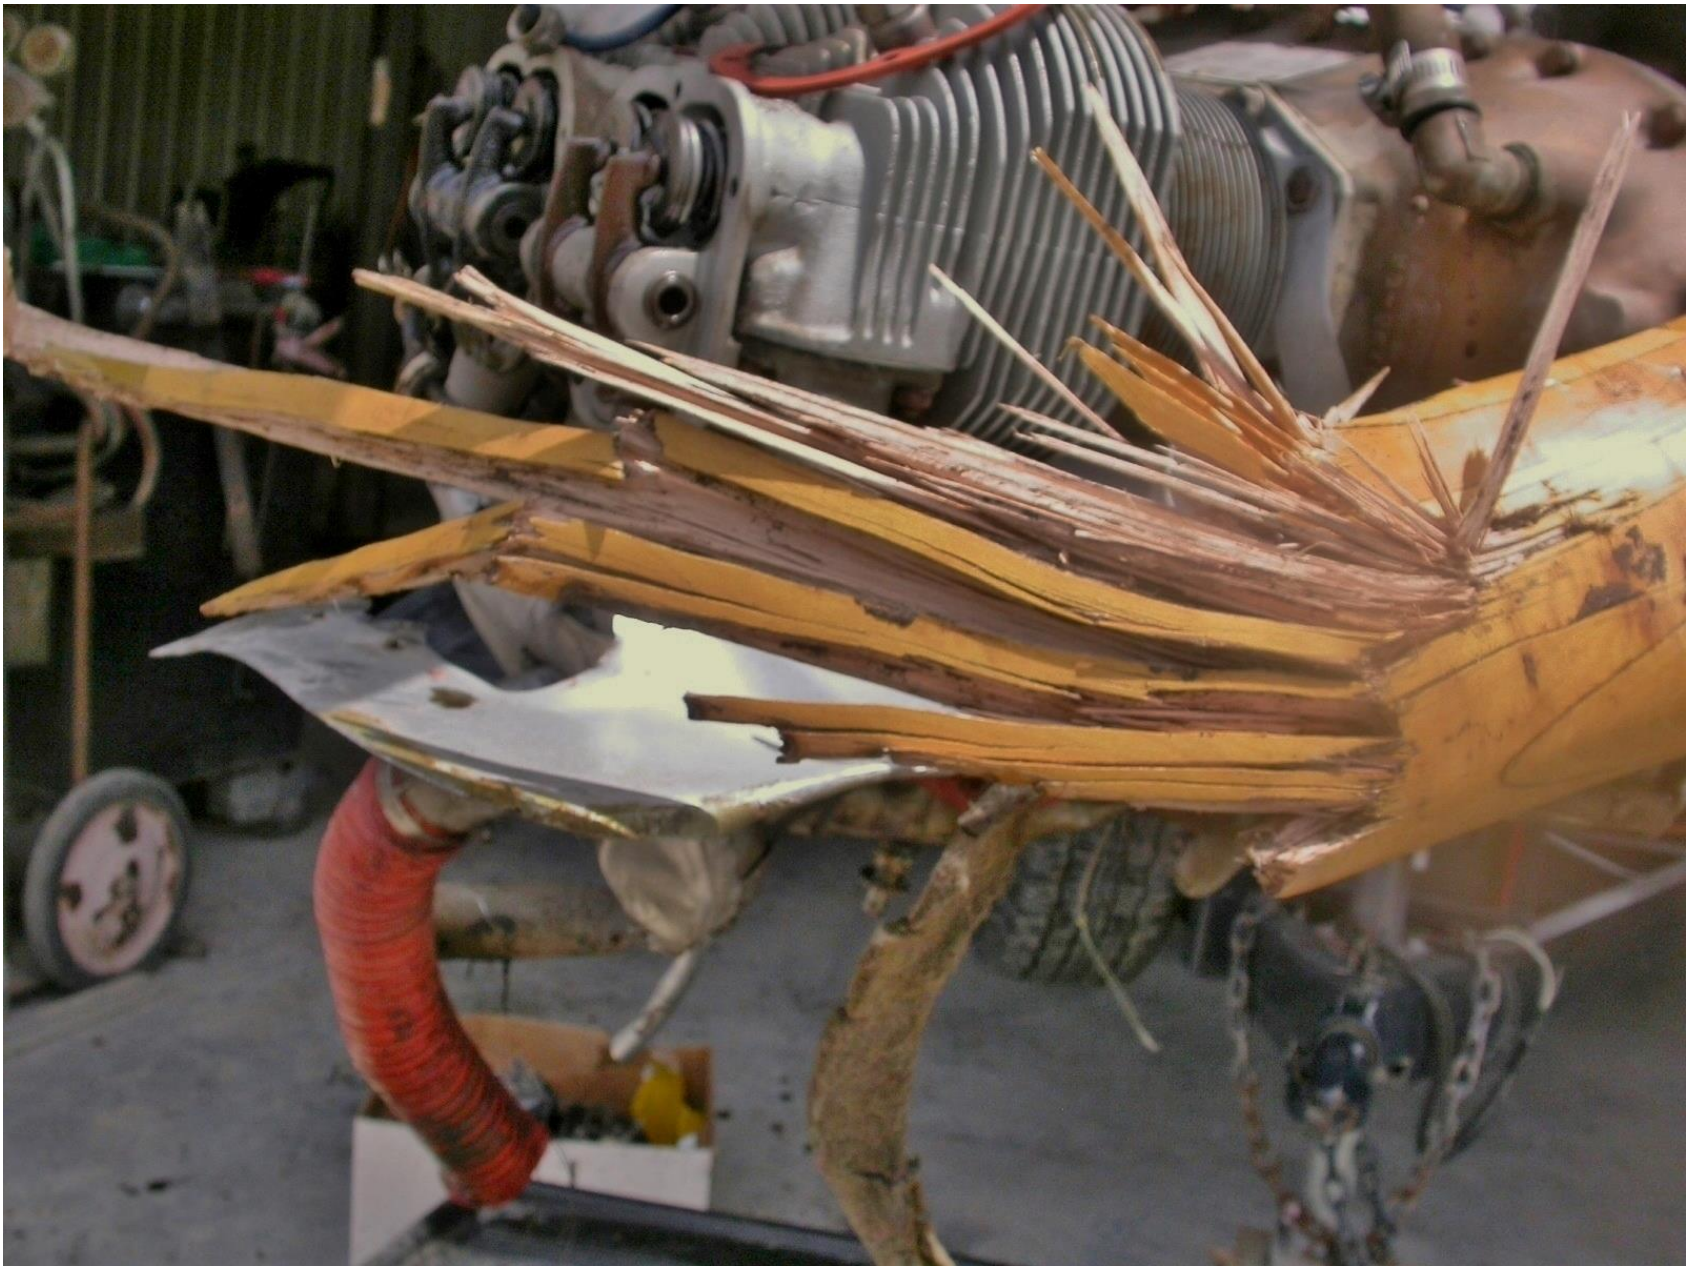
Photo 10 – View of the wooden propeller blade that was broken and splintered.
