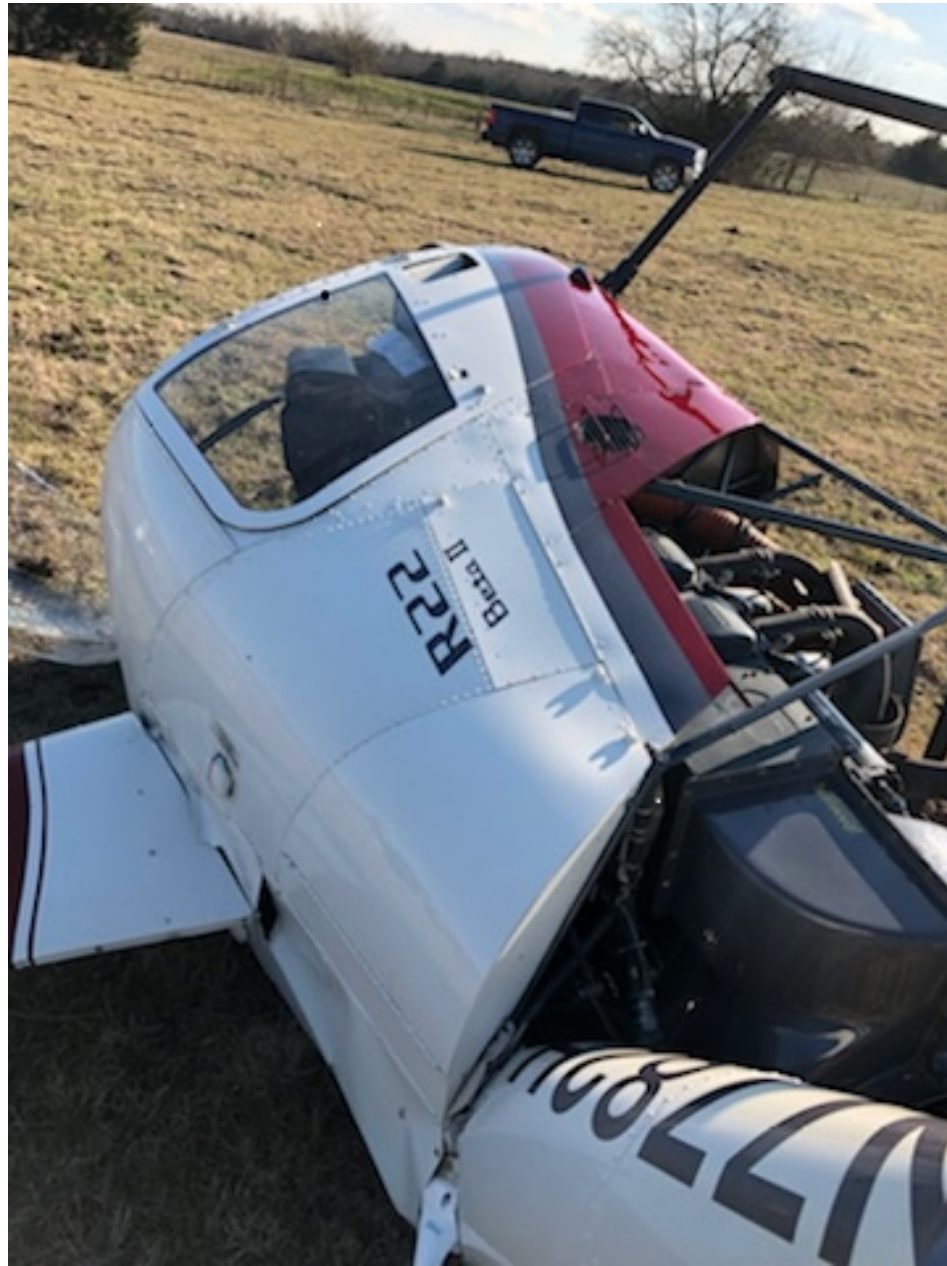
Photo 1 – View of the helicopter on its side in a field (FAA Photo)

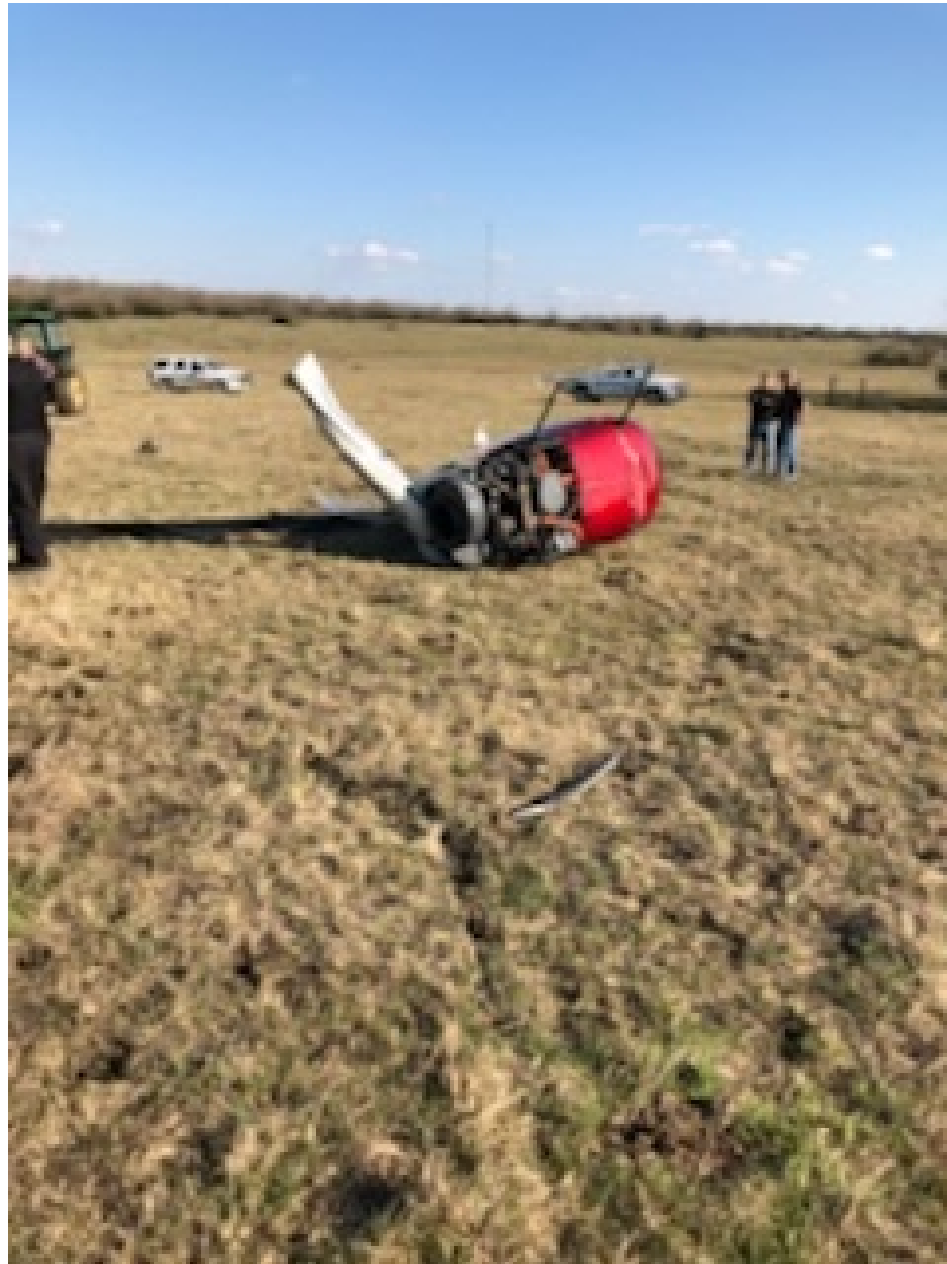
Photo 2 – View of helicopter on its side in a field (FAA Photo)

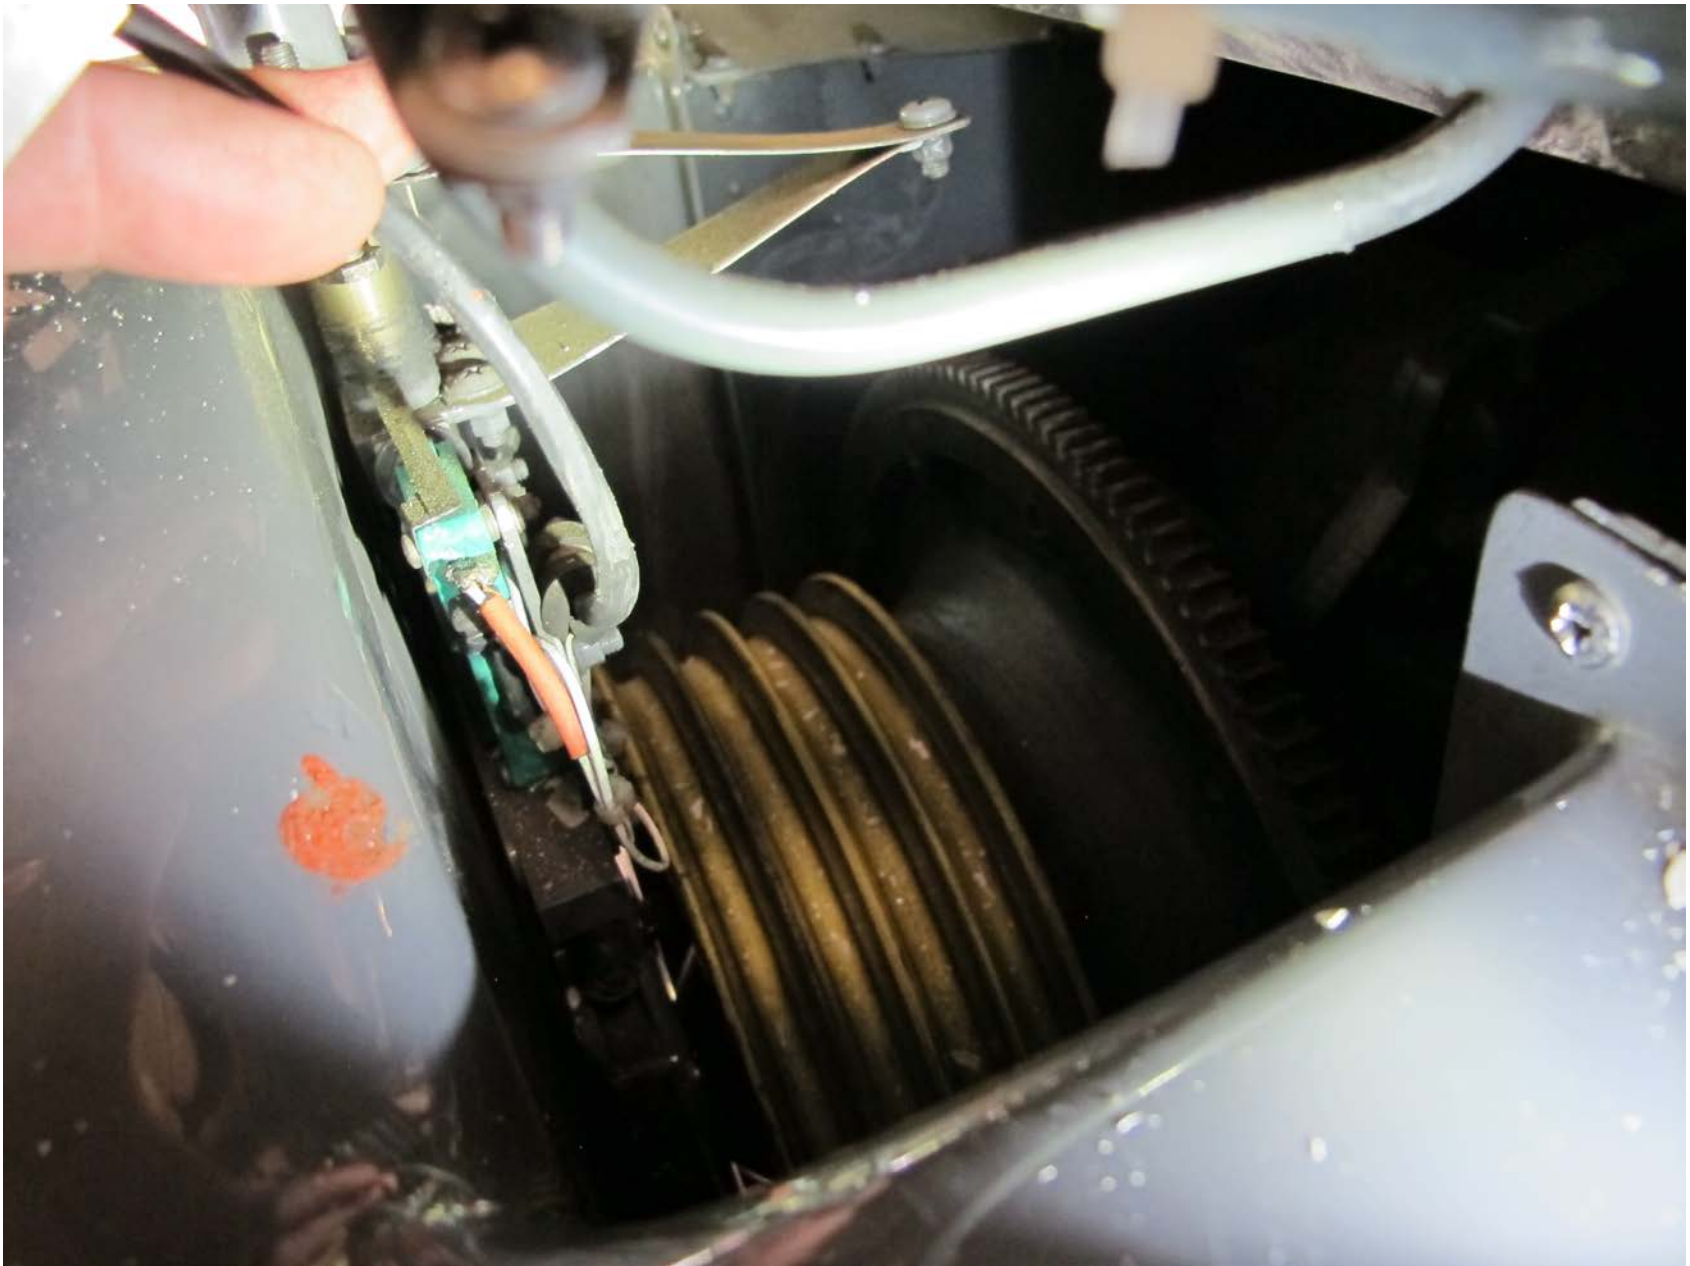
Photo 3 – View of lower sheave (RH Photo)

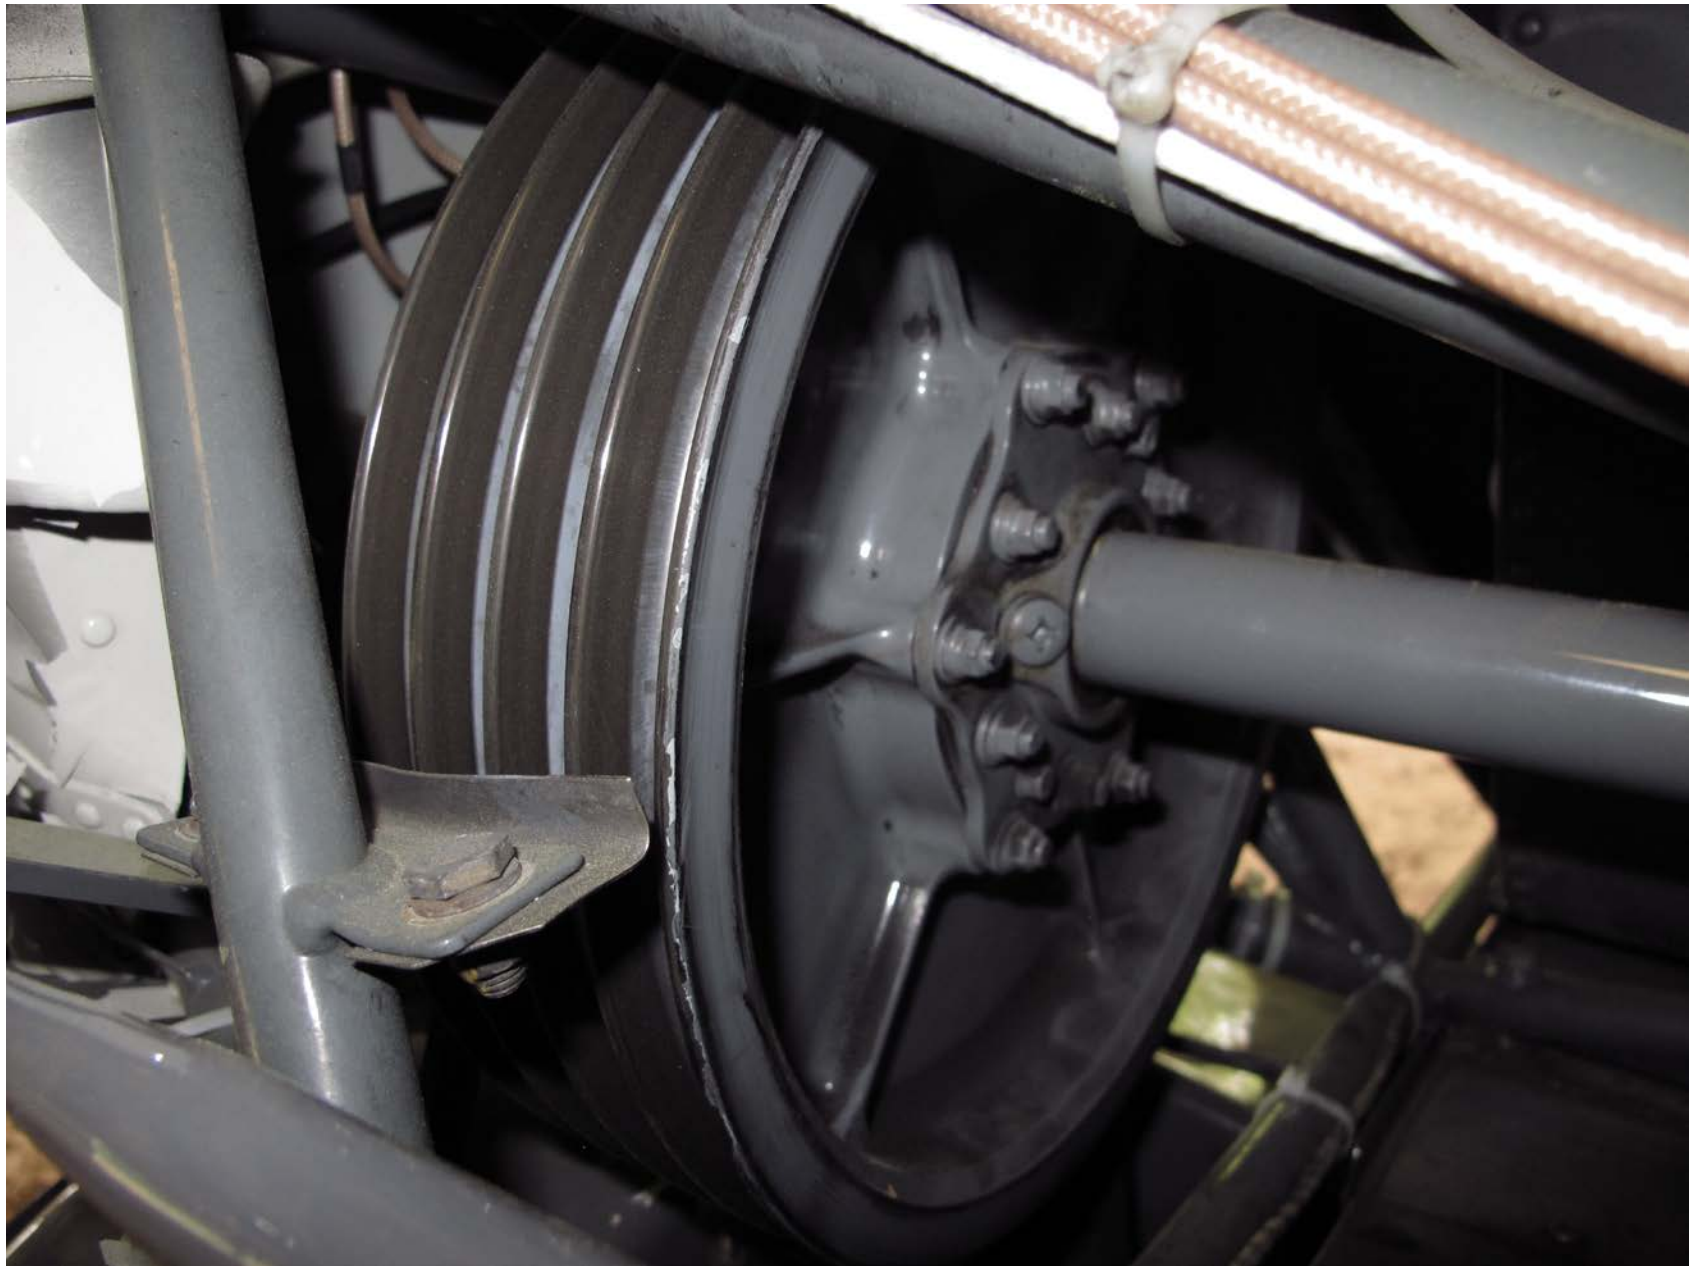
Photo 4 – View of upper sheave (RH Photo)

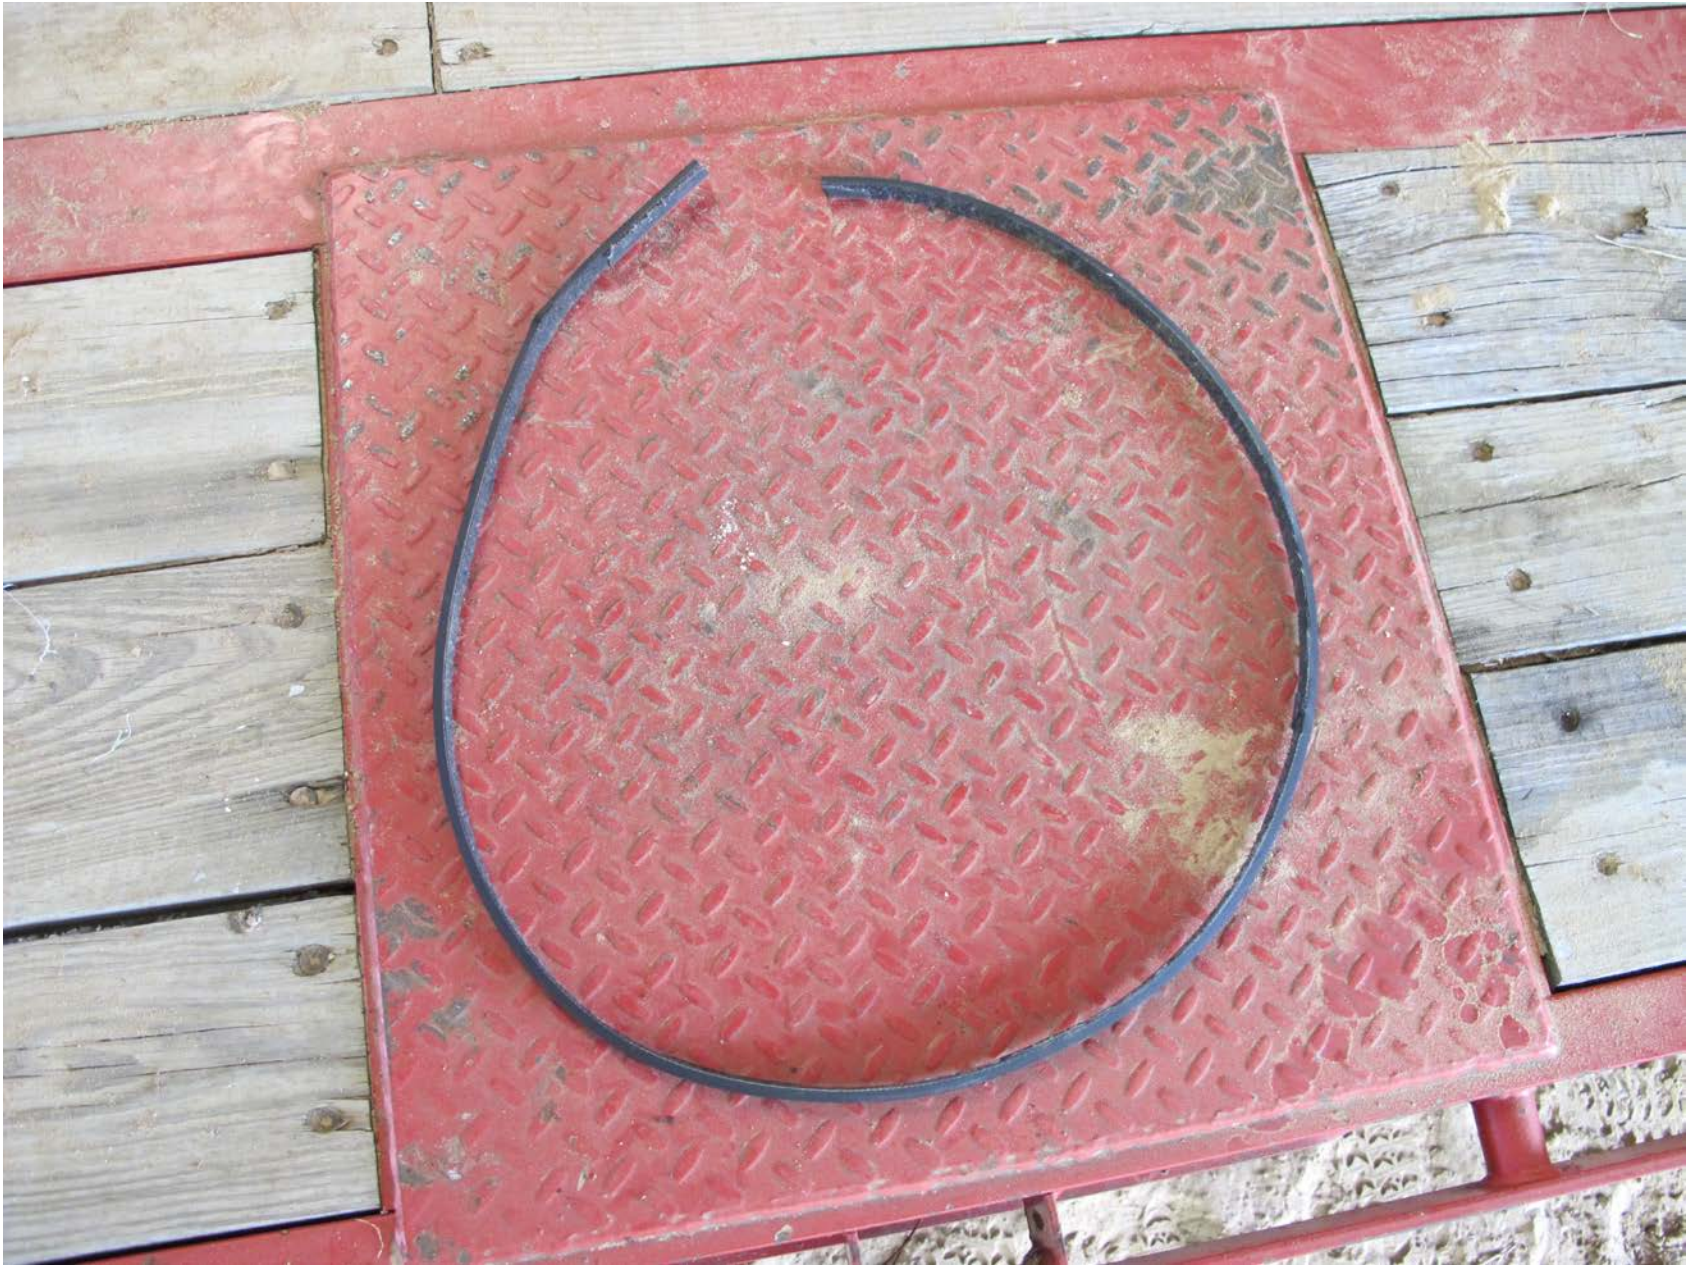
Photo 5 – Photo of a V-belt (RH Photo)

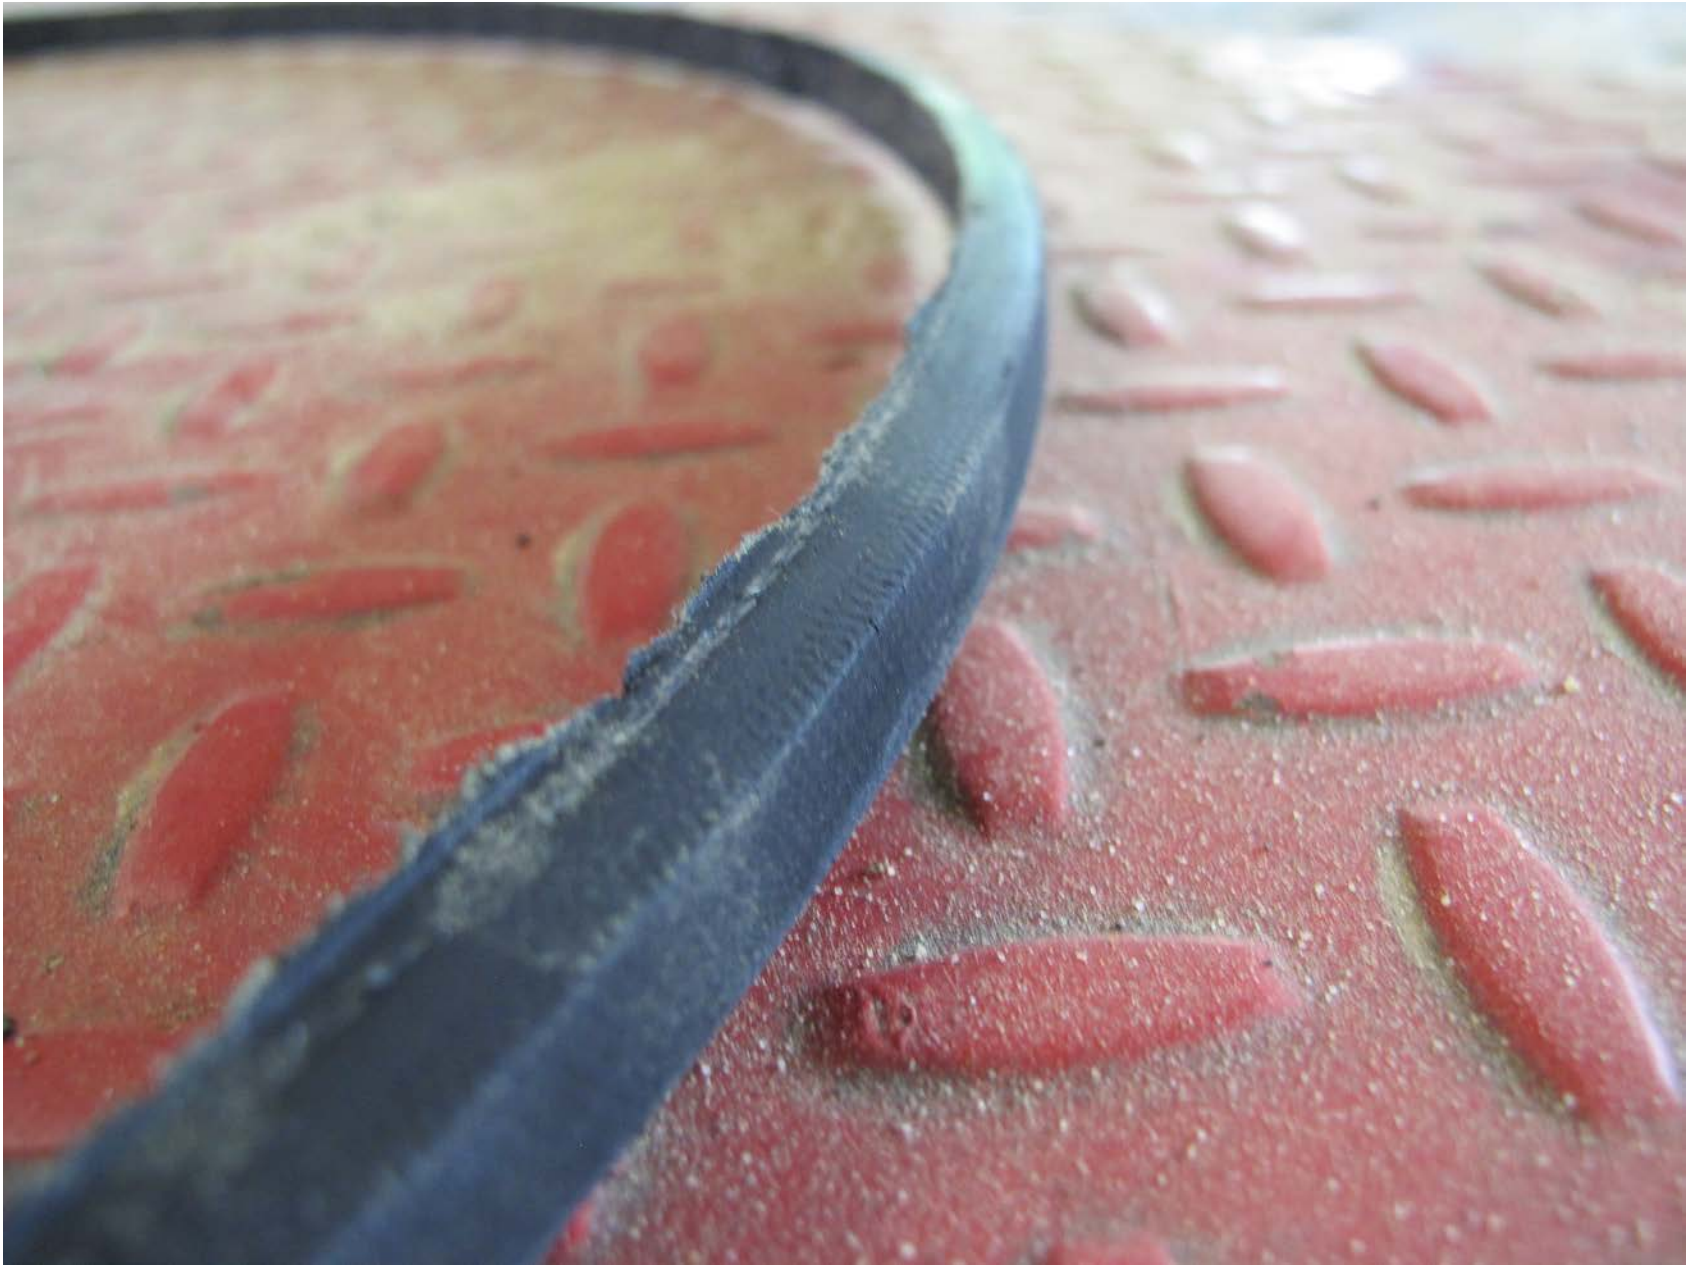
Photo 6 – View of V-belt contact surface (RH Photo)

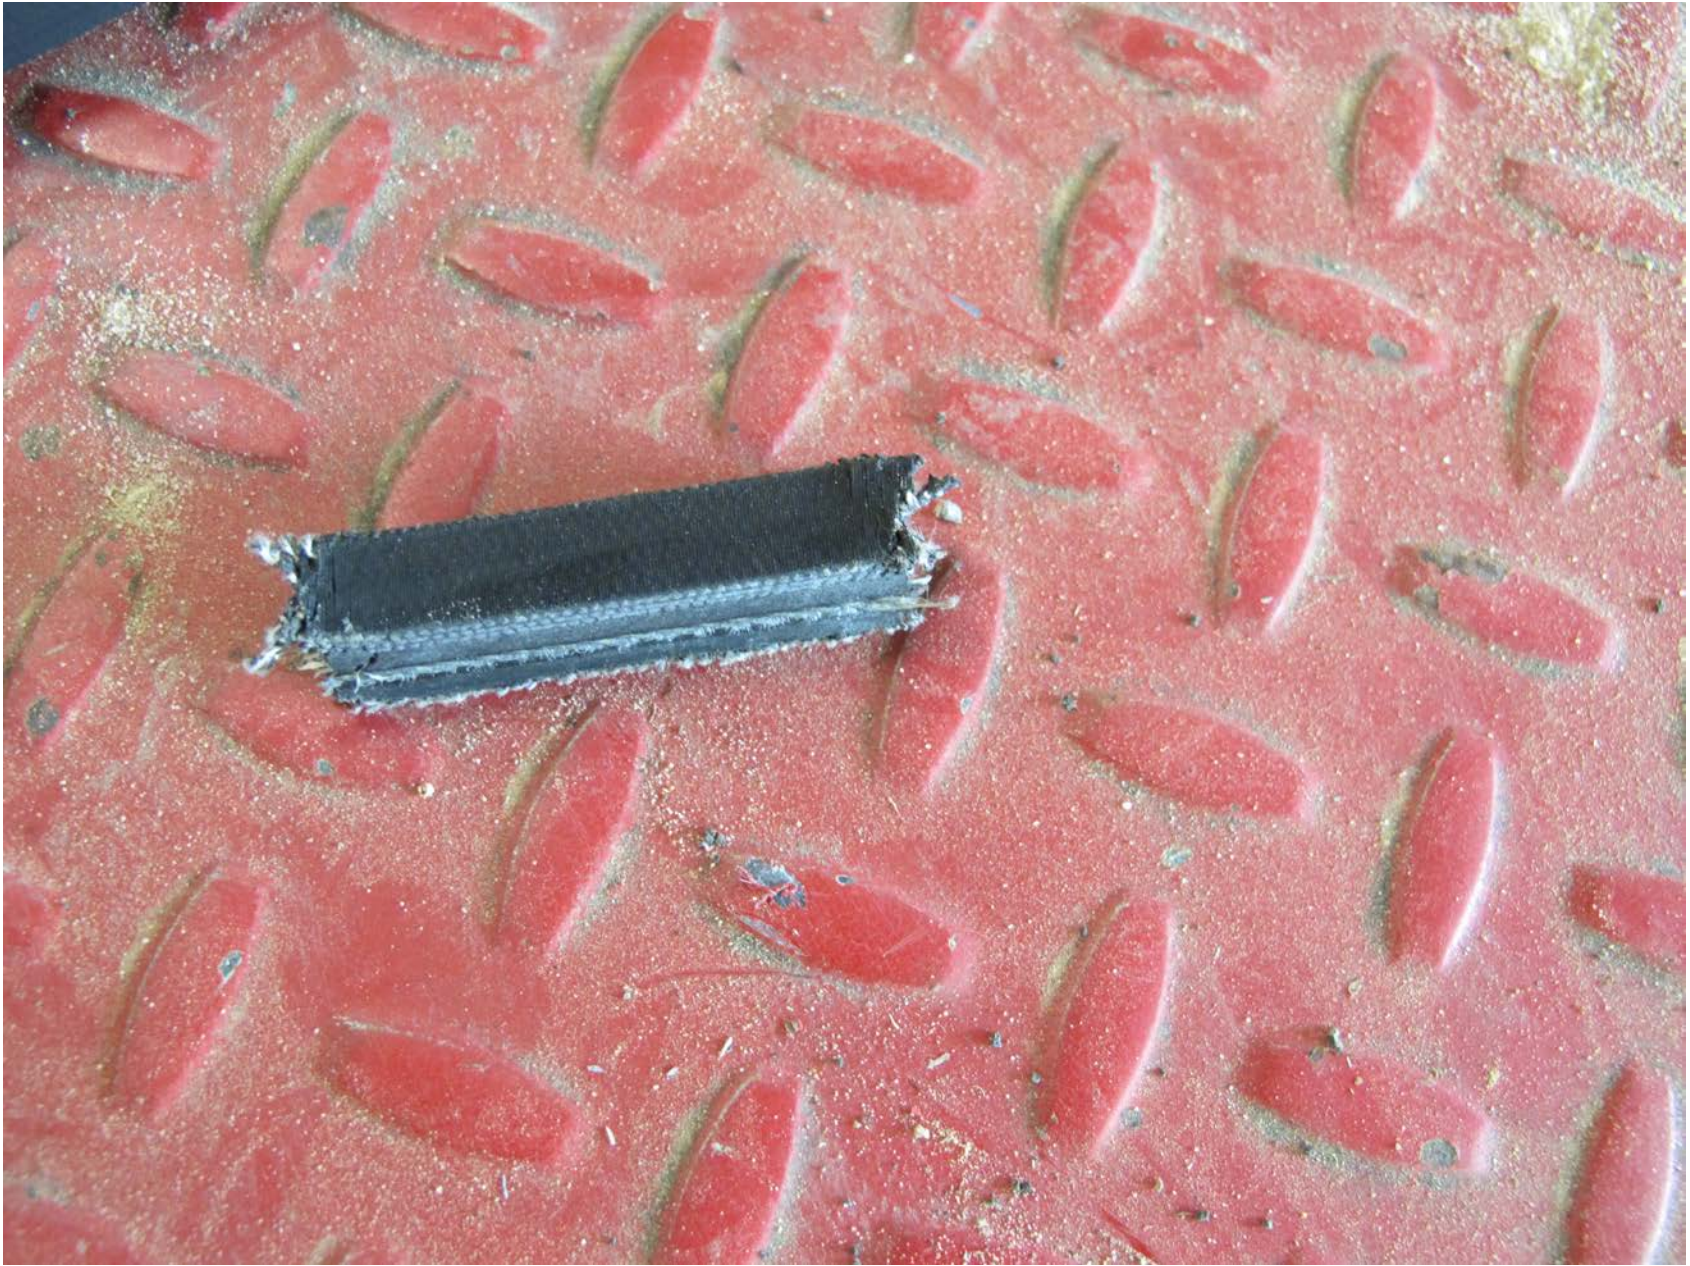
Photo 7 – View of small section of V-belt recovered separately (RH Photo)

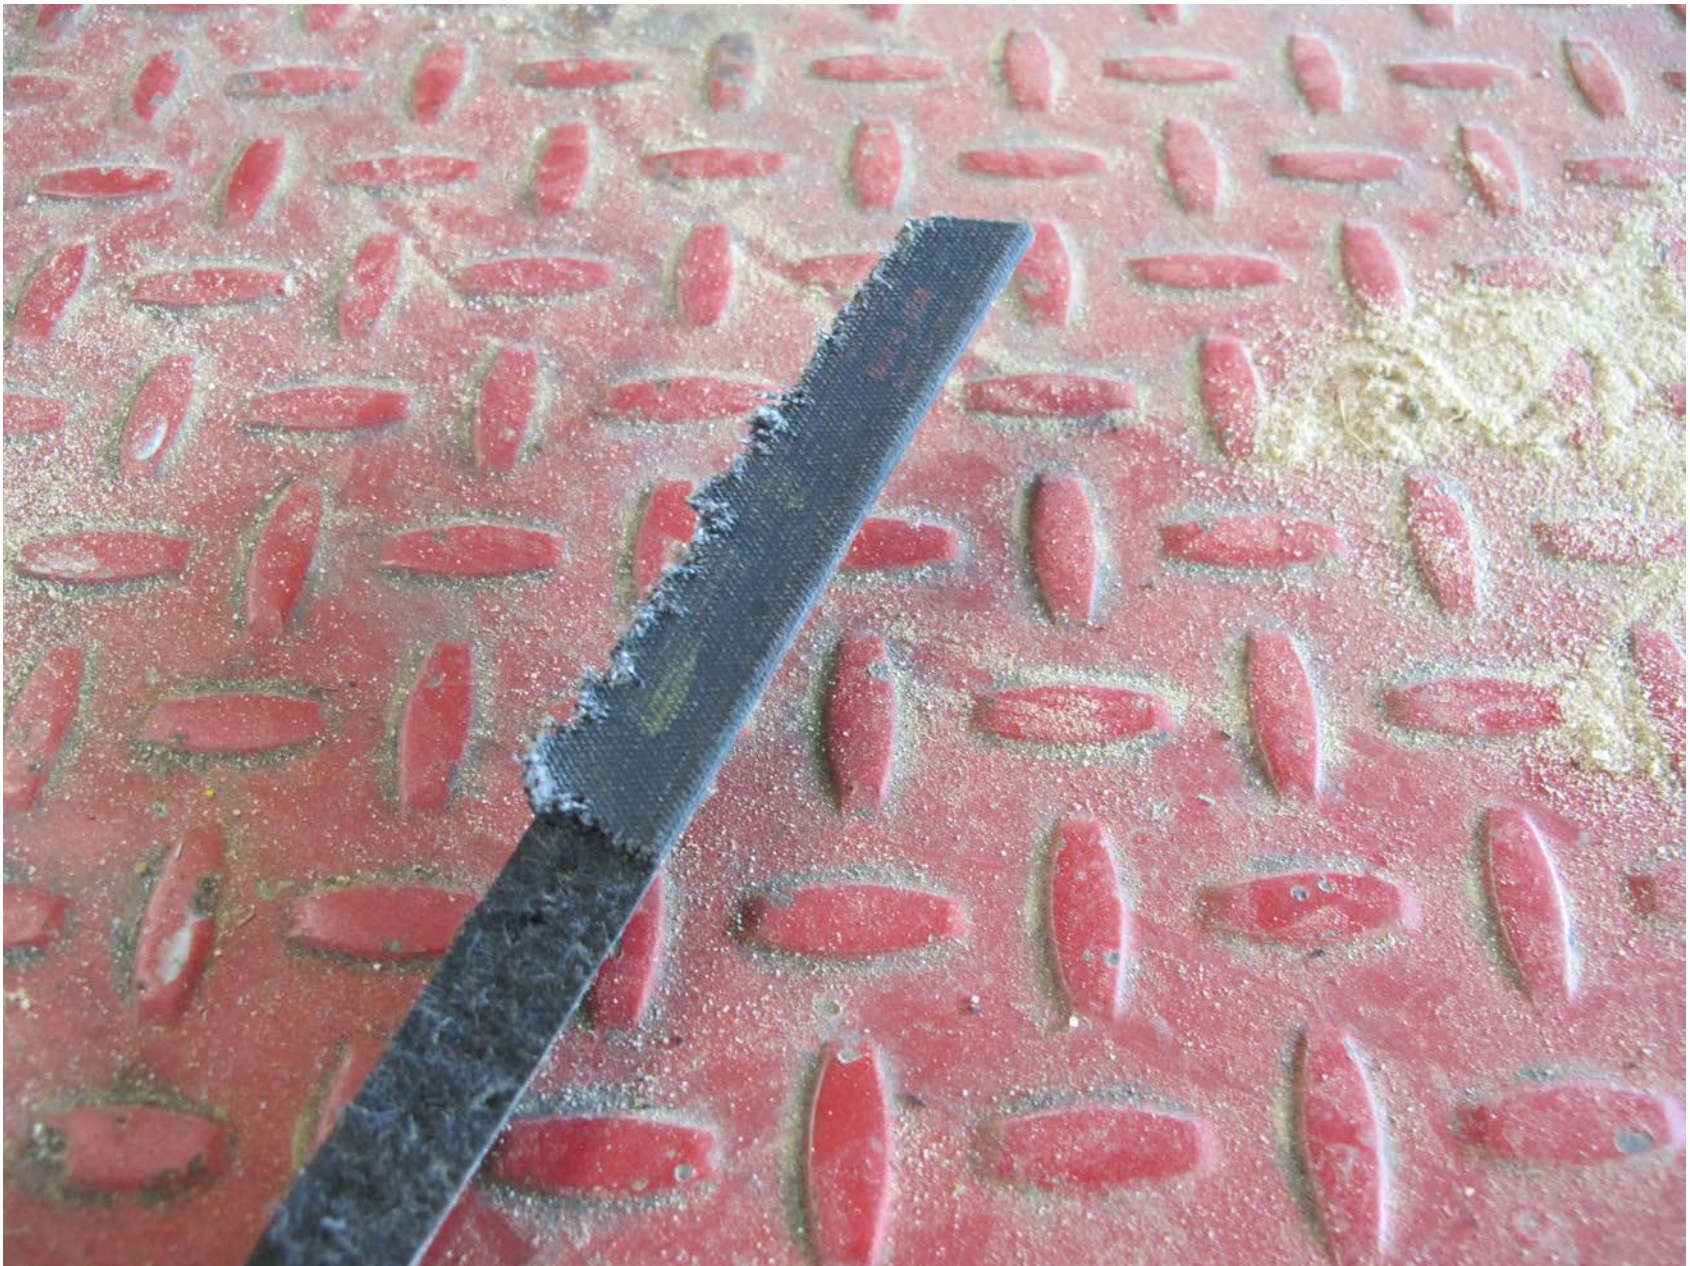
Photo 8 – View of damage to V-belt. Note: V-belt cut for removal (RH Photo)

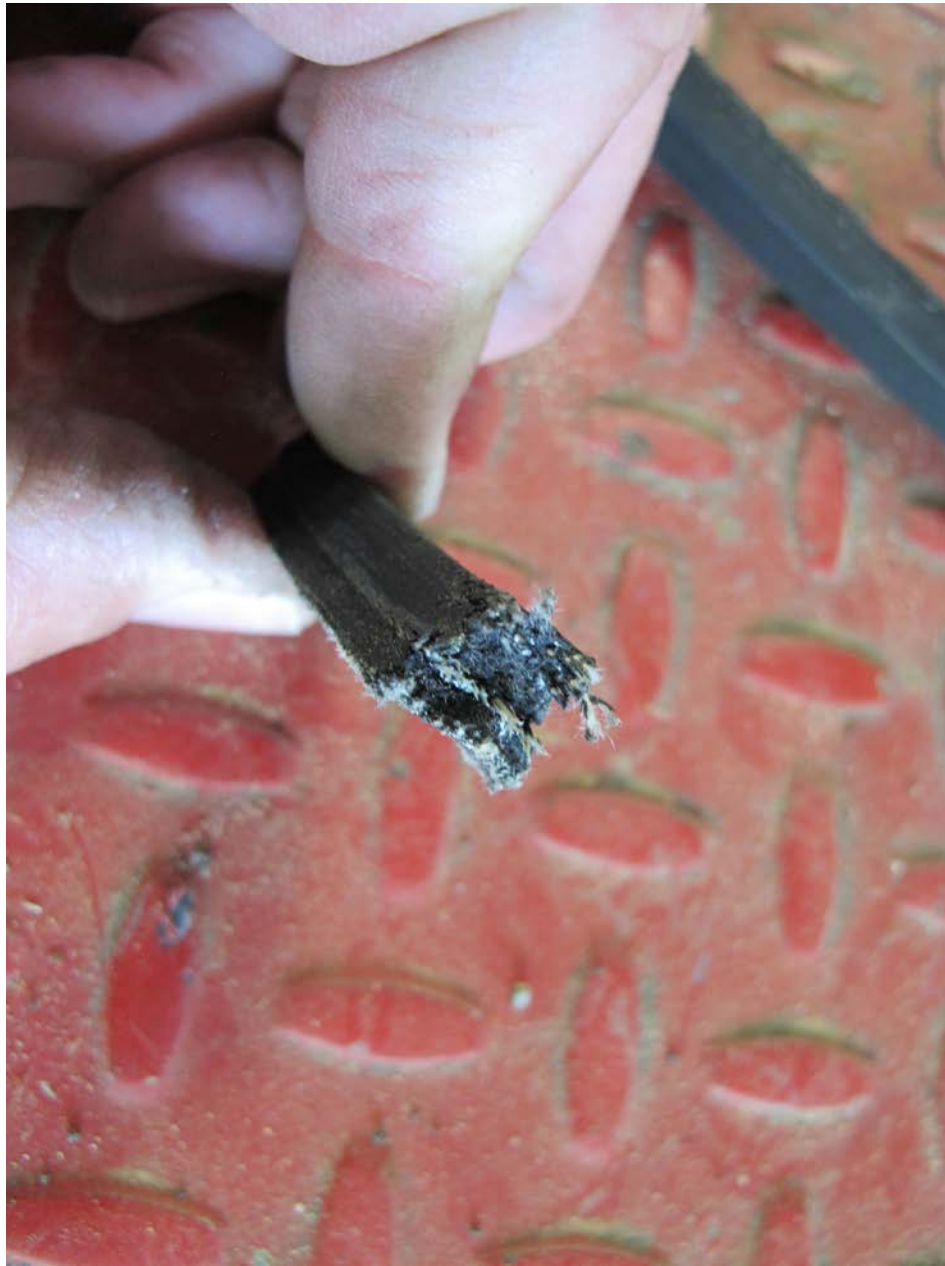
Photo 9 – Fracture surface of small section of V-belt (RH Photo)

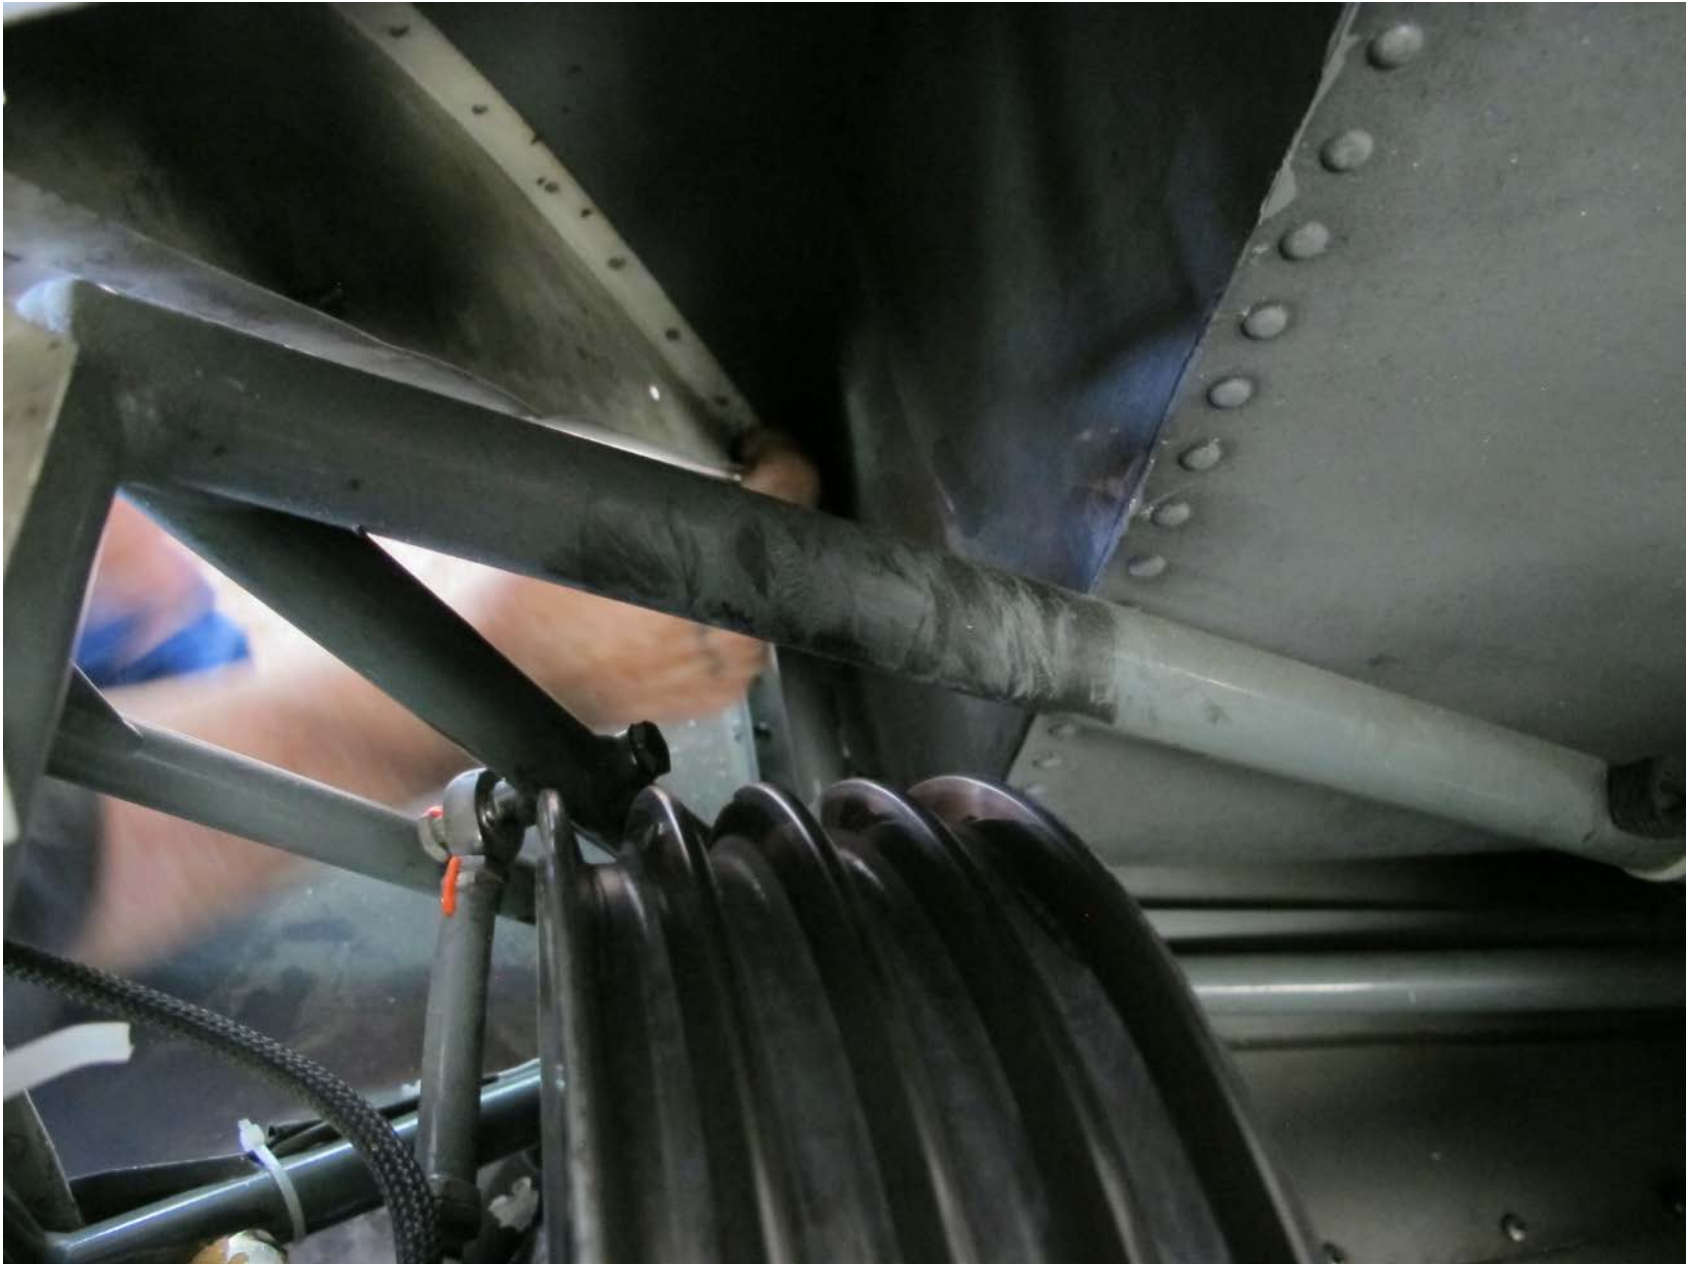
Photo 10 – Rubber residue on frame tube adjacent to V-belt grooves and forward of grooves (RH Photo)

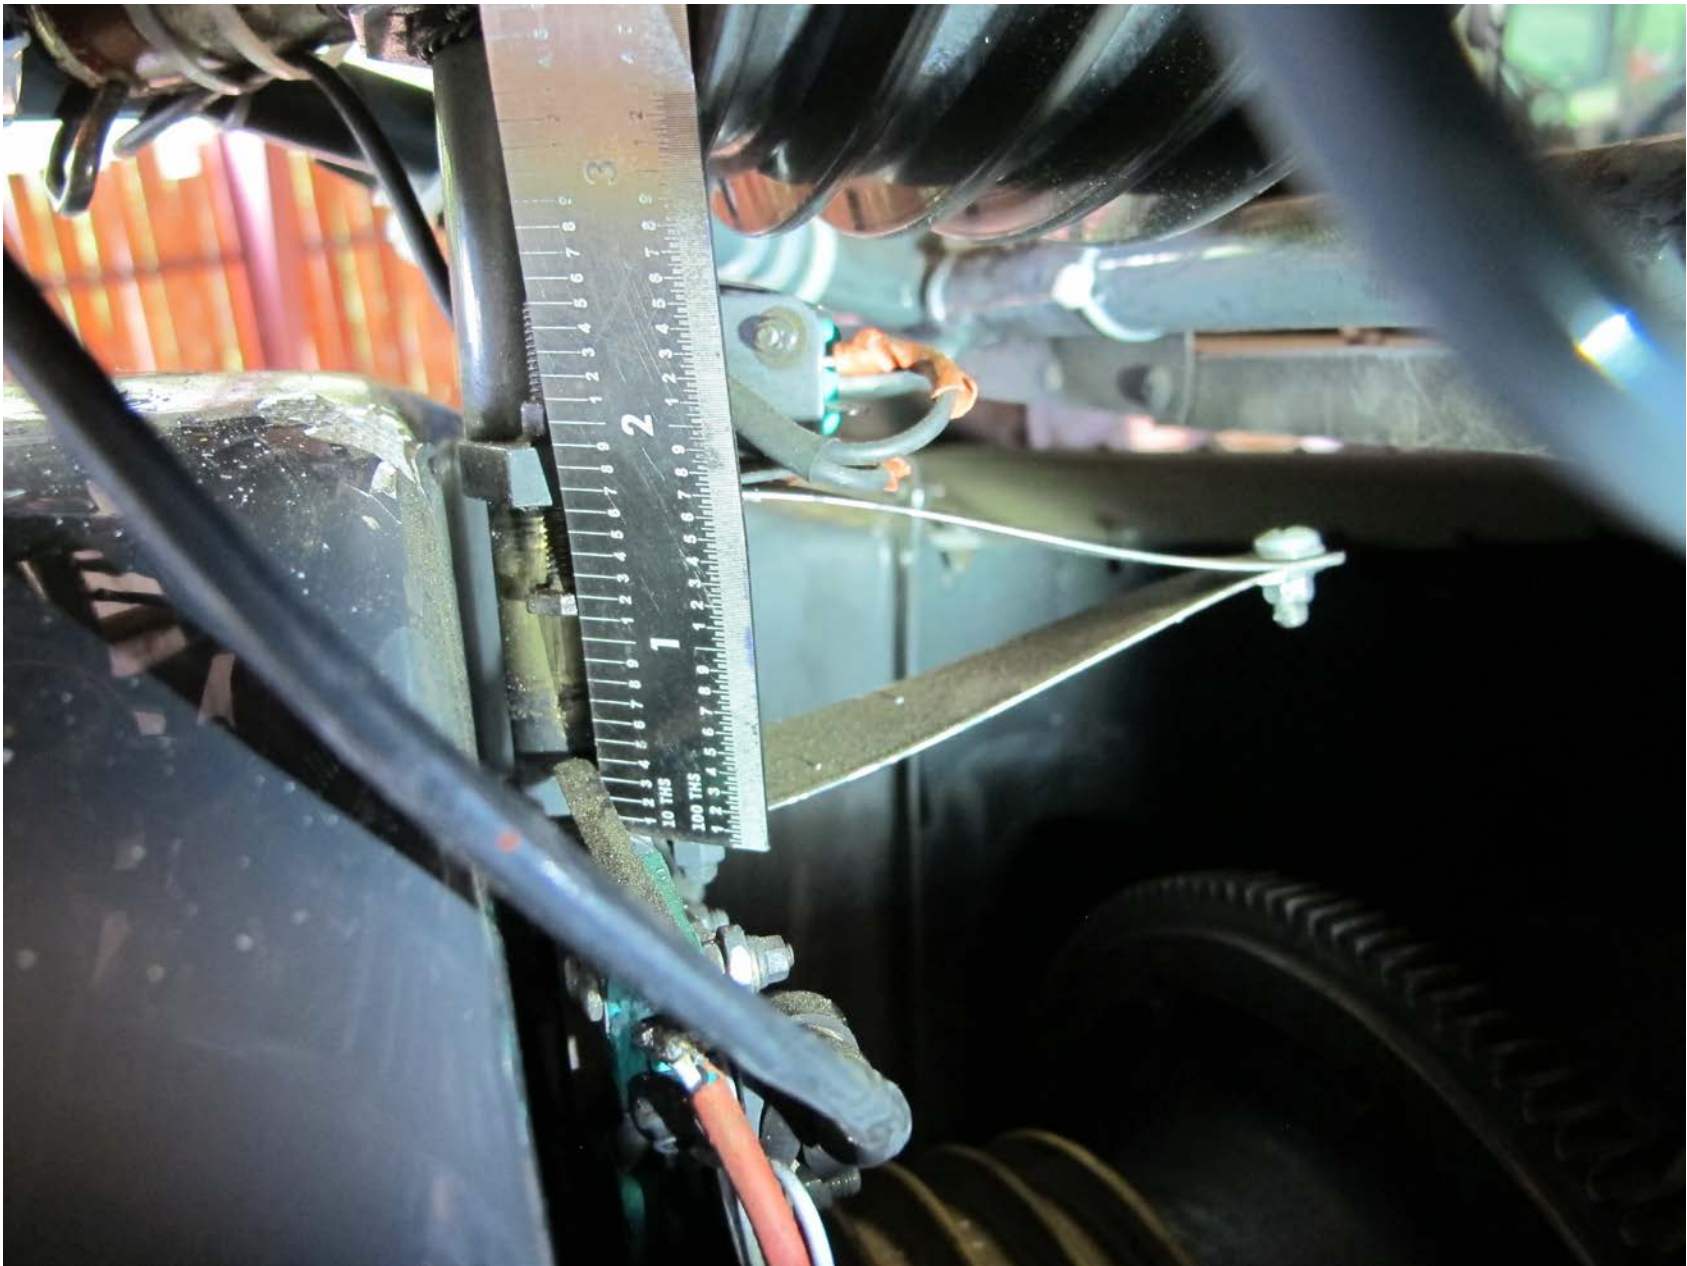
Photo 11 – View of clutch actuator extension distance (RH Photo)

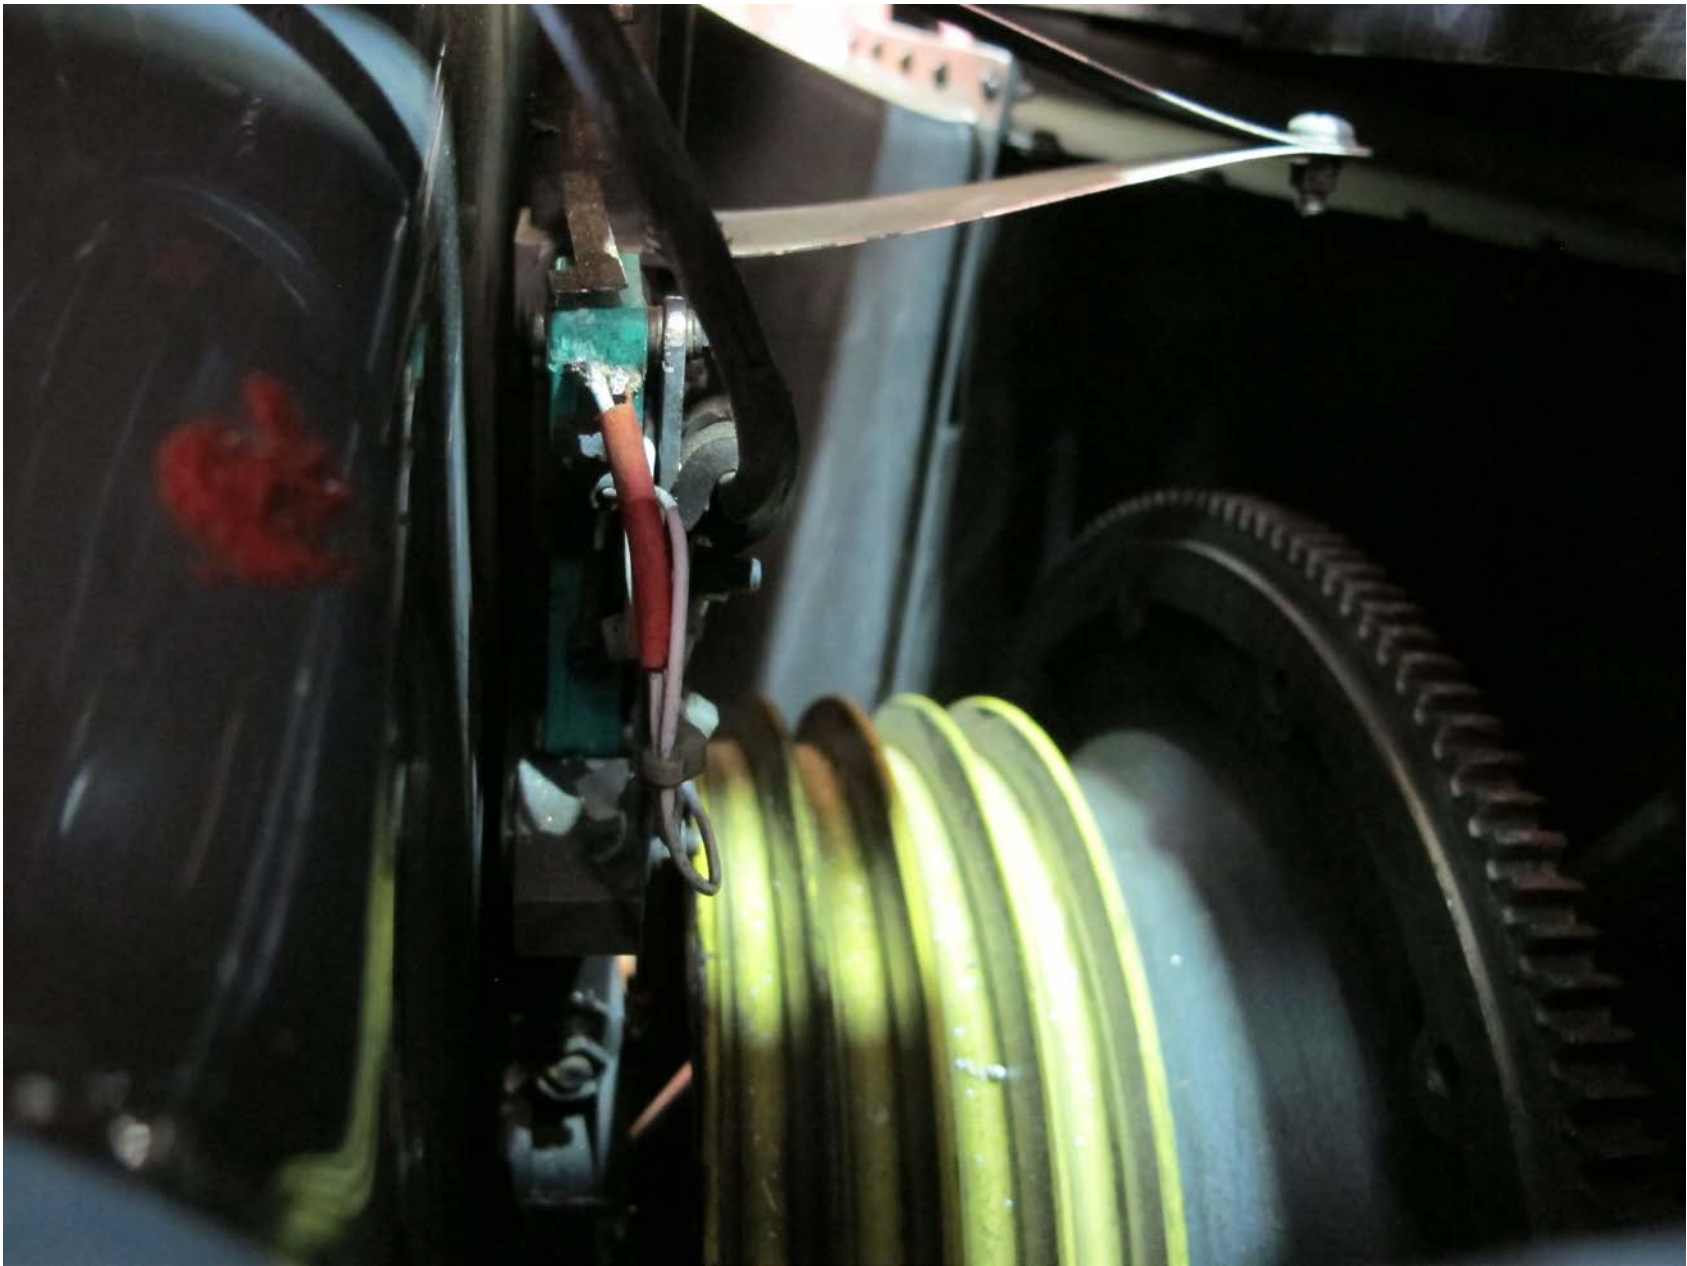
Photo 12 – View of field repair on actuator switch (RH Photo)
