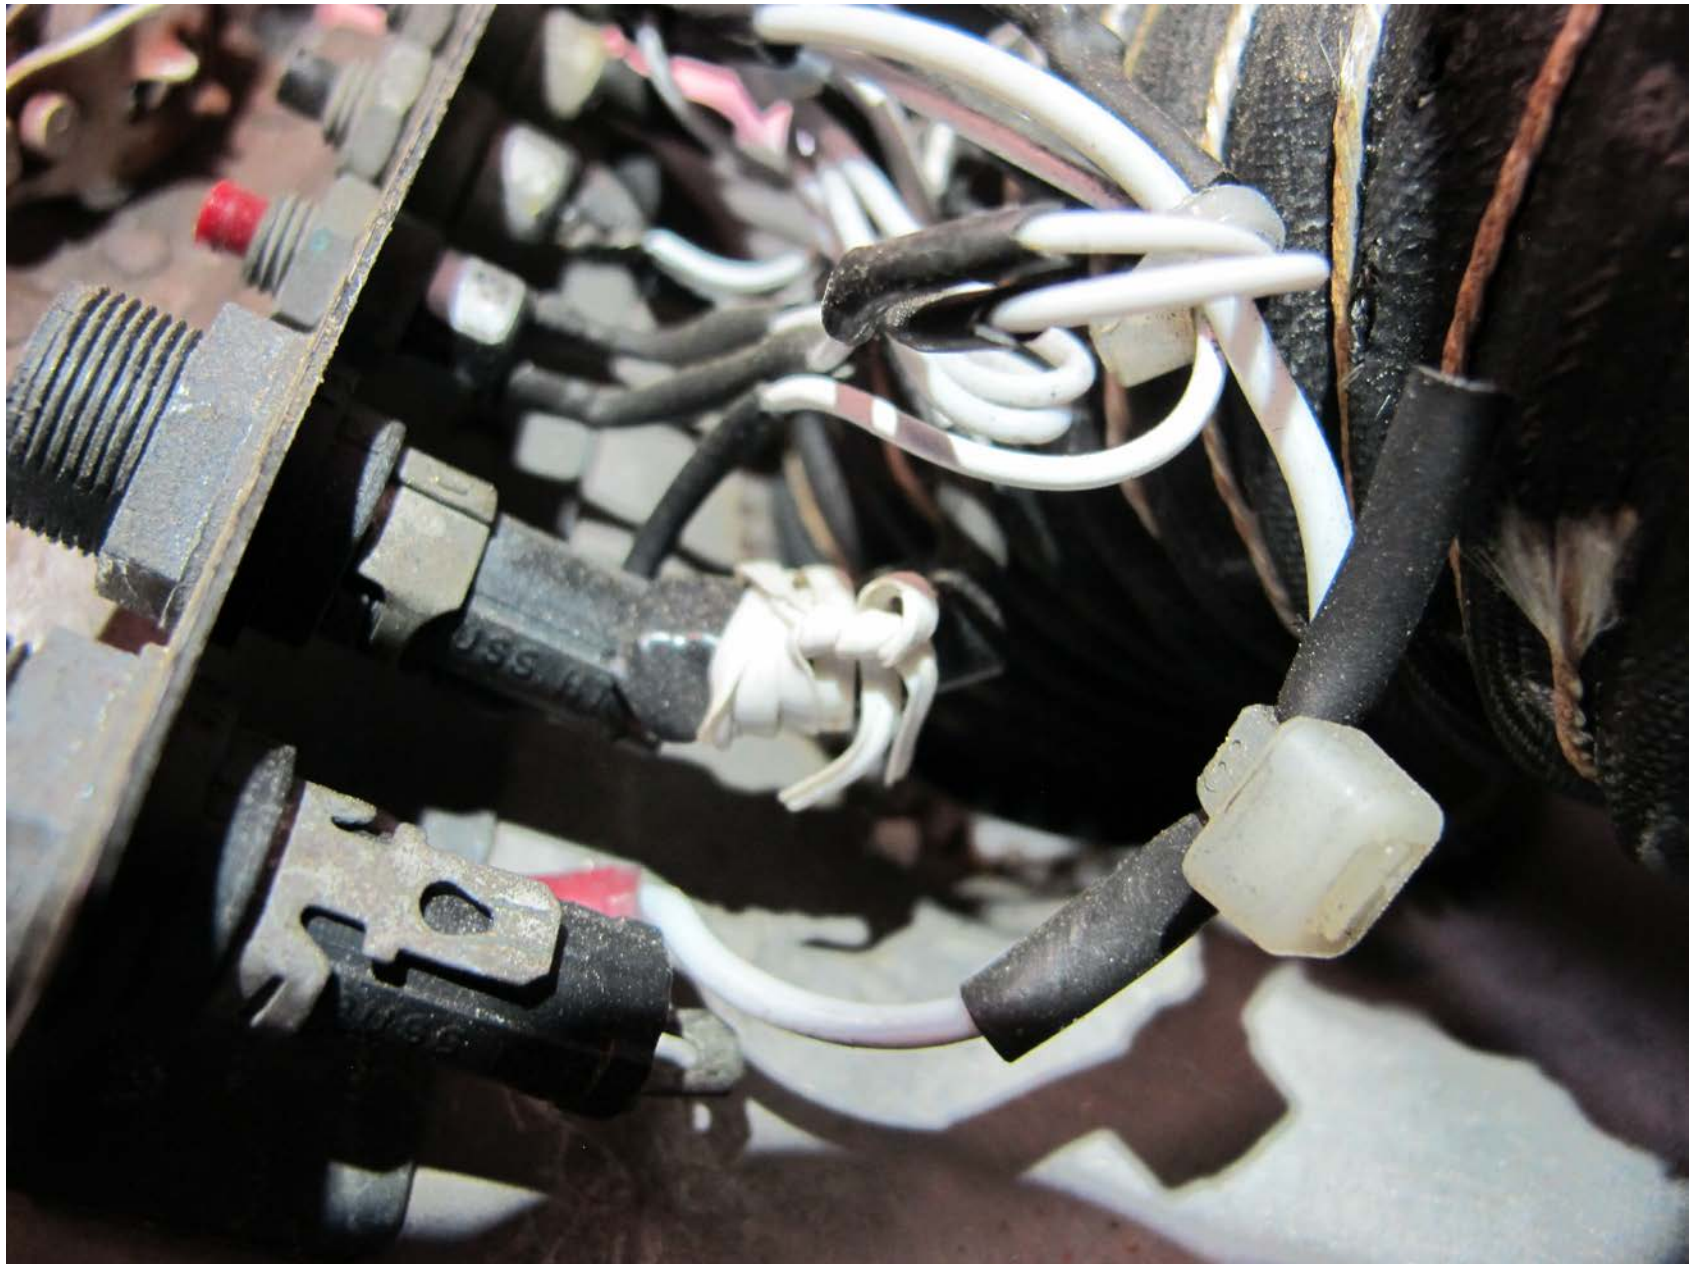
Photo 13 – View of wire tie and tape repair on actuator wires (RH Photo)

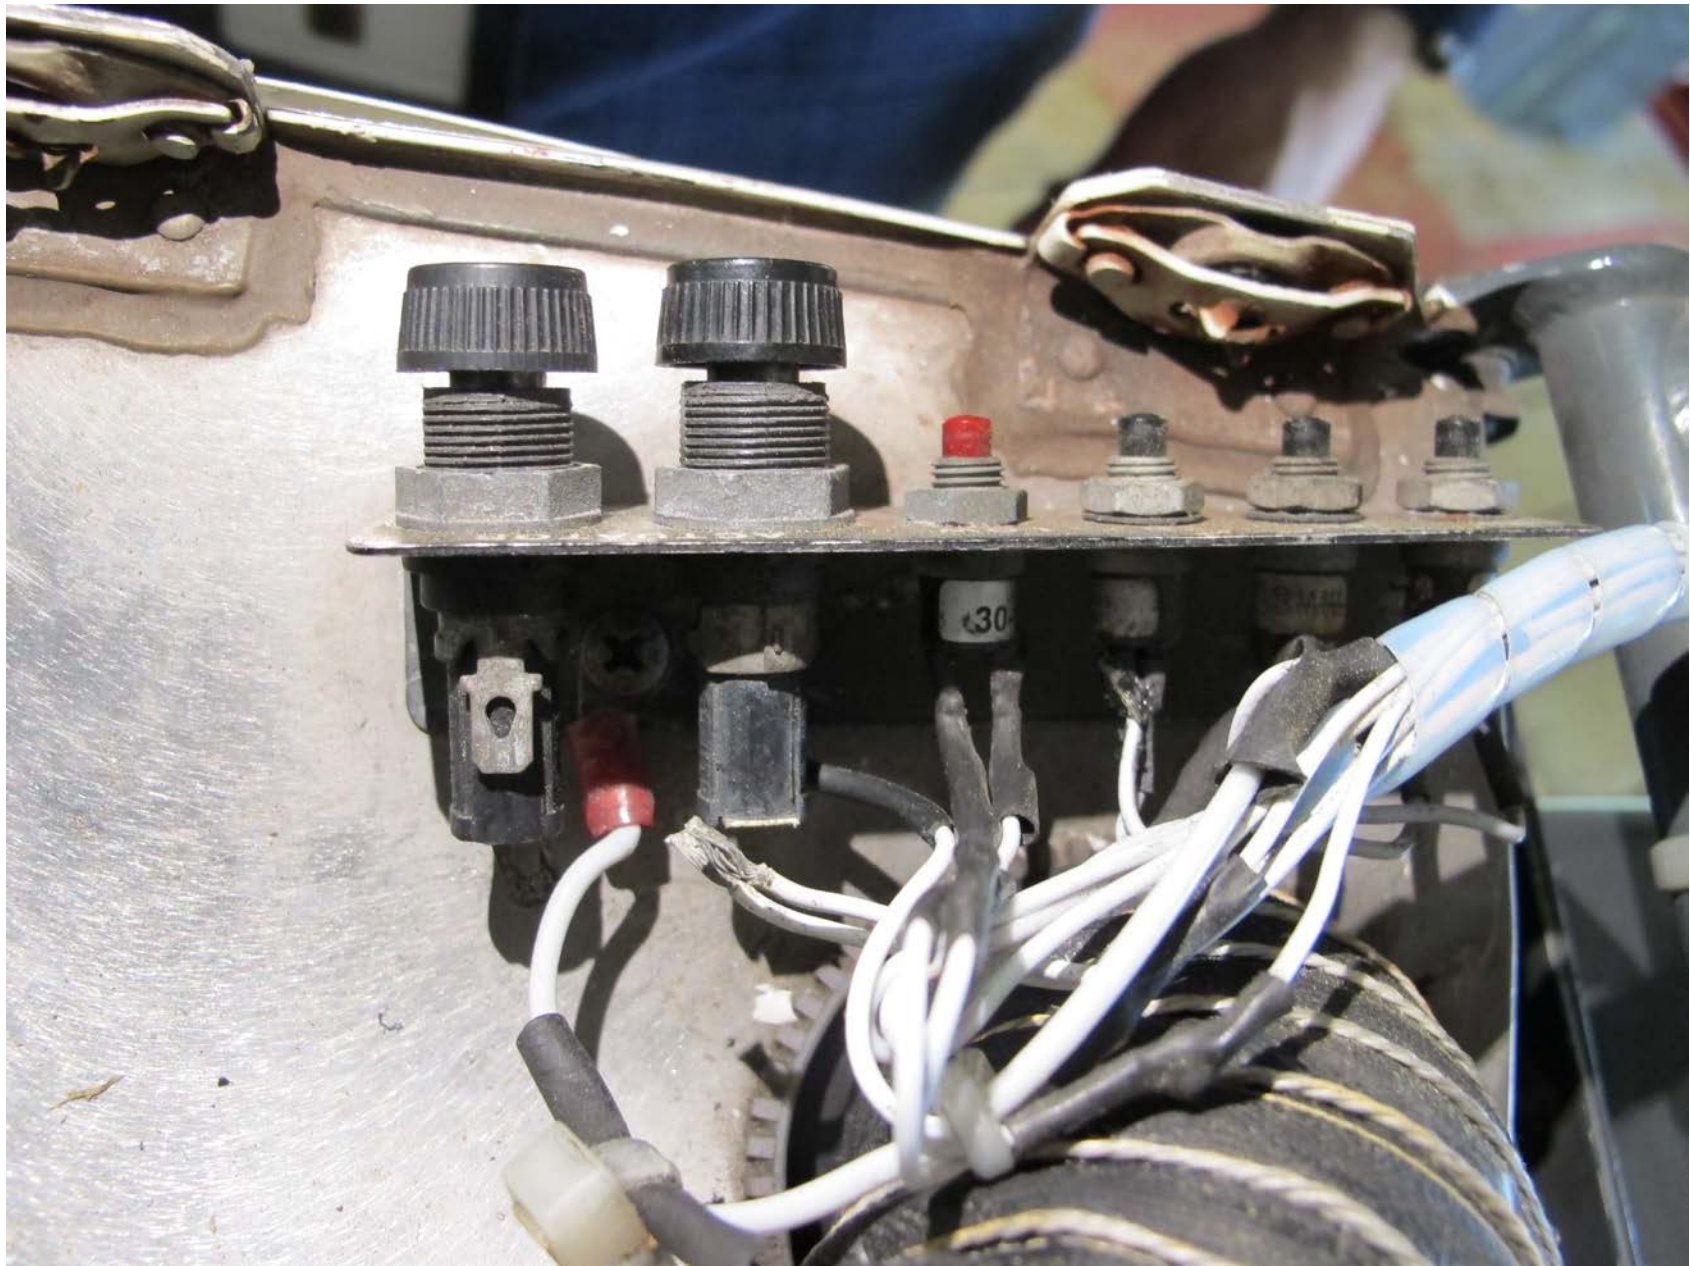
Photo 14 – View of terminal condition with wire tie and tape removed (RH Photo)

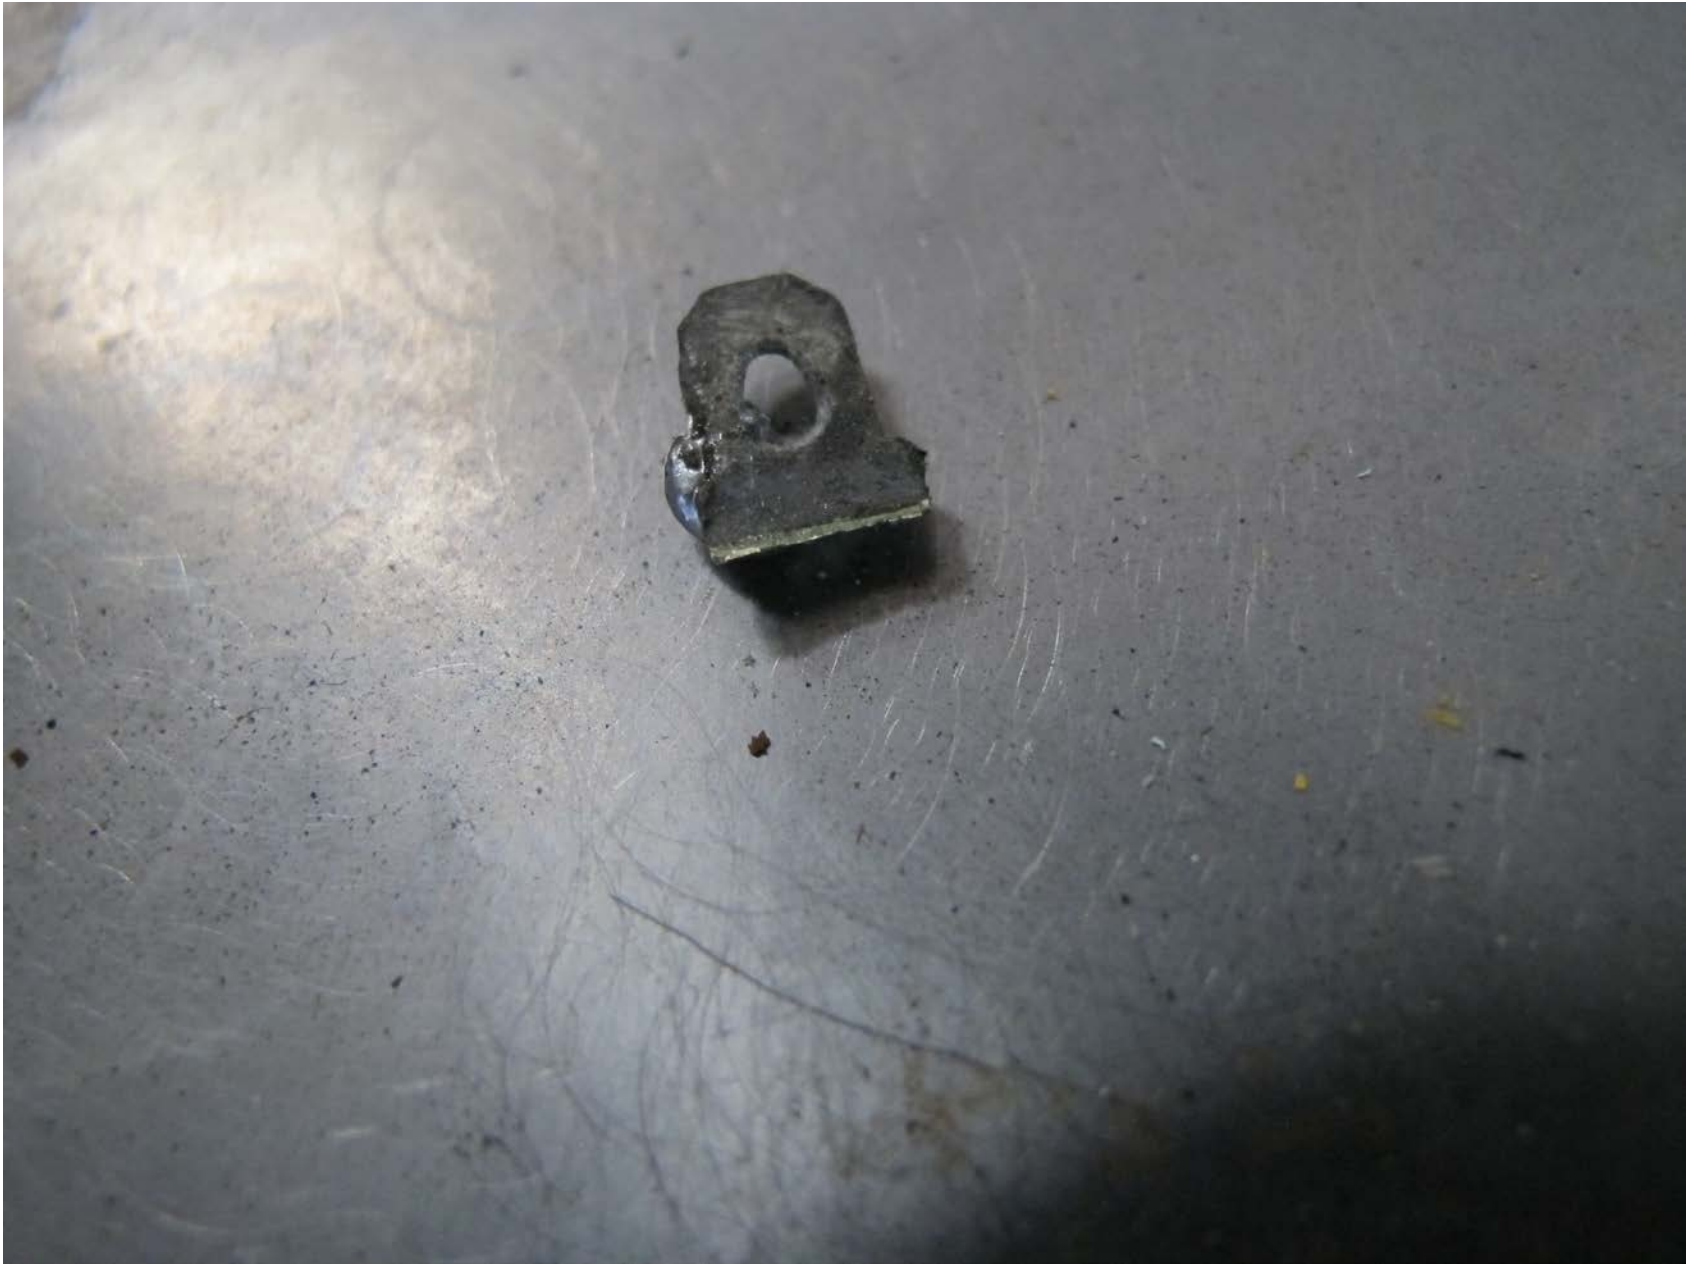
Photo 15 – Terminal of fuse holder (RH Photo)

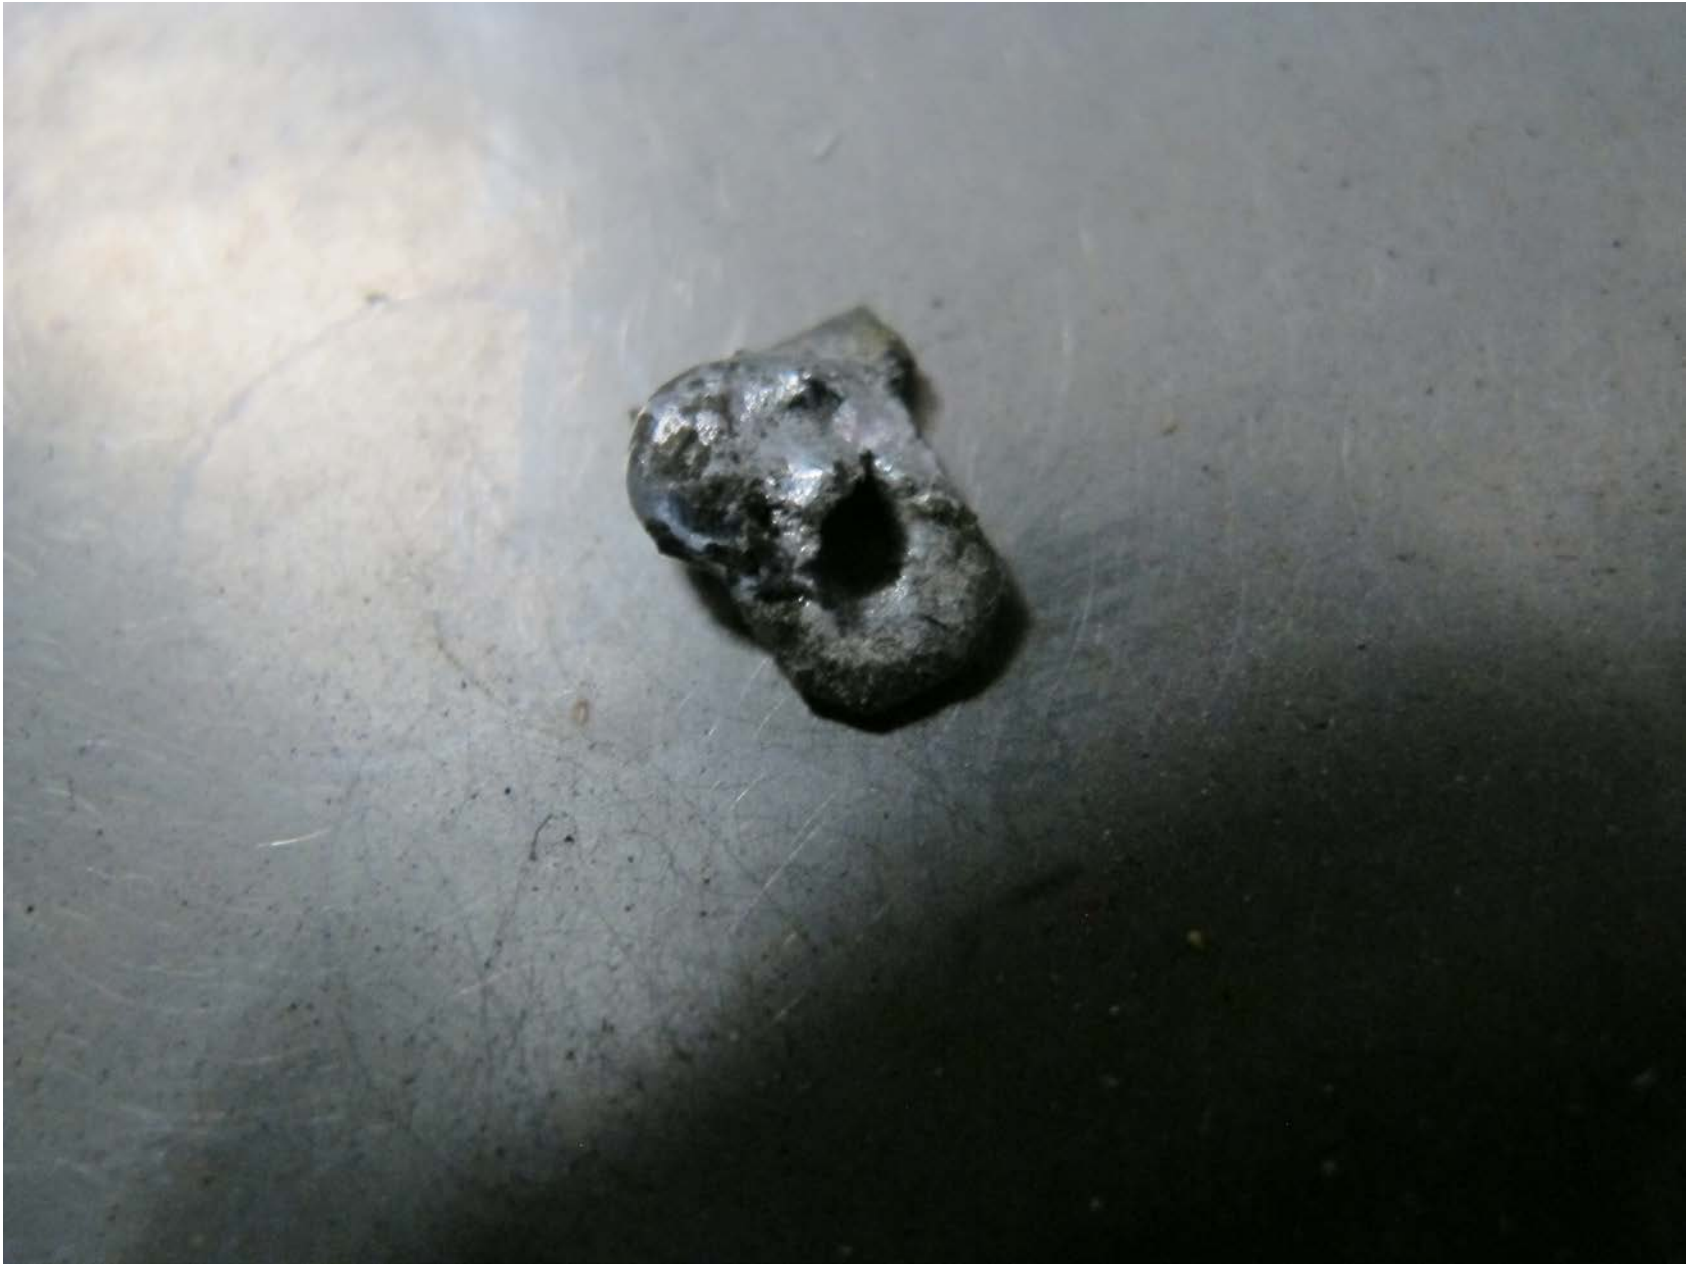
Photo 16 – View of the backside of the terminal fuse holder (RH Photo)

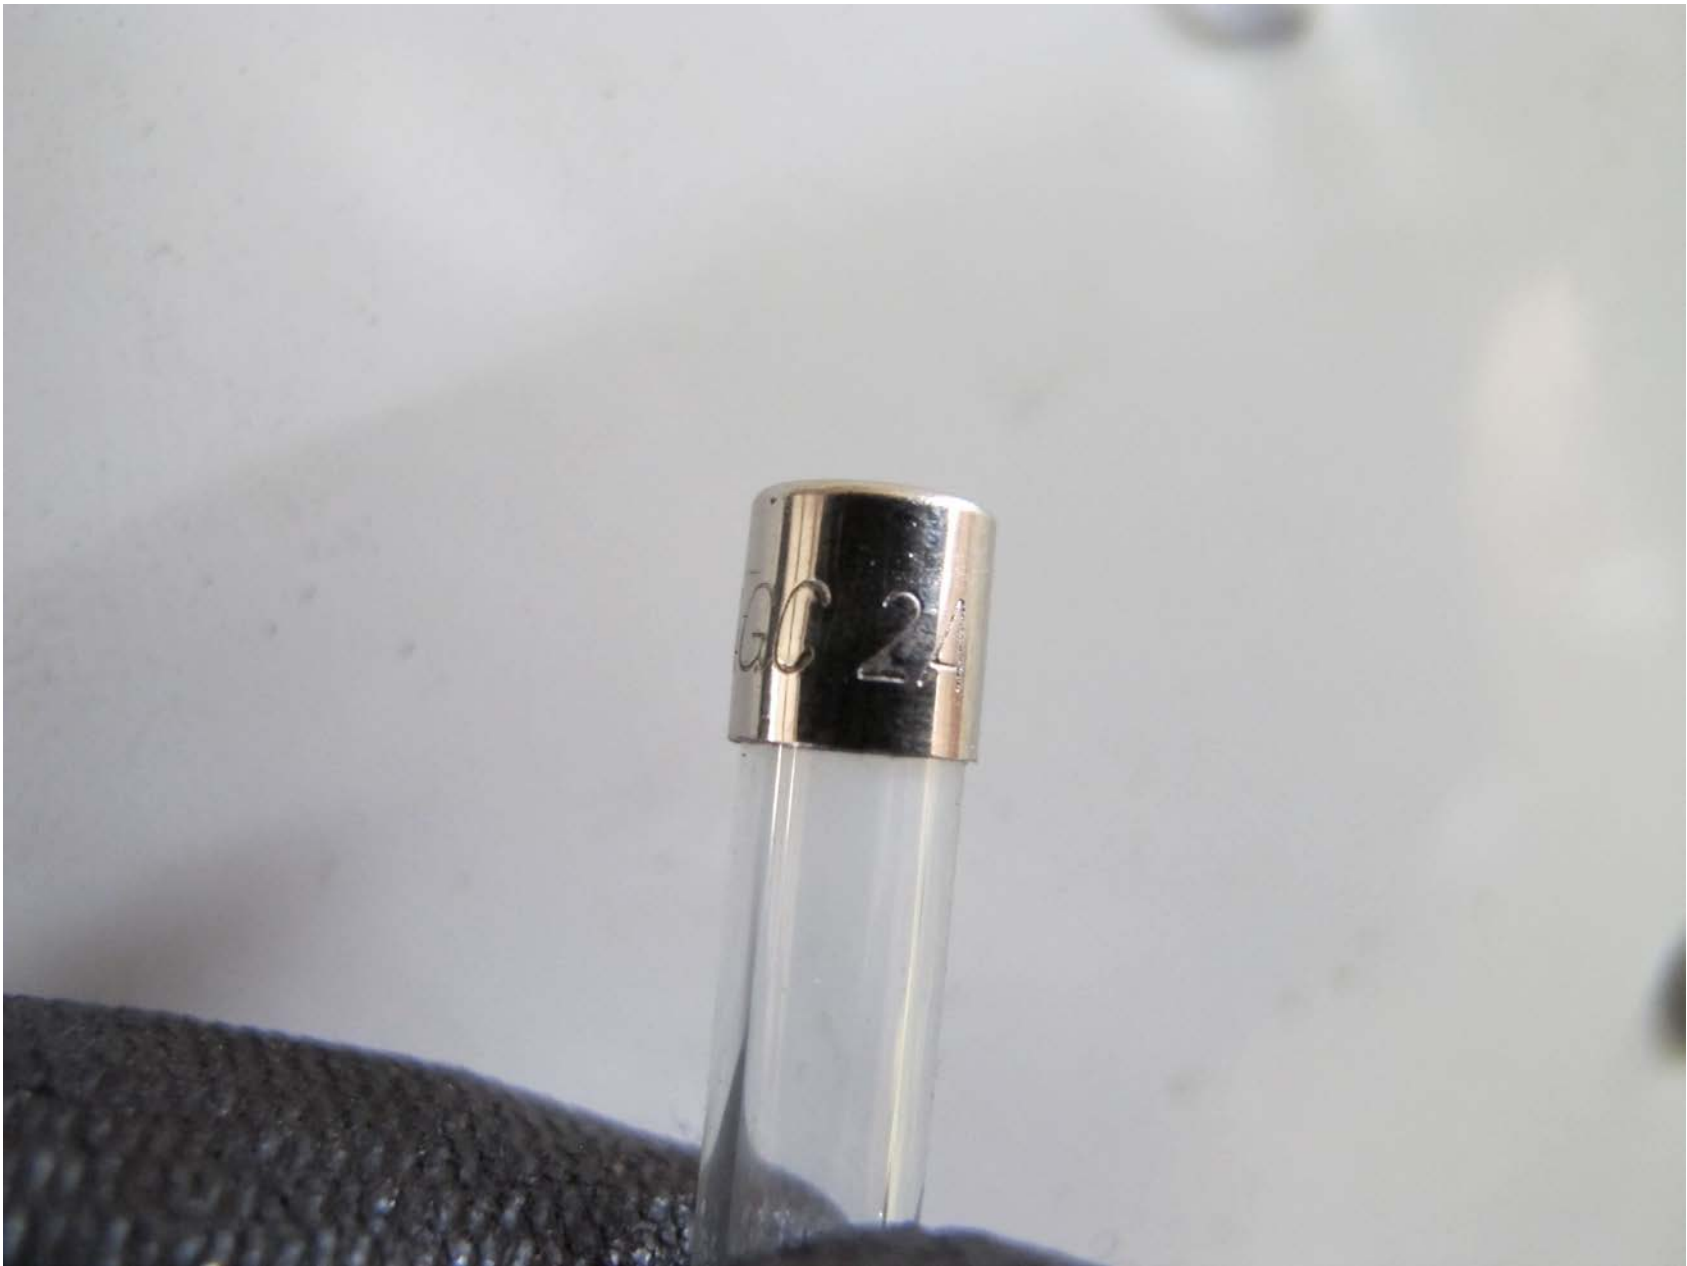
Photo 17 – View of the 2-Amp fuse removed from the fuse holder (Blown) (H Photo)

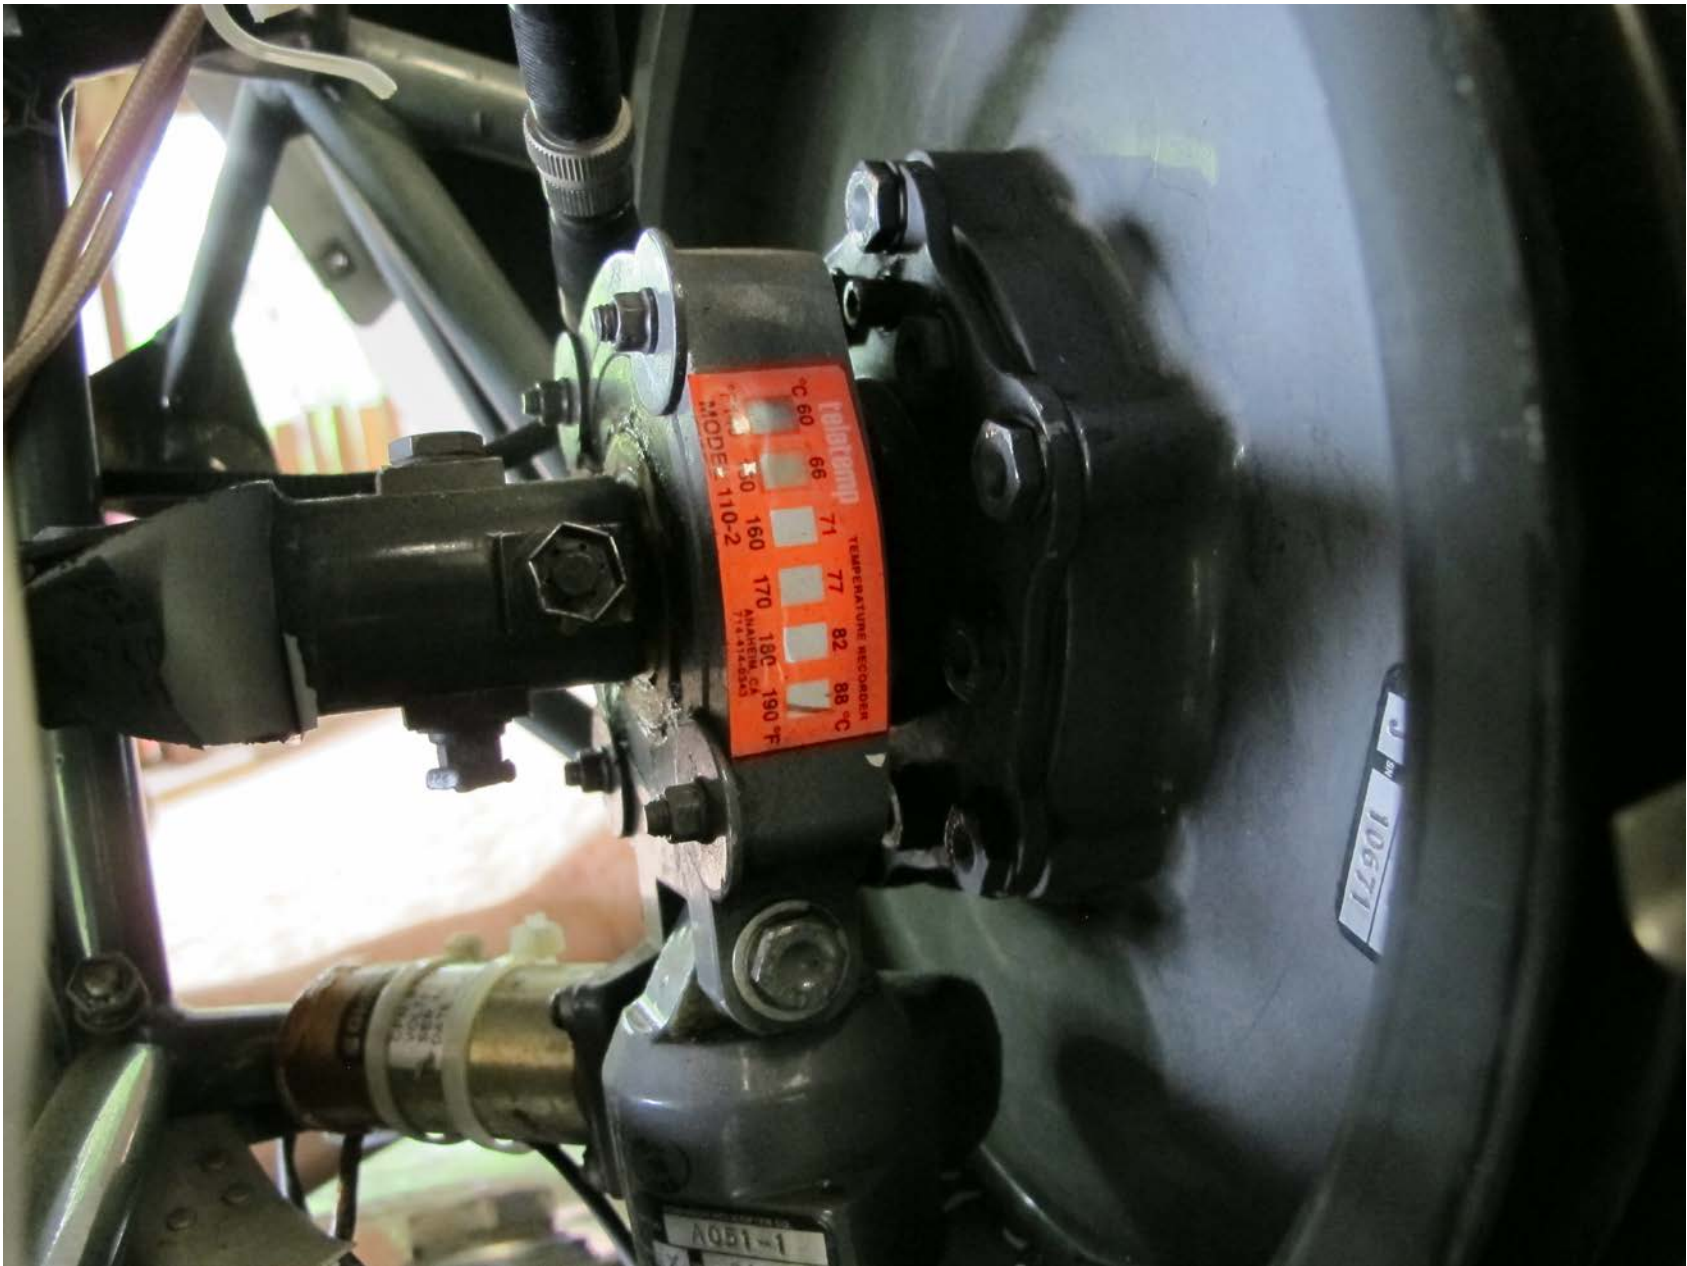
Photo 18 – View of upper actuator support bearing (RH Photo)
