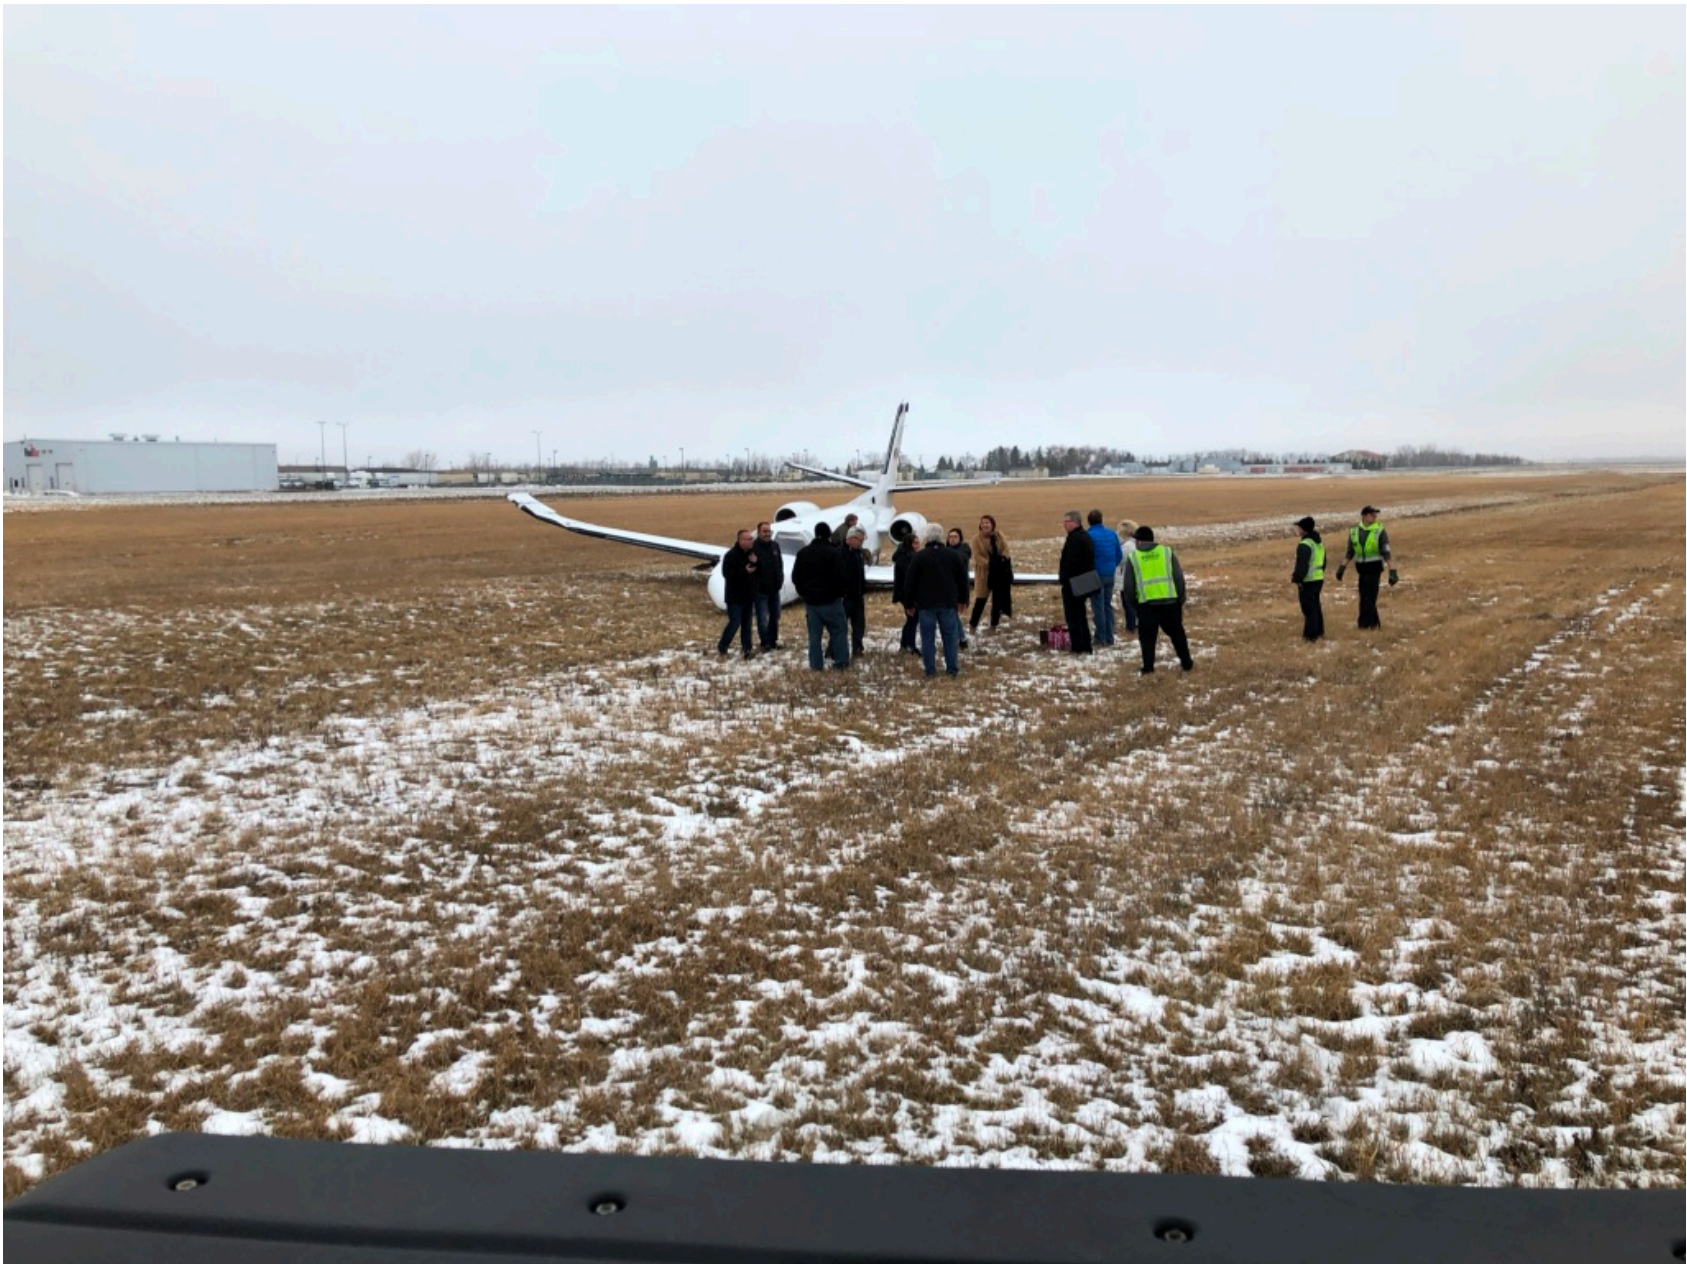
Photo 1 – View of passengers and first responders near the accident airplane (Jet Center photo)

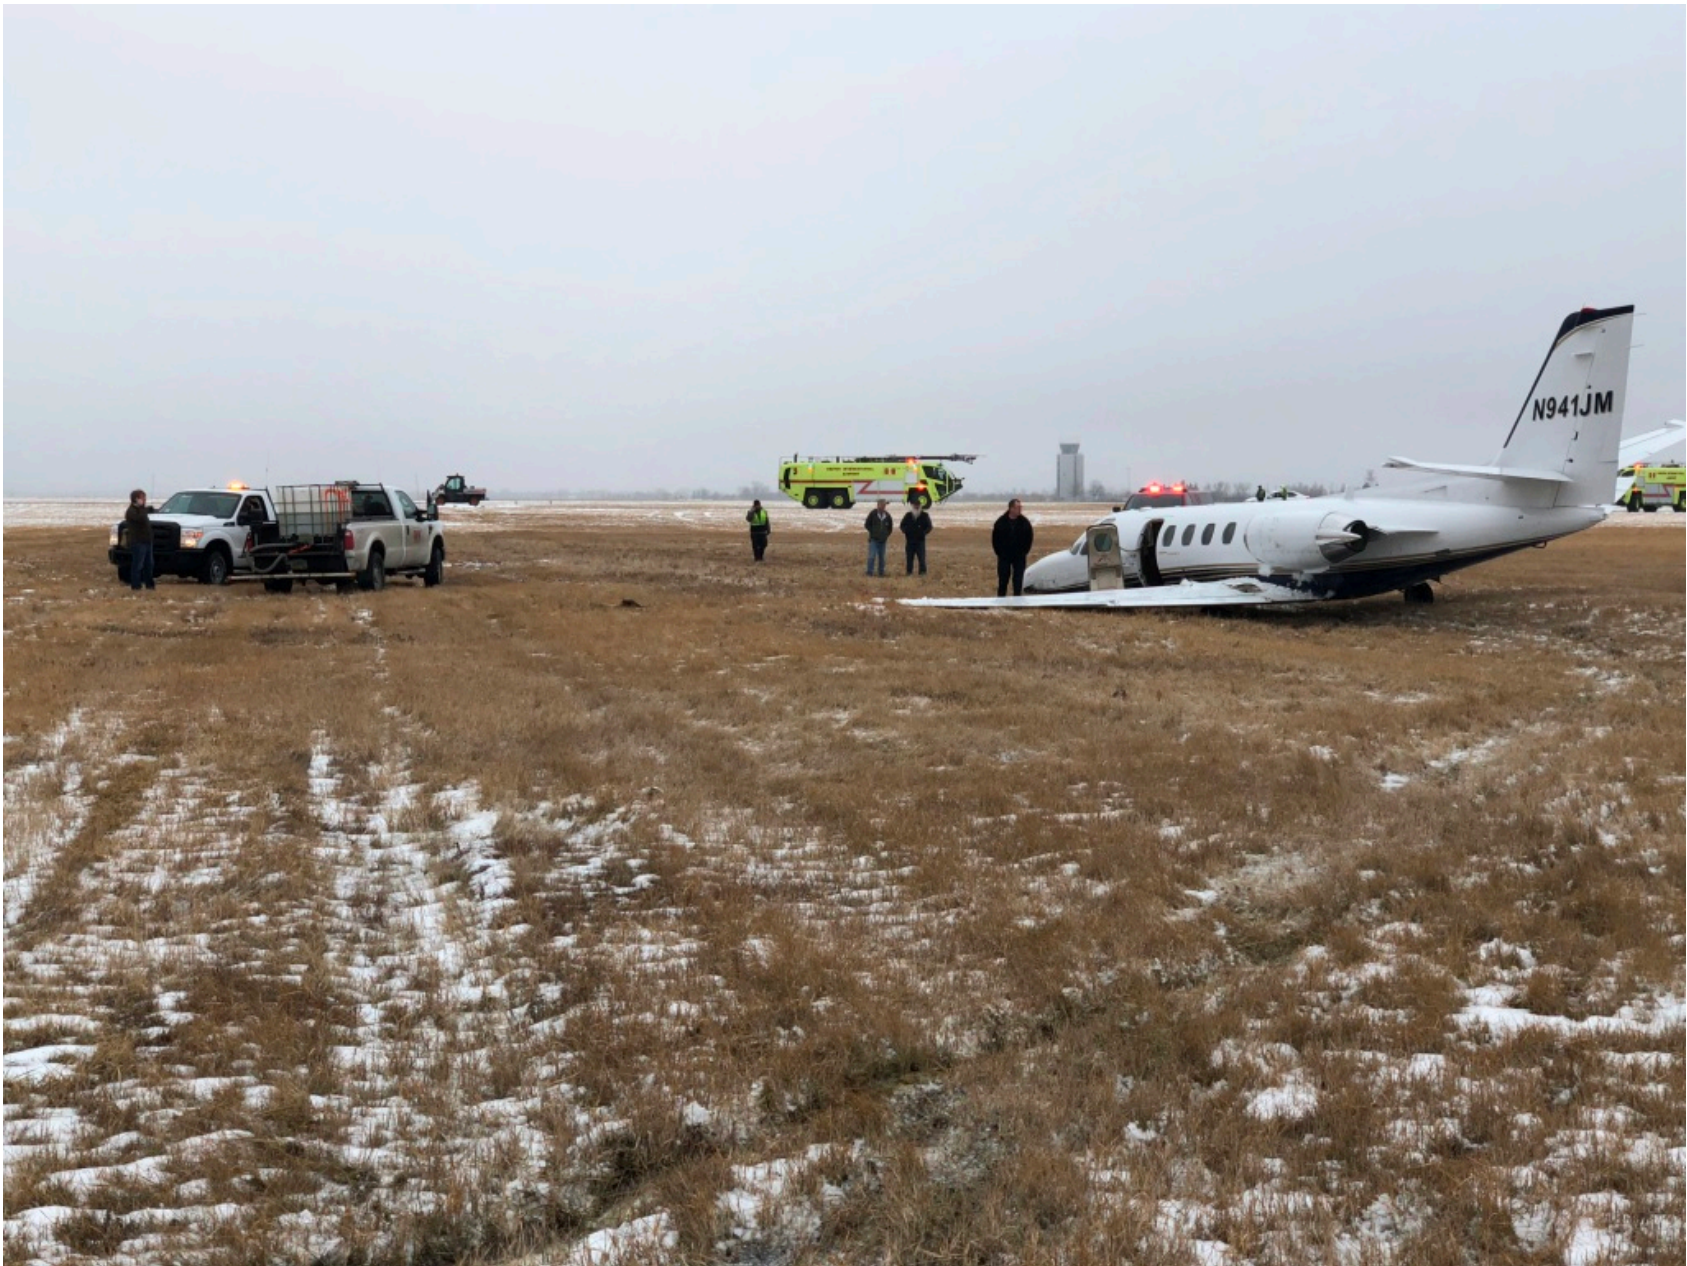
Photo 2 – View of emergency personnel and first responders at accident site (Jet Center photo)

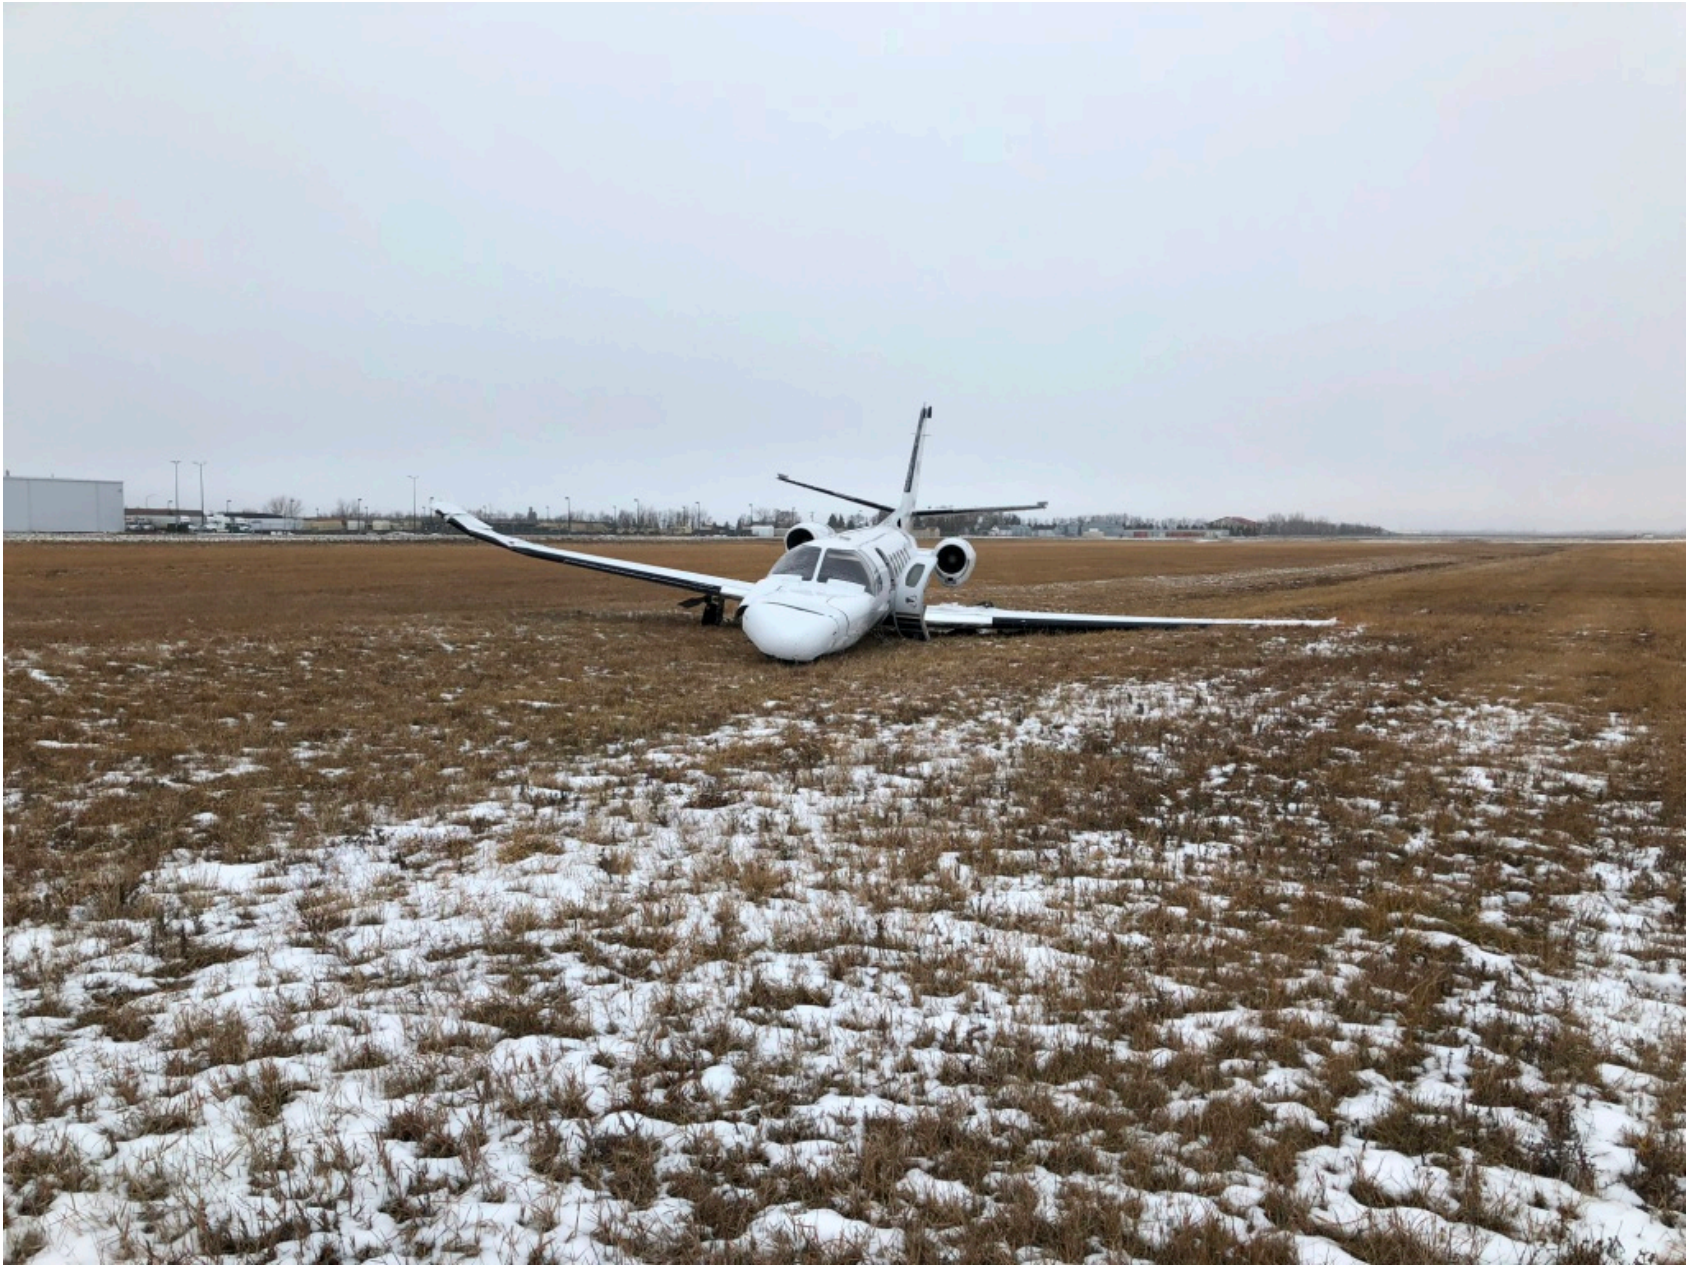
Photo 3 – View of the accident site from the front of the airplane (Jet Center photo)

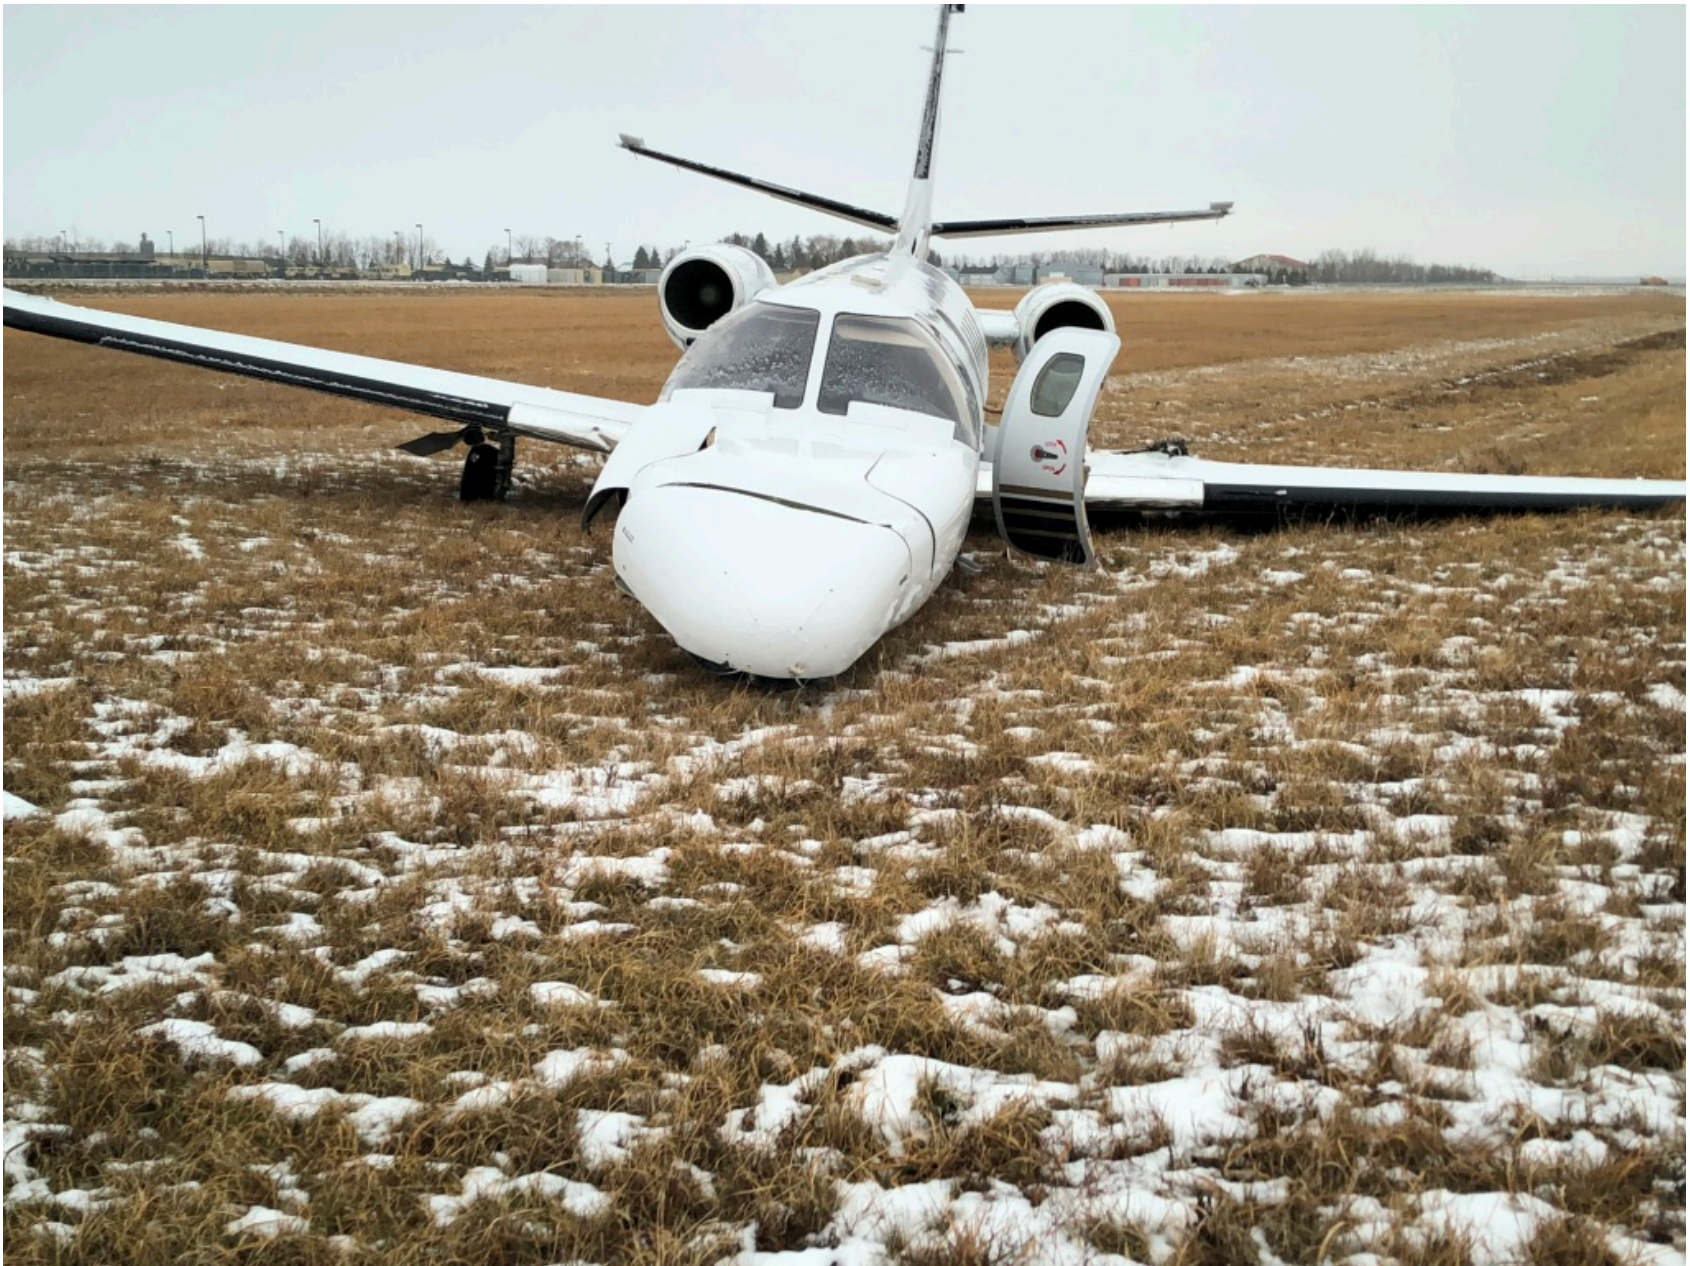
Photo 4 – View of the front of the airplane (Jet Center photo)

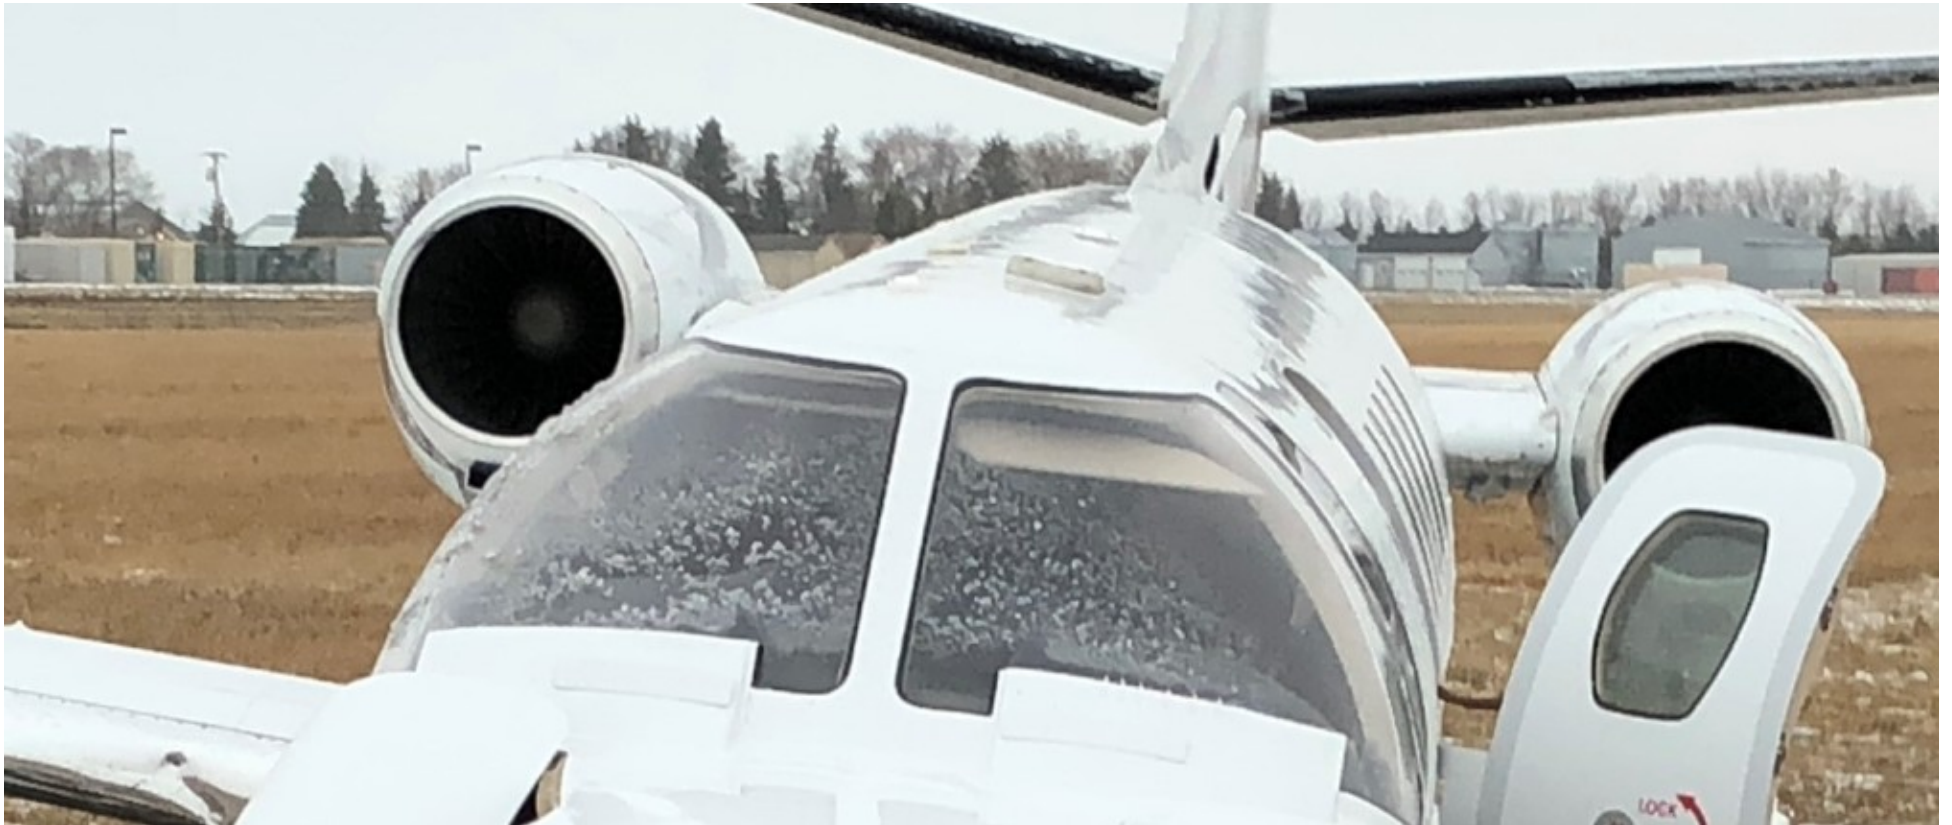
Photo 5 – View of the ice build-up on the airplane’s windshield (Jet Center photo)

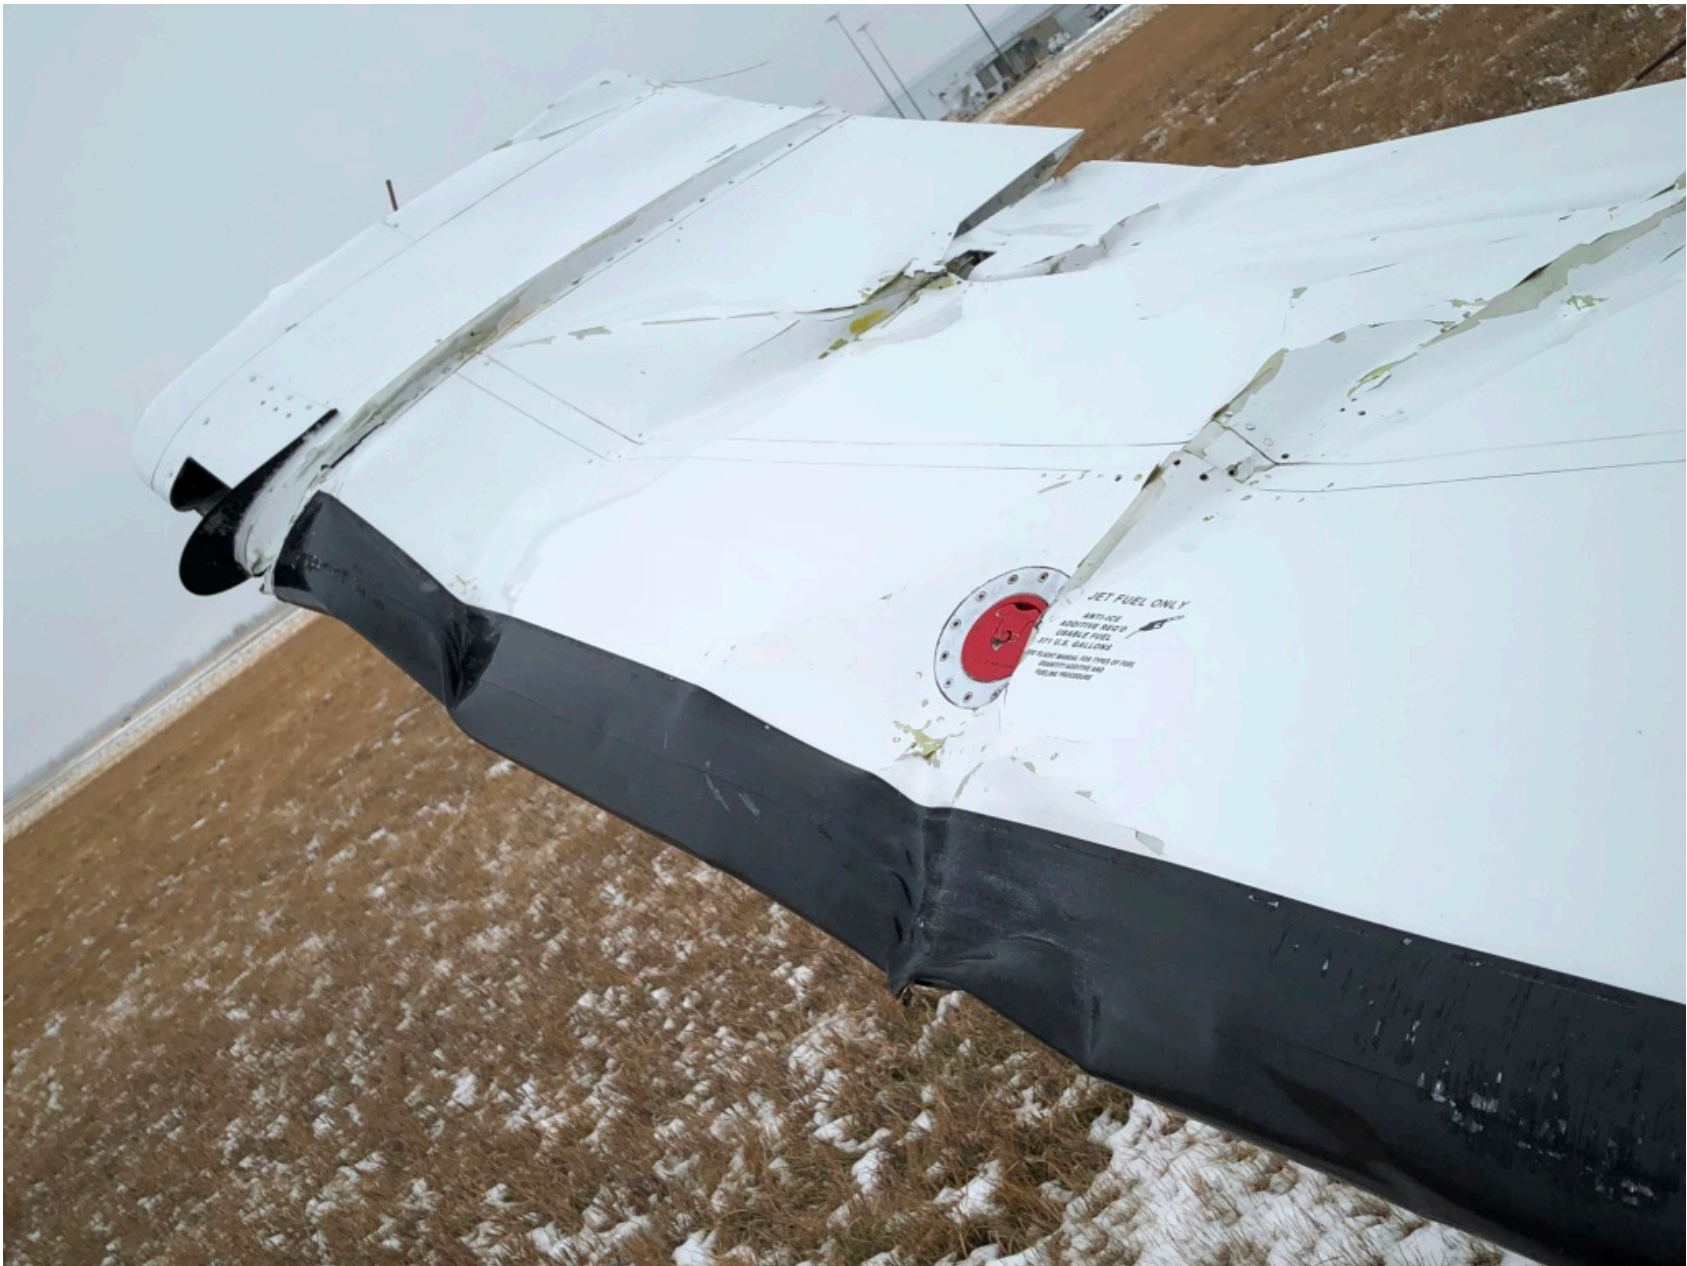
Photo 7 - View of the damage to the right wing (Jet Center photo)

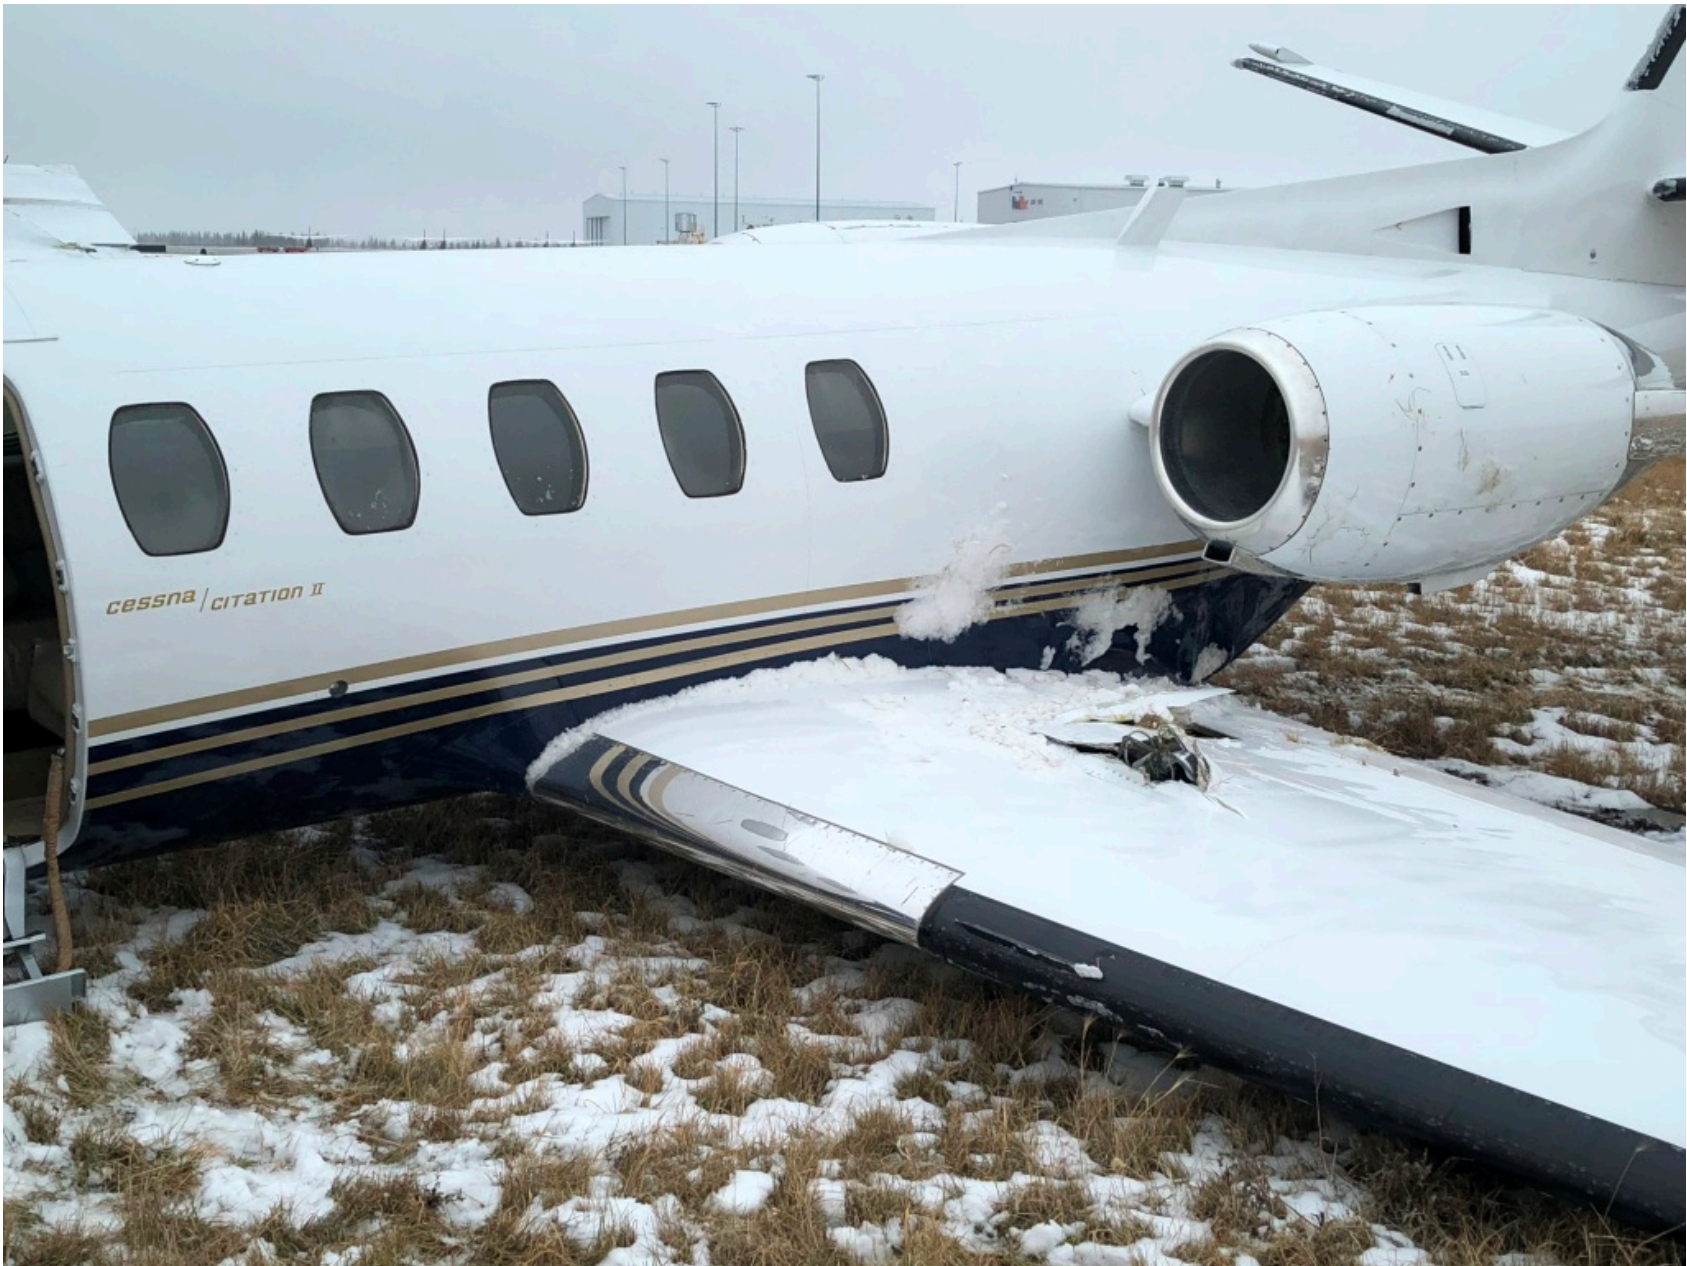
Photo 8 - View of the damage to the left wing (Jet Center photo)

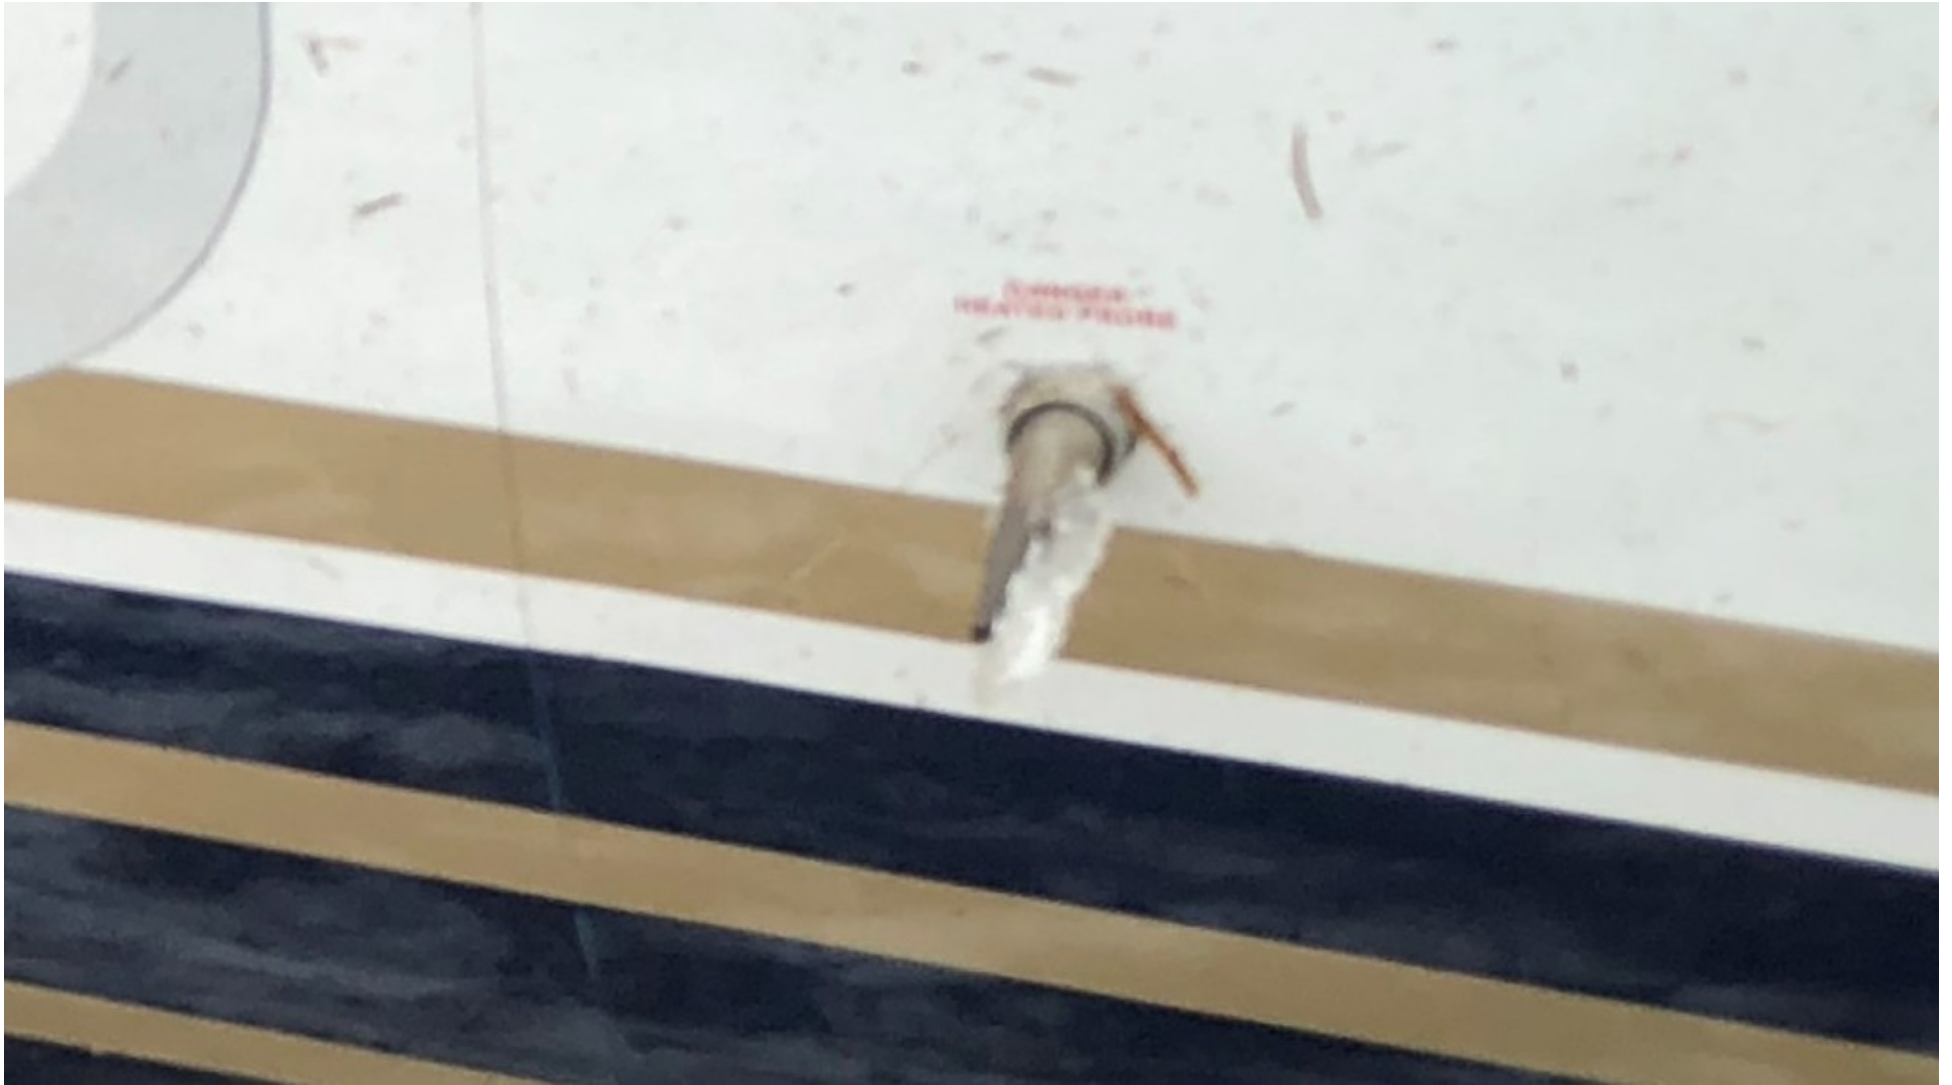
Photo 9 – View of ice build-up on the AOA probe (Jet Center photo)

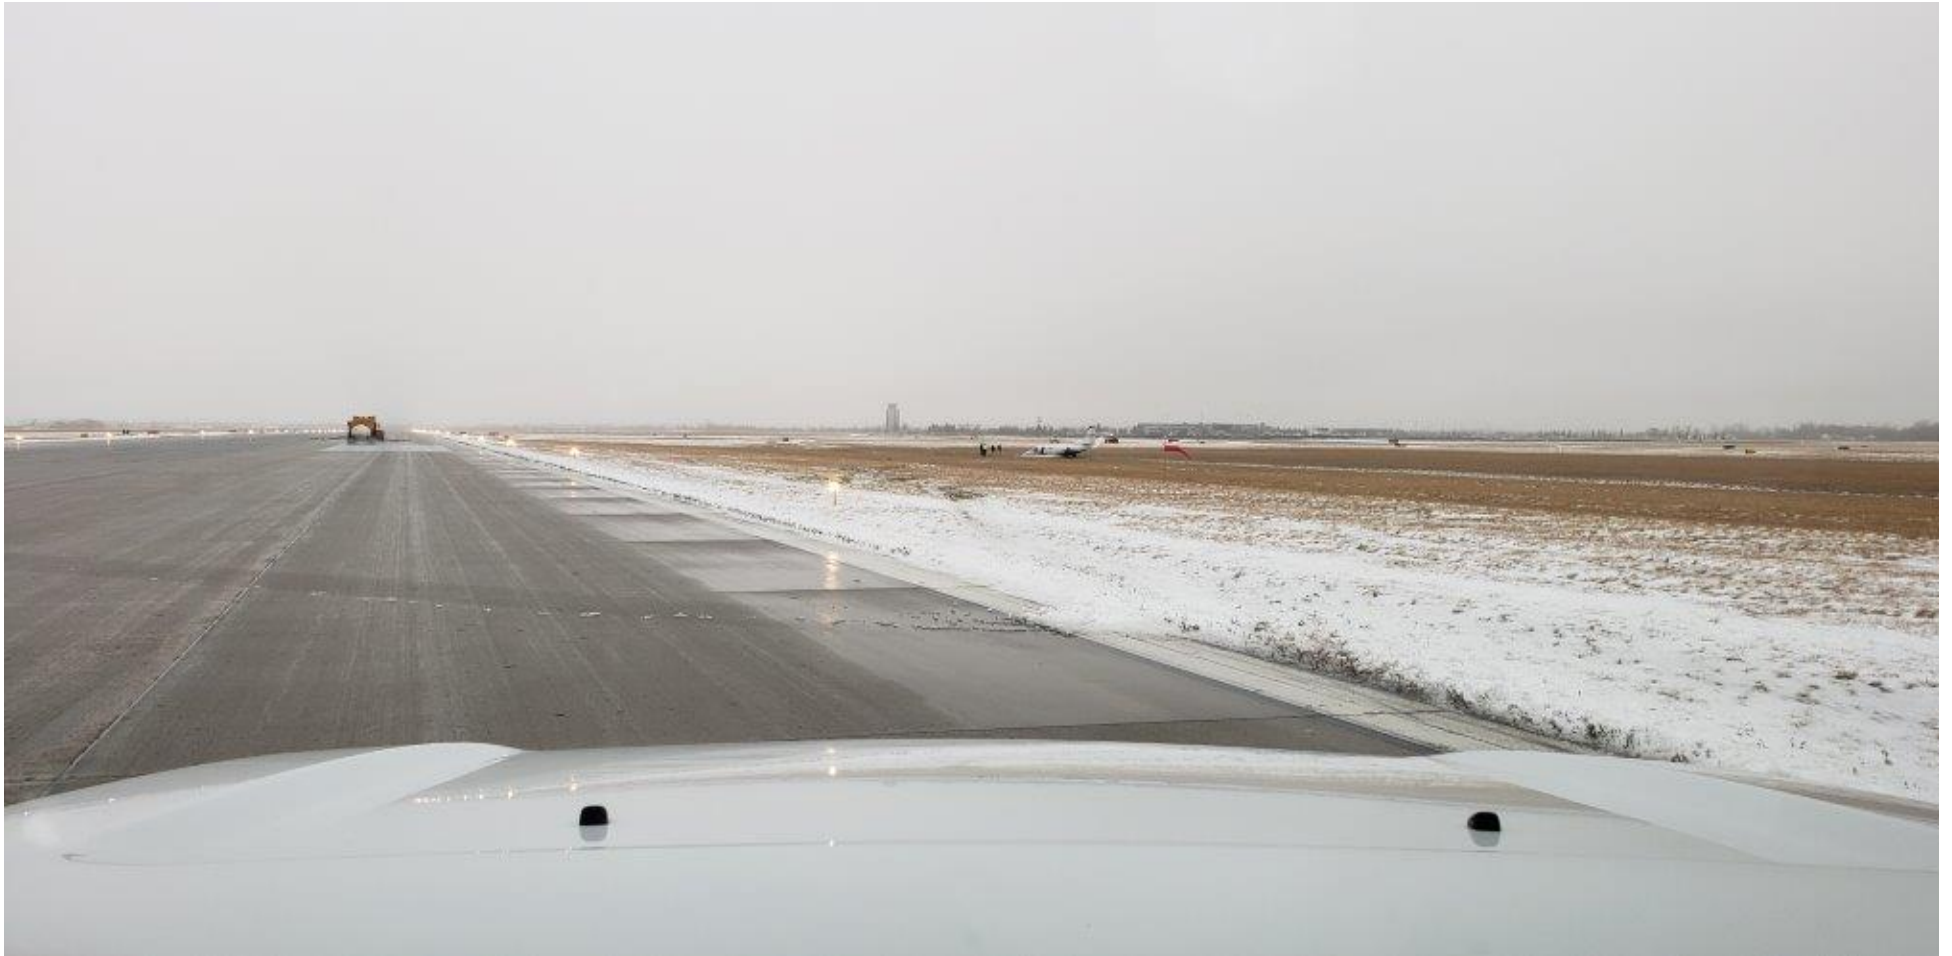
Photo 10 – View of runway and the airplane in the grass infield (FAA photo)

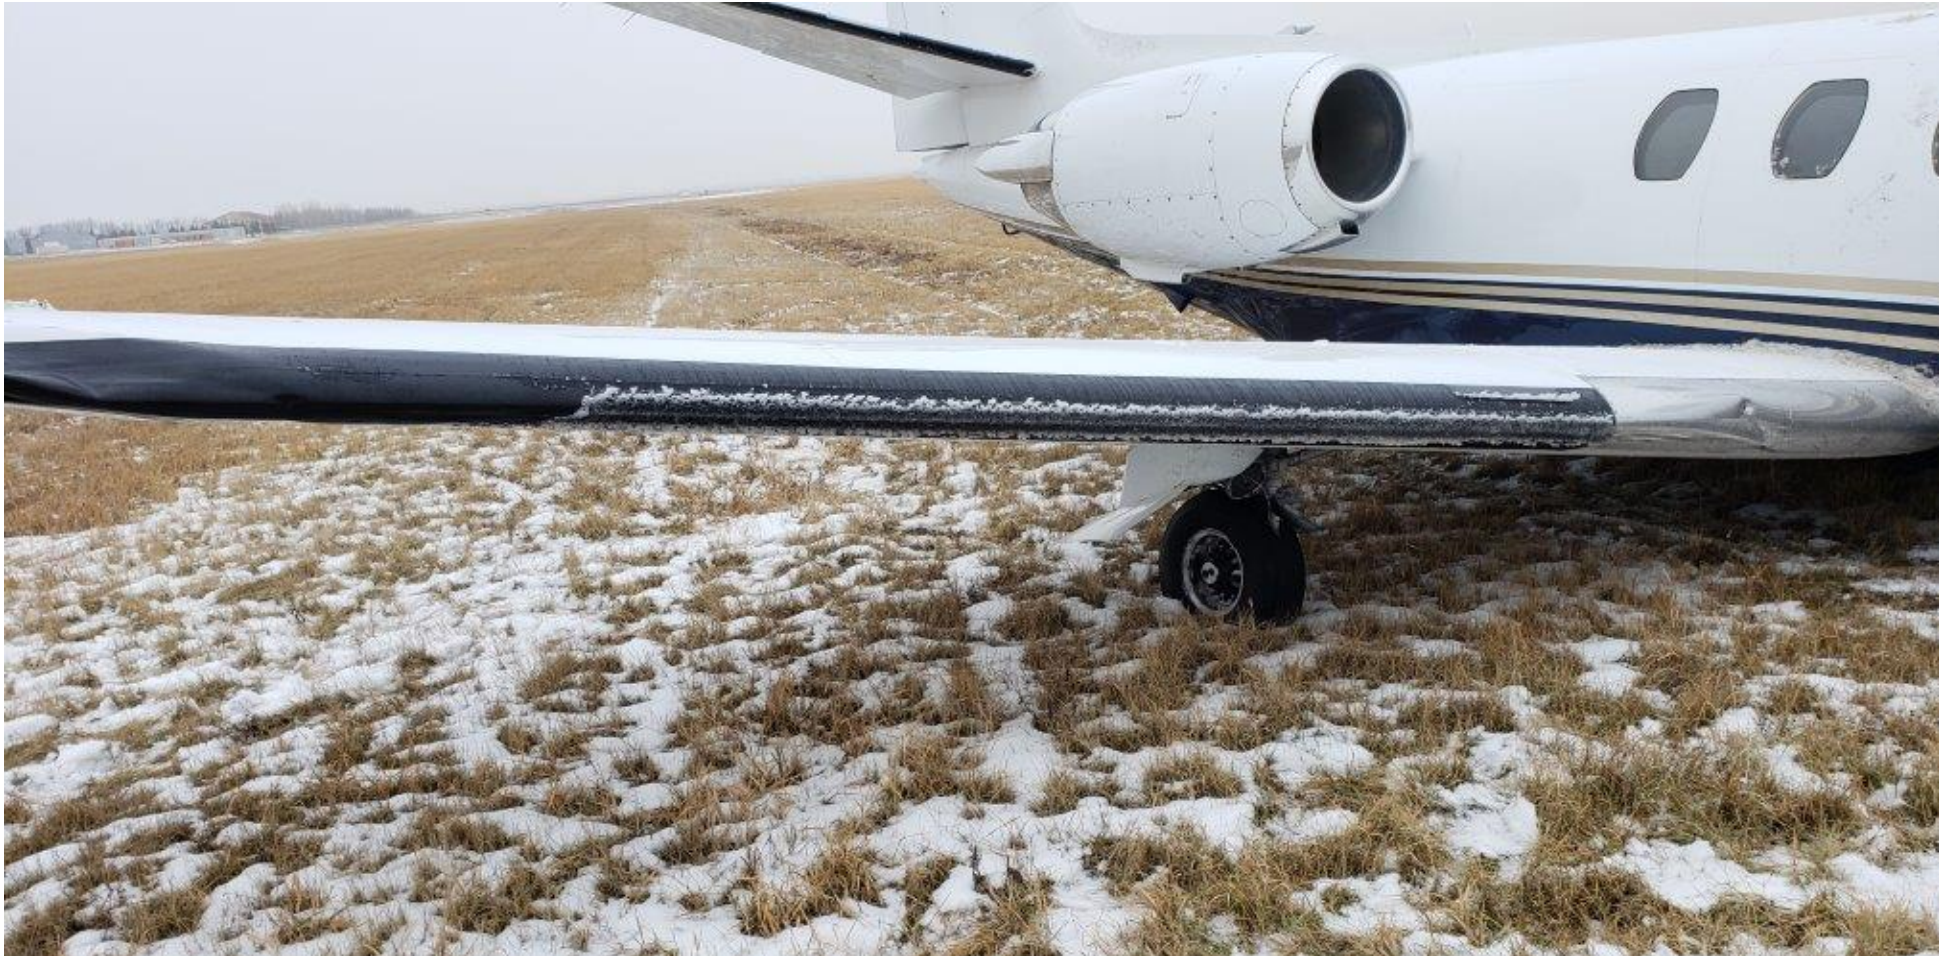
Photo 11 – View of the ice build-up on the leading edge of the right wing (FAA photo)

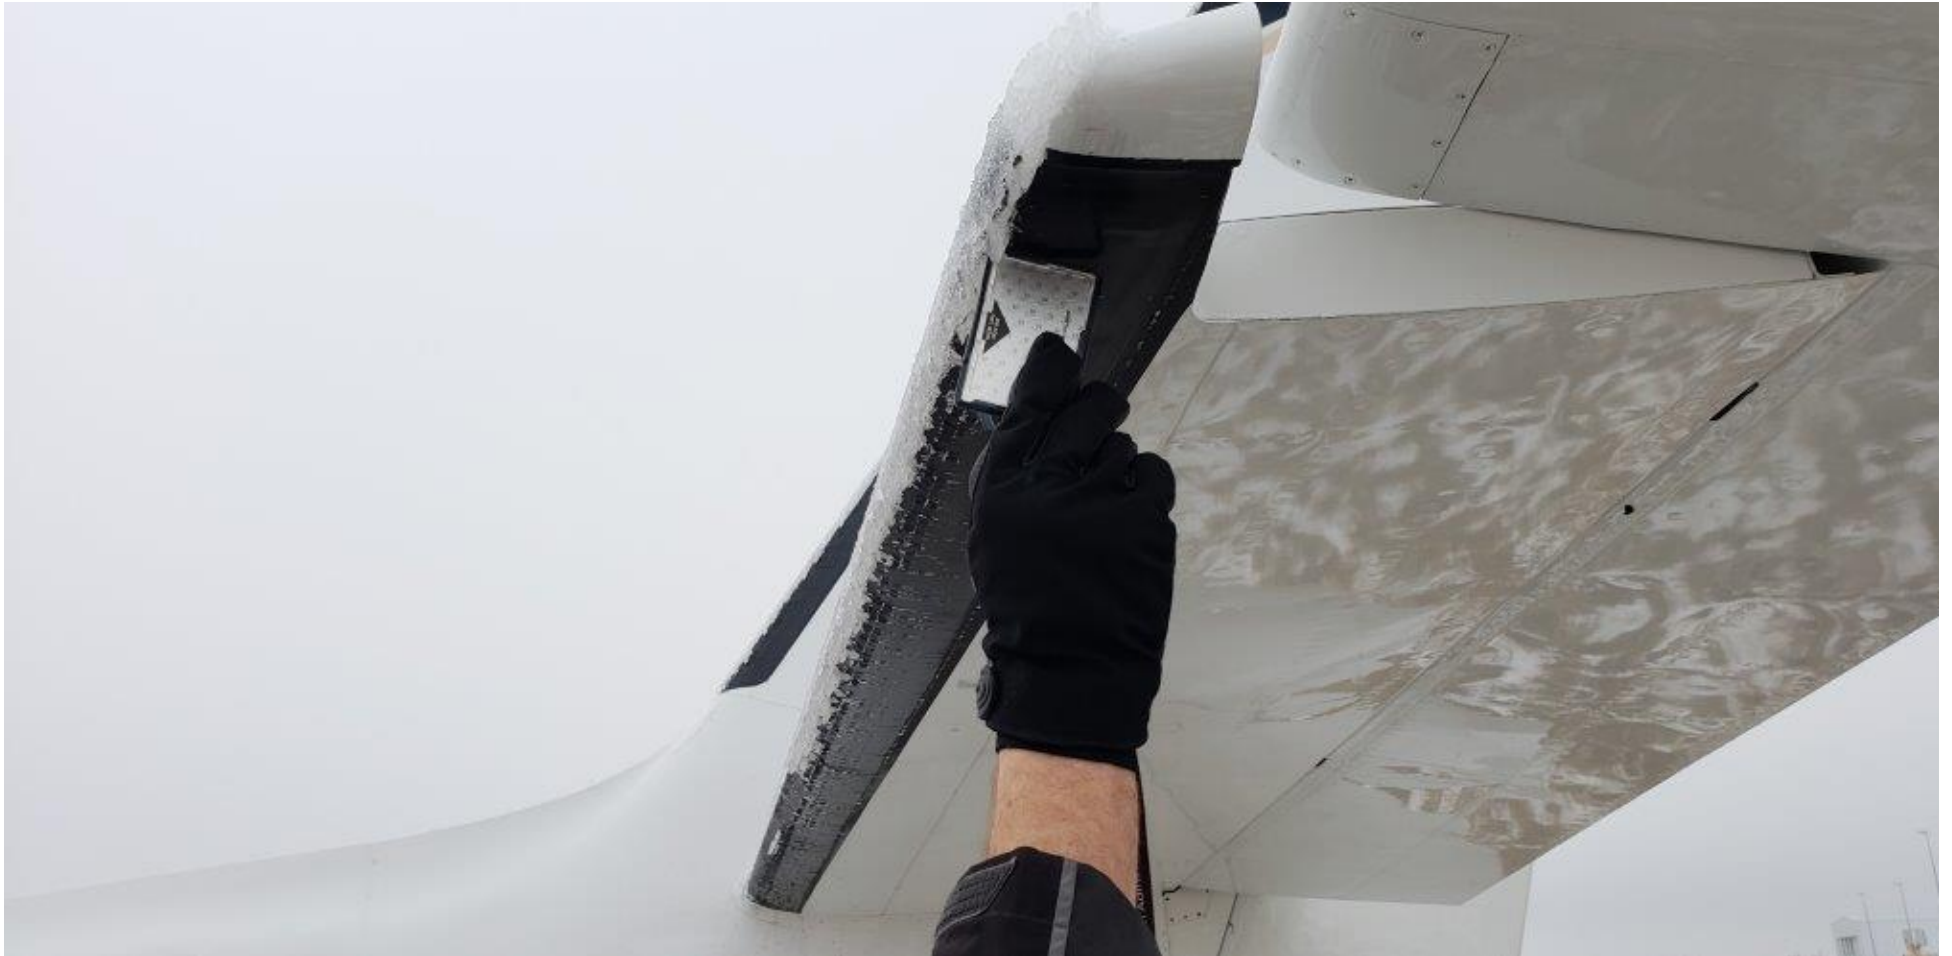
Photo 12 – View of ice build-up on left horizontal stabilizer (FAA photo)
