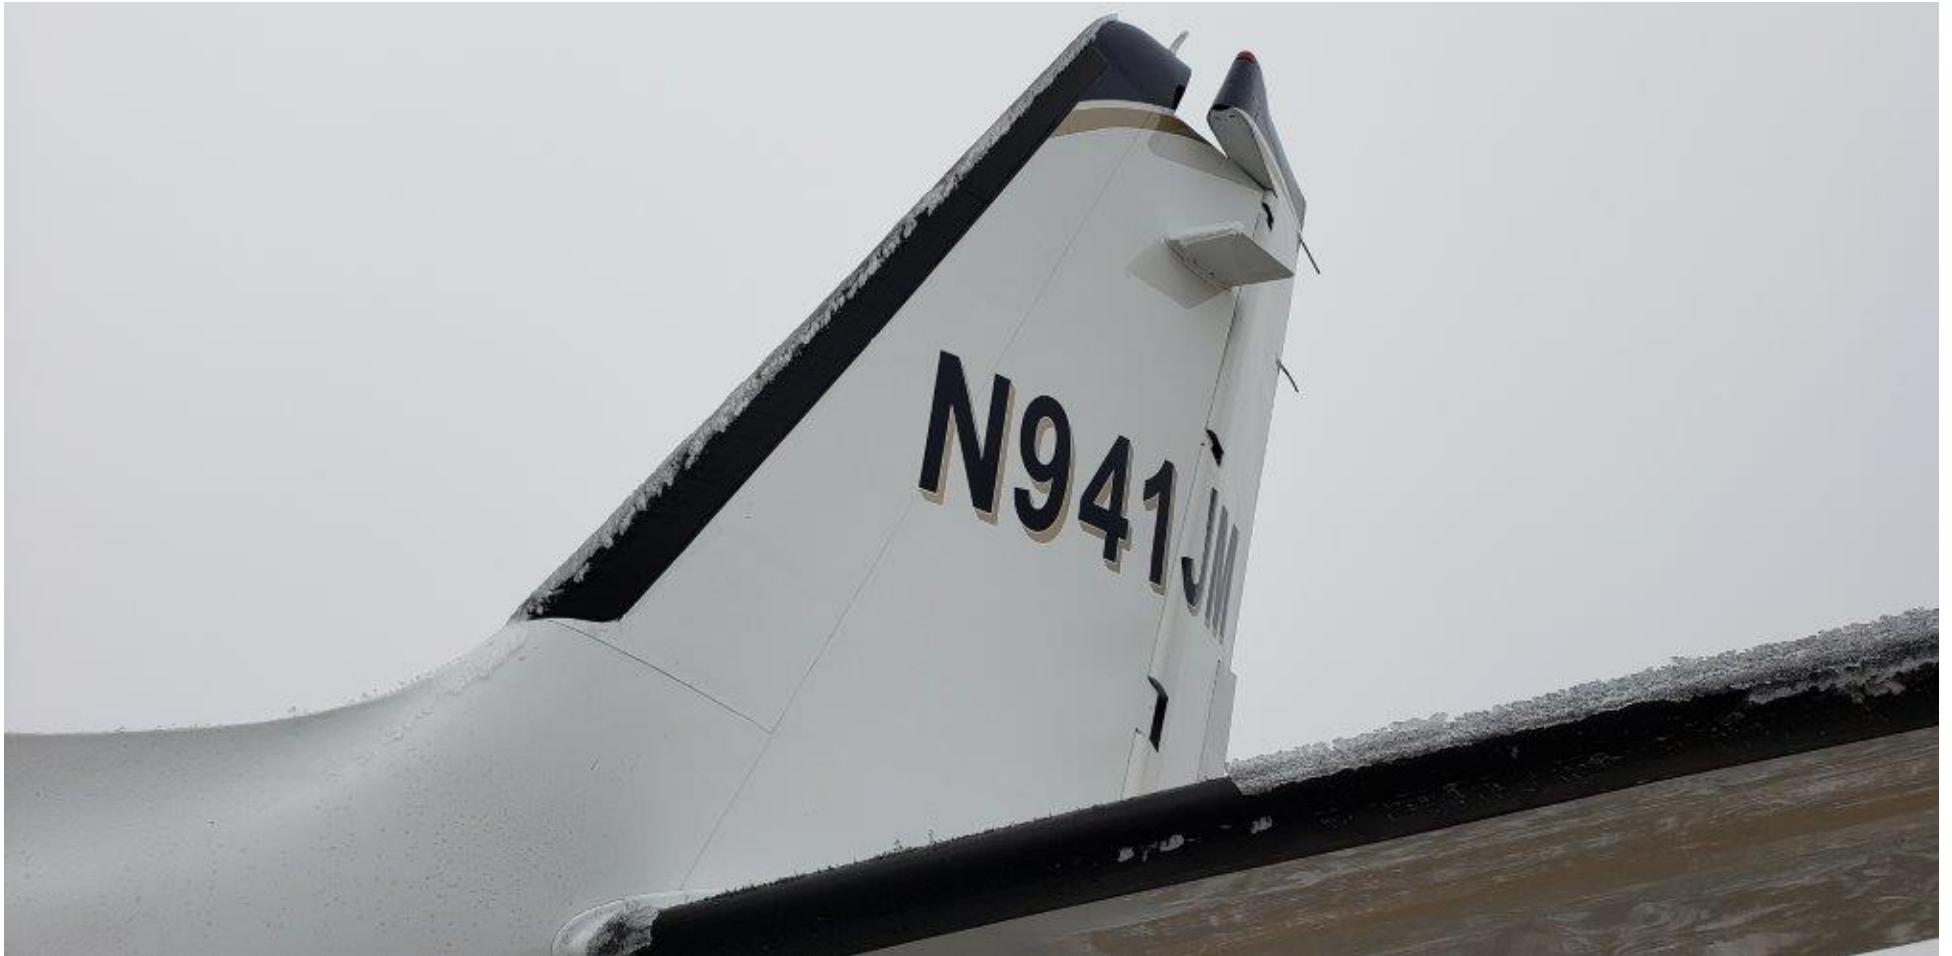
Photo 13 – View of ice build-up of left horizontal and vertical stabilizer (FAA photo)

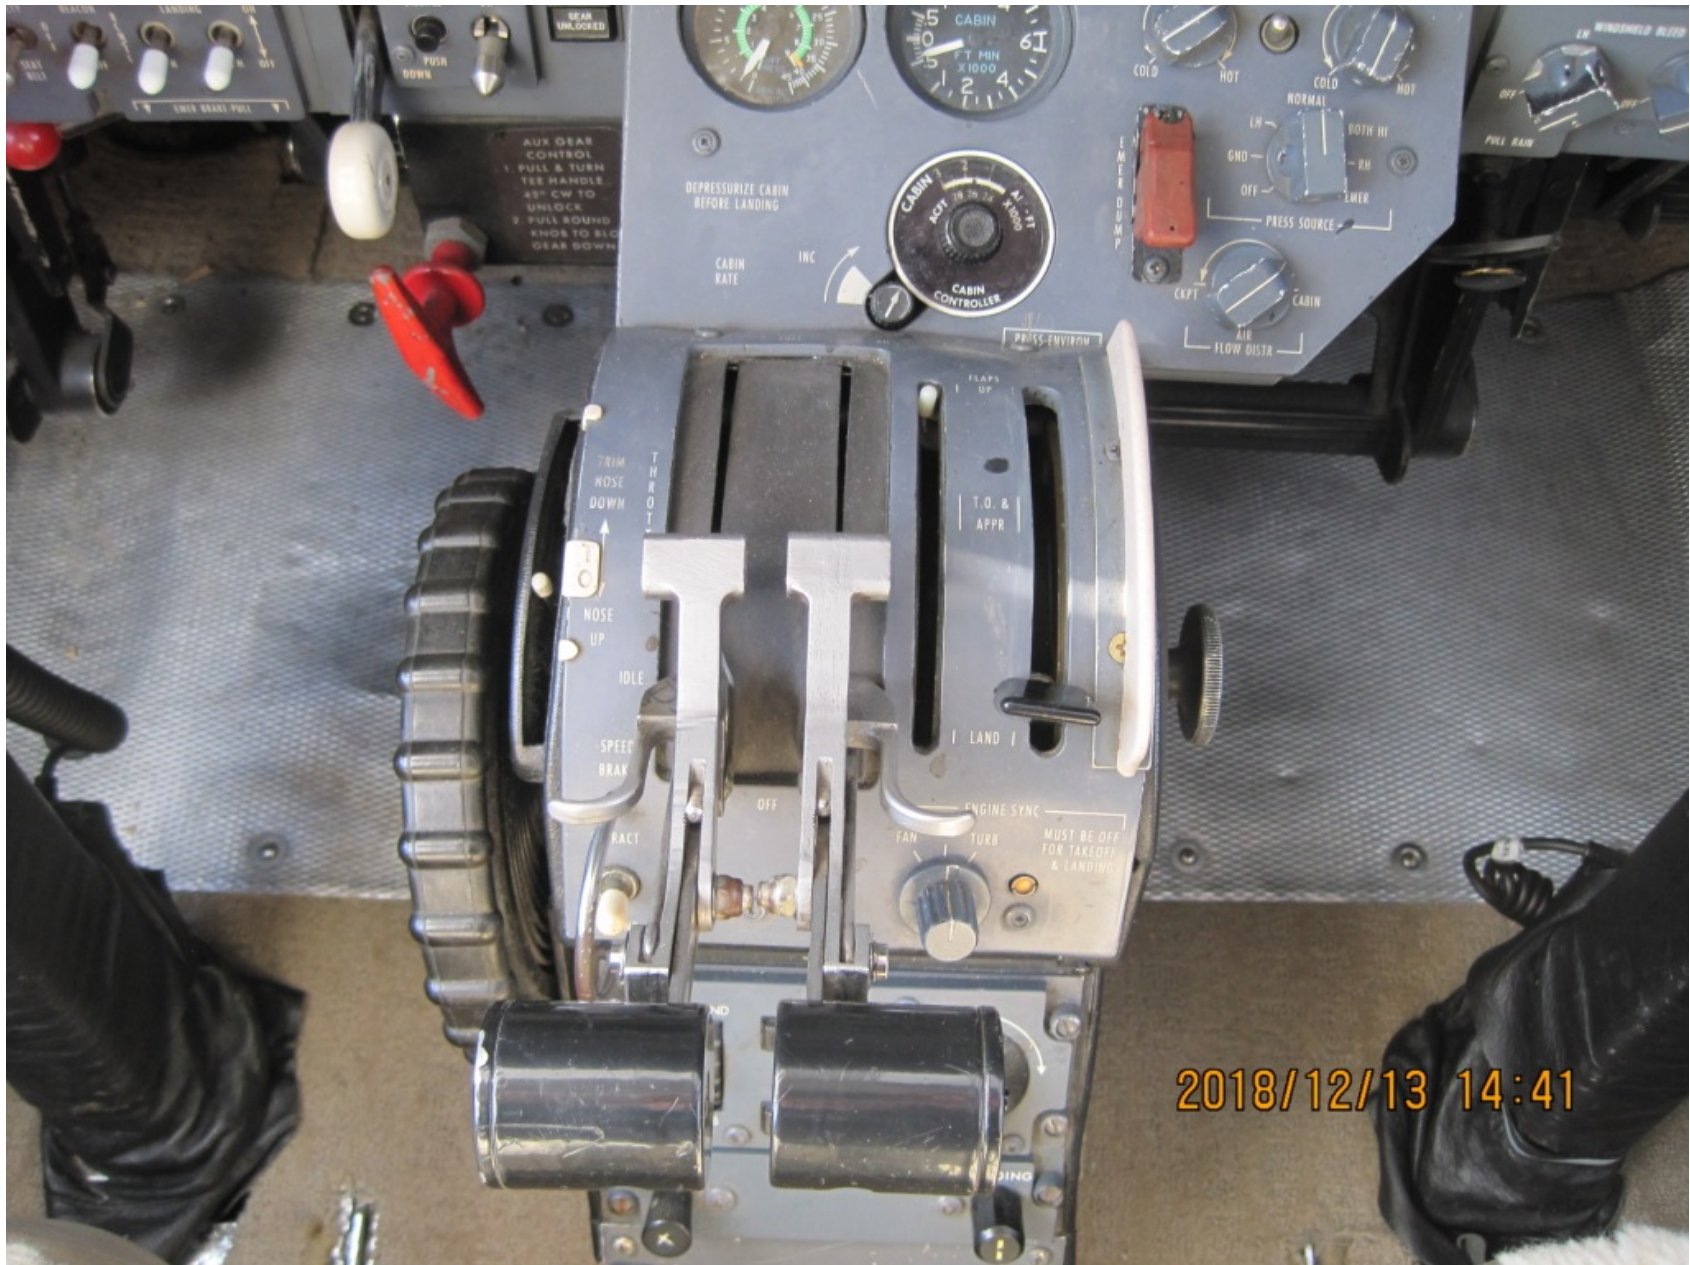
Photo 14 – View of the airplane’s center pedestal (FAA photo)

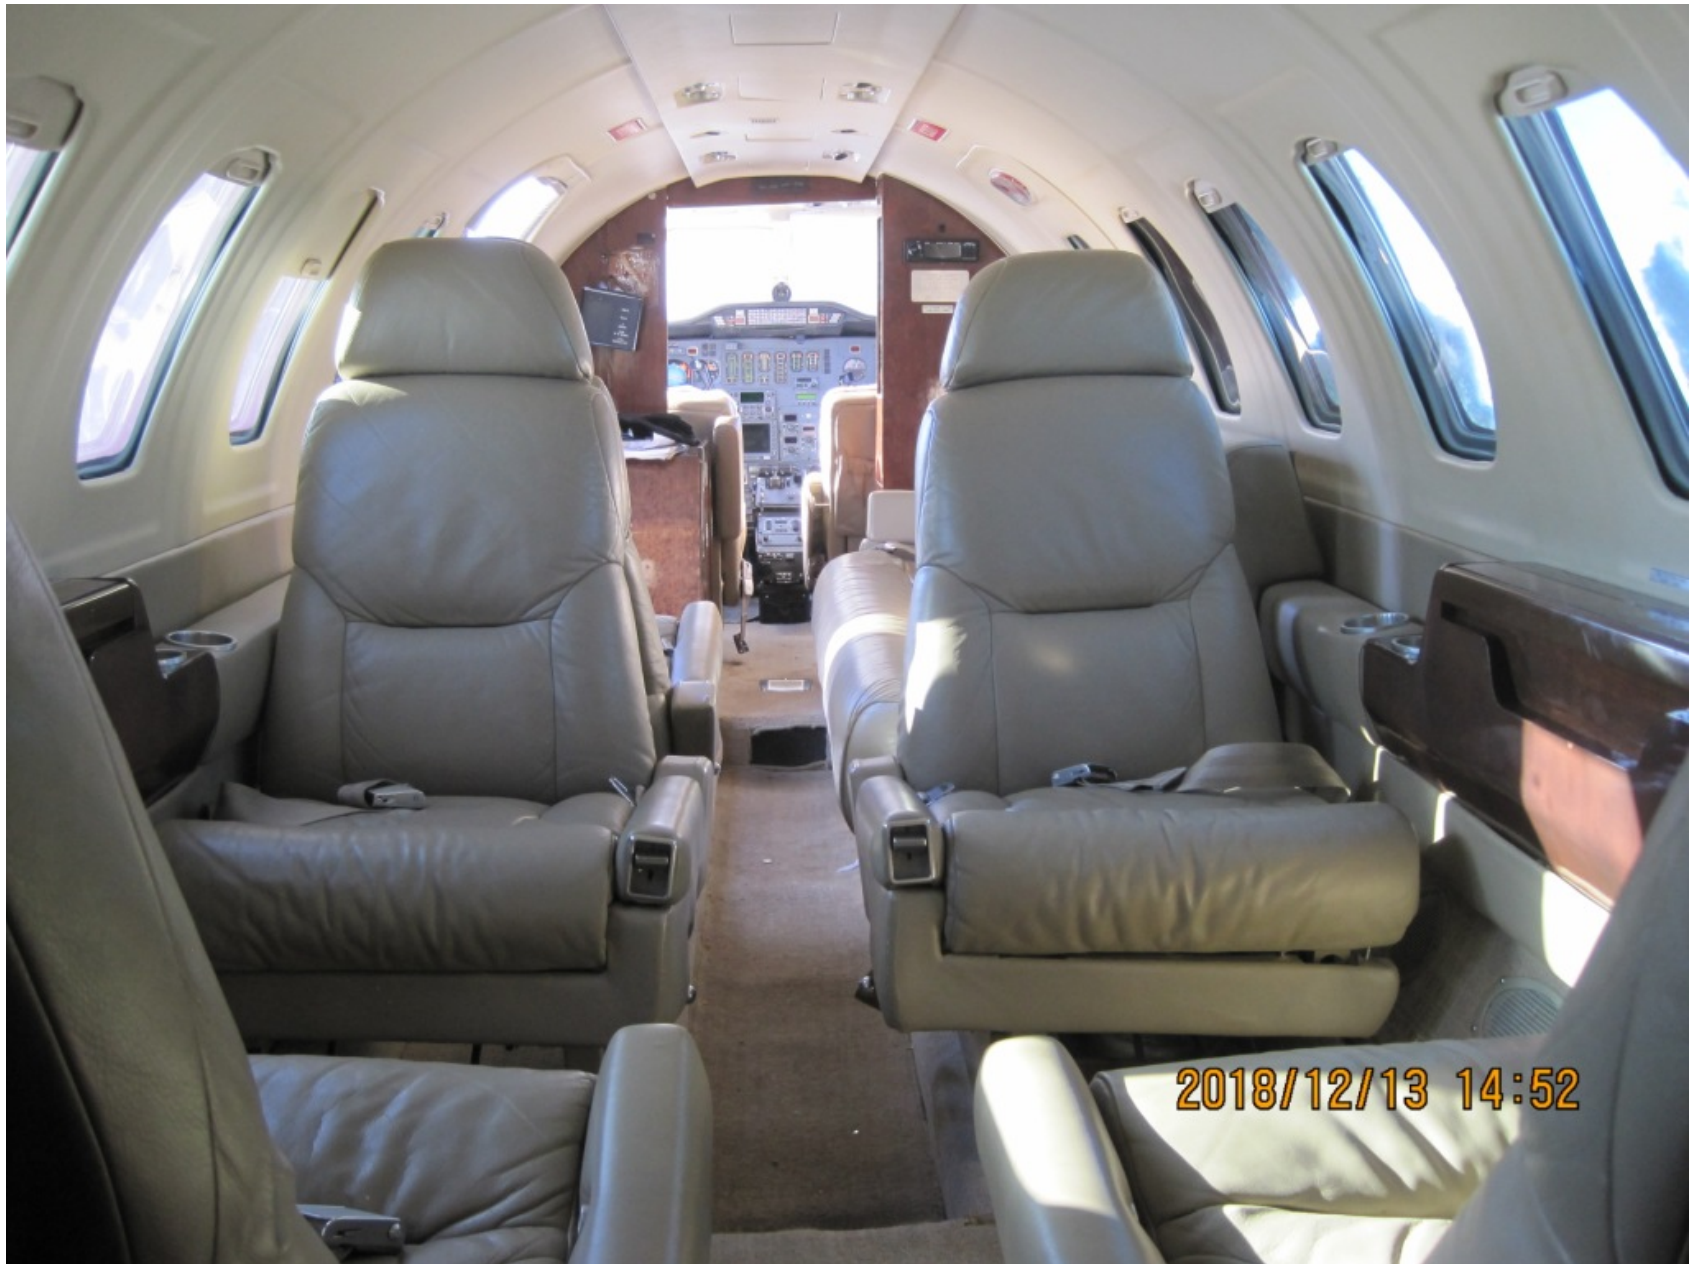
Photo 15 – View of the airplane’s cabin from the rear (FAA photo)

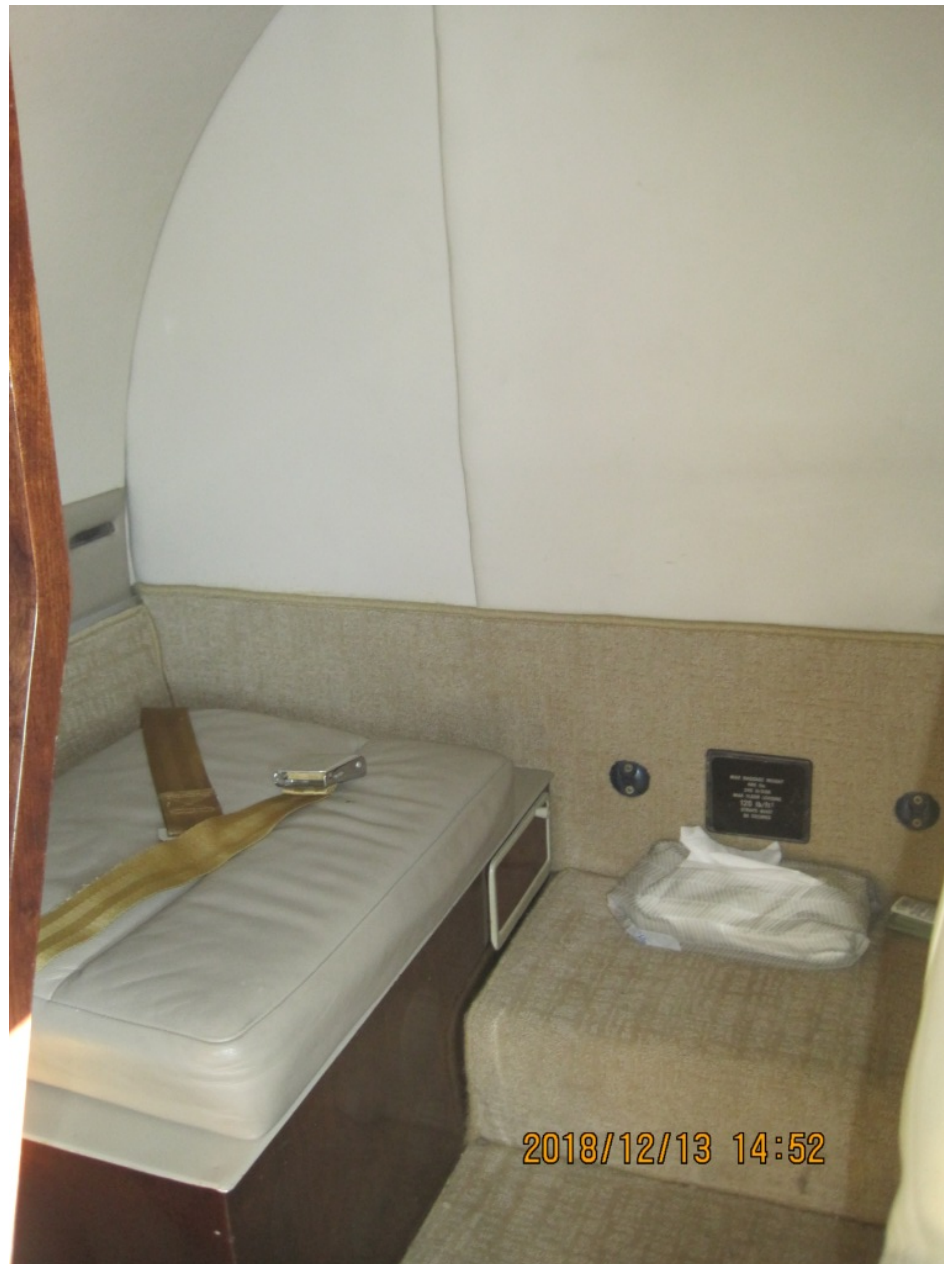
Photo 16 – View of seat positioned over the toilet (FAA photo)

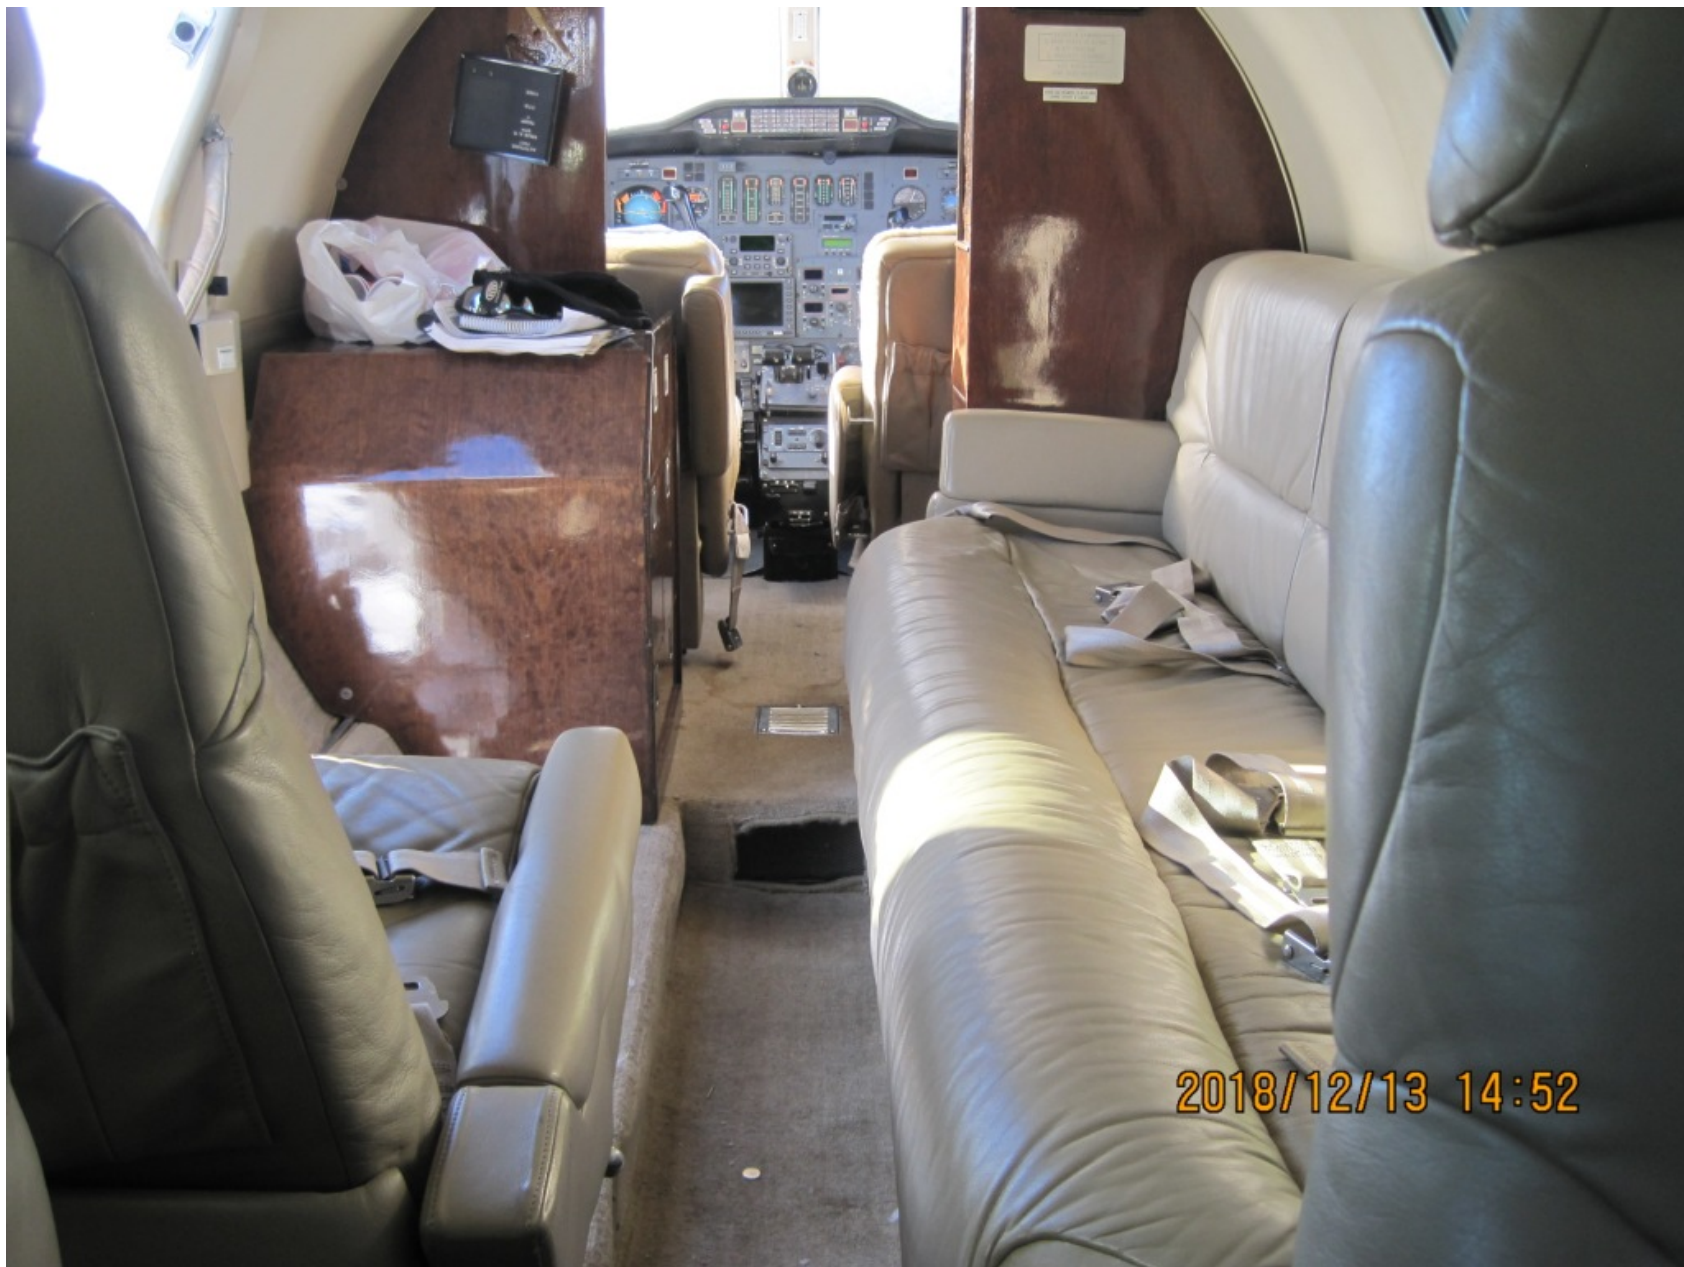
Photo 17 – View of the couch and cabinet (FAA photo)

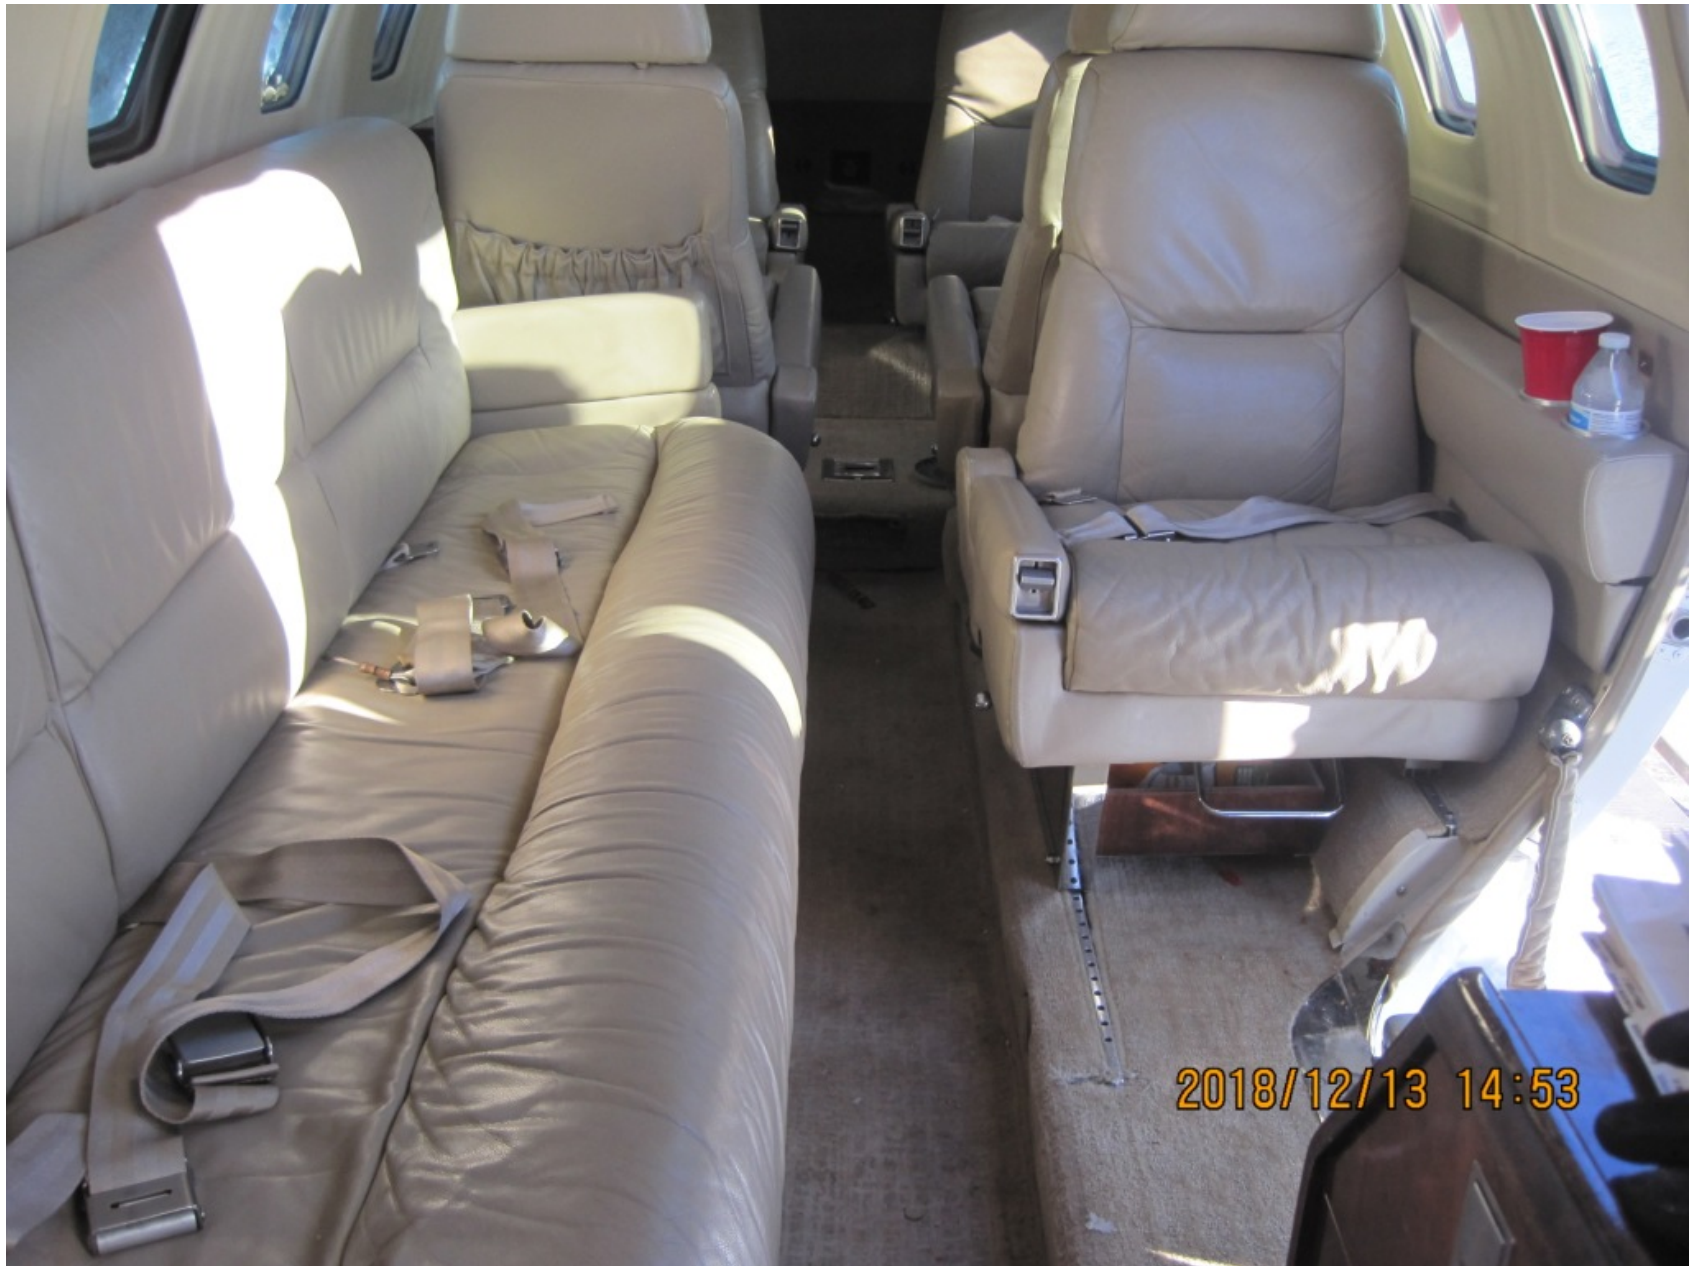
Photo 18 – View of couch, cabinet, seats from the front of the cabin (FAA photo)

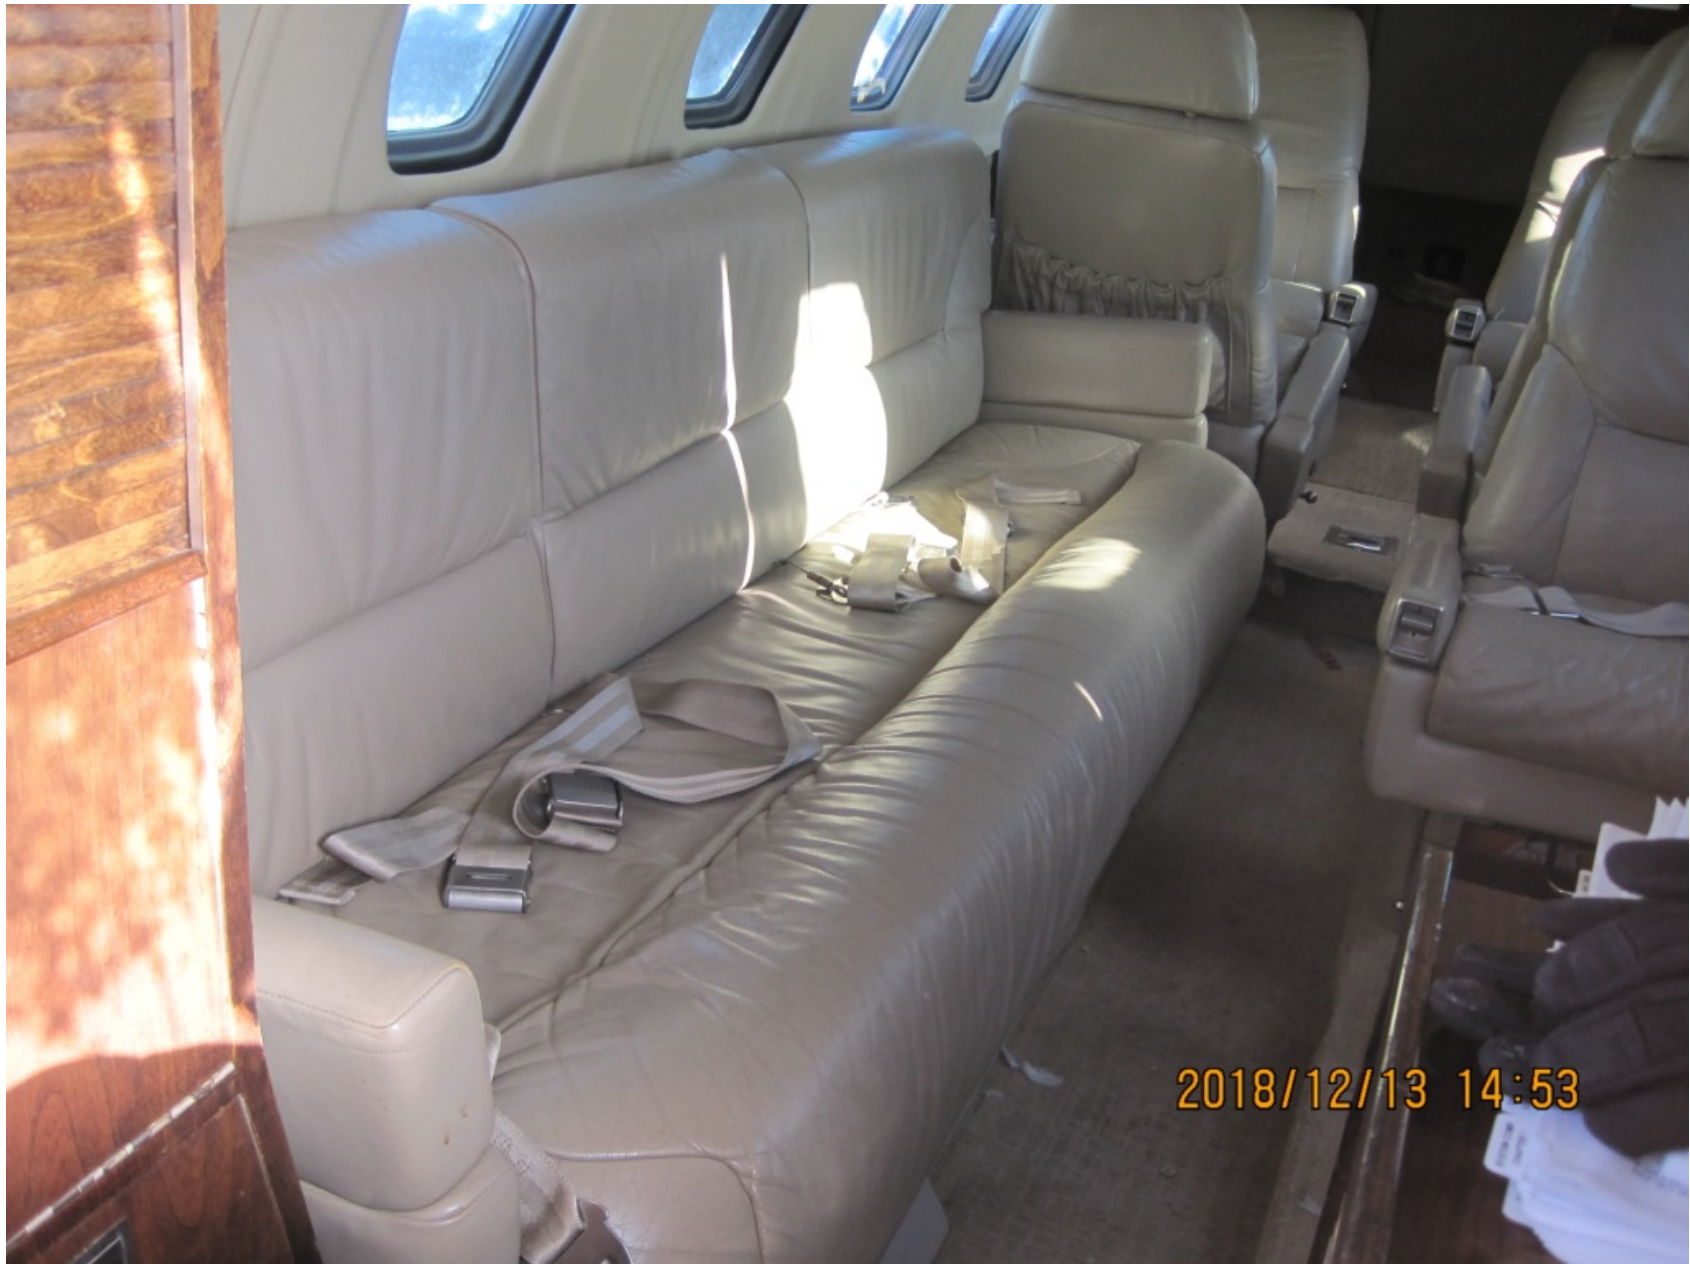
Photo 19 – View of the couch and its seatbelts (FAA photo)

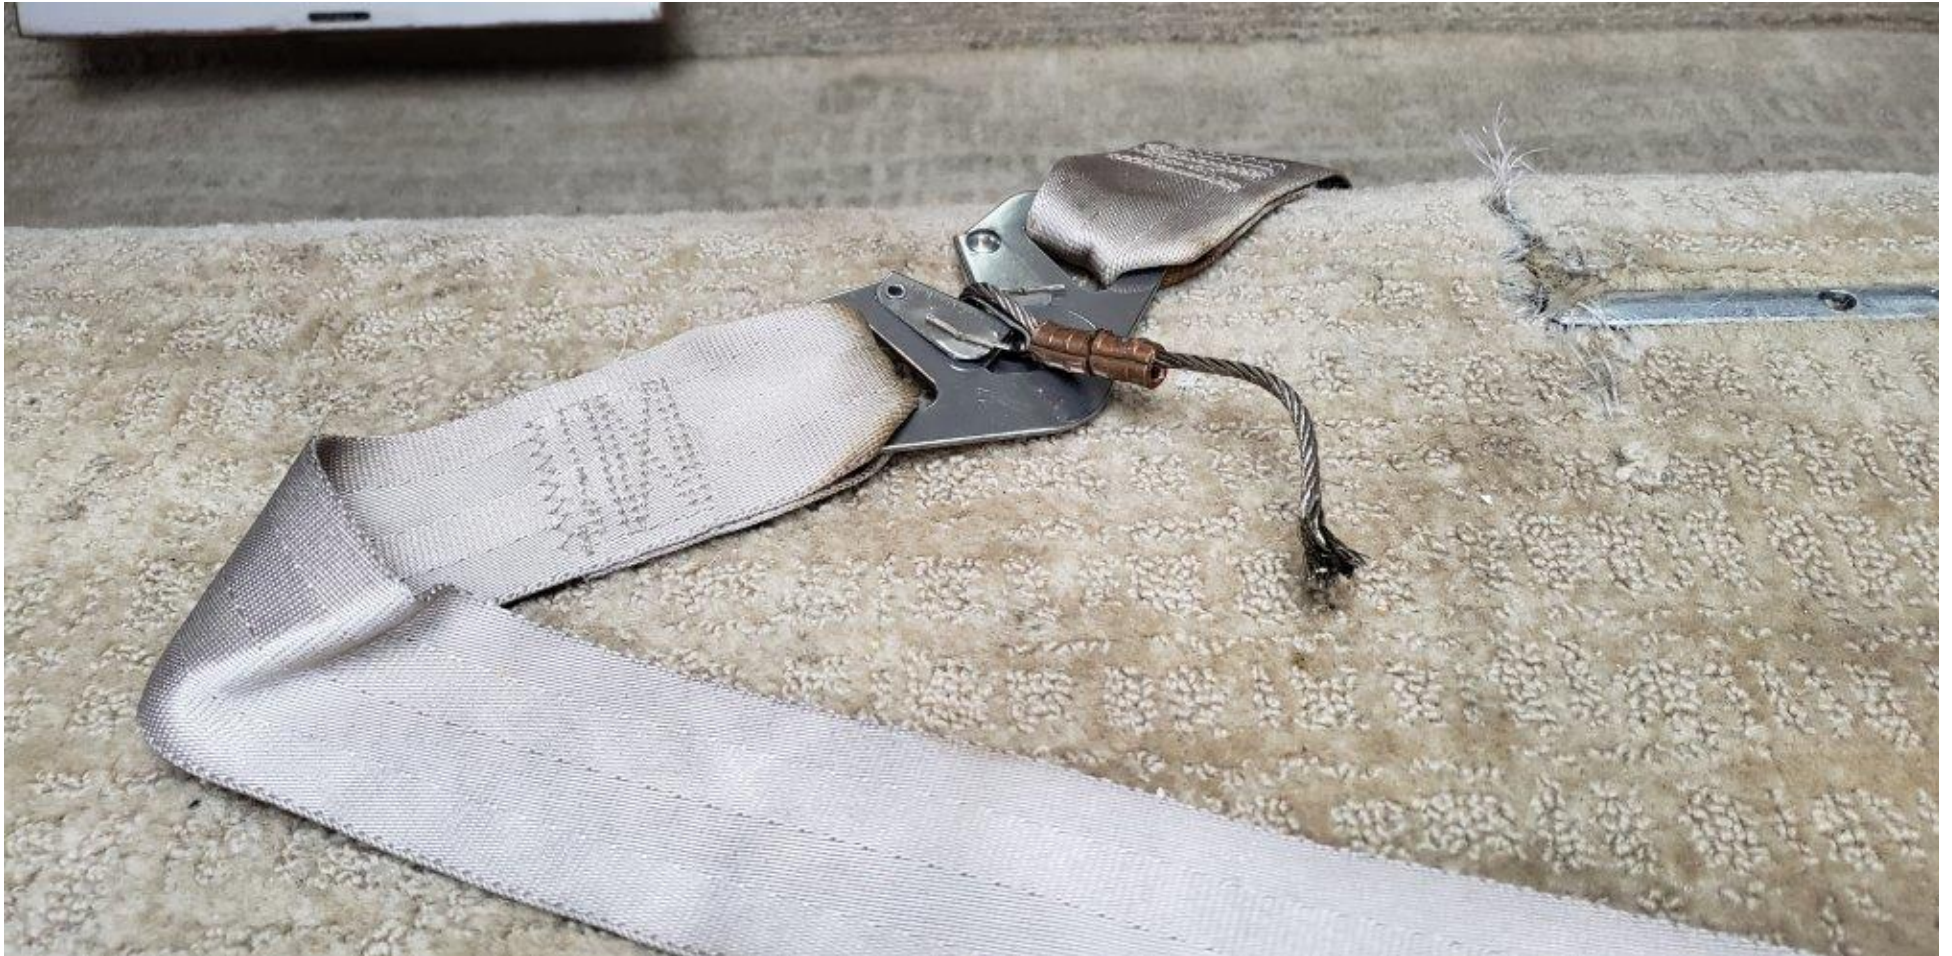
Photo 20 – View of couch seatbelt with broken steel cable (FAA photo)
