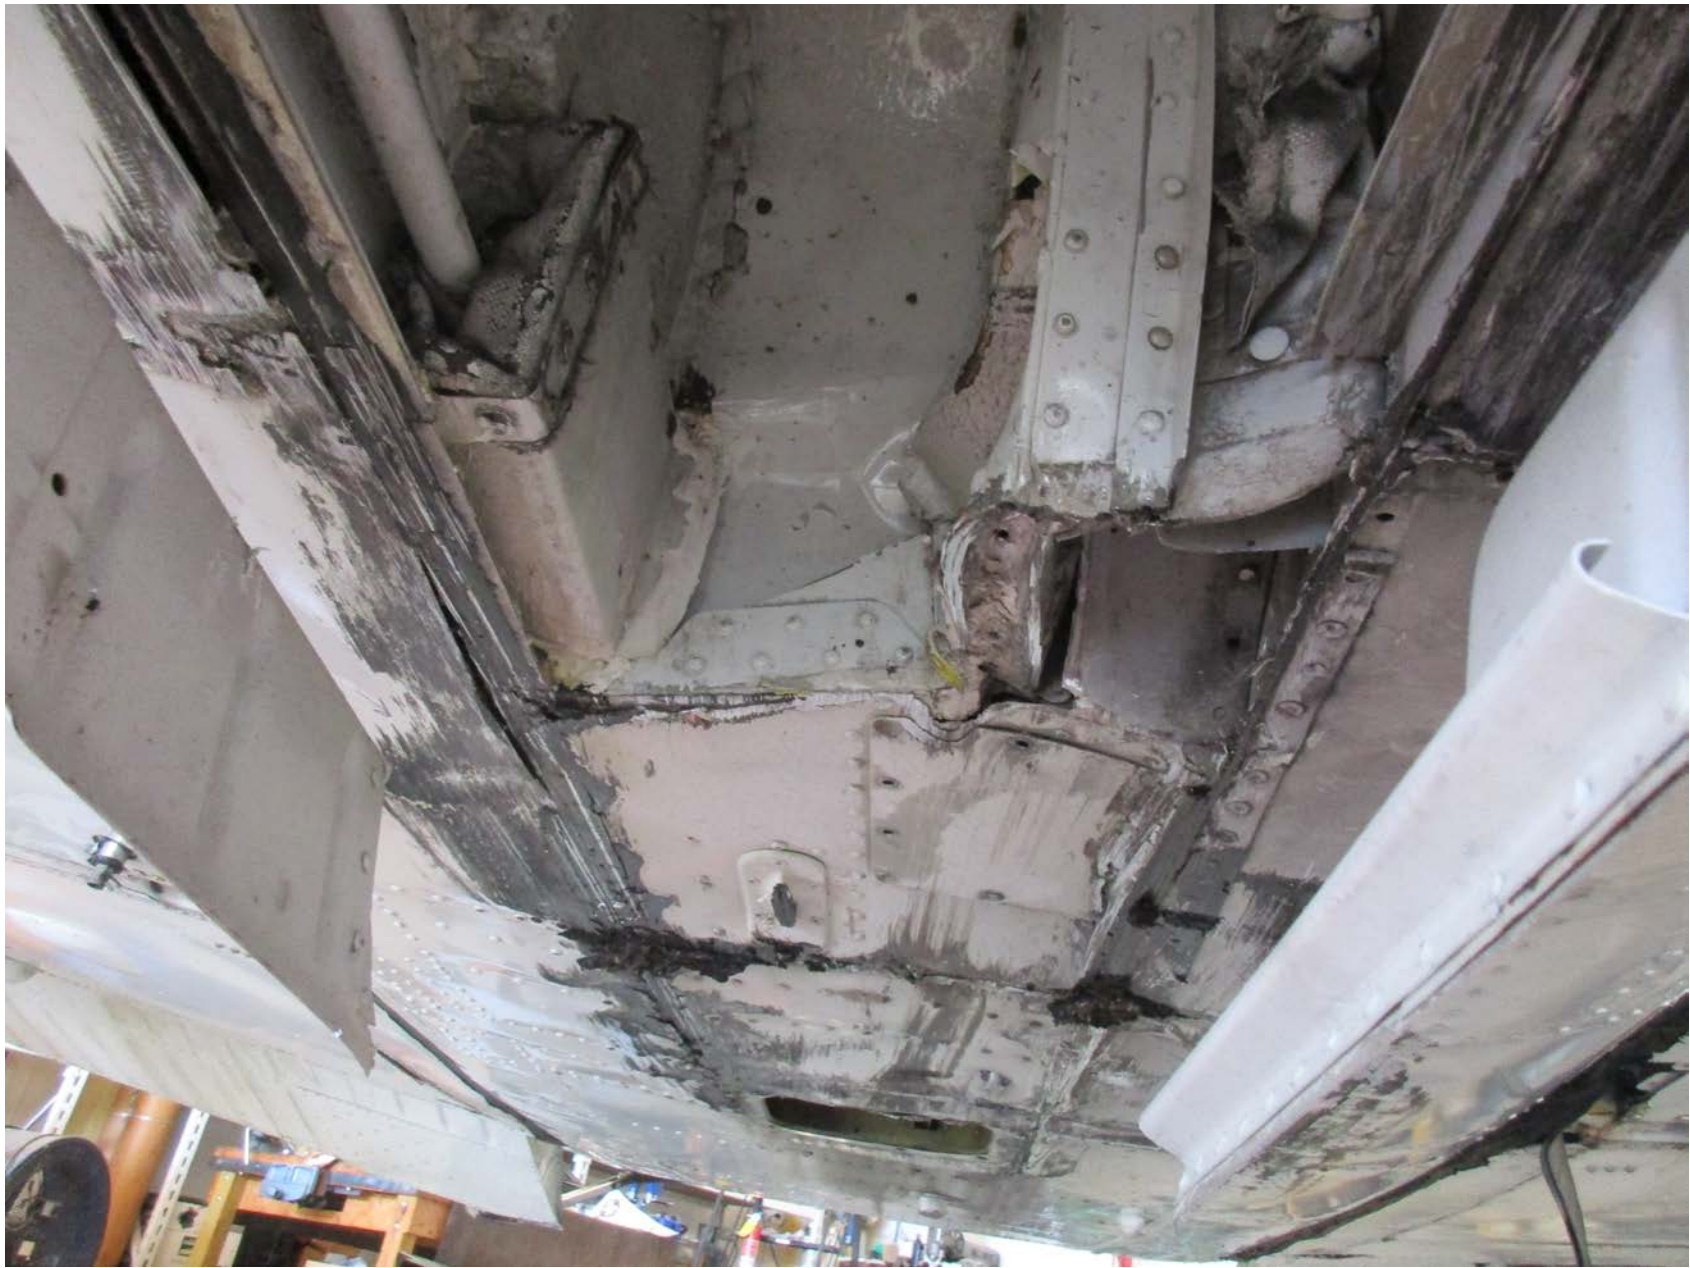
Photo 1 – View of damage to stringers, longerons, and carry through (Courtesy of FAA)
