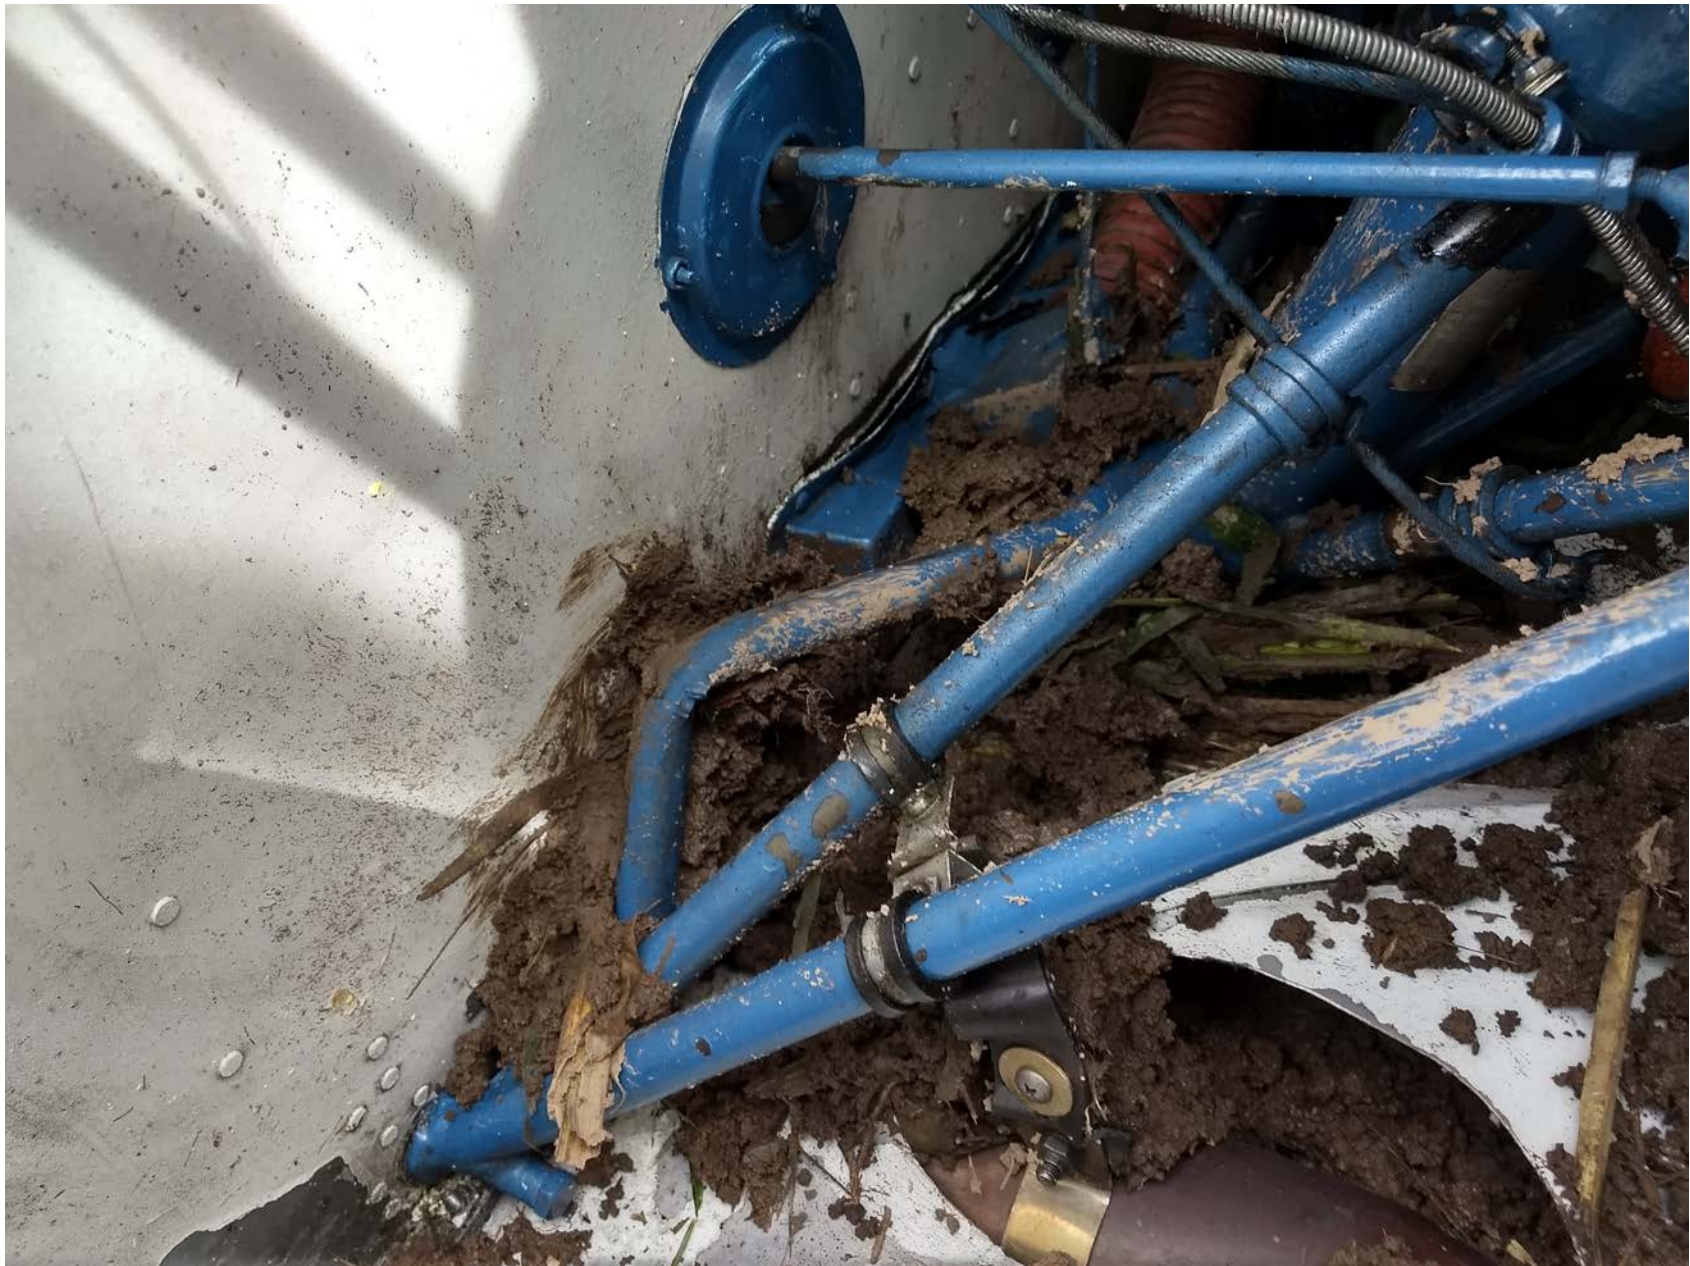
Photo 1 – View of damage to engine mounts (Courtesy of FAA)
