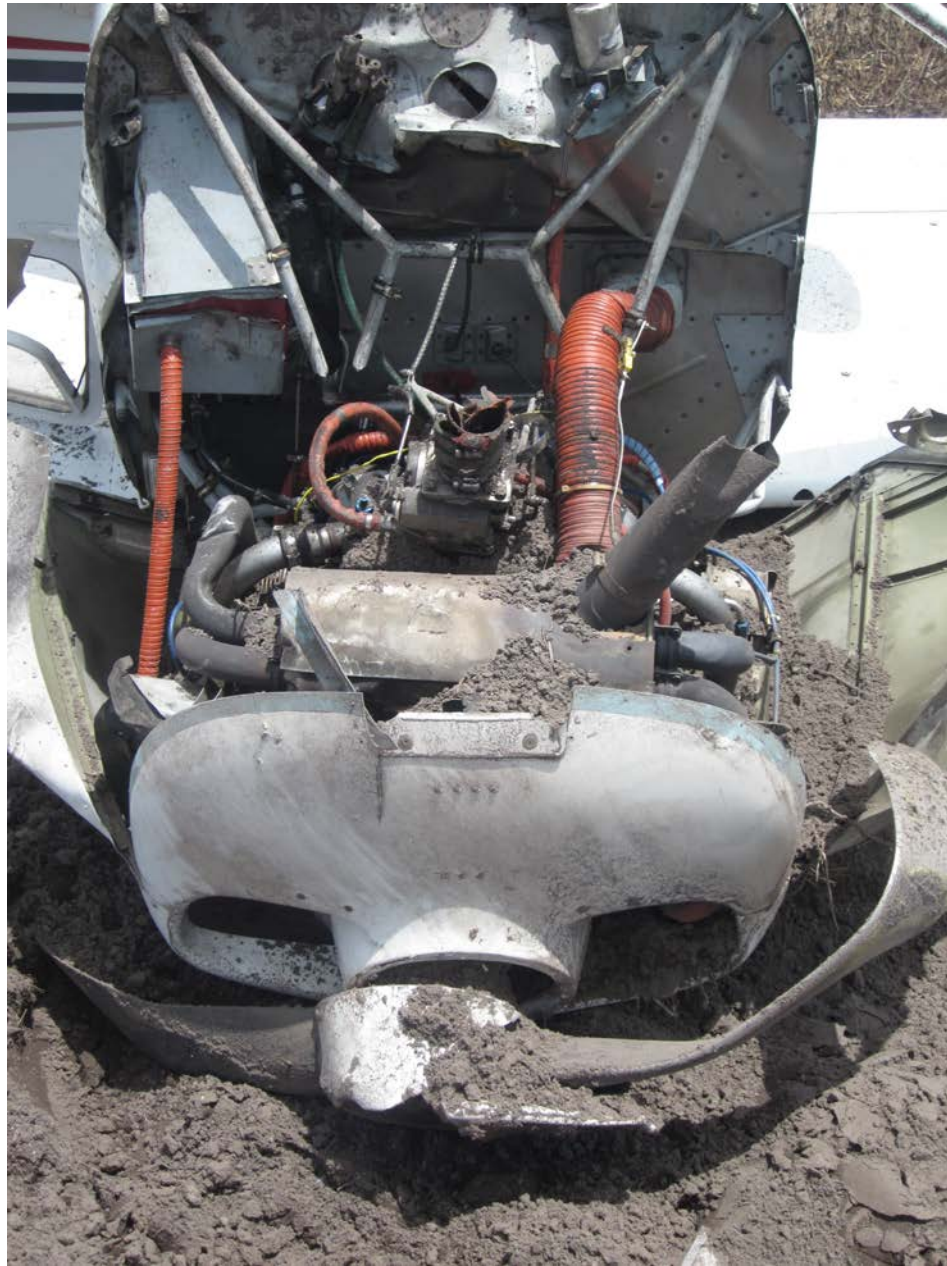
**Photo 1 – View of damage to the engine mounts (Courtesy of FAA)**
