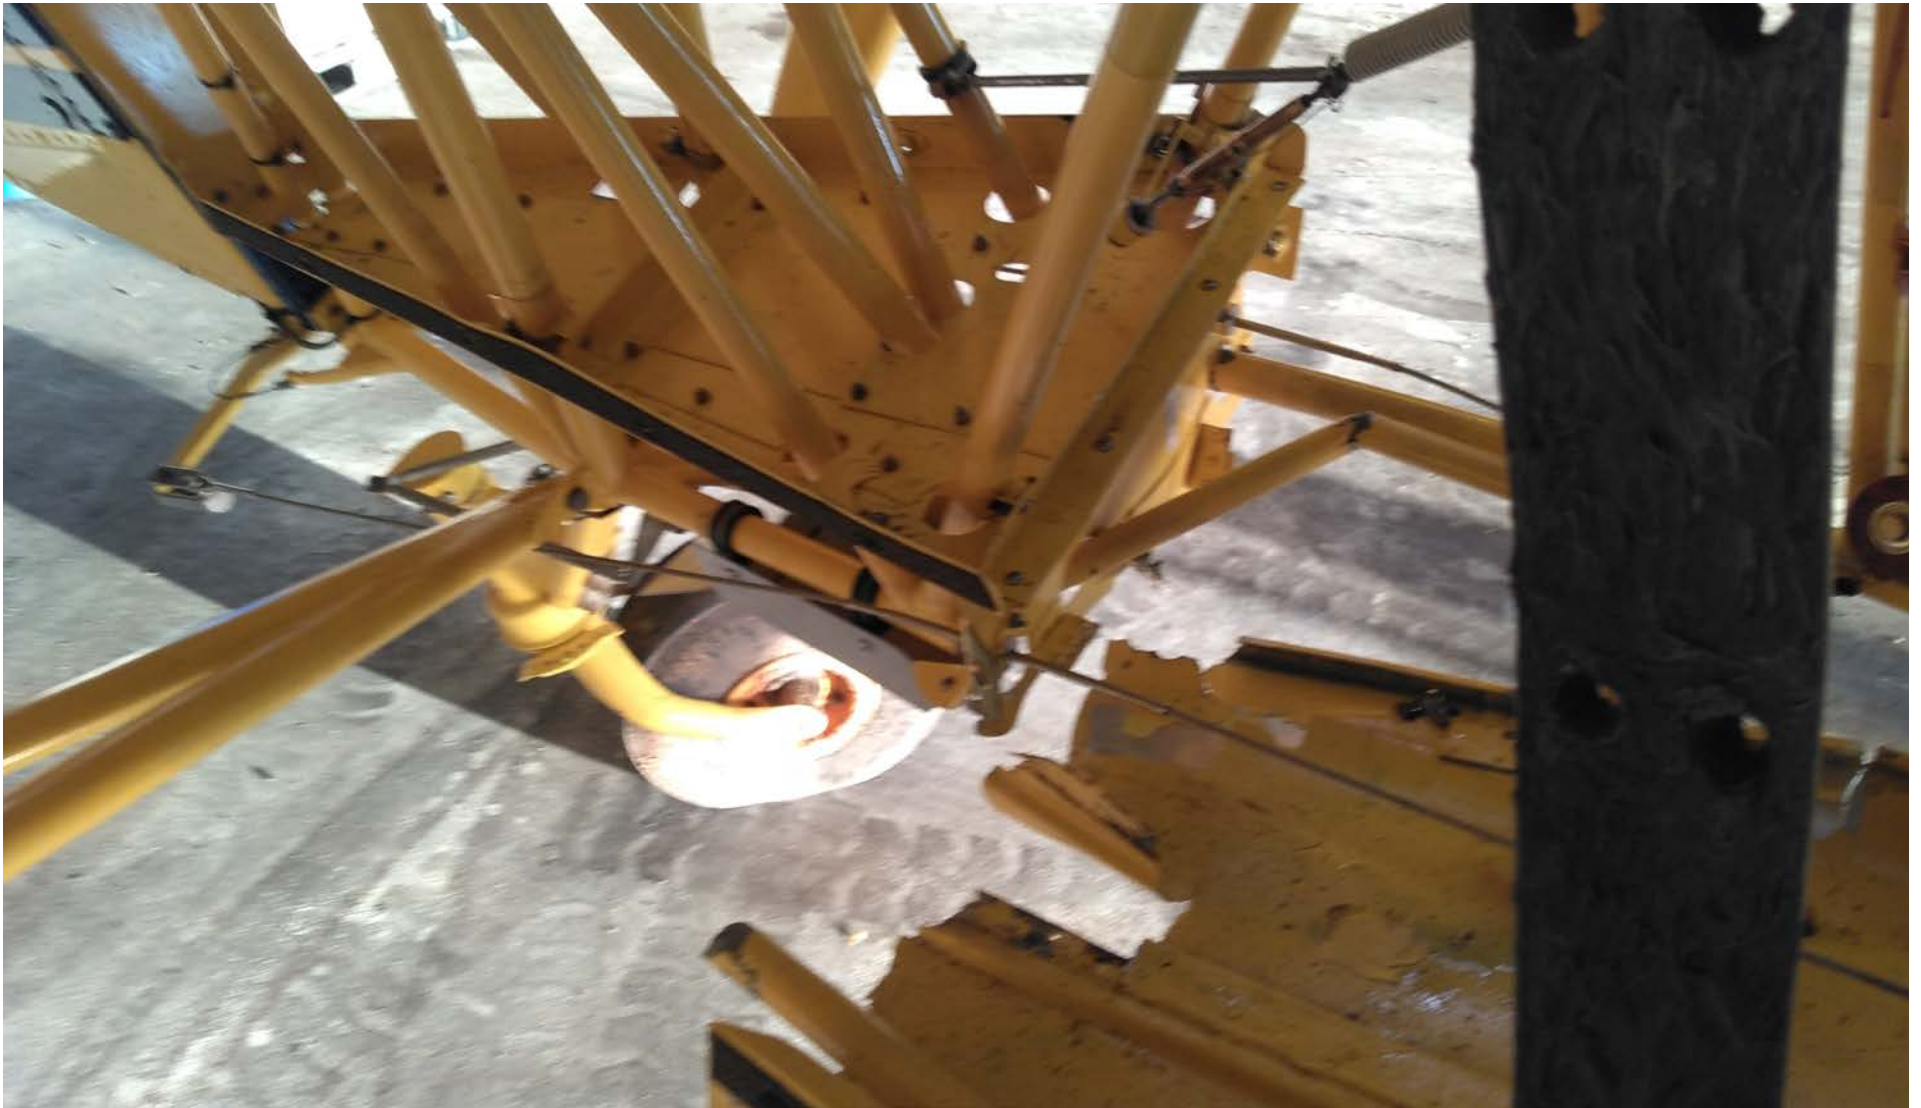
Photo 1 – View of damage to the airplane’s longerons (Courtesy of Operator)
