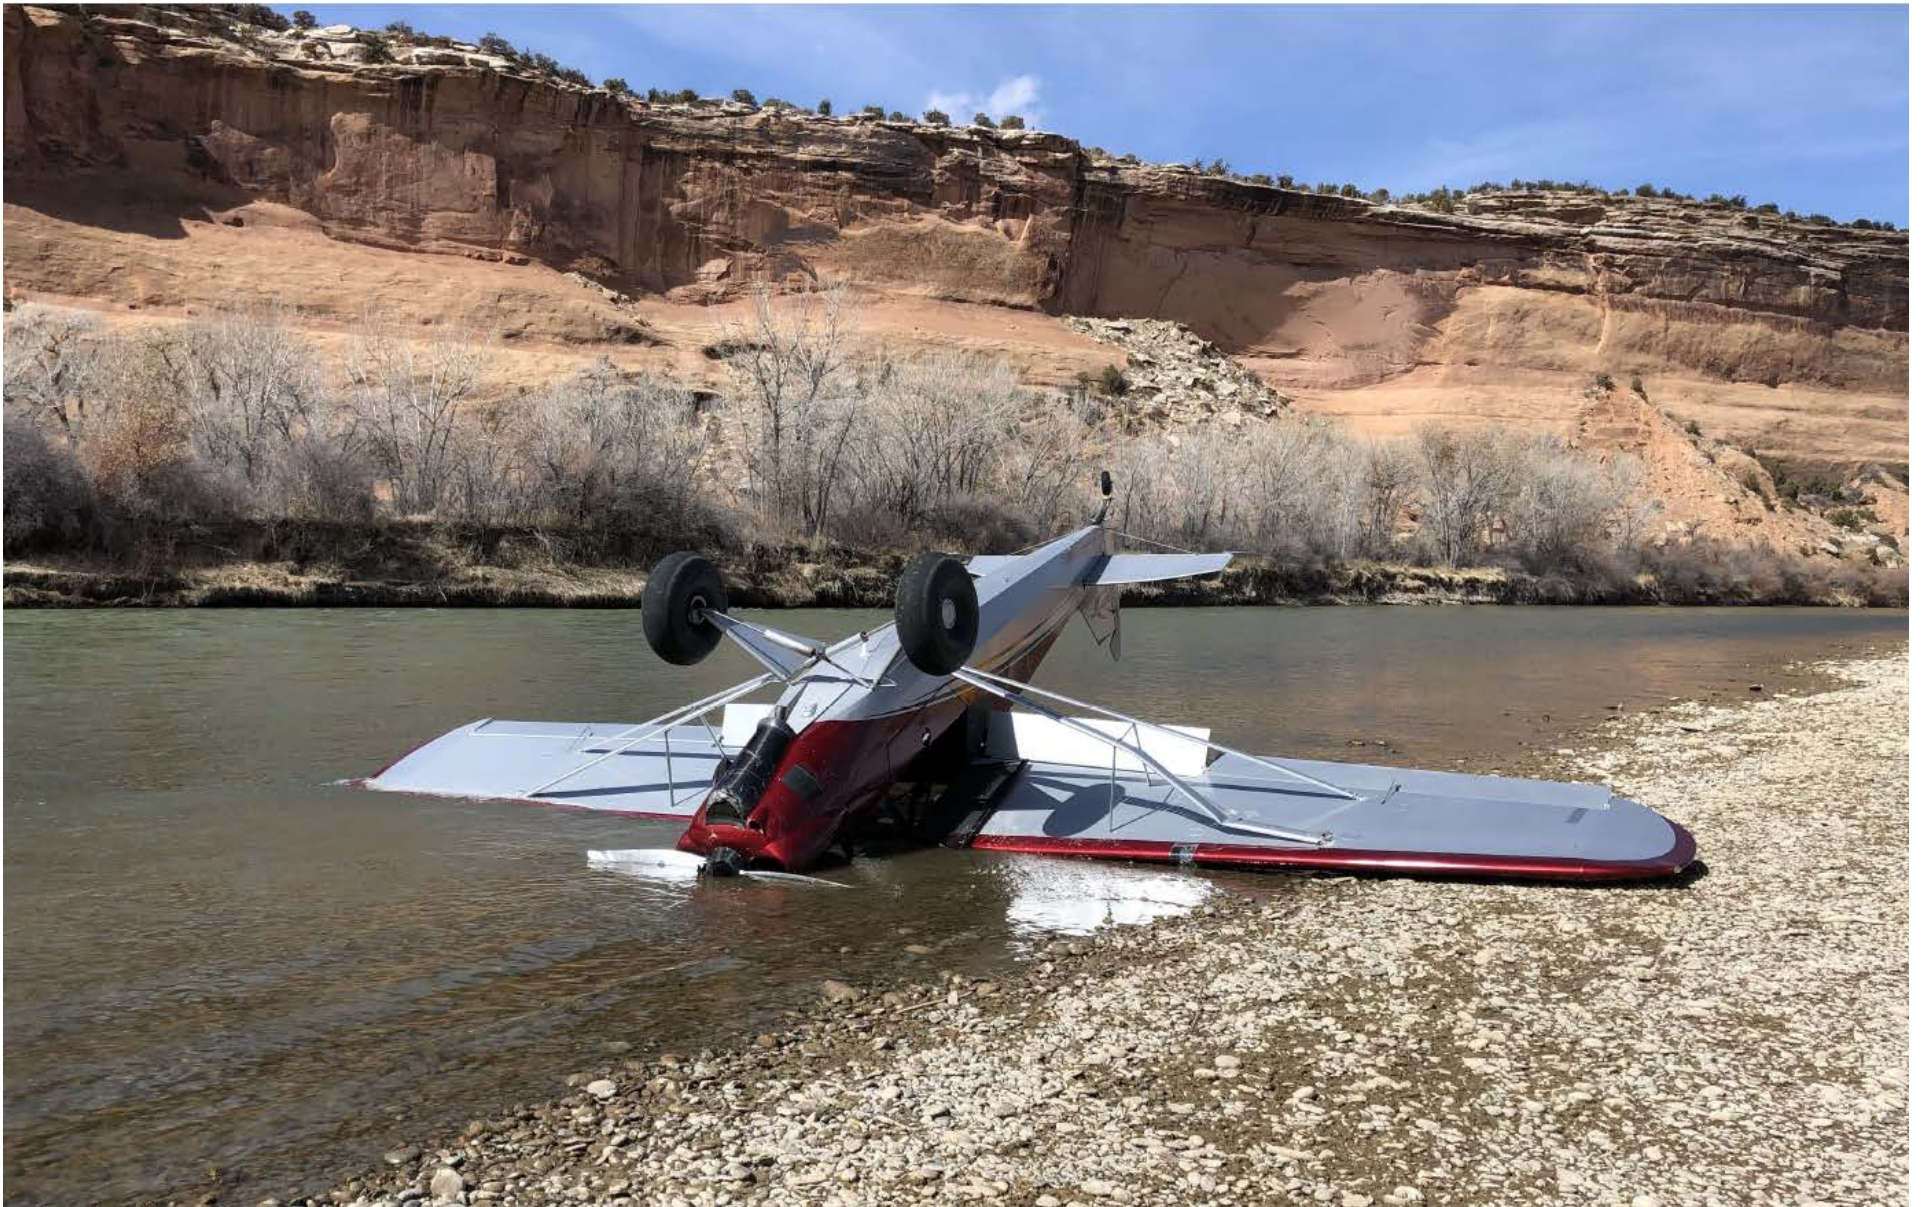
Photo 1 – View of damage to the right wing lift strut (Courtesy of Operator)
