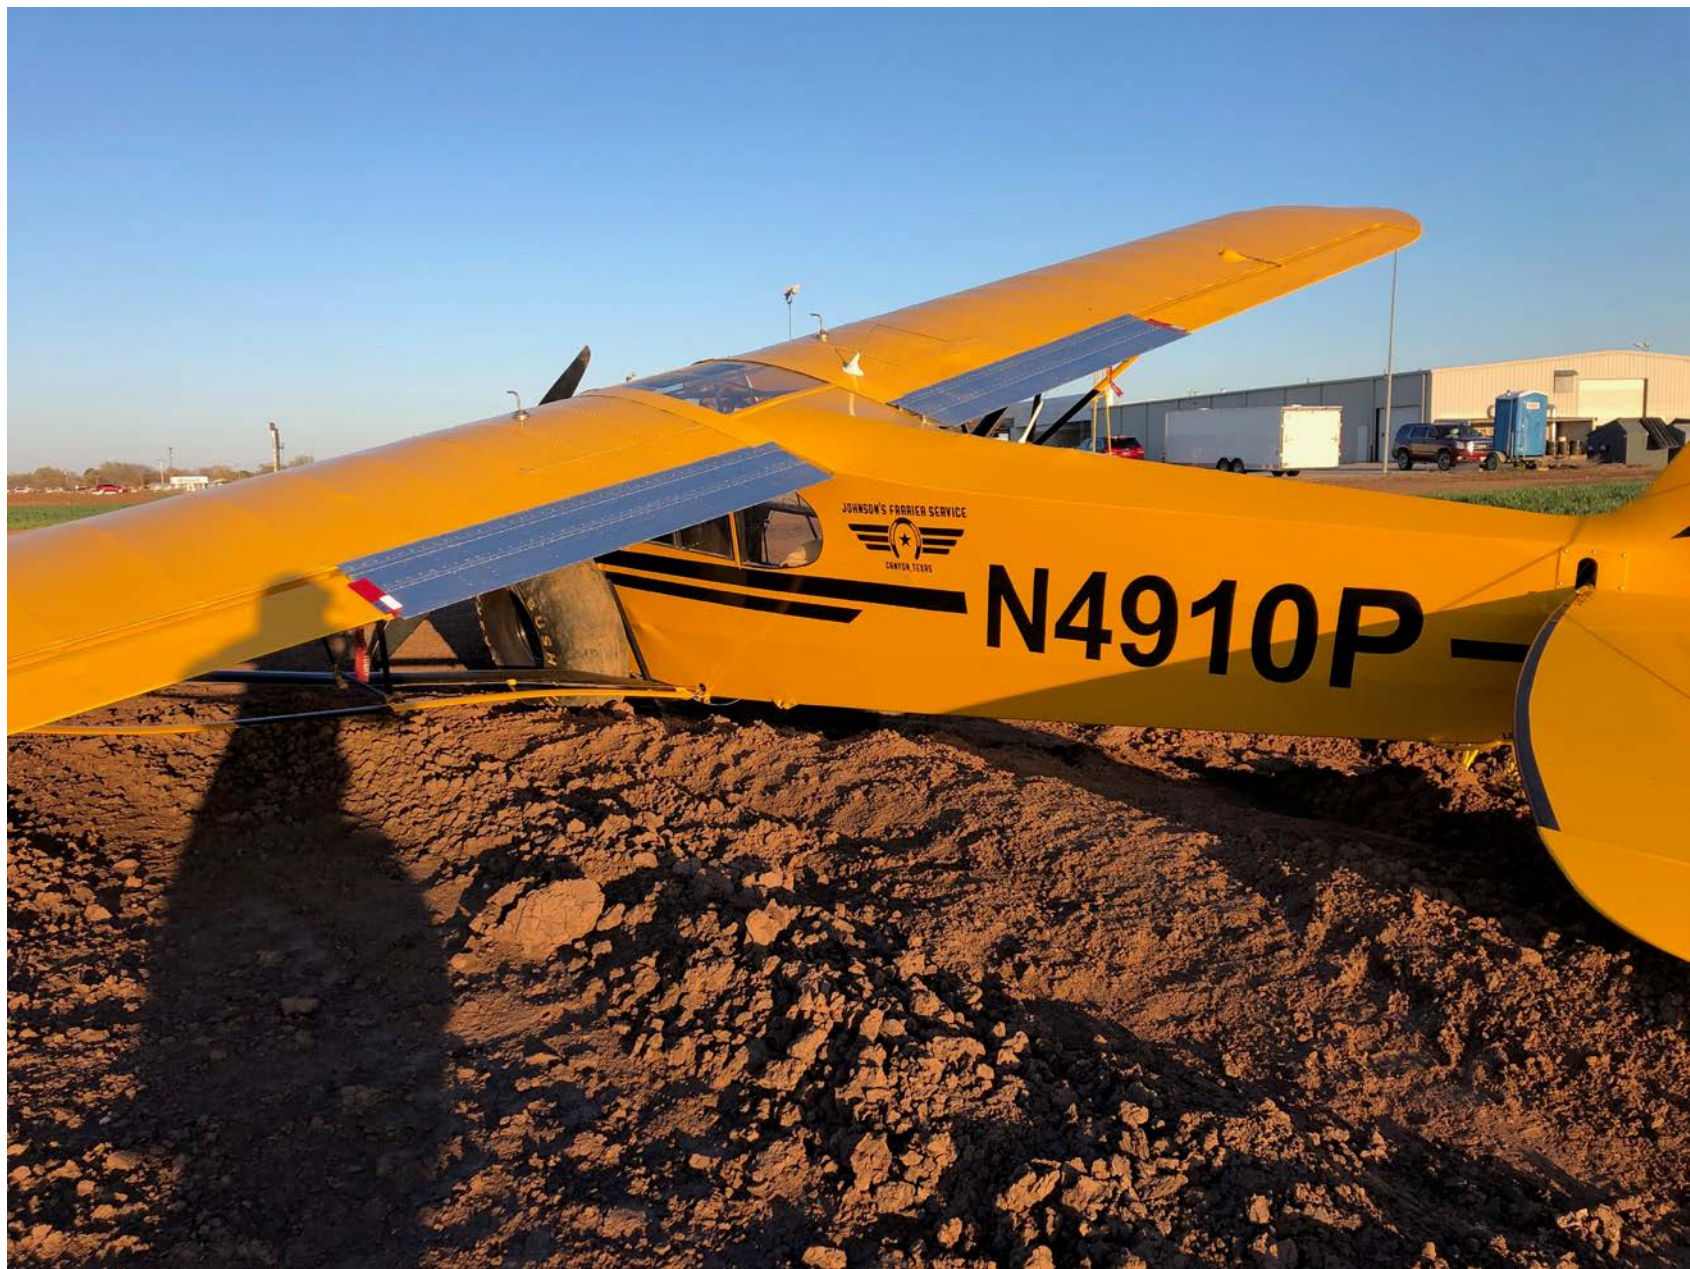
**Photo 1 – View of damage to the left wing lift struts (Courtesy of Operator)**
