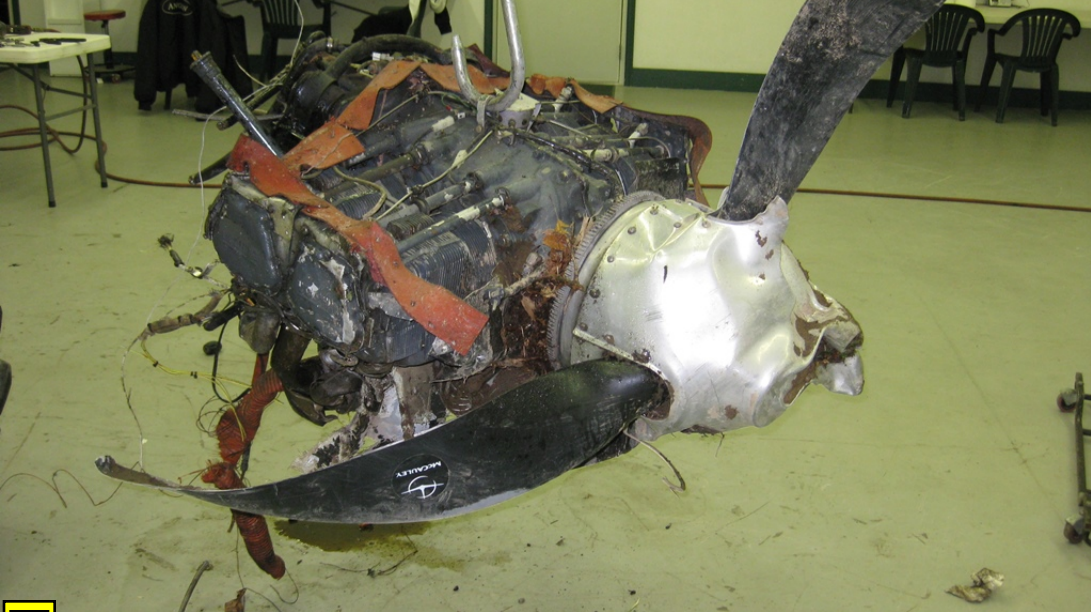
Photograph # 5: Engine After Recovery (Photo Courtesy of FAA)
