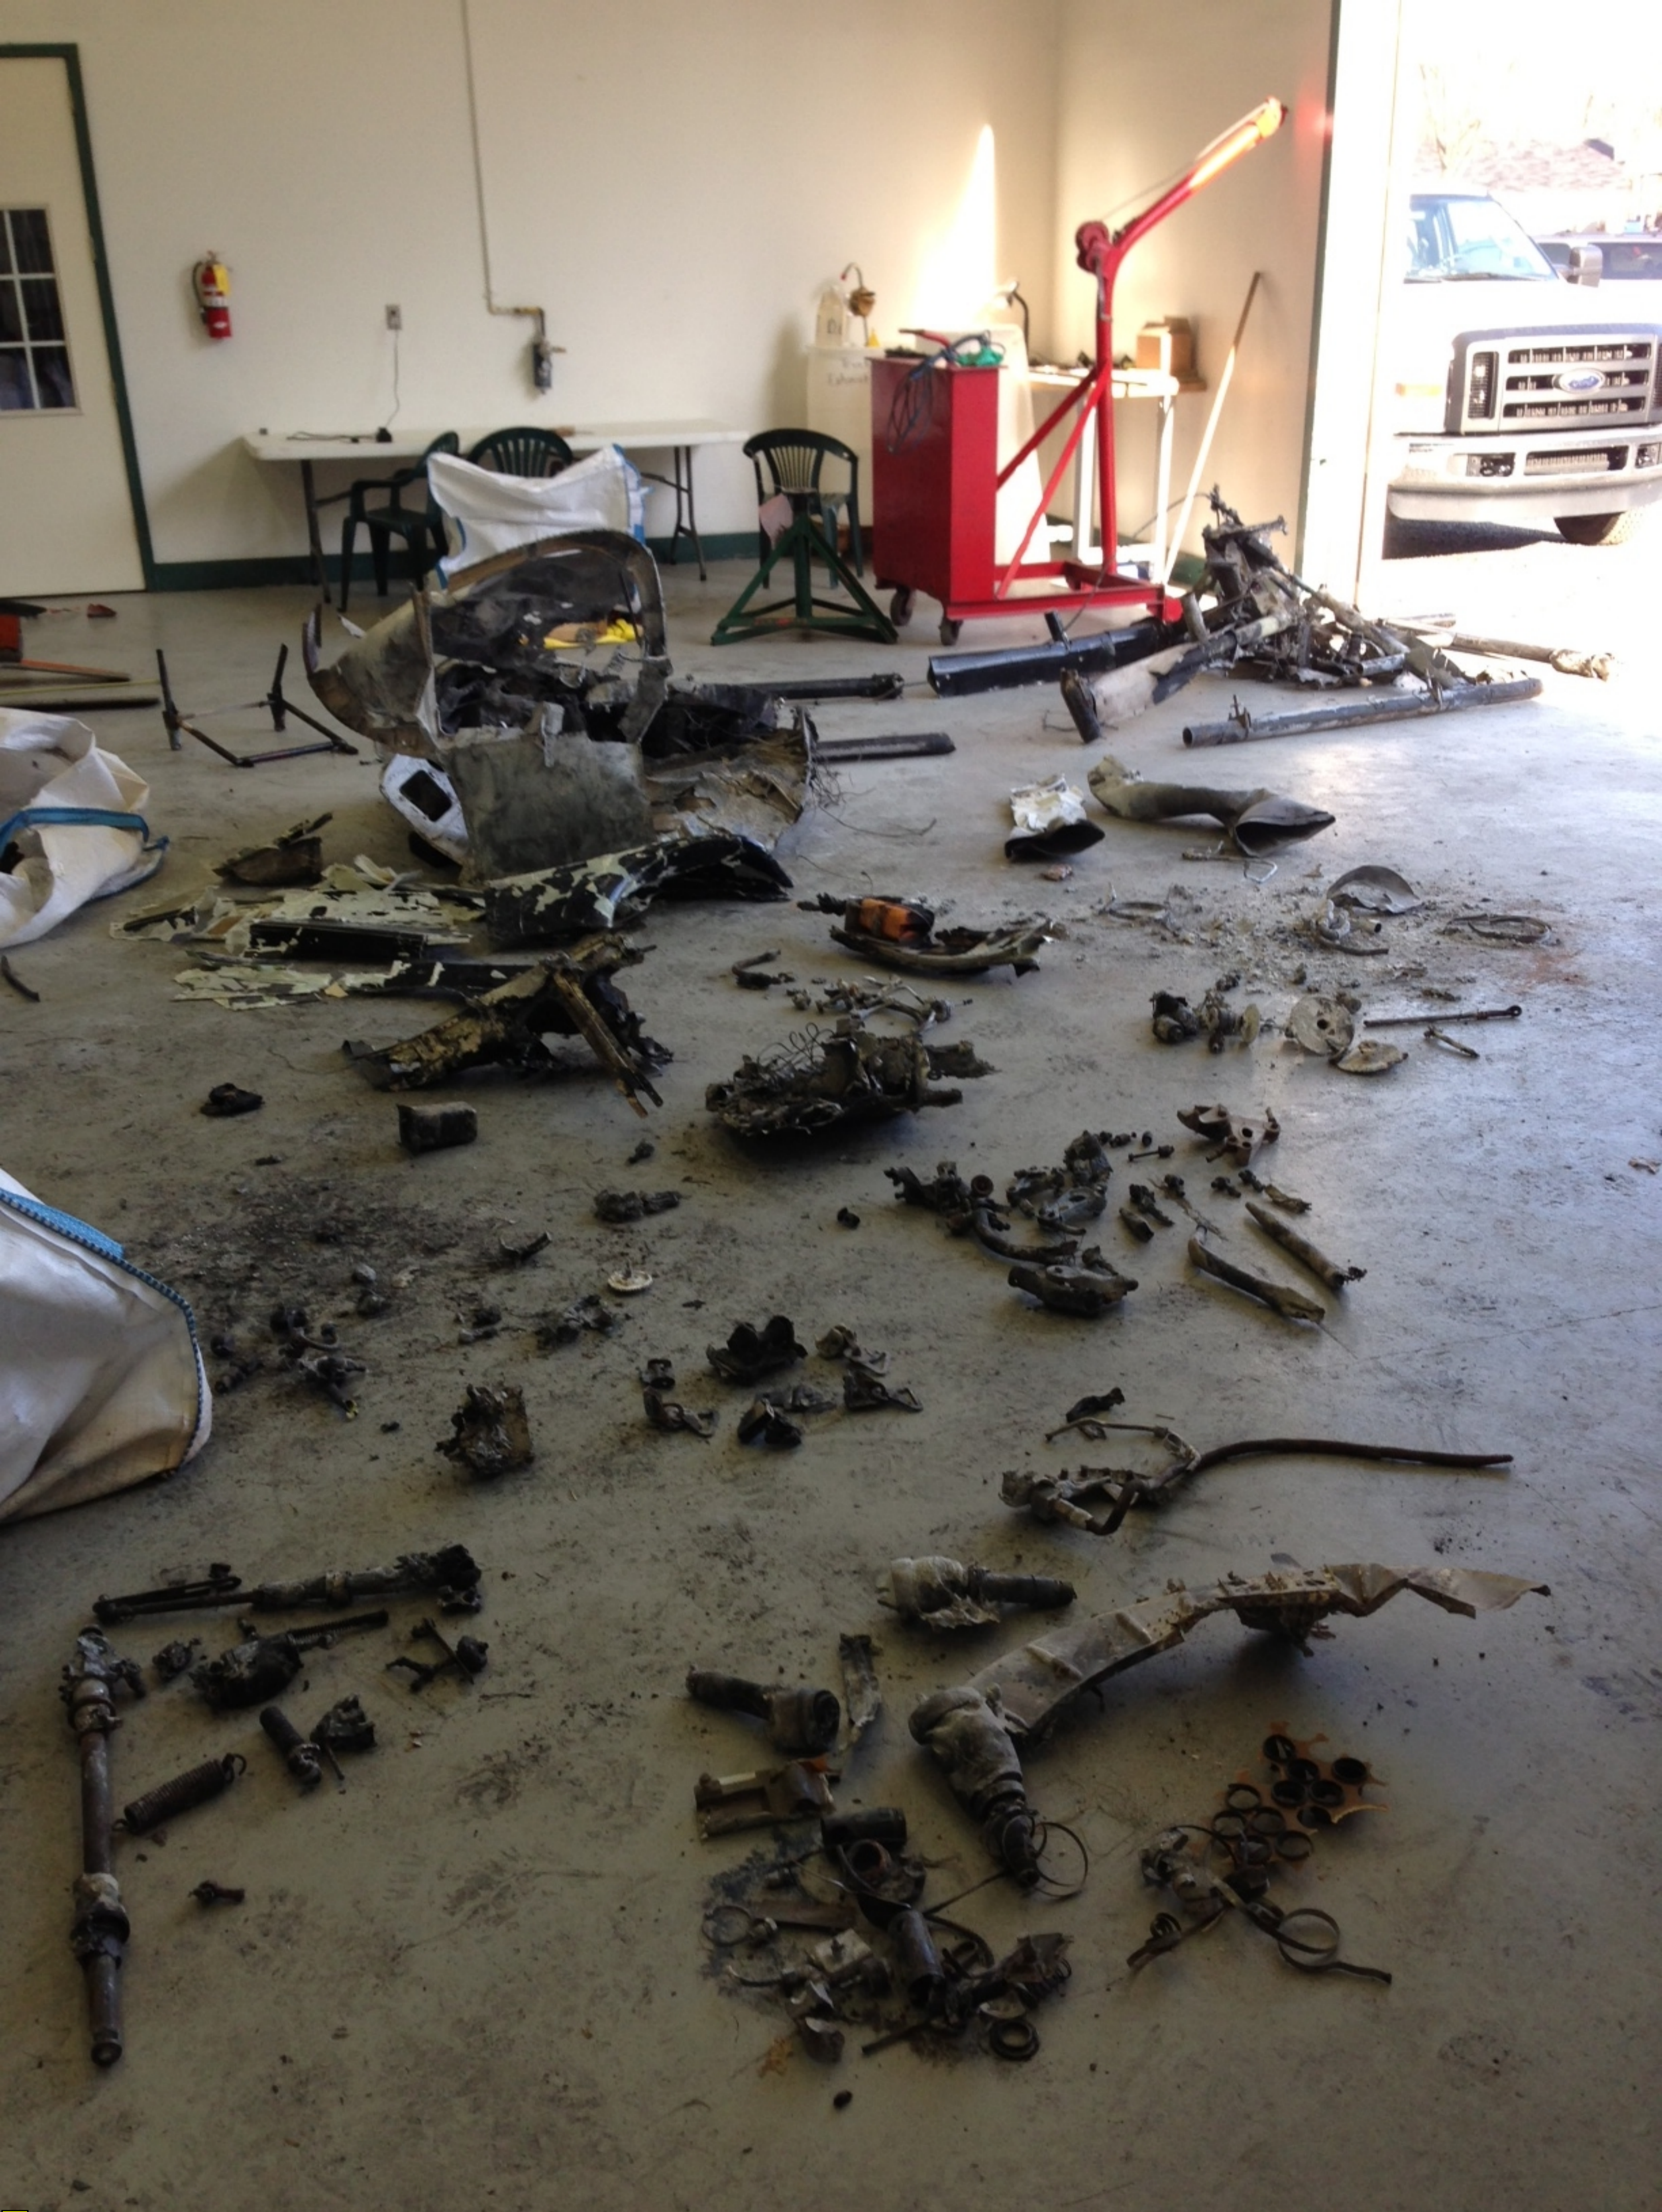
Photograph # 5 – View of wreckage during examination at recovery facility
