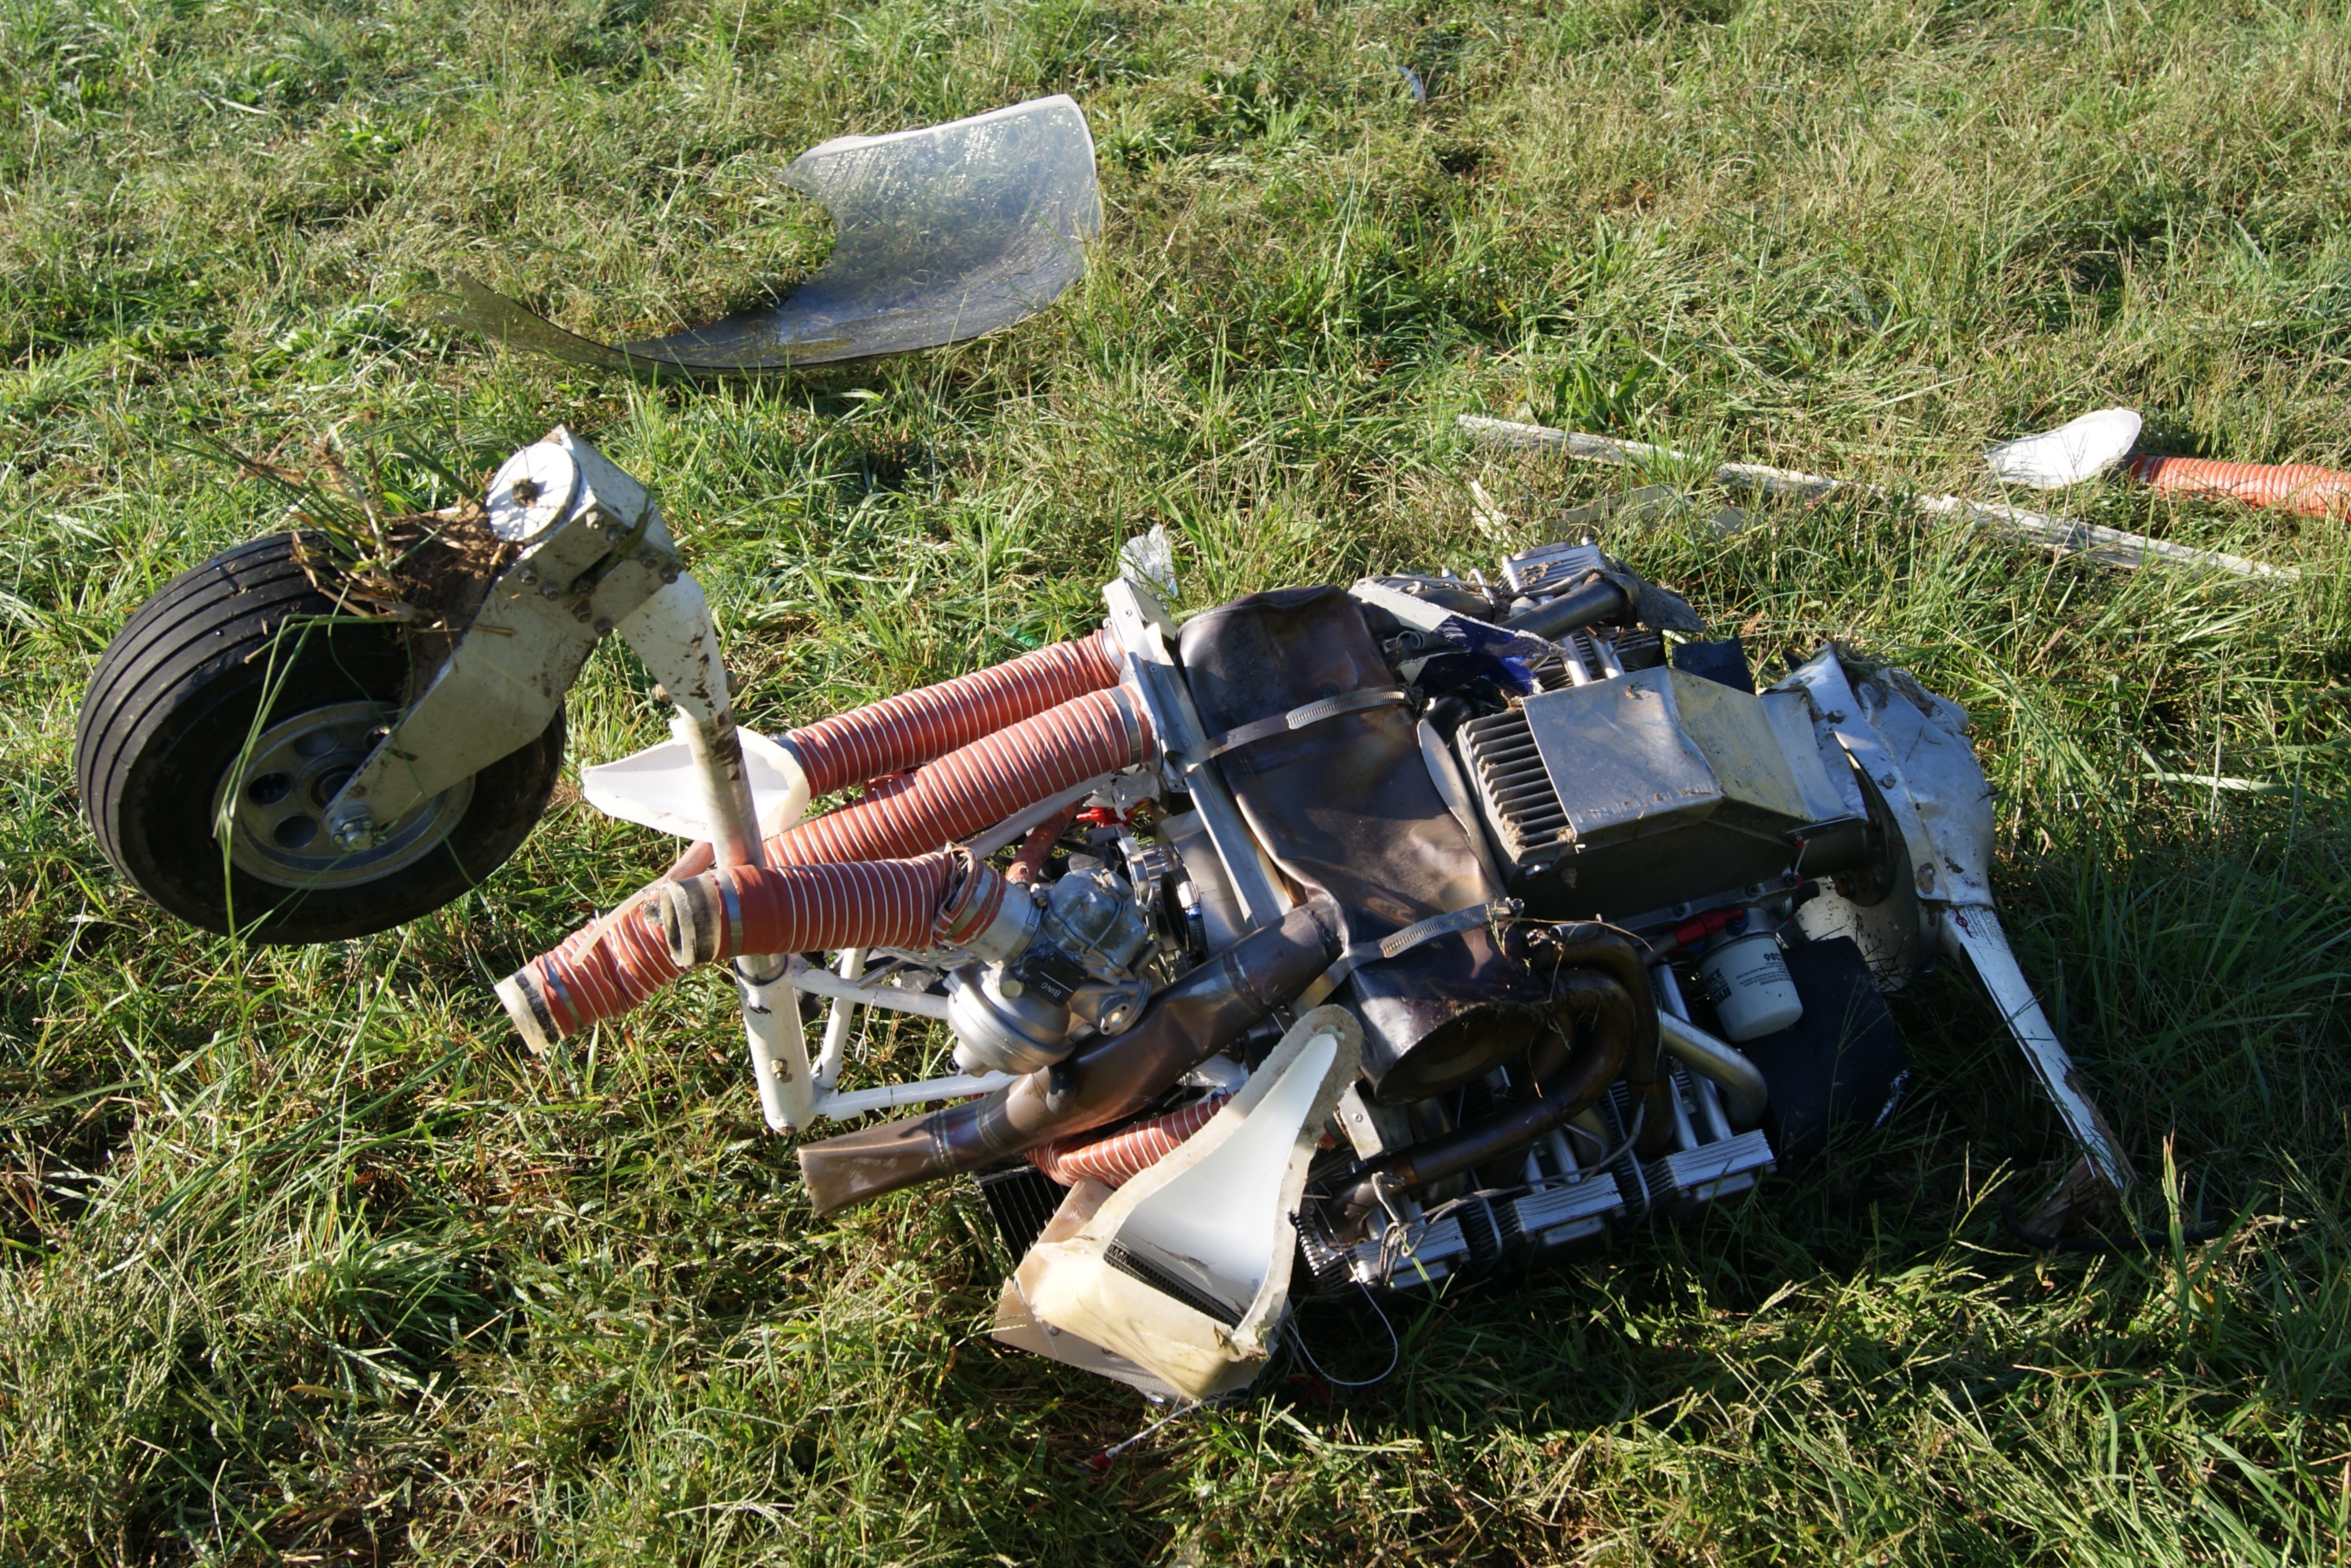
Photograph # 9 - Engine as it came to rest with nose gear attached
