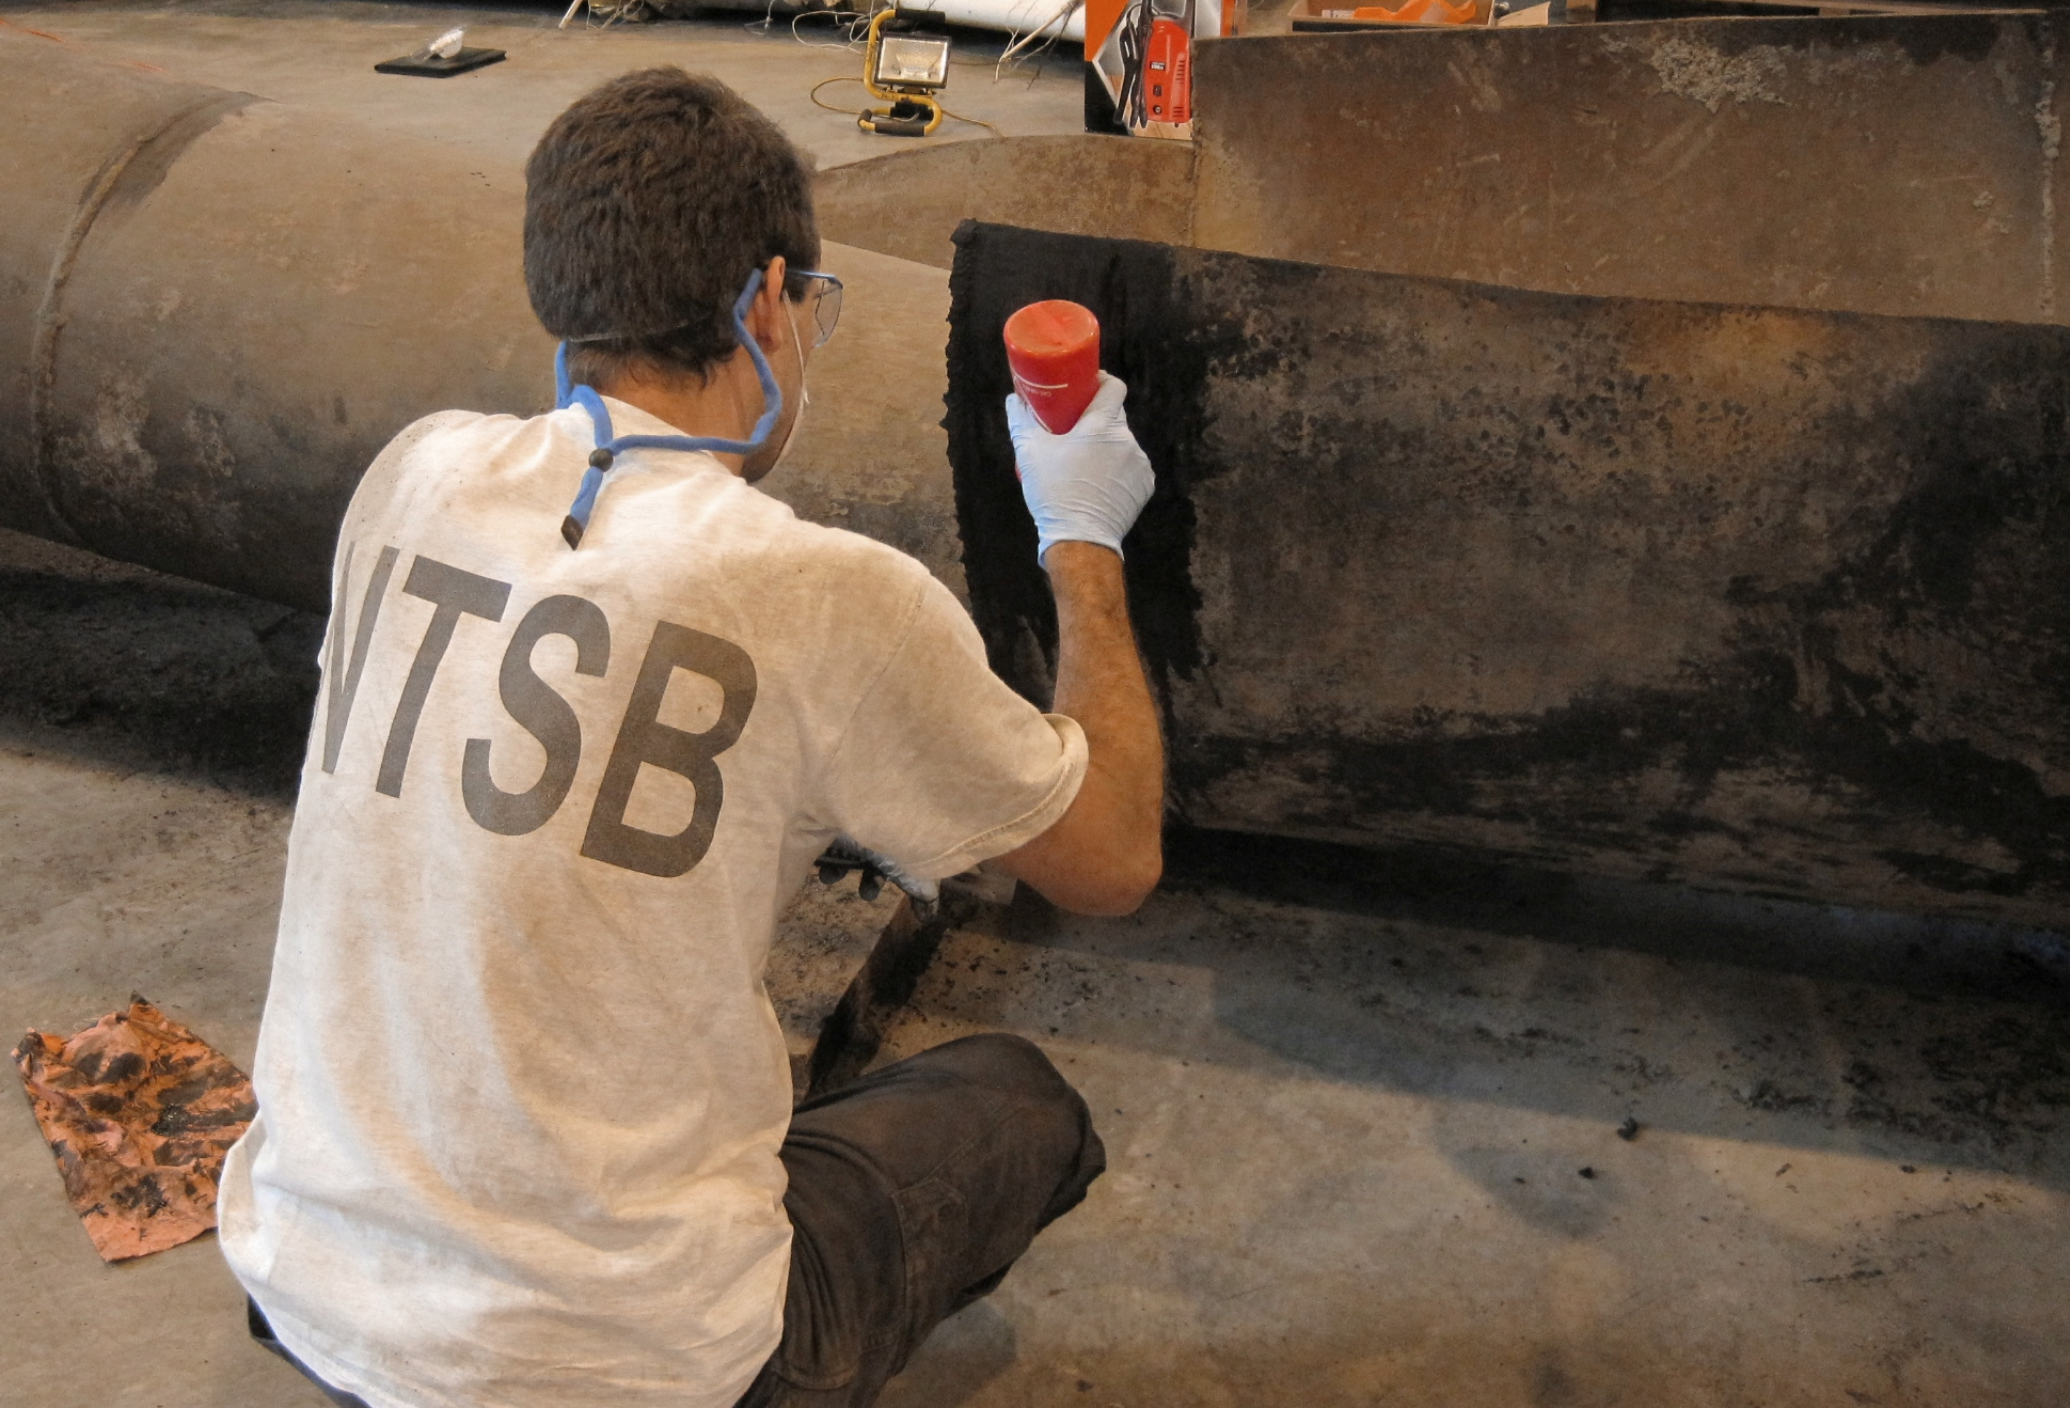
Photograph of an NTSB investigator examining fracture surfaces
