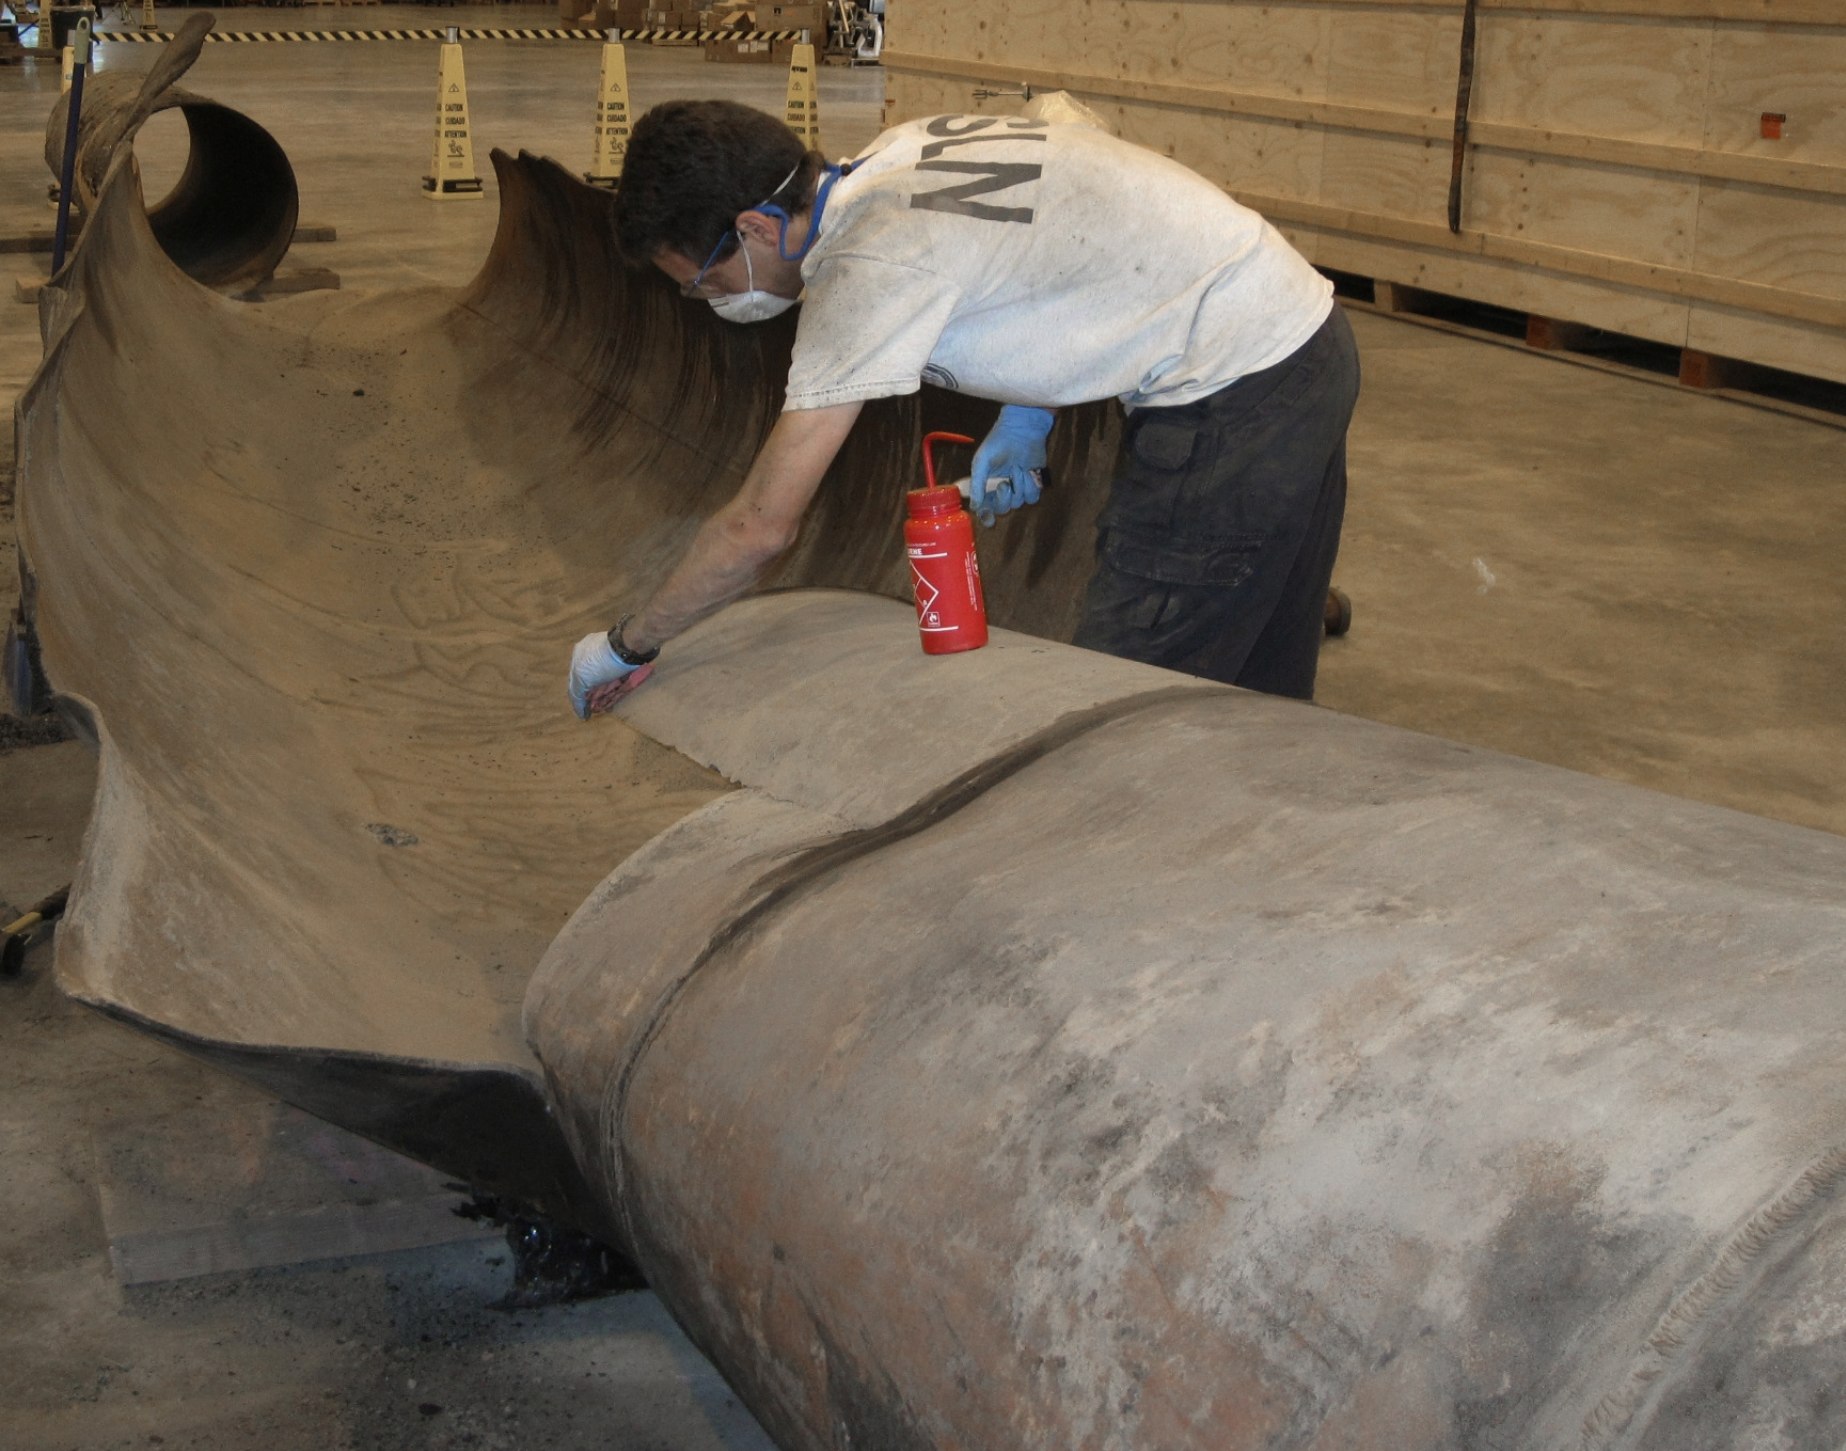
Photograph showing a view of the ruptured pipe piece with an NTSB investigator examining the fracture surfaces
