**Photo 1 – N123JN Mooney M20K wreckage debris locations on a Google Earth image.**

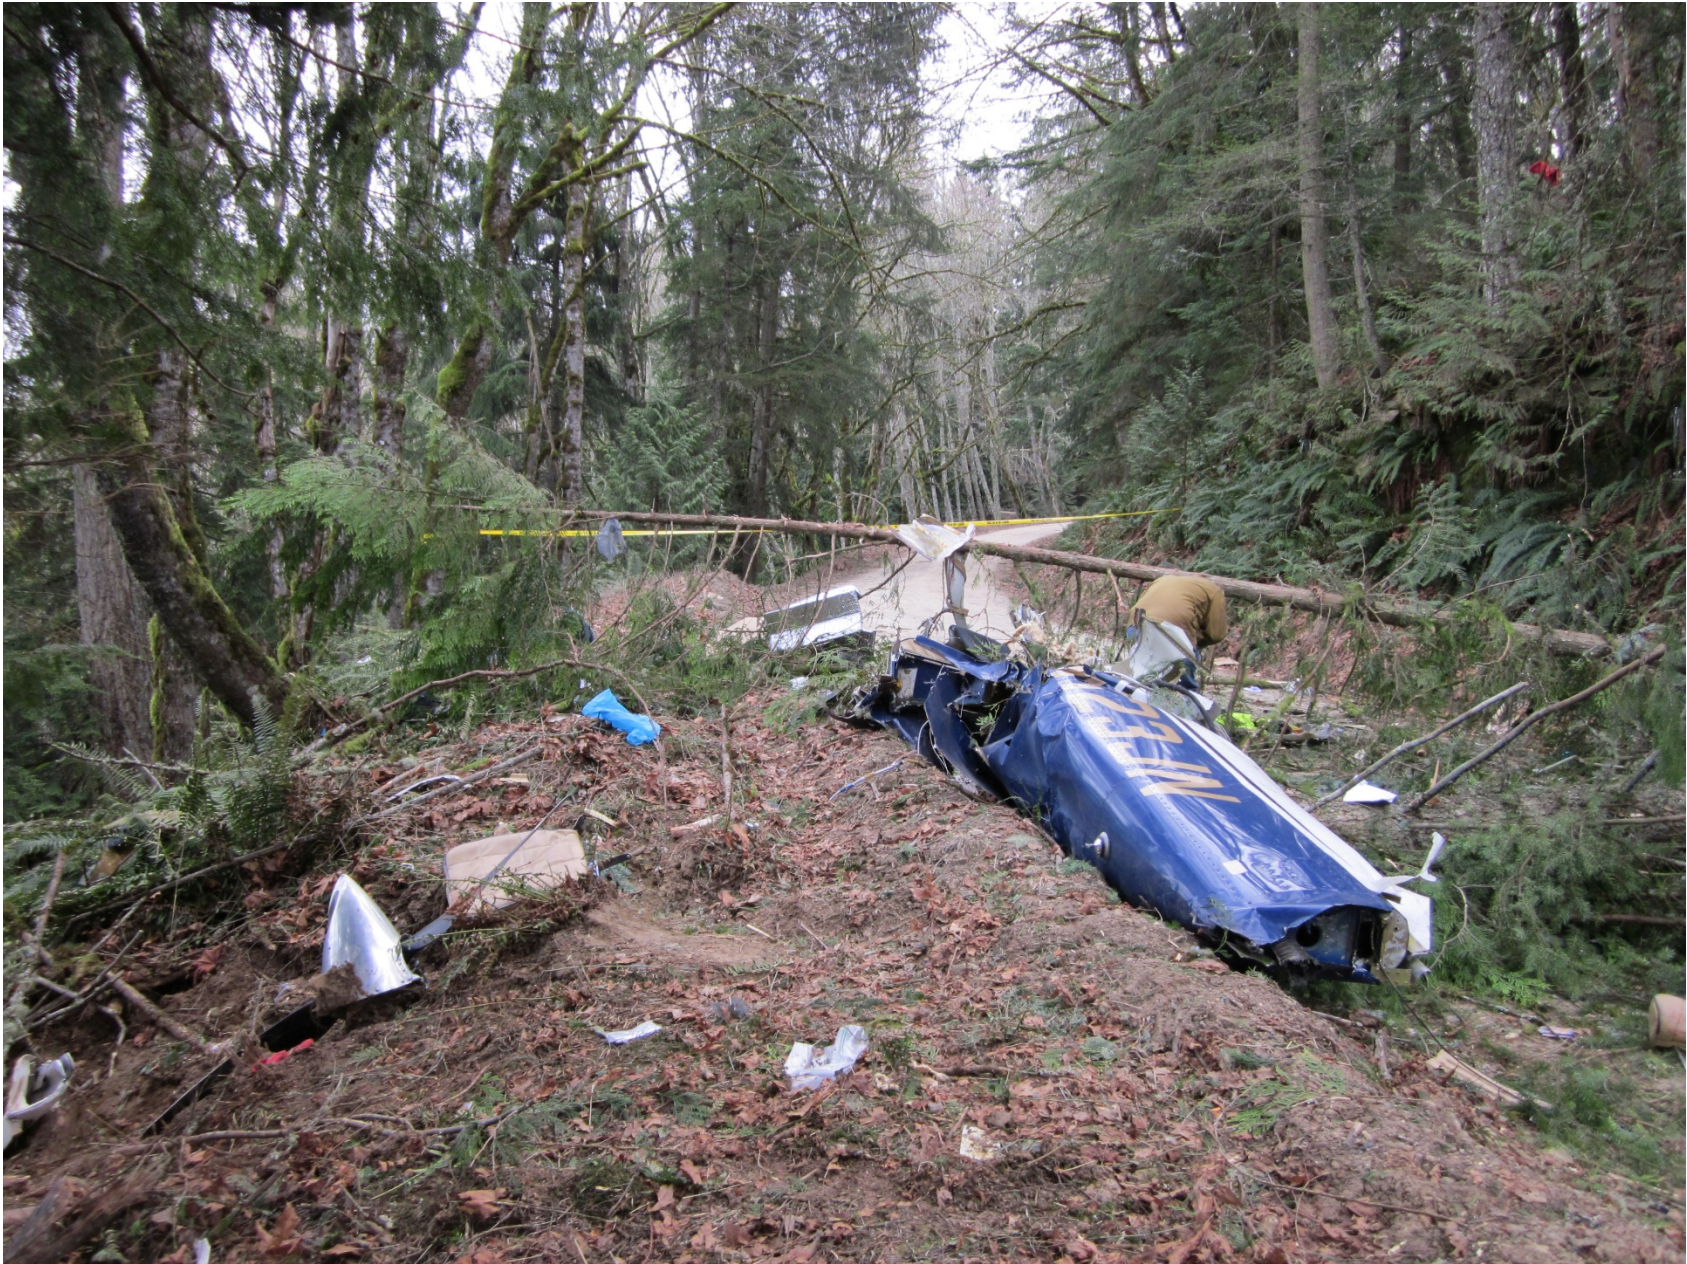
**Photo 2 - Main wreckage site indicating aft fuselage and propeller.**

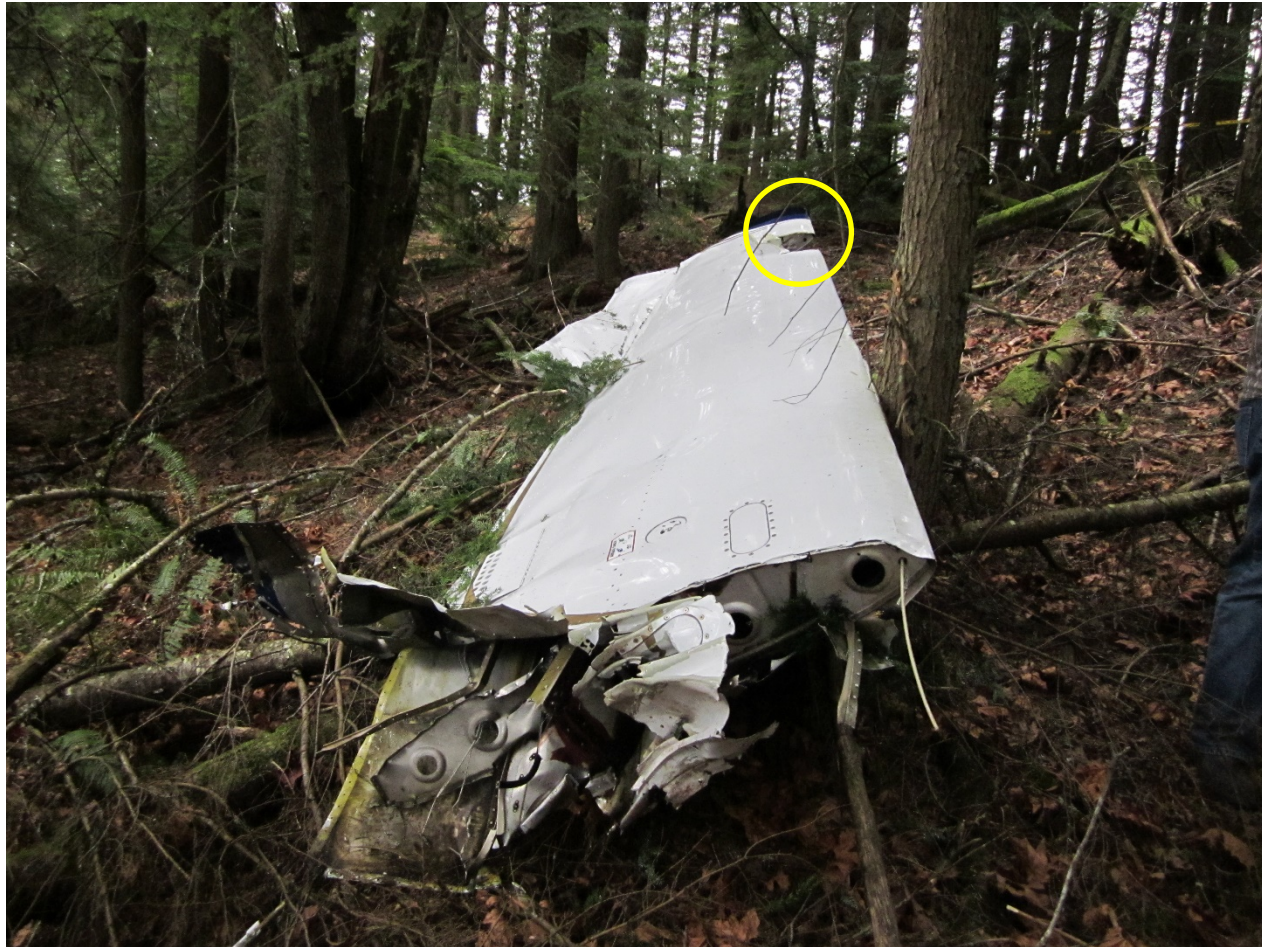
**Photo 4 - Left wing exhibiting tree strike at outer section.**

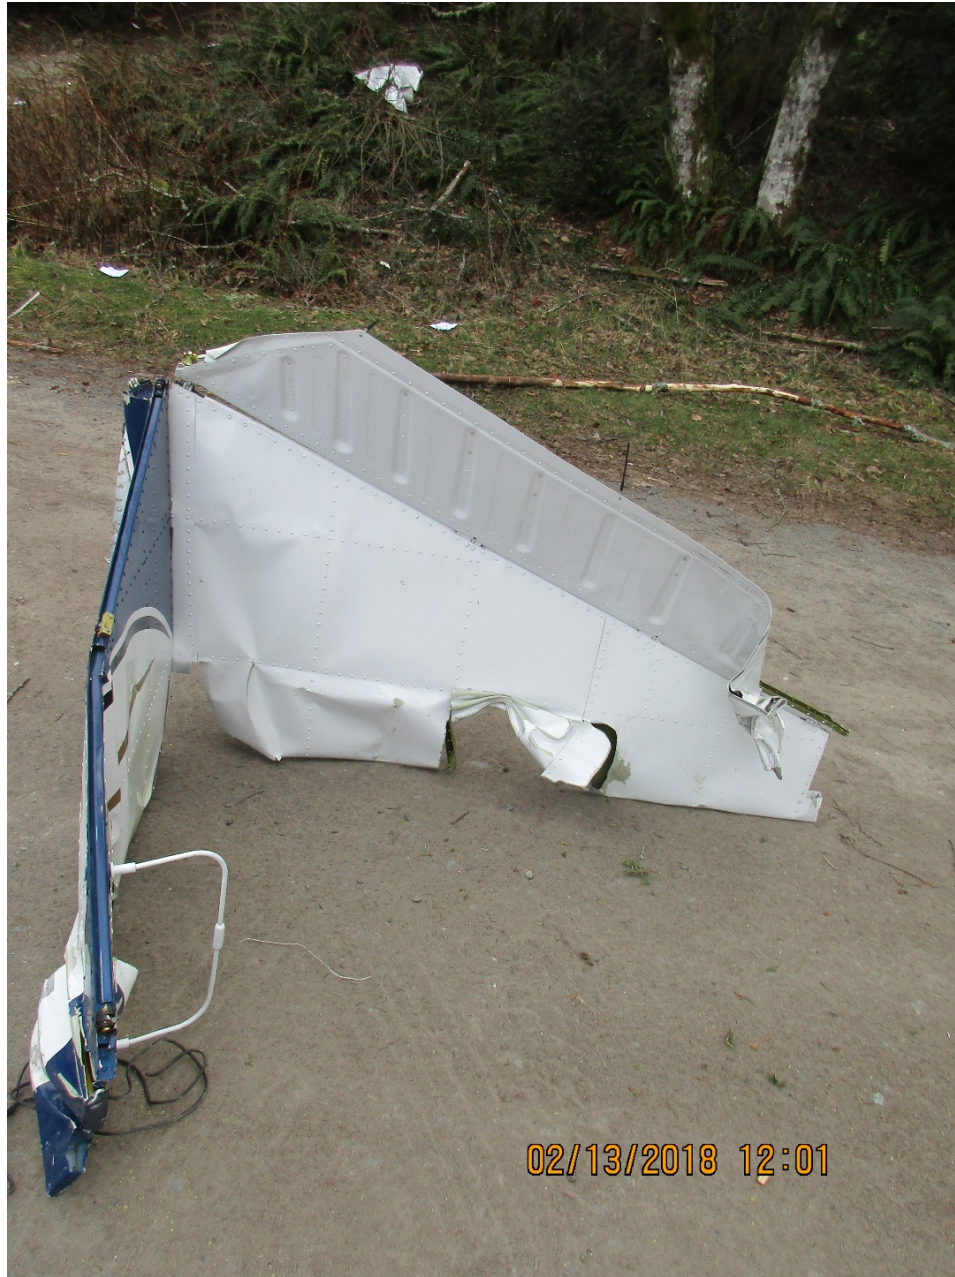
**Photo 5 - Vertical and left horizontal stabilizer. (courtesy of FAA)**

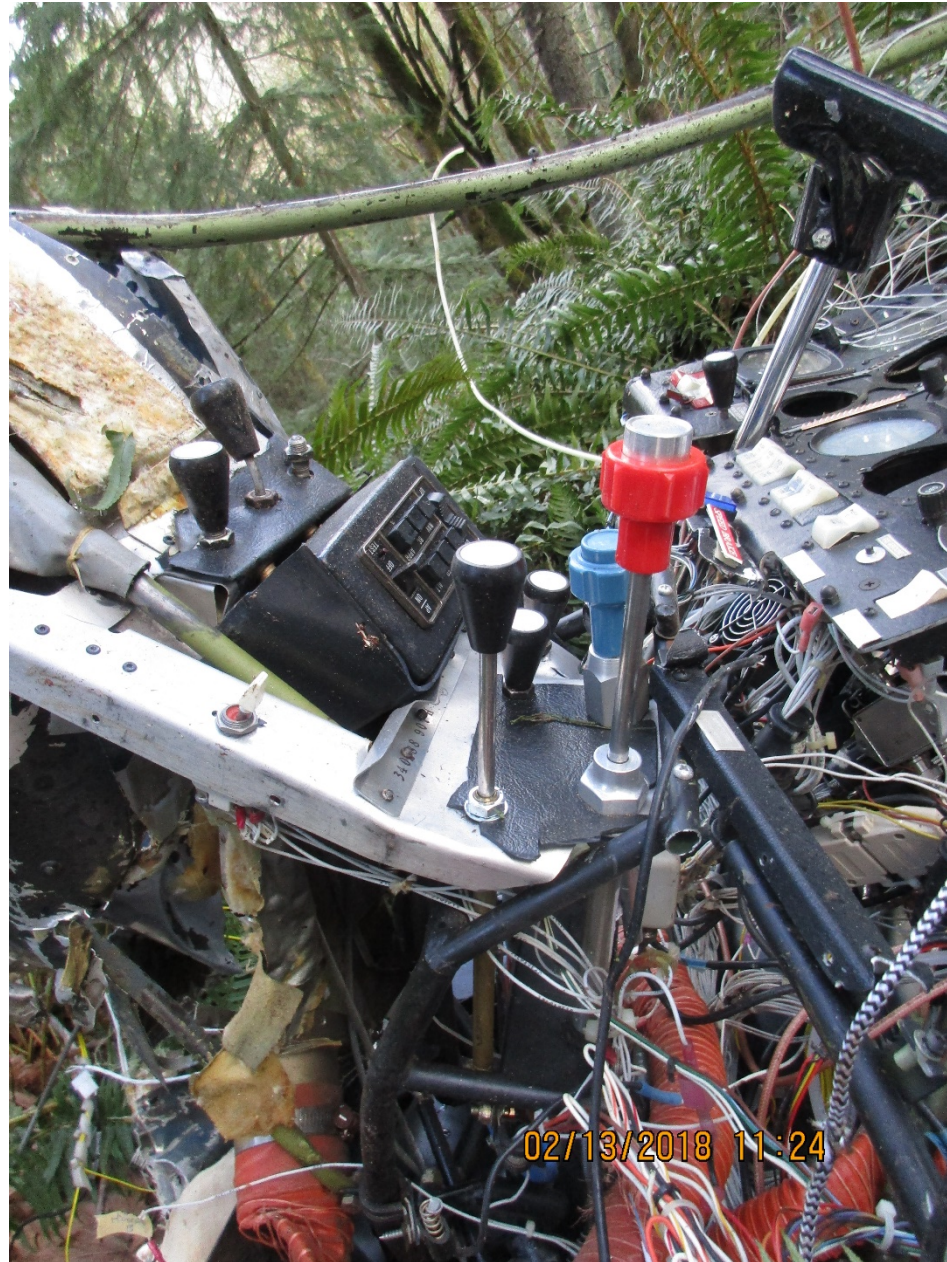
**Photo 6 - Cockpit section indicating engine controls and instrument panel. (Courtesy of FAA)**

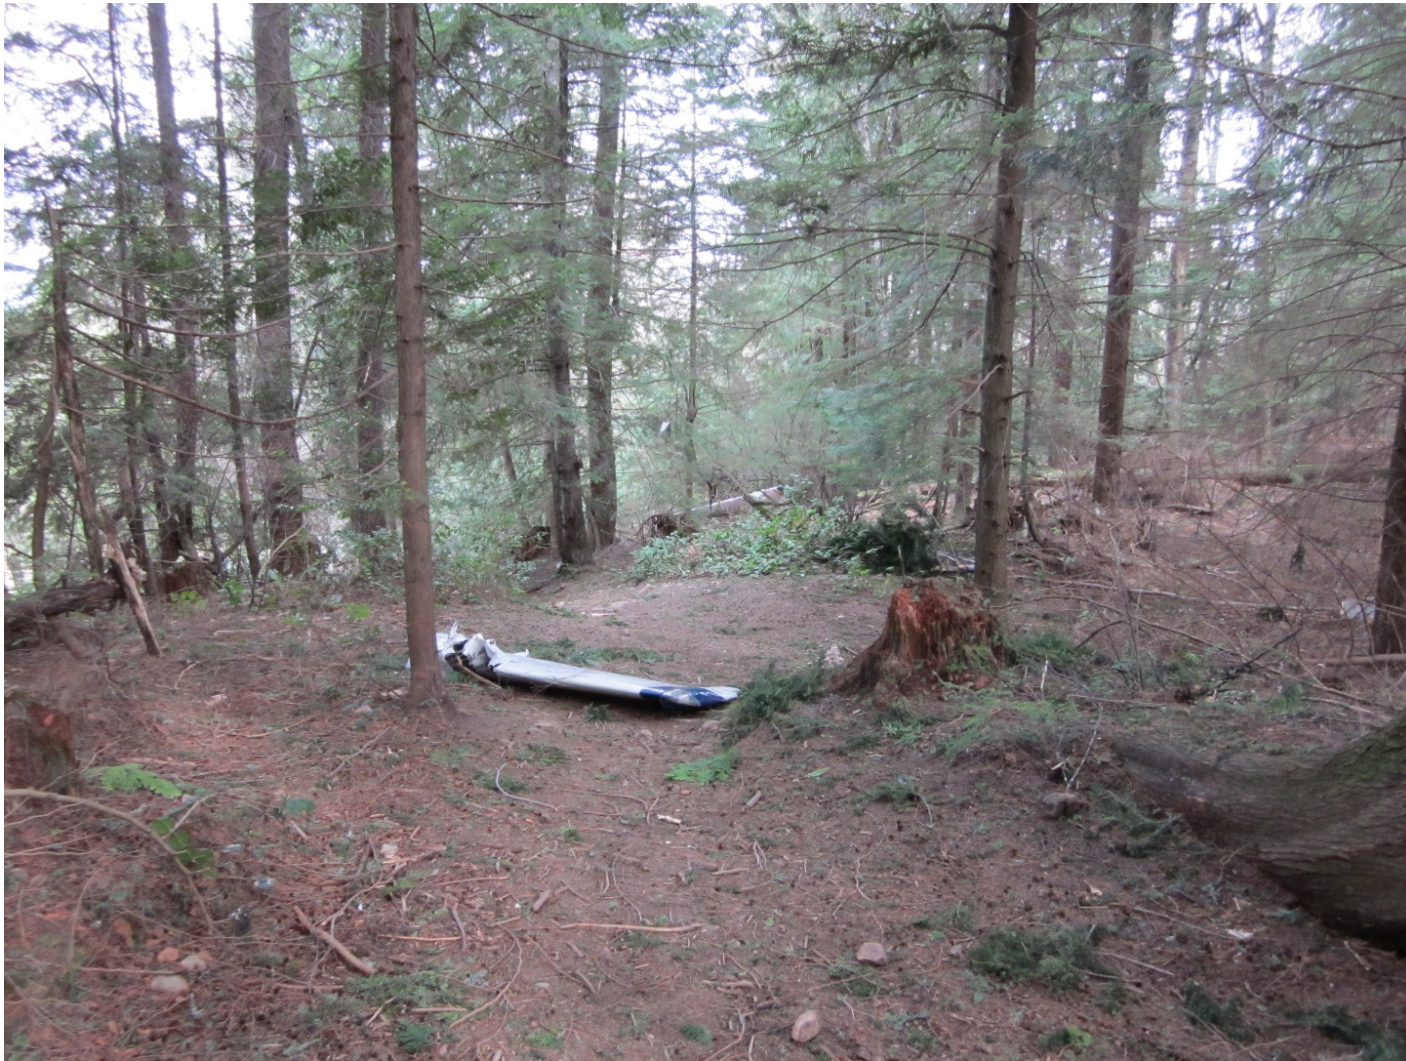
**Photo 7- Right separated outboard wing near initial impact site.**

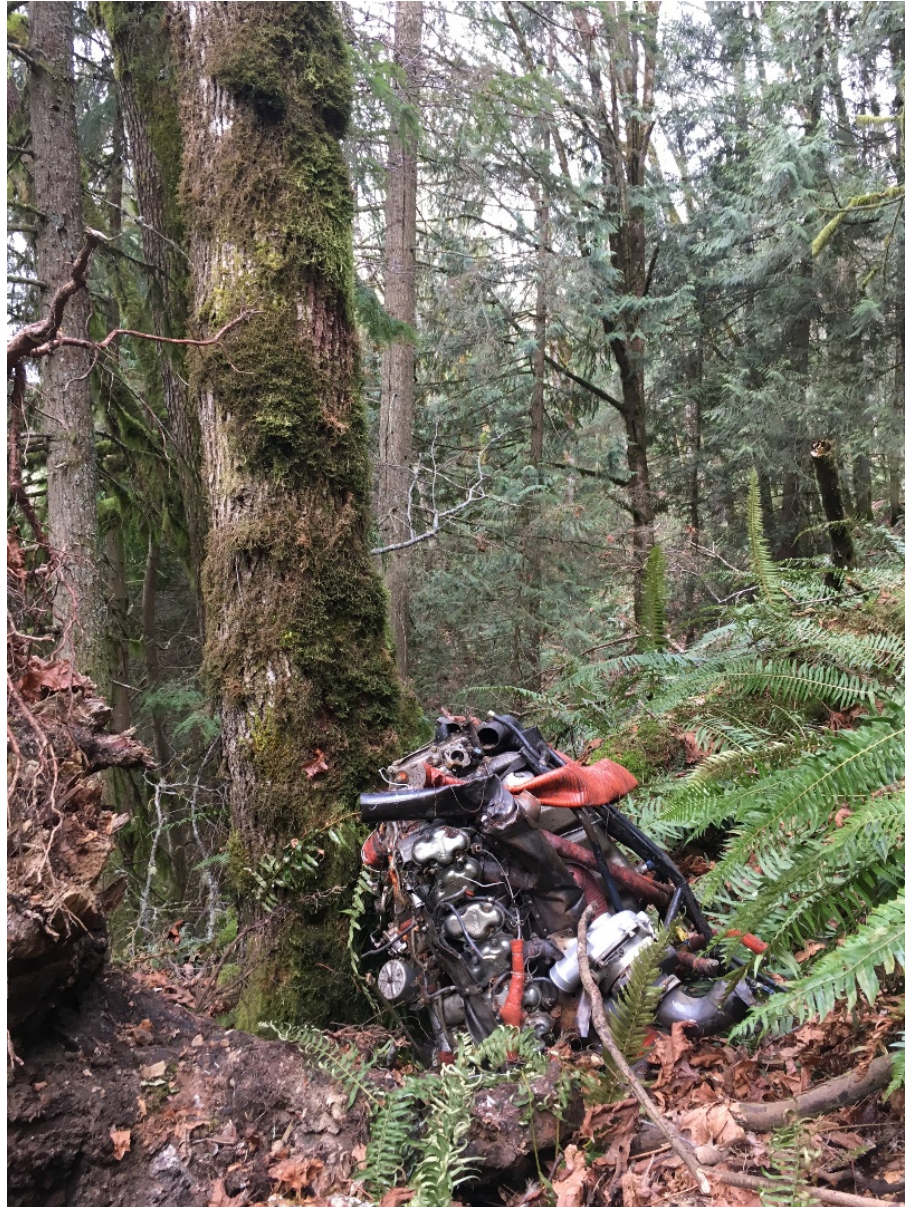
**Photo 8 - Engine separated from the wreckage, leaning against a tree at the end of the debris field.**
