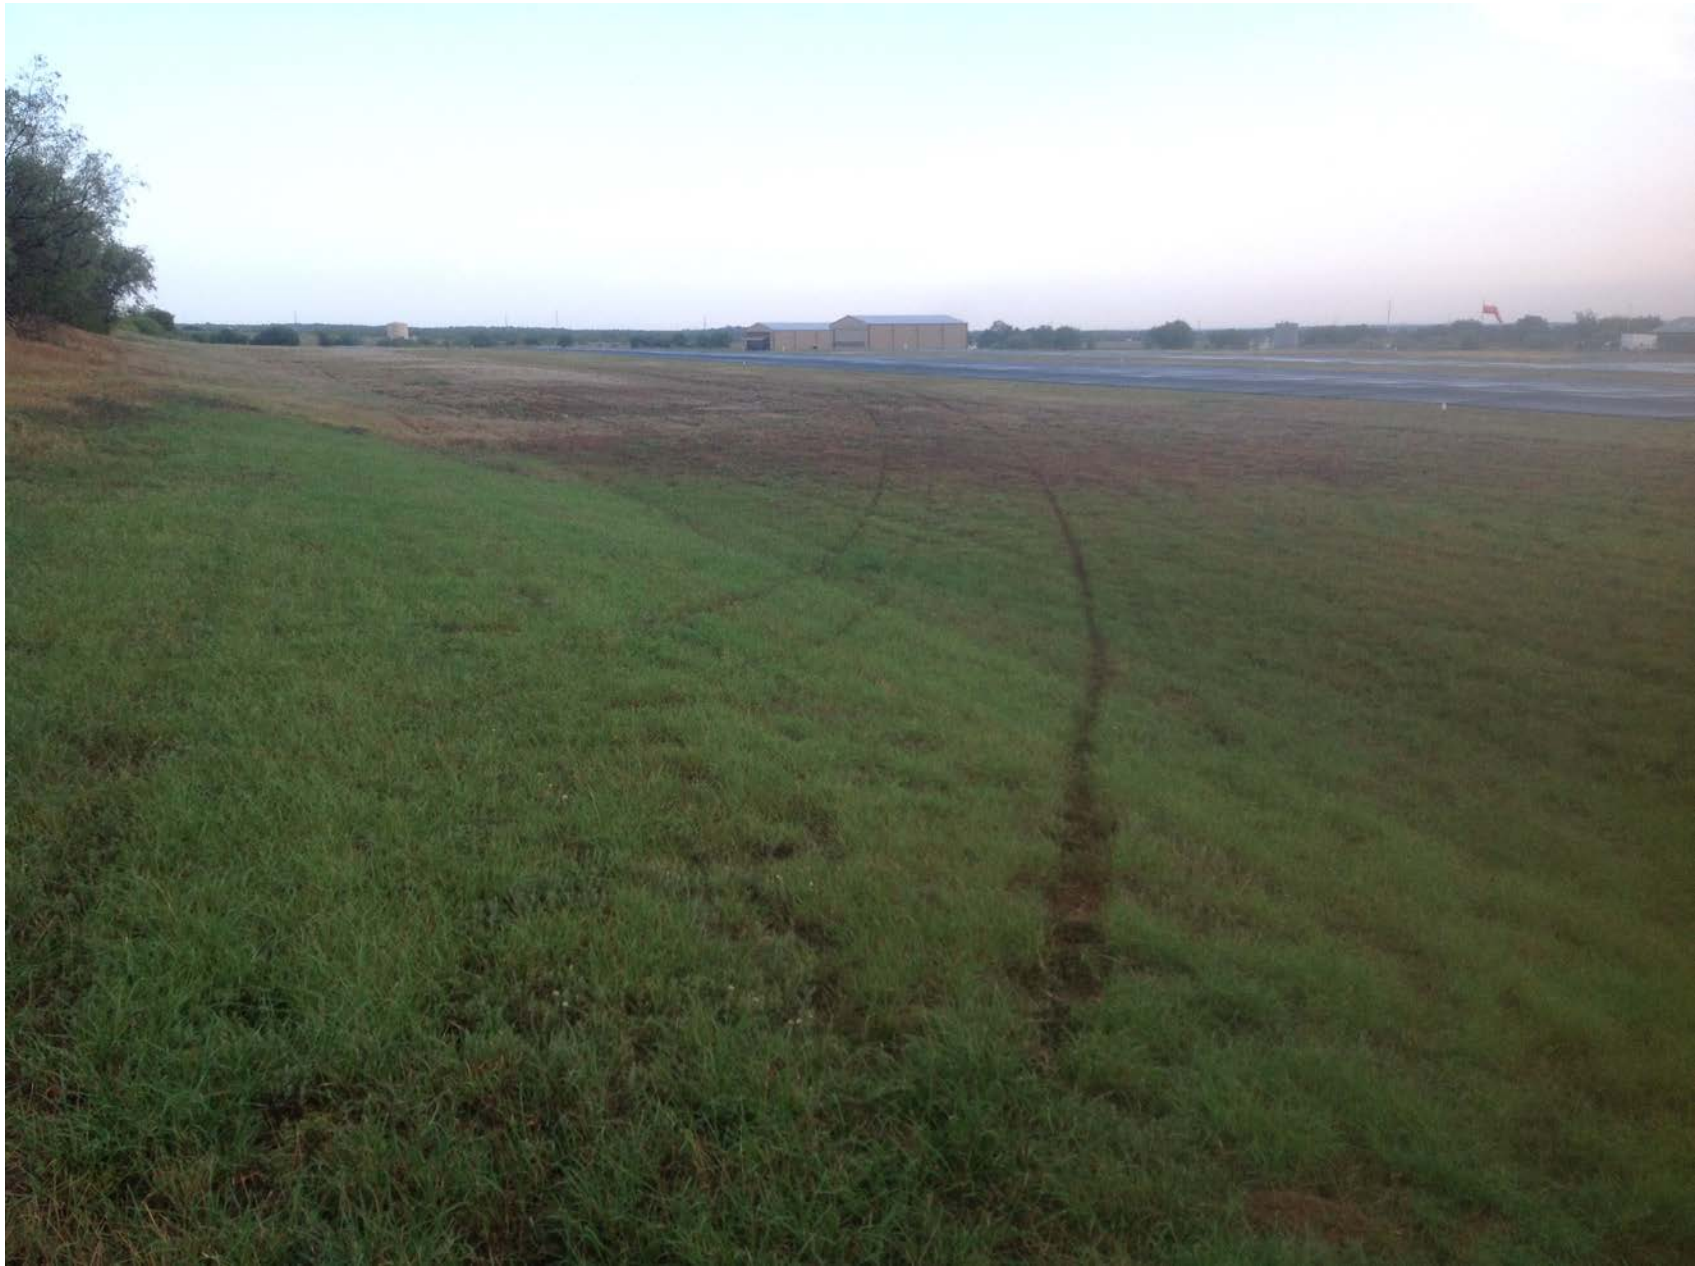
**Photo 1 – View of the ground scars through the grass with the runway in the background.**

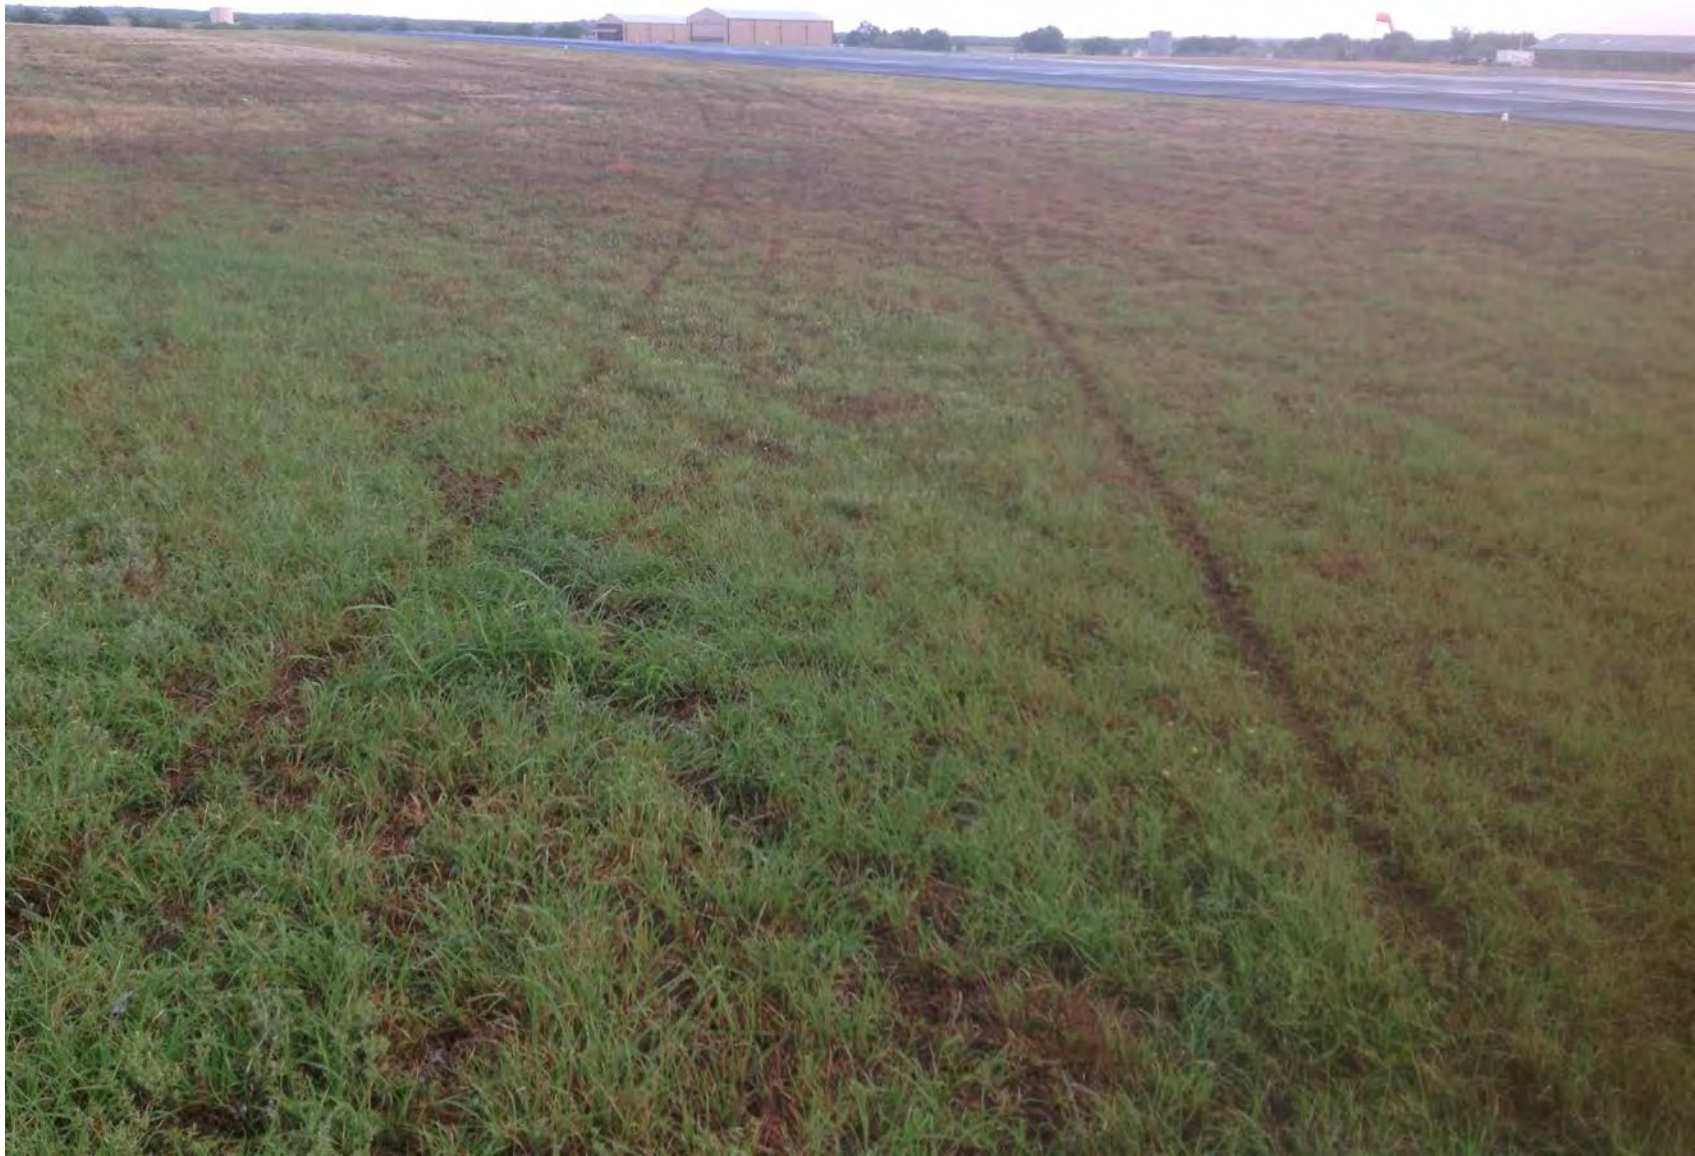
**Photo 2 - View of the ground scars through the grass with the runway in the background.**

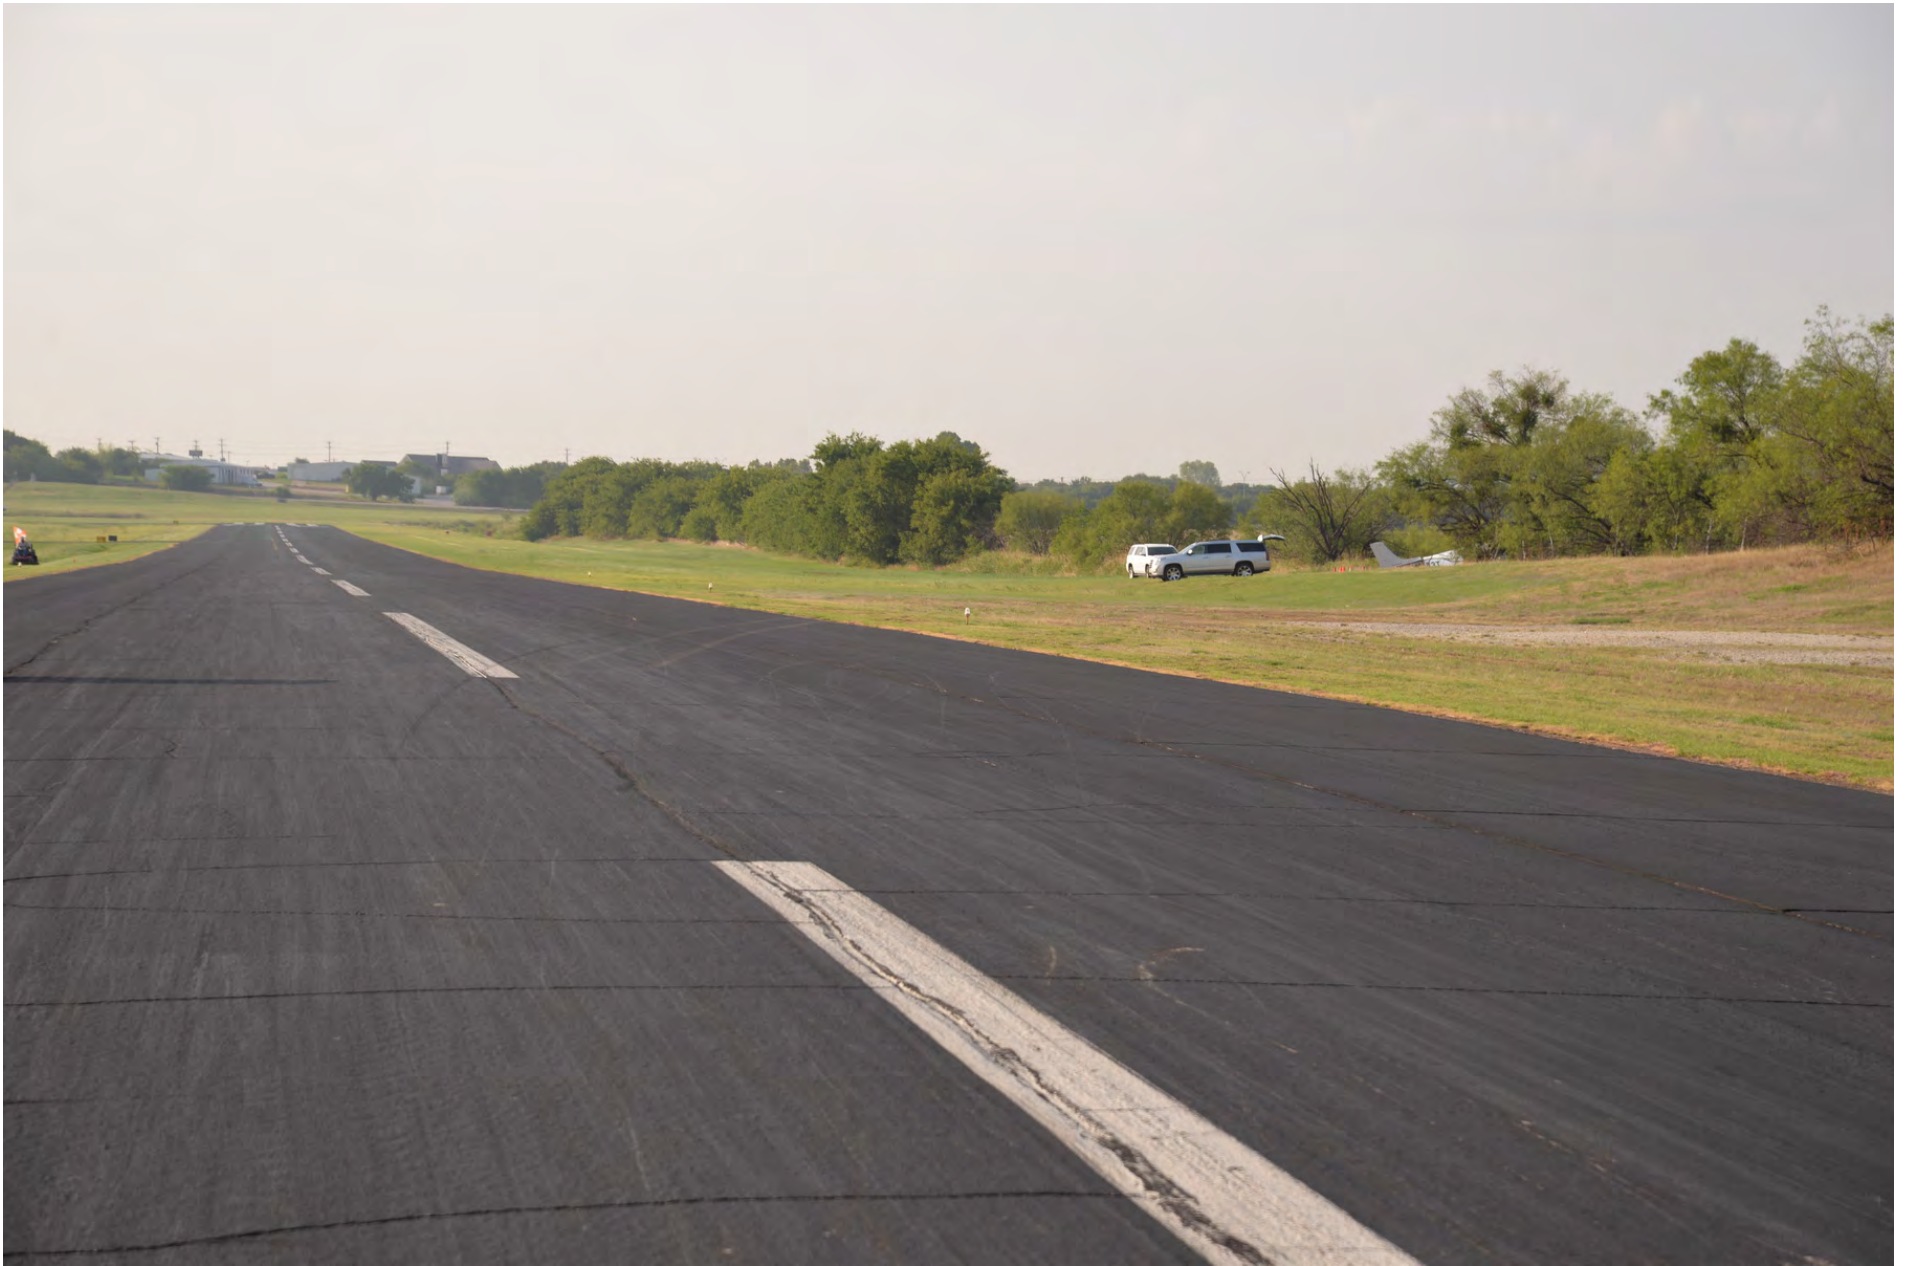
**Photo 3 - View of the runway looking towards the wreckage.**

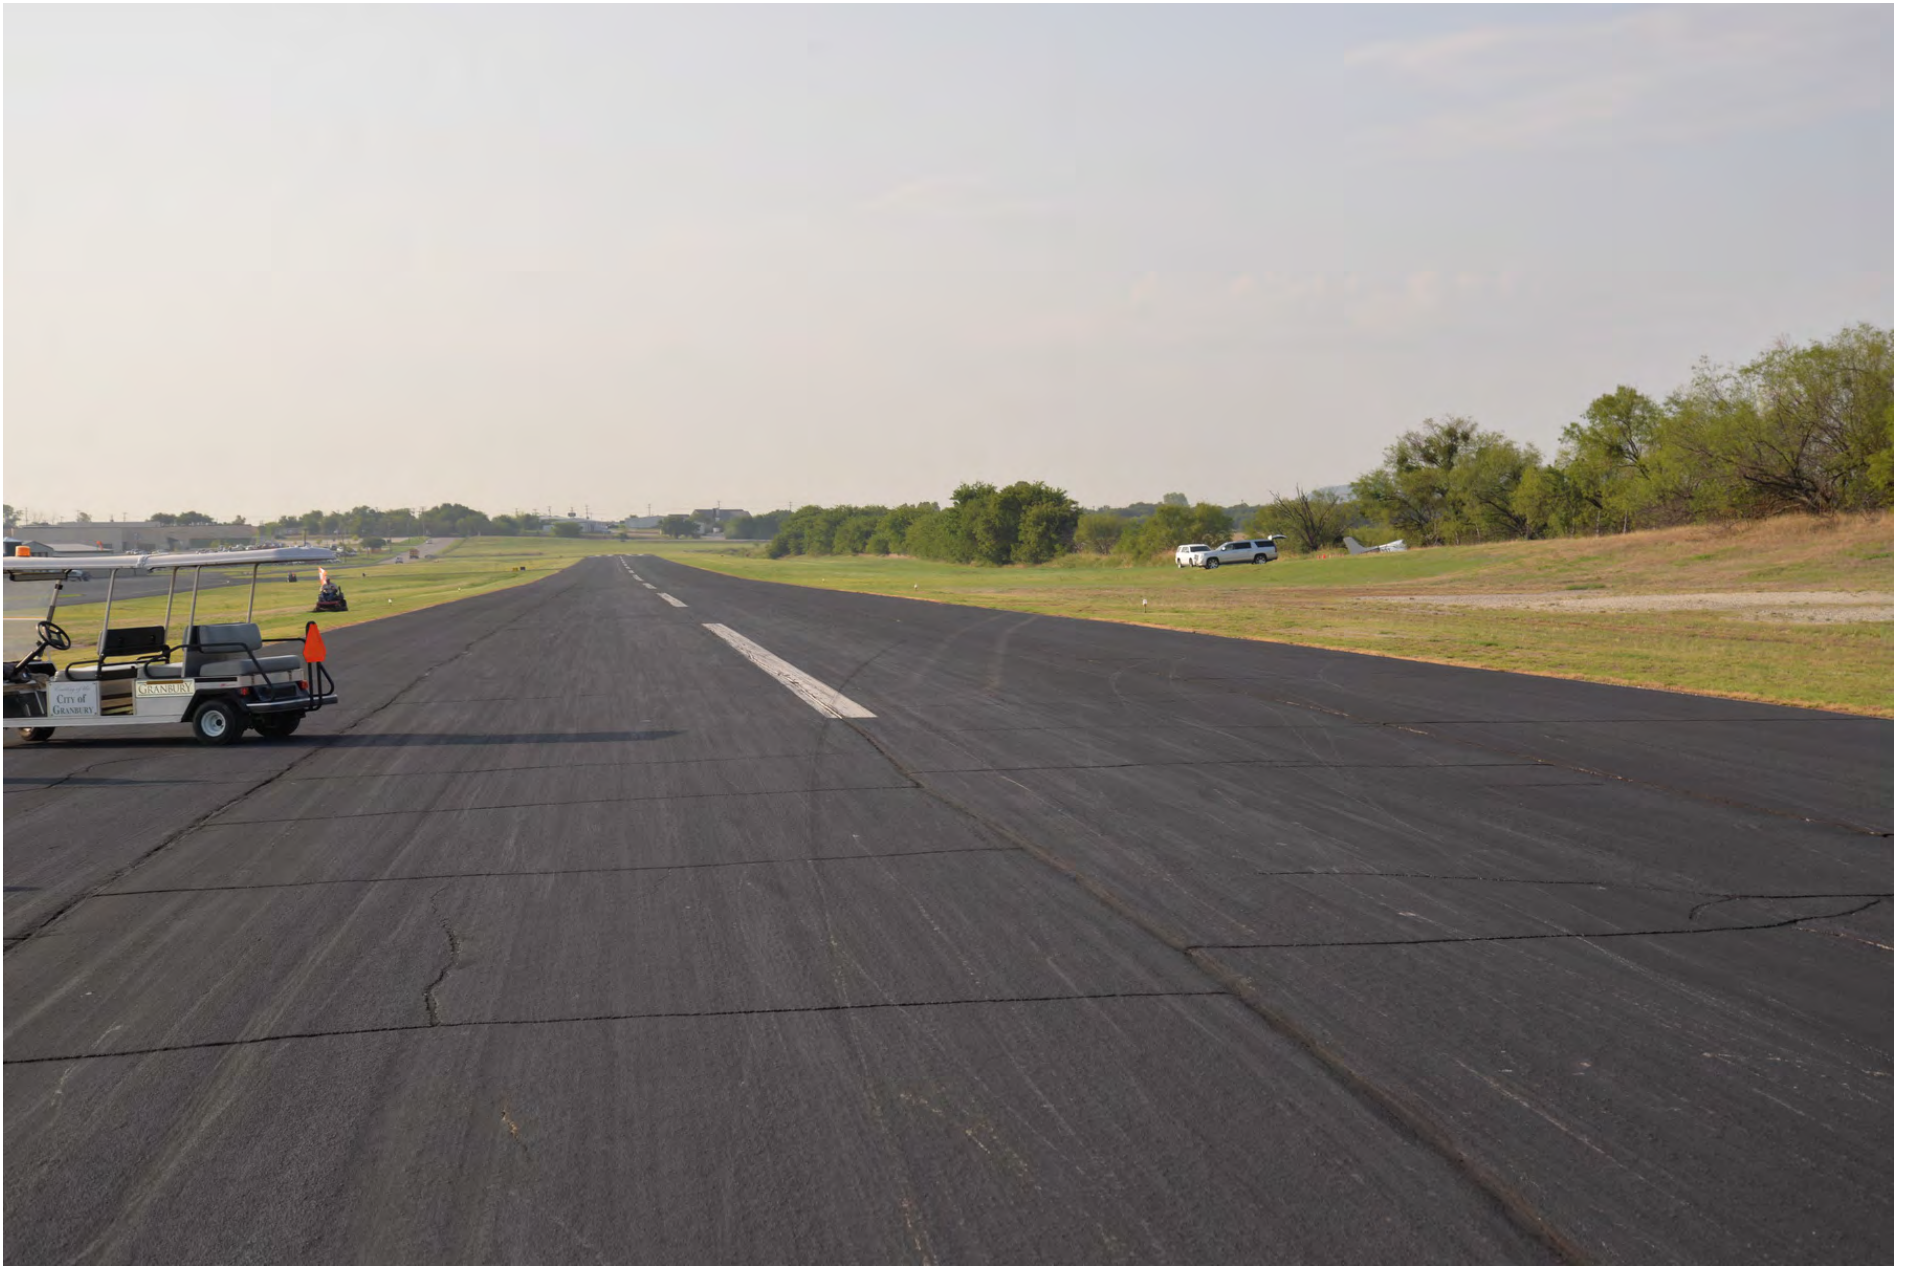
**Photo 4 - View of the runway looking towards the wreckage.**

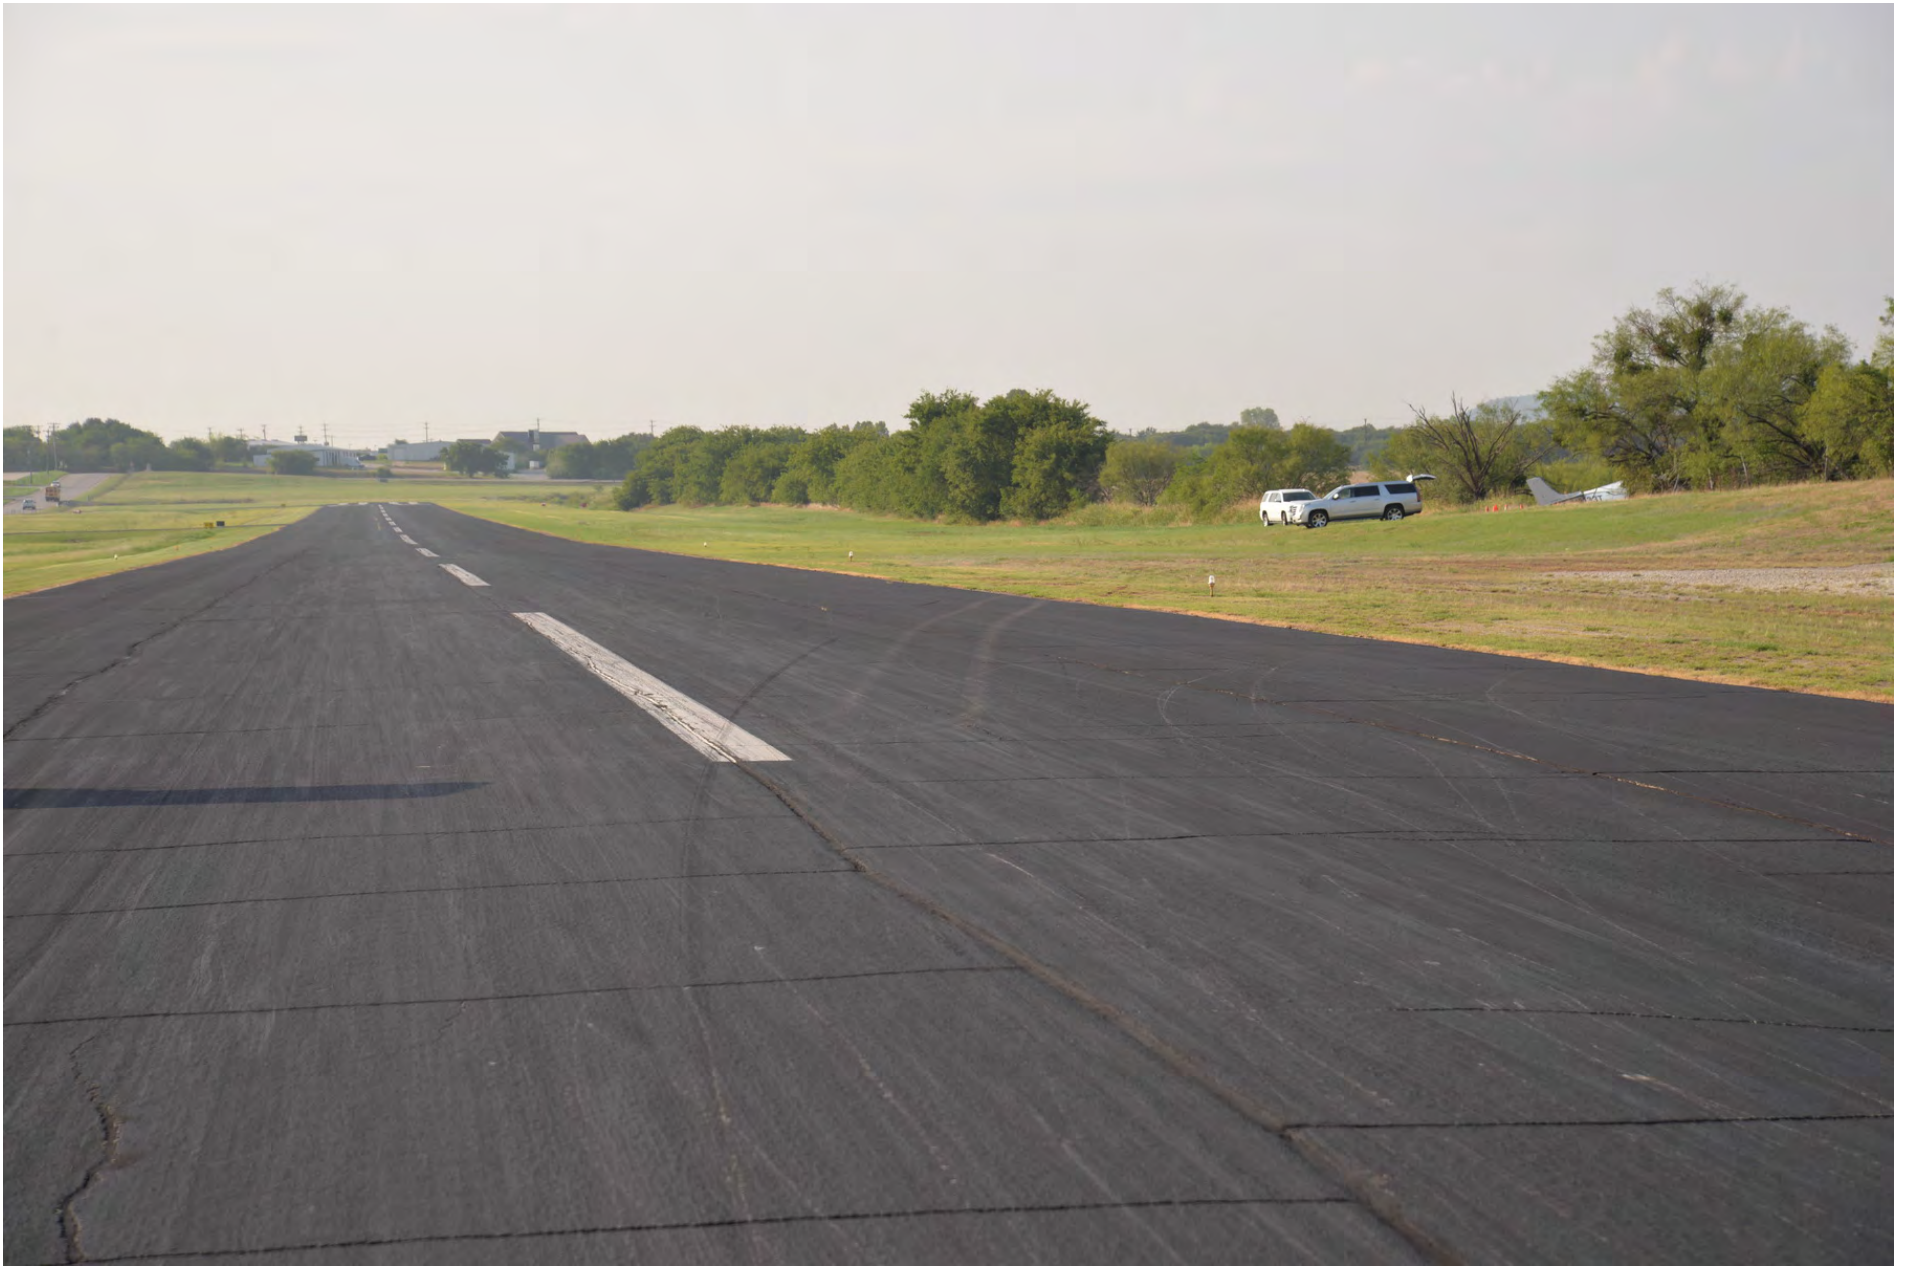
**Photo 5 - View of the runway looking towards the wreckage.**

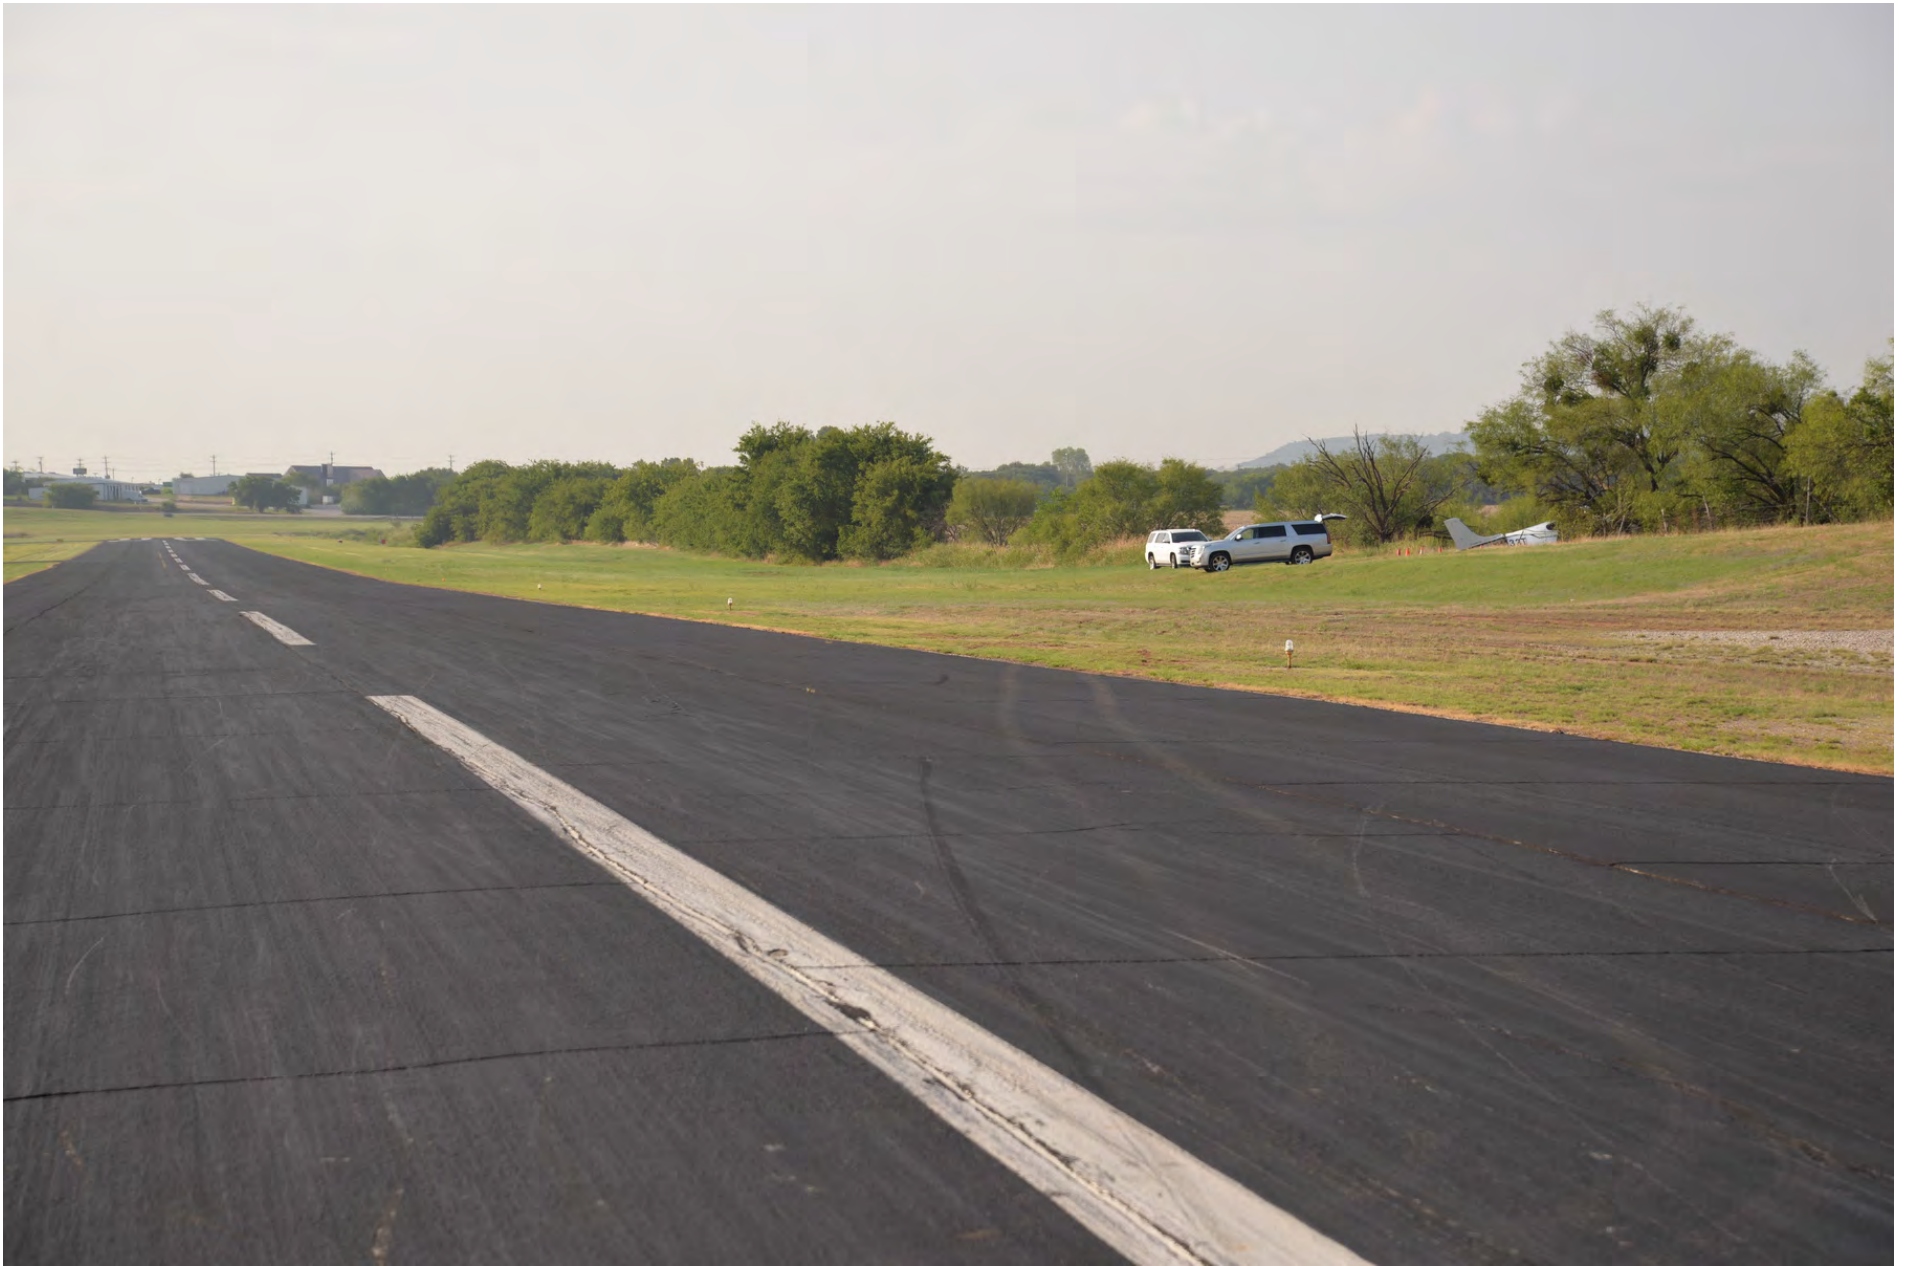
**Photo 6 - Close-up view of the runway looking towards the wreckage.**

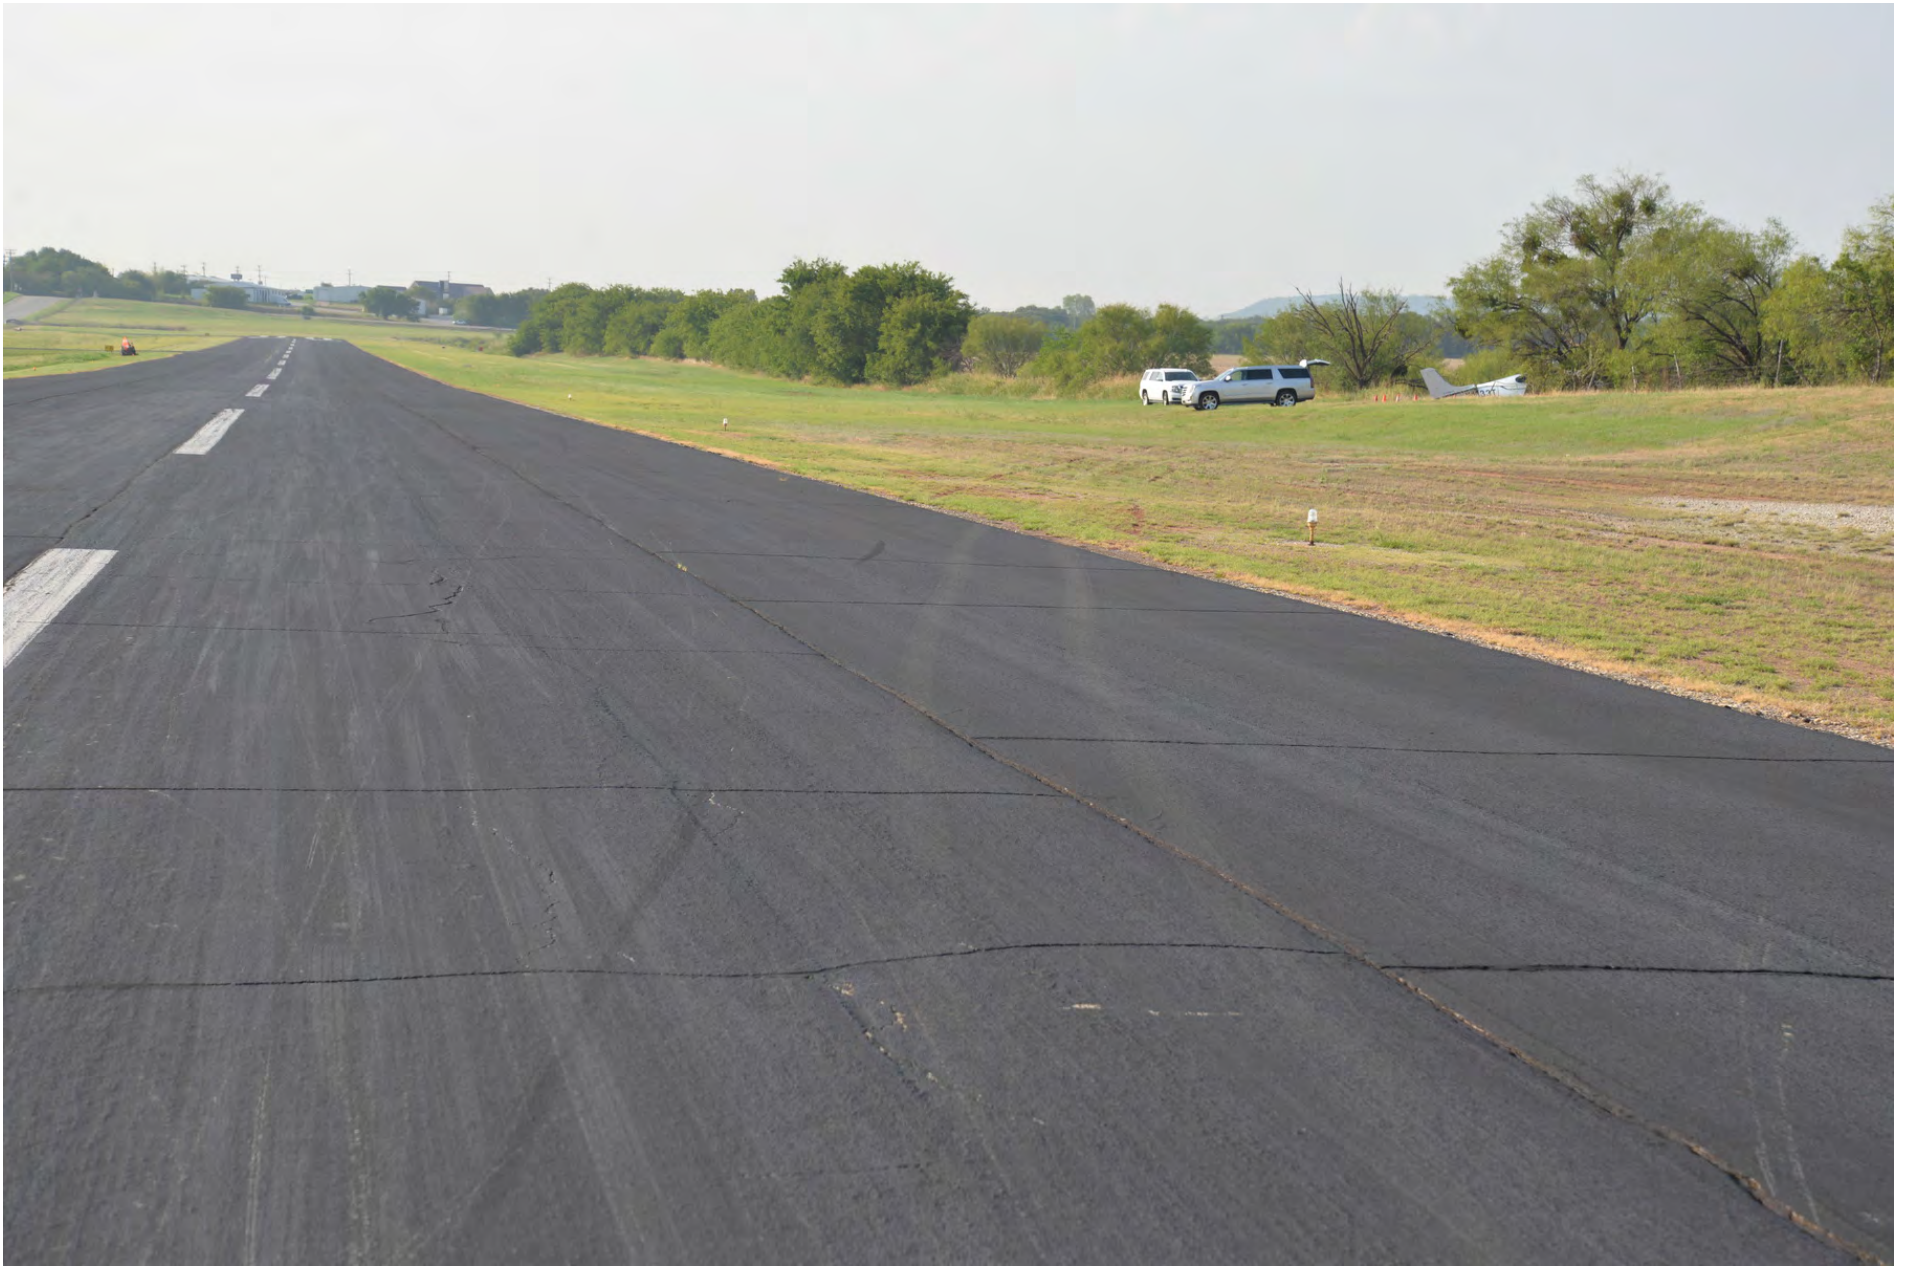
**Photo 7 - Close-up view of the runway looking towards the wreckage.**

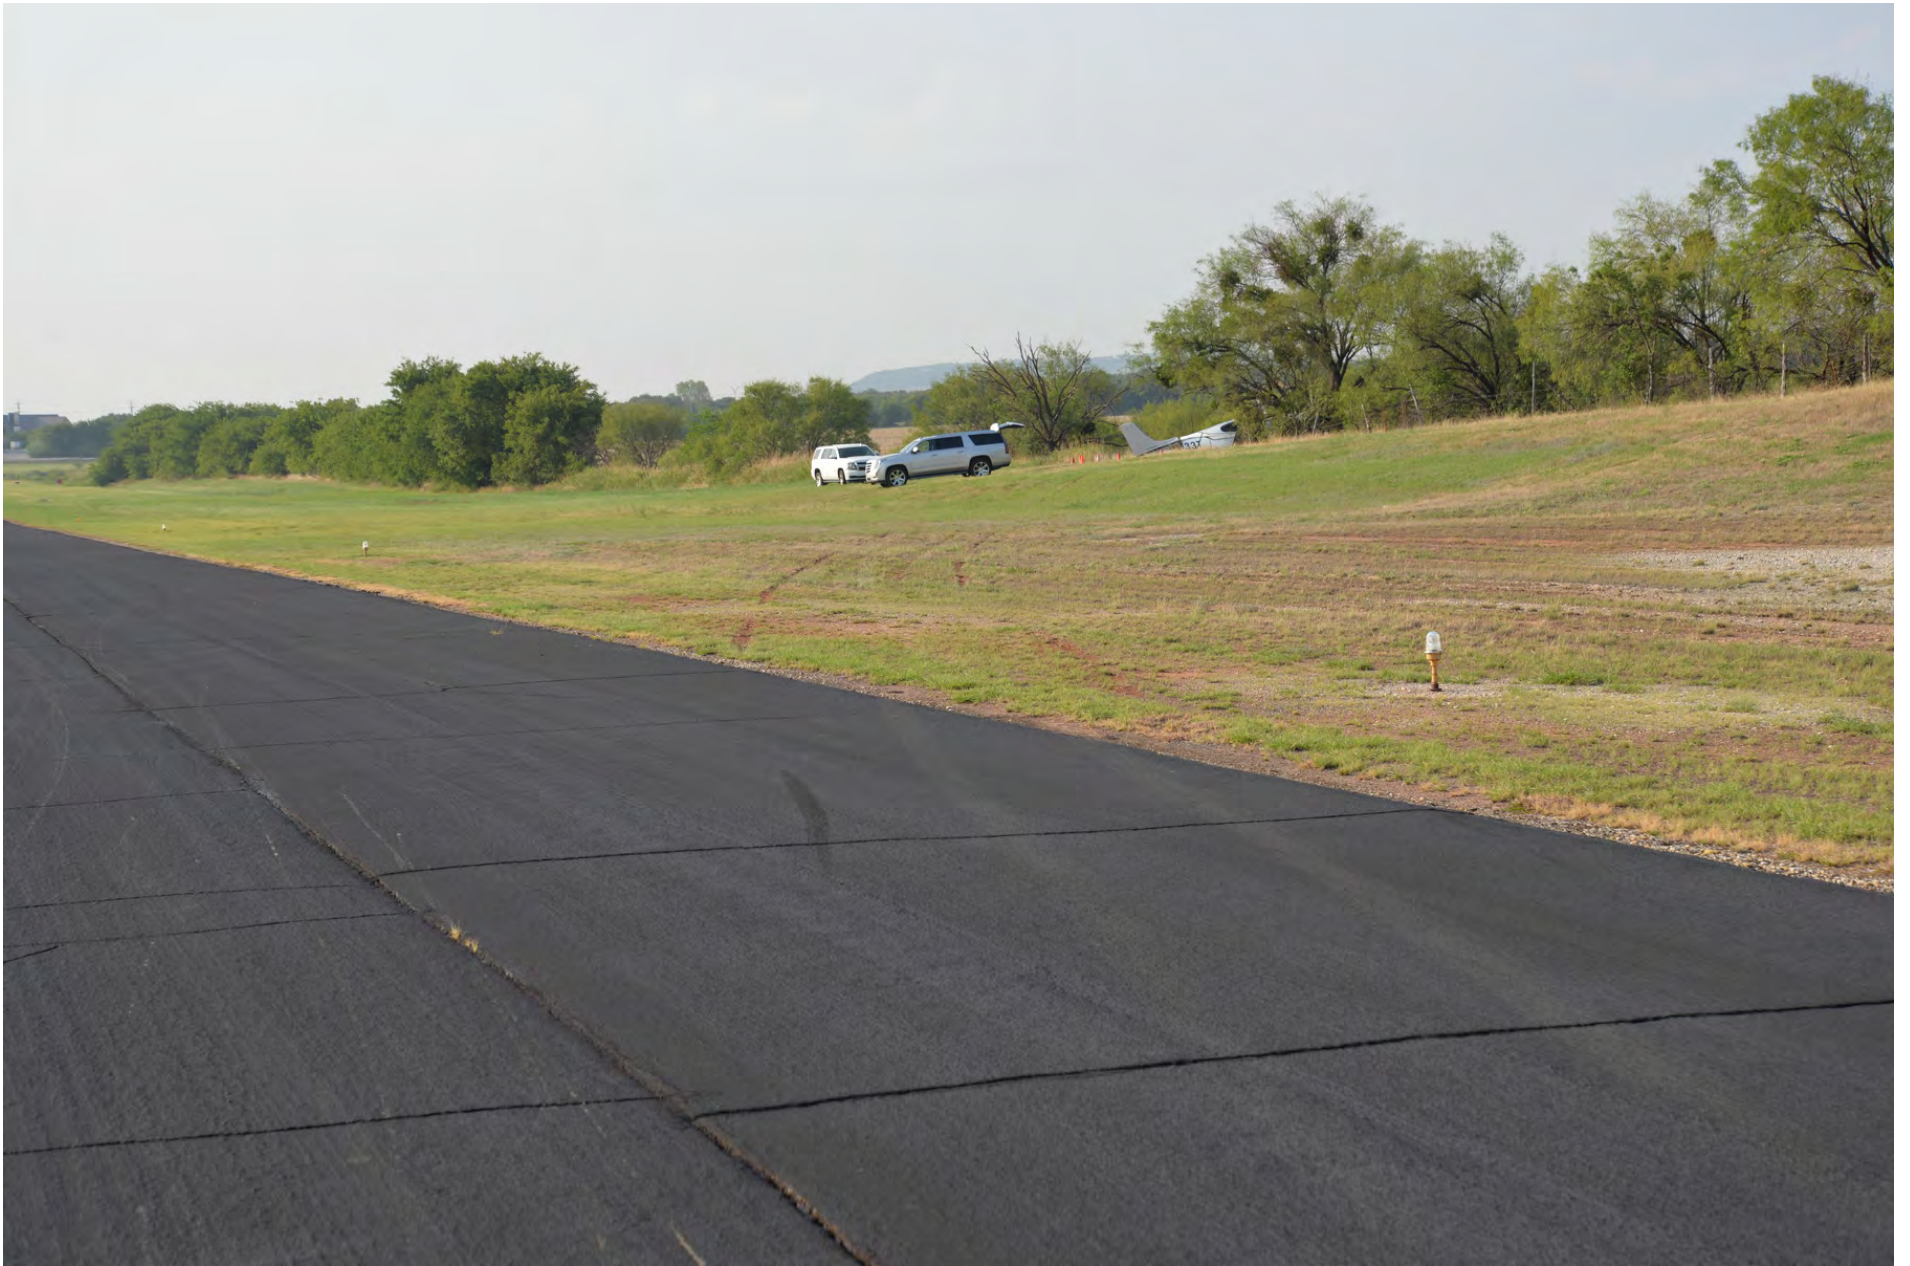
**Photo 8 - Close-up view of the runway looking towards the wreckage.**

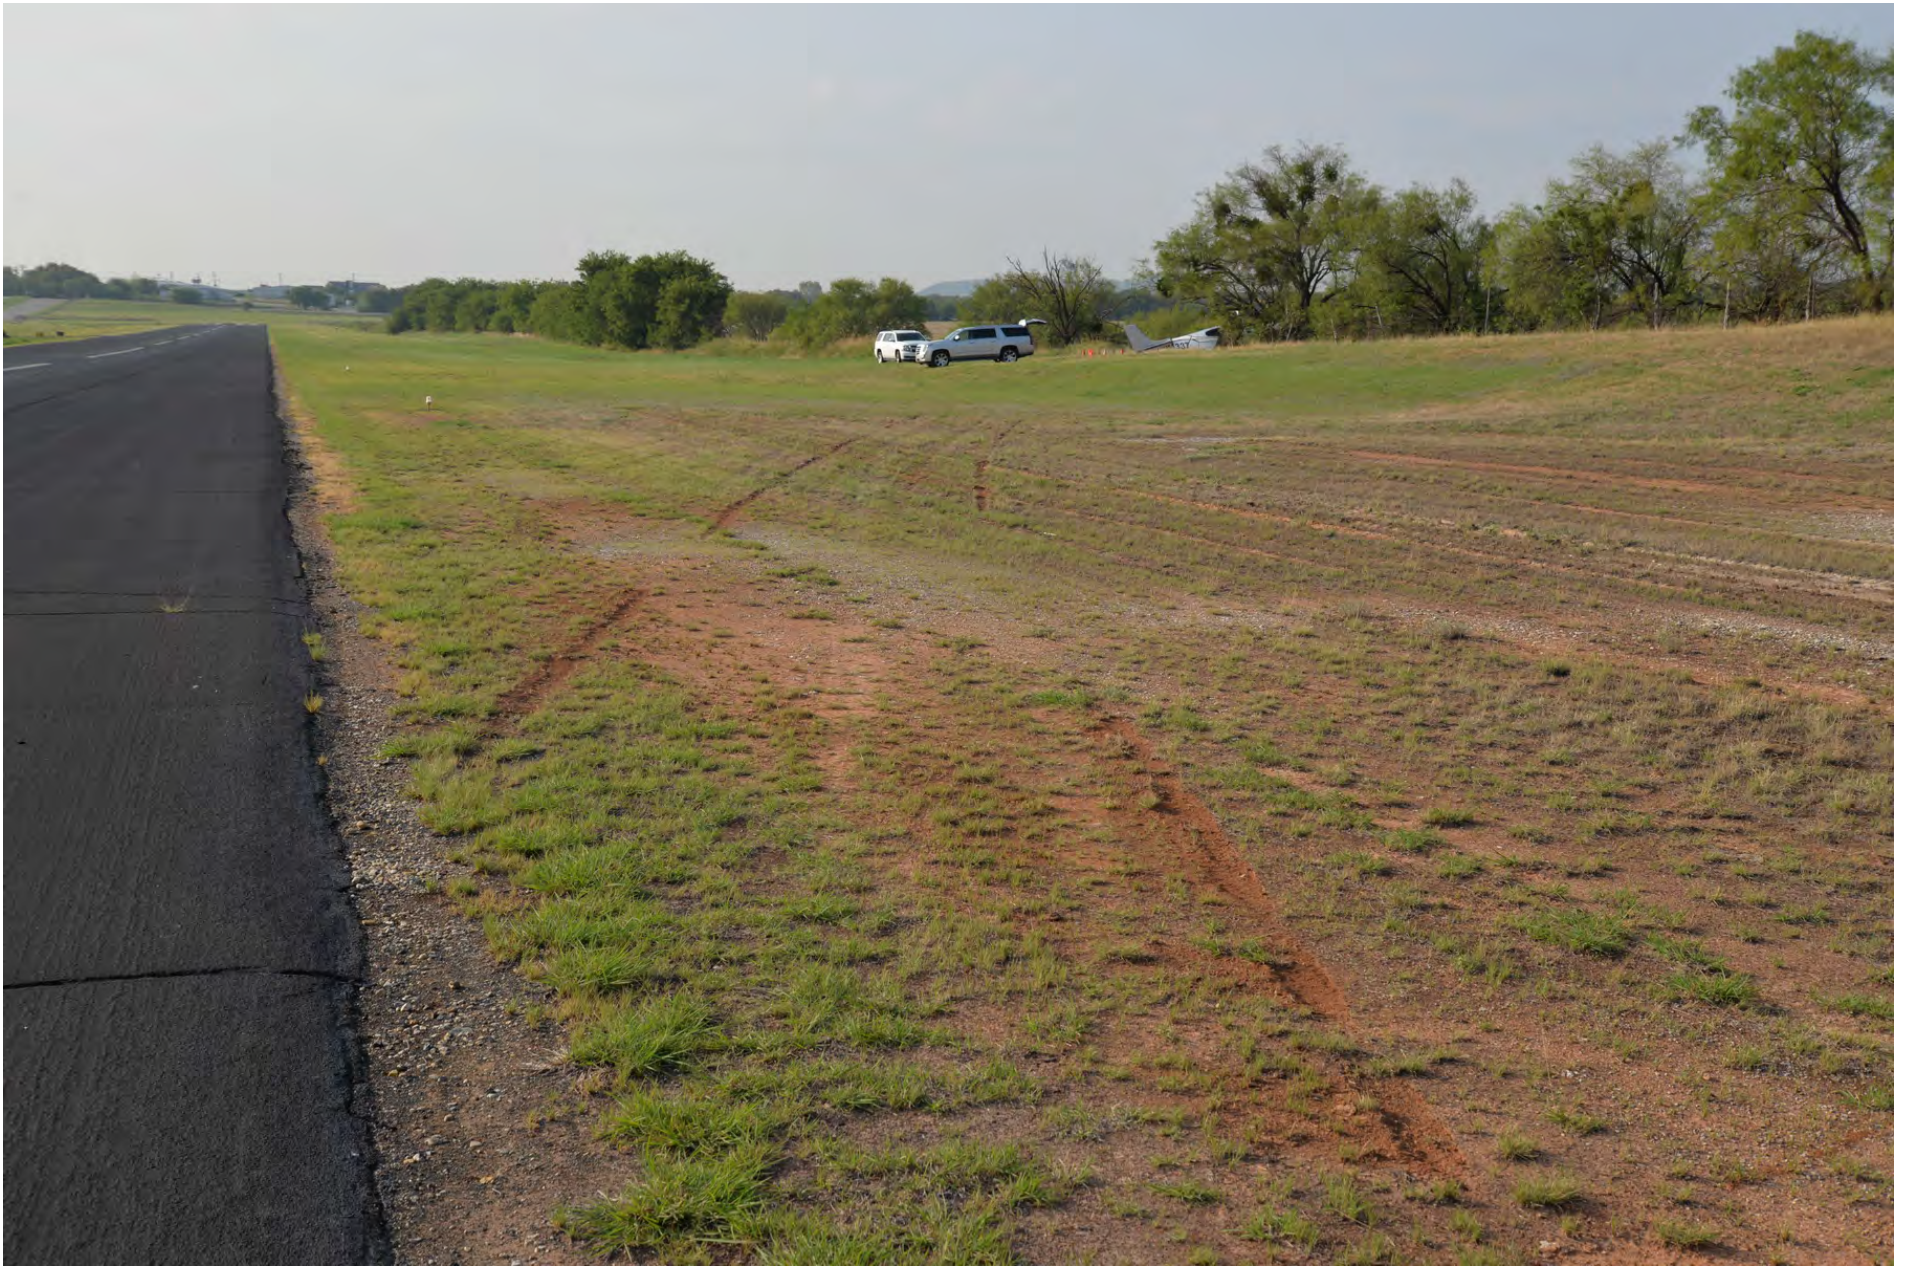
**Photo 9 - Close-up view of ground scars in the grass near the runway edge looking towards the wreckage.**
