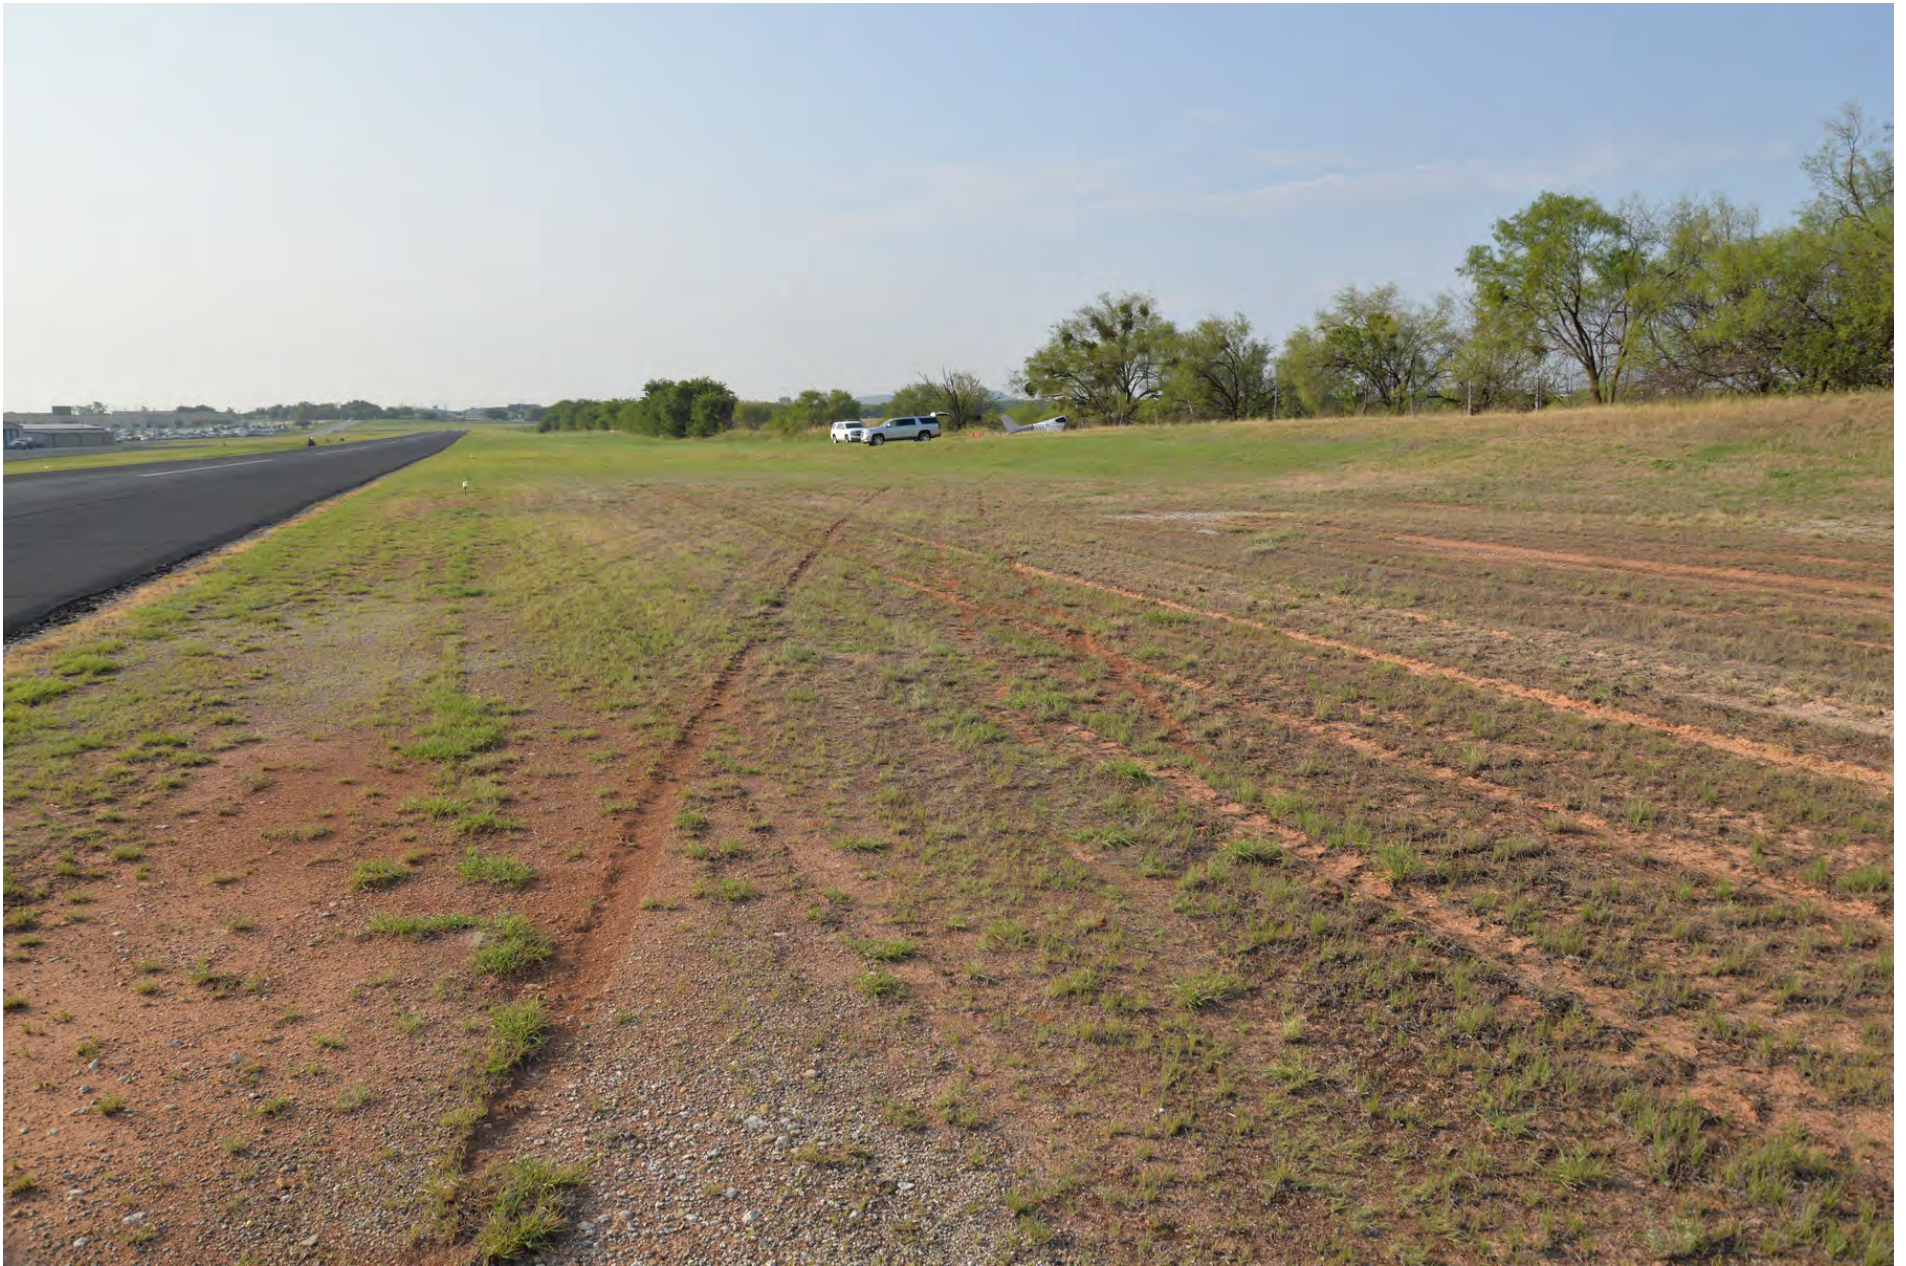
**Photo 10 - Close-up view of ground scars in the grass near the runway edge looking towards the wreckage.**

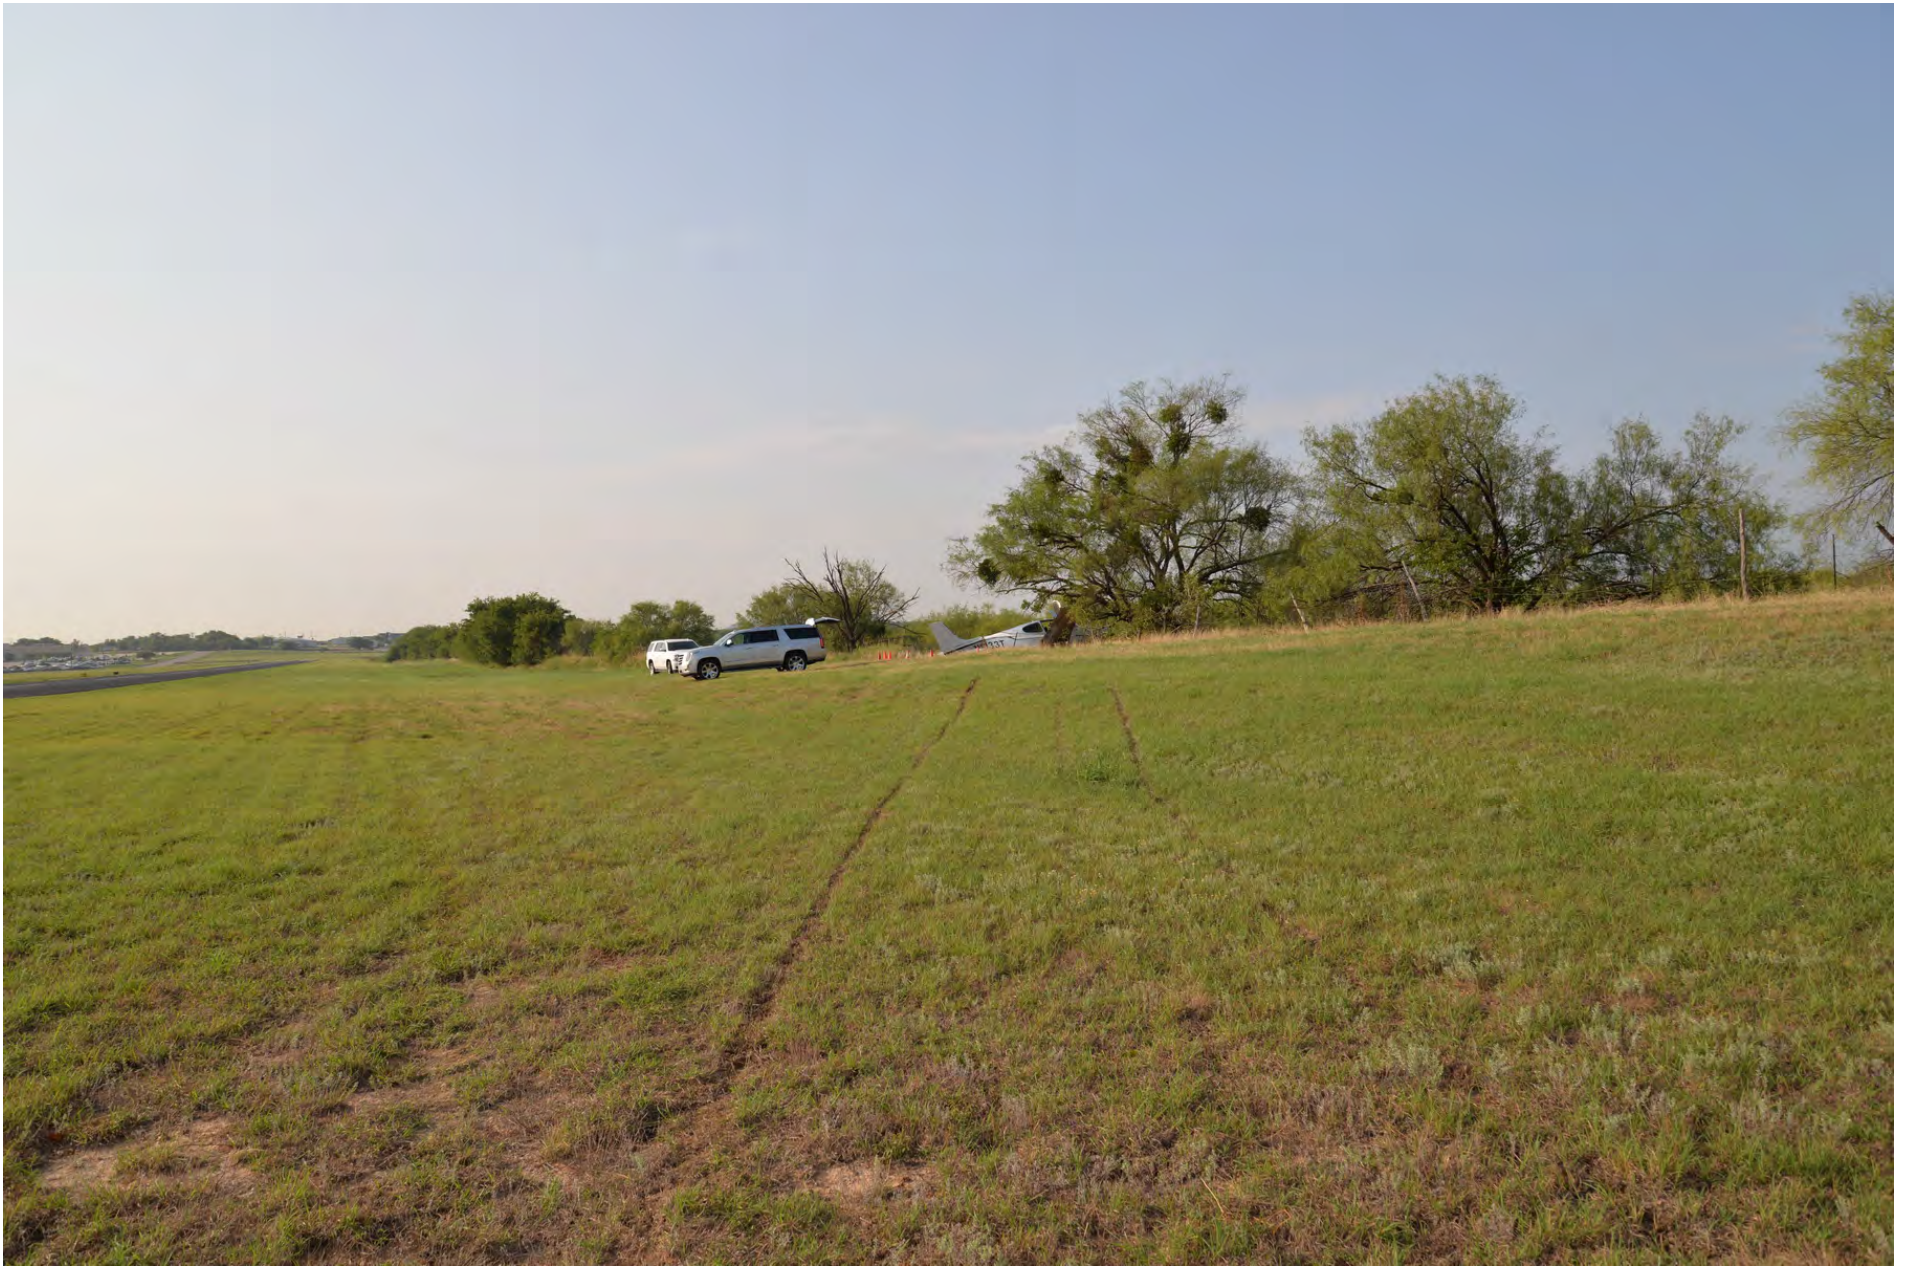
**Photo 11 - View of ground scars in the grass looking towards the wreckage.**

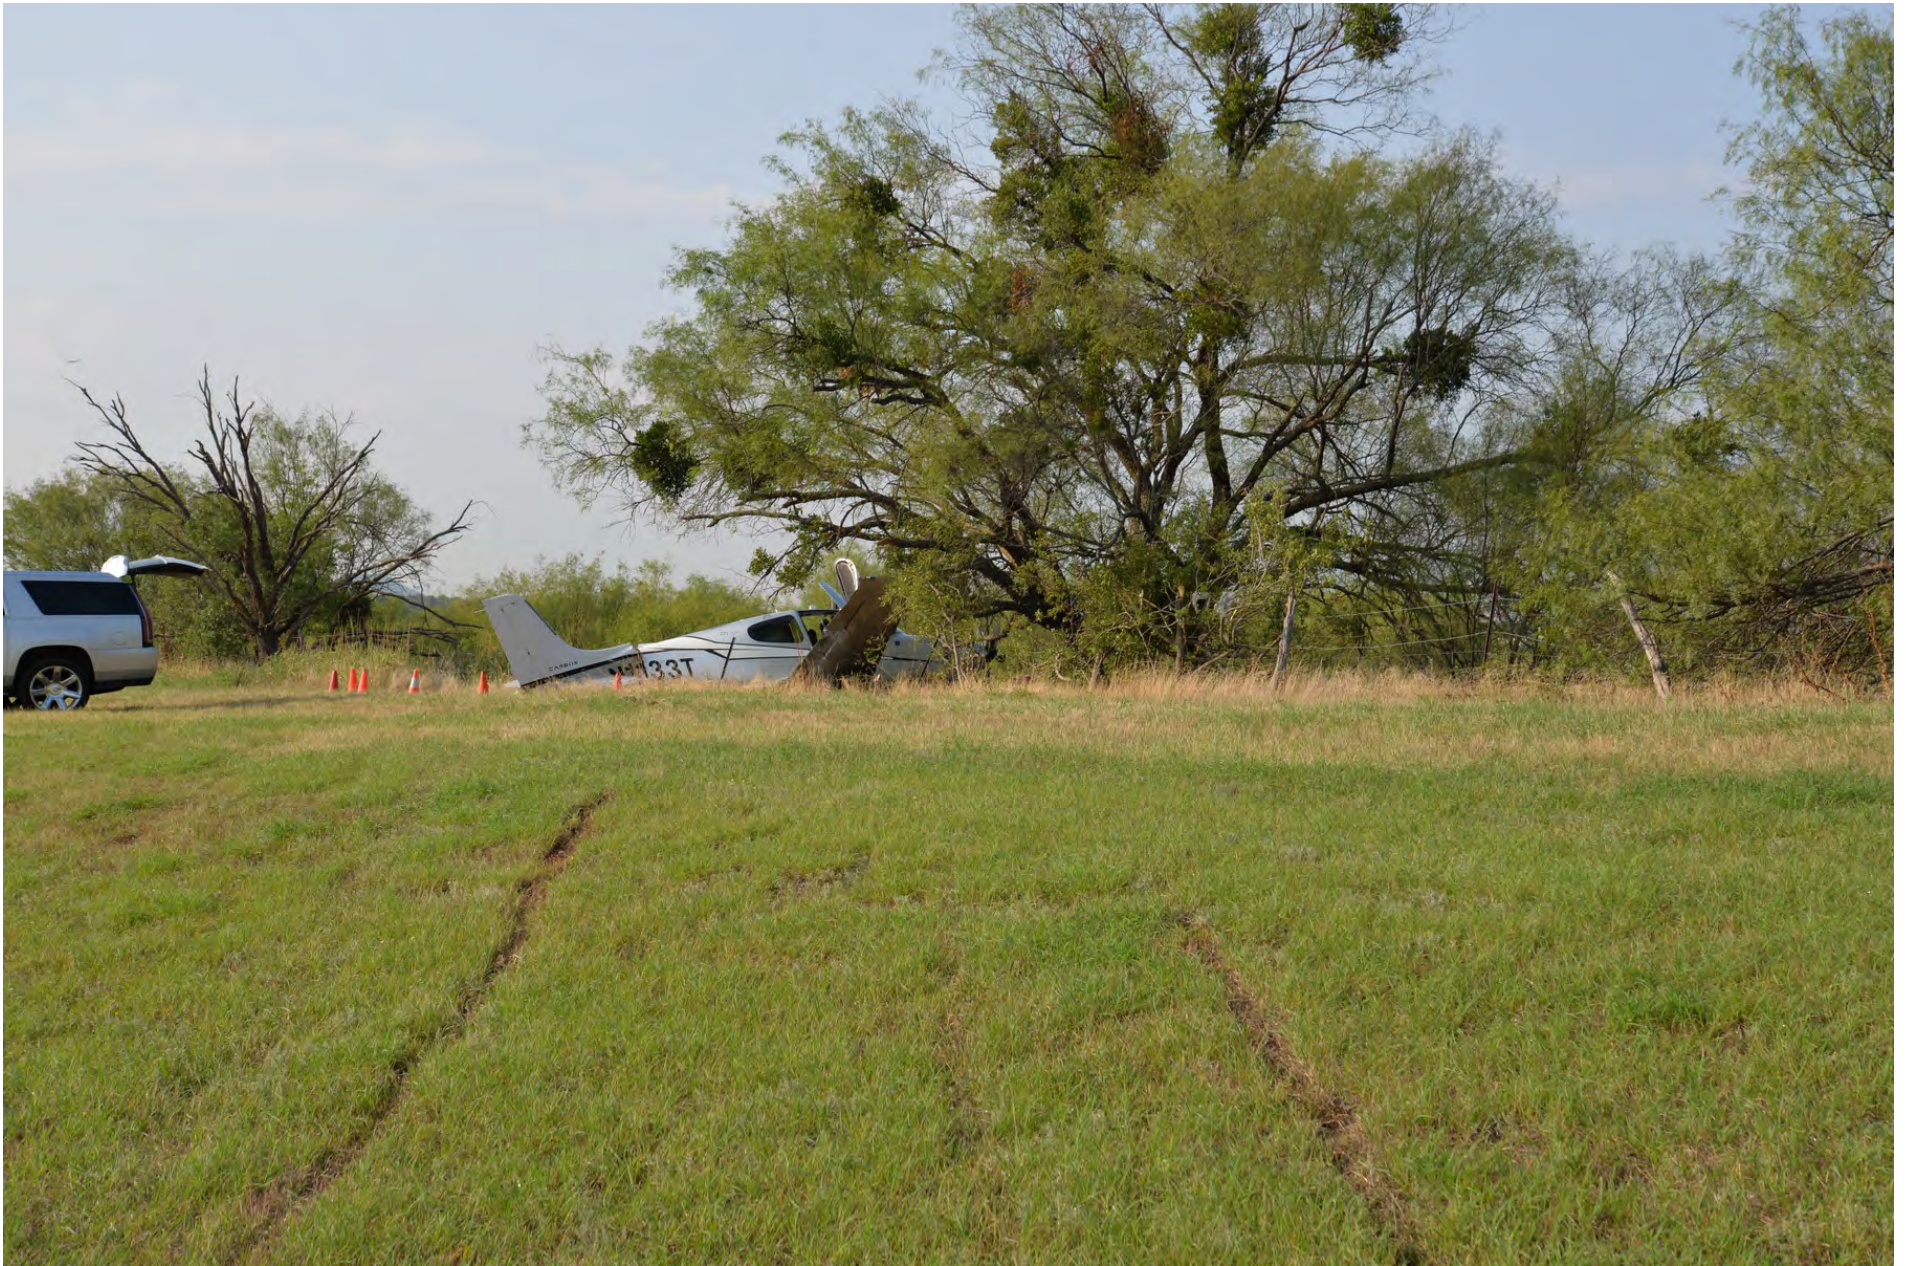
**Photo 12 - Close-up view of ground scars in the grass looking towards the wreckage.**

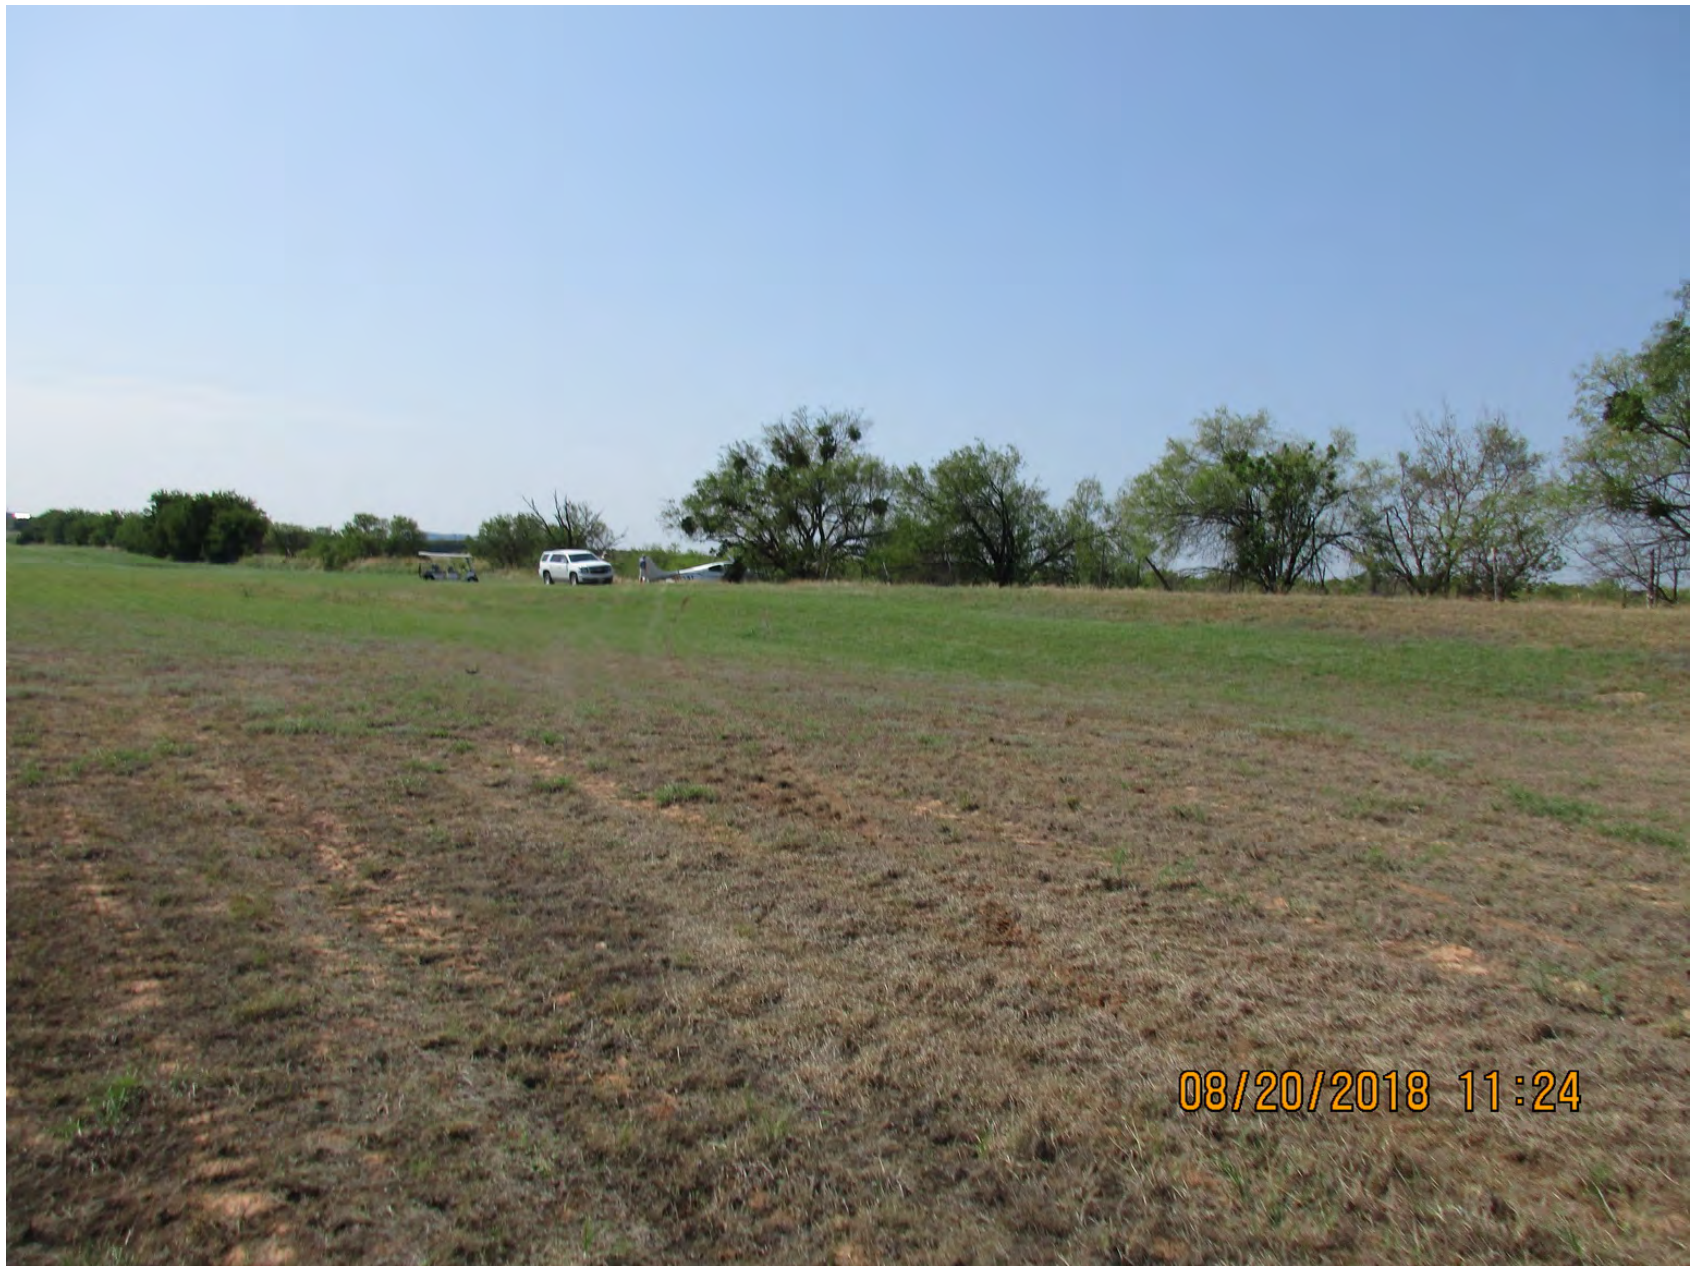
**Photo 13 - Close-up view of ground scars in the grass looking towards the wreckage.**

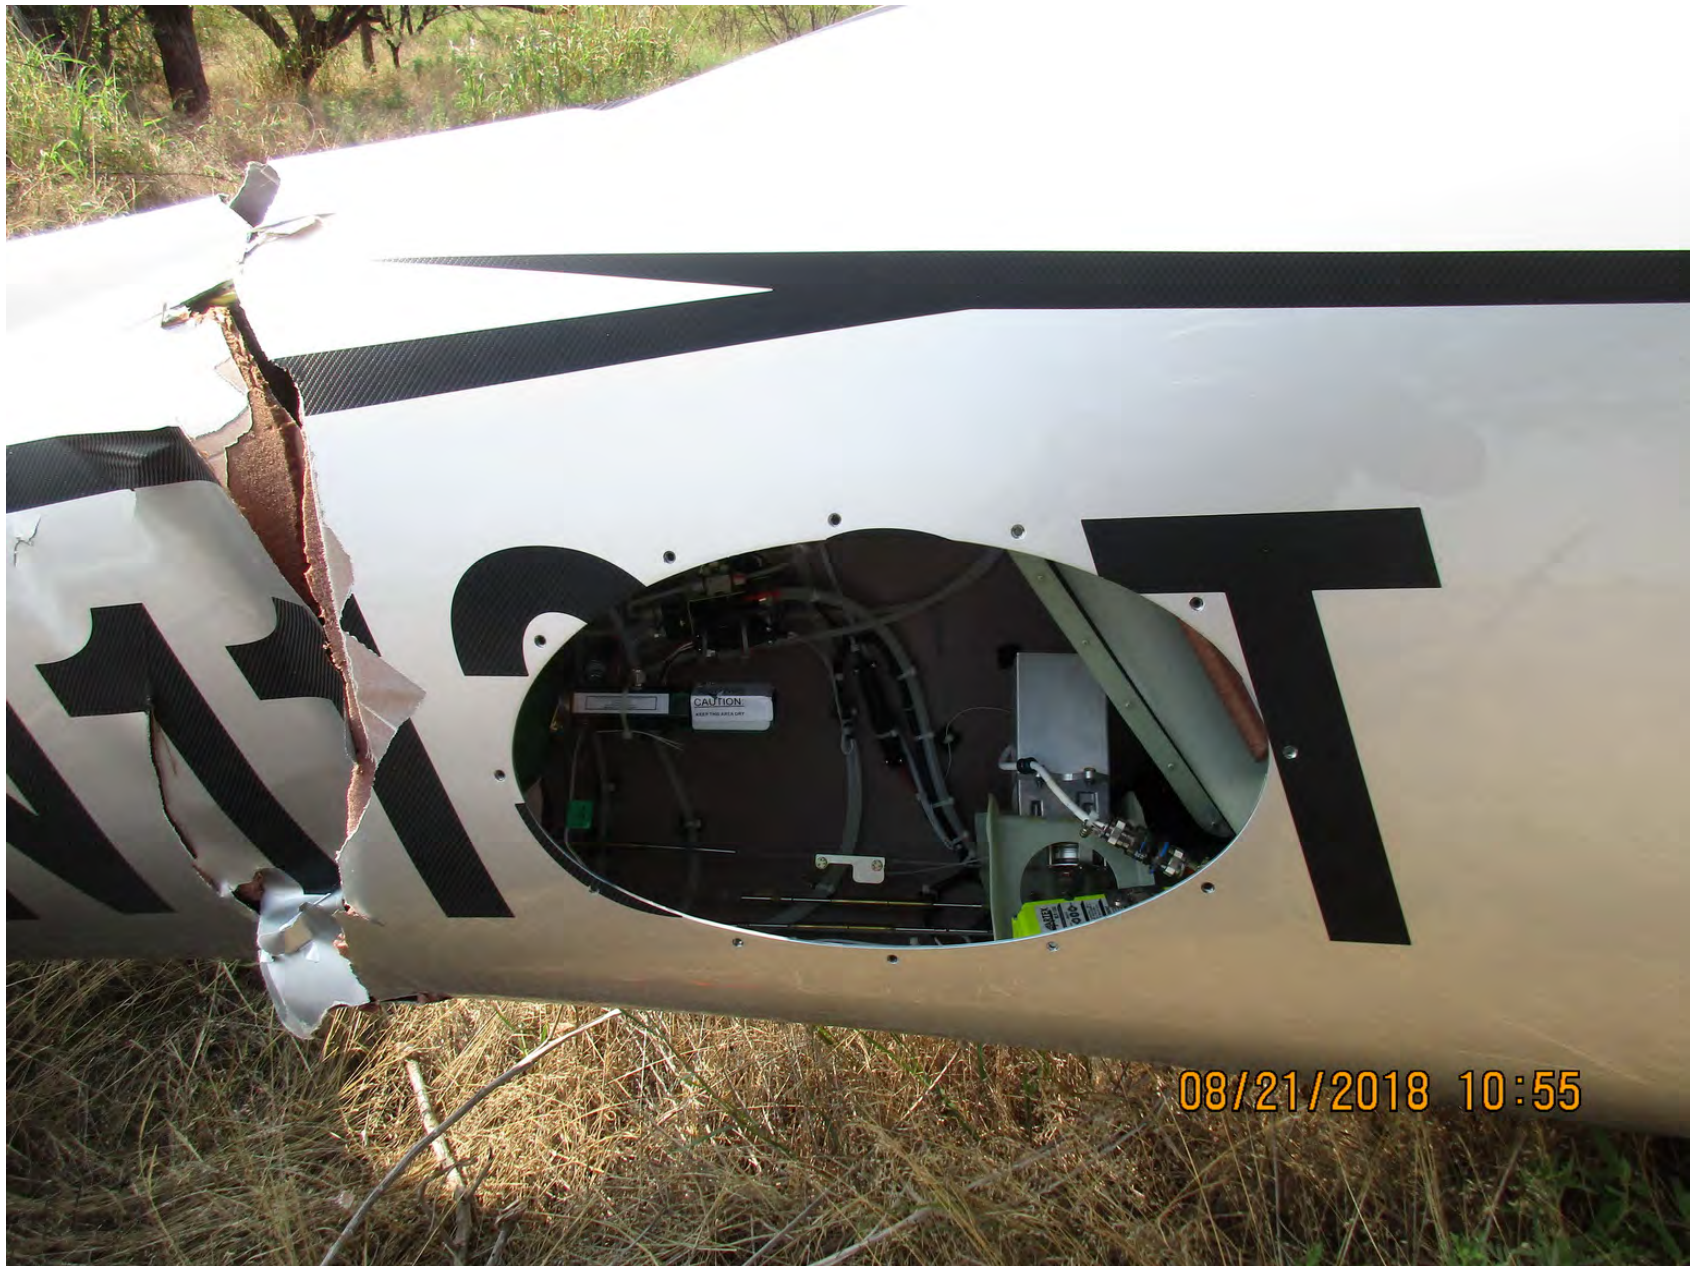
**Photo 14 - View of an open fuselage panel. The yaw damper servo is inside the panel opening.**

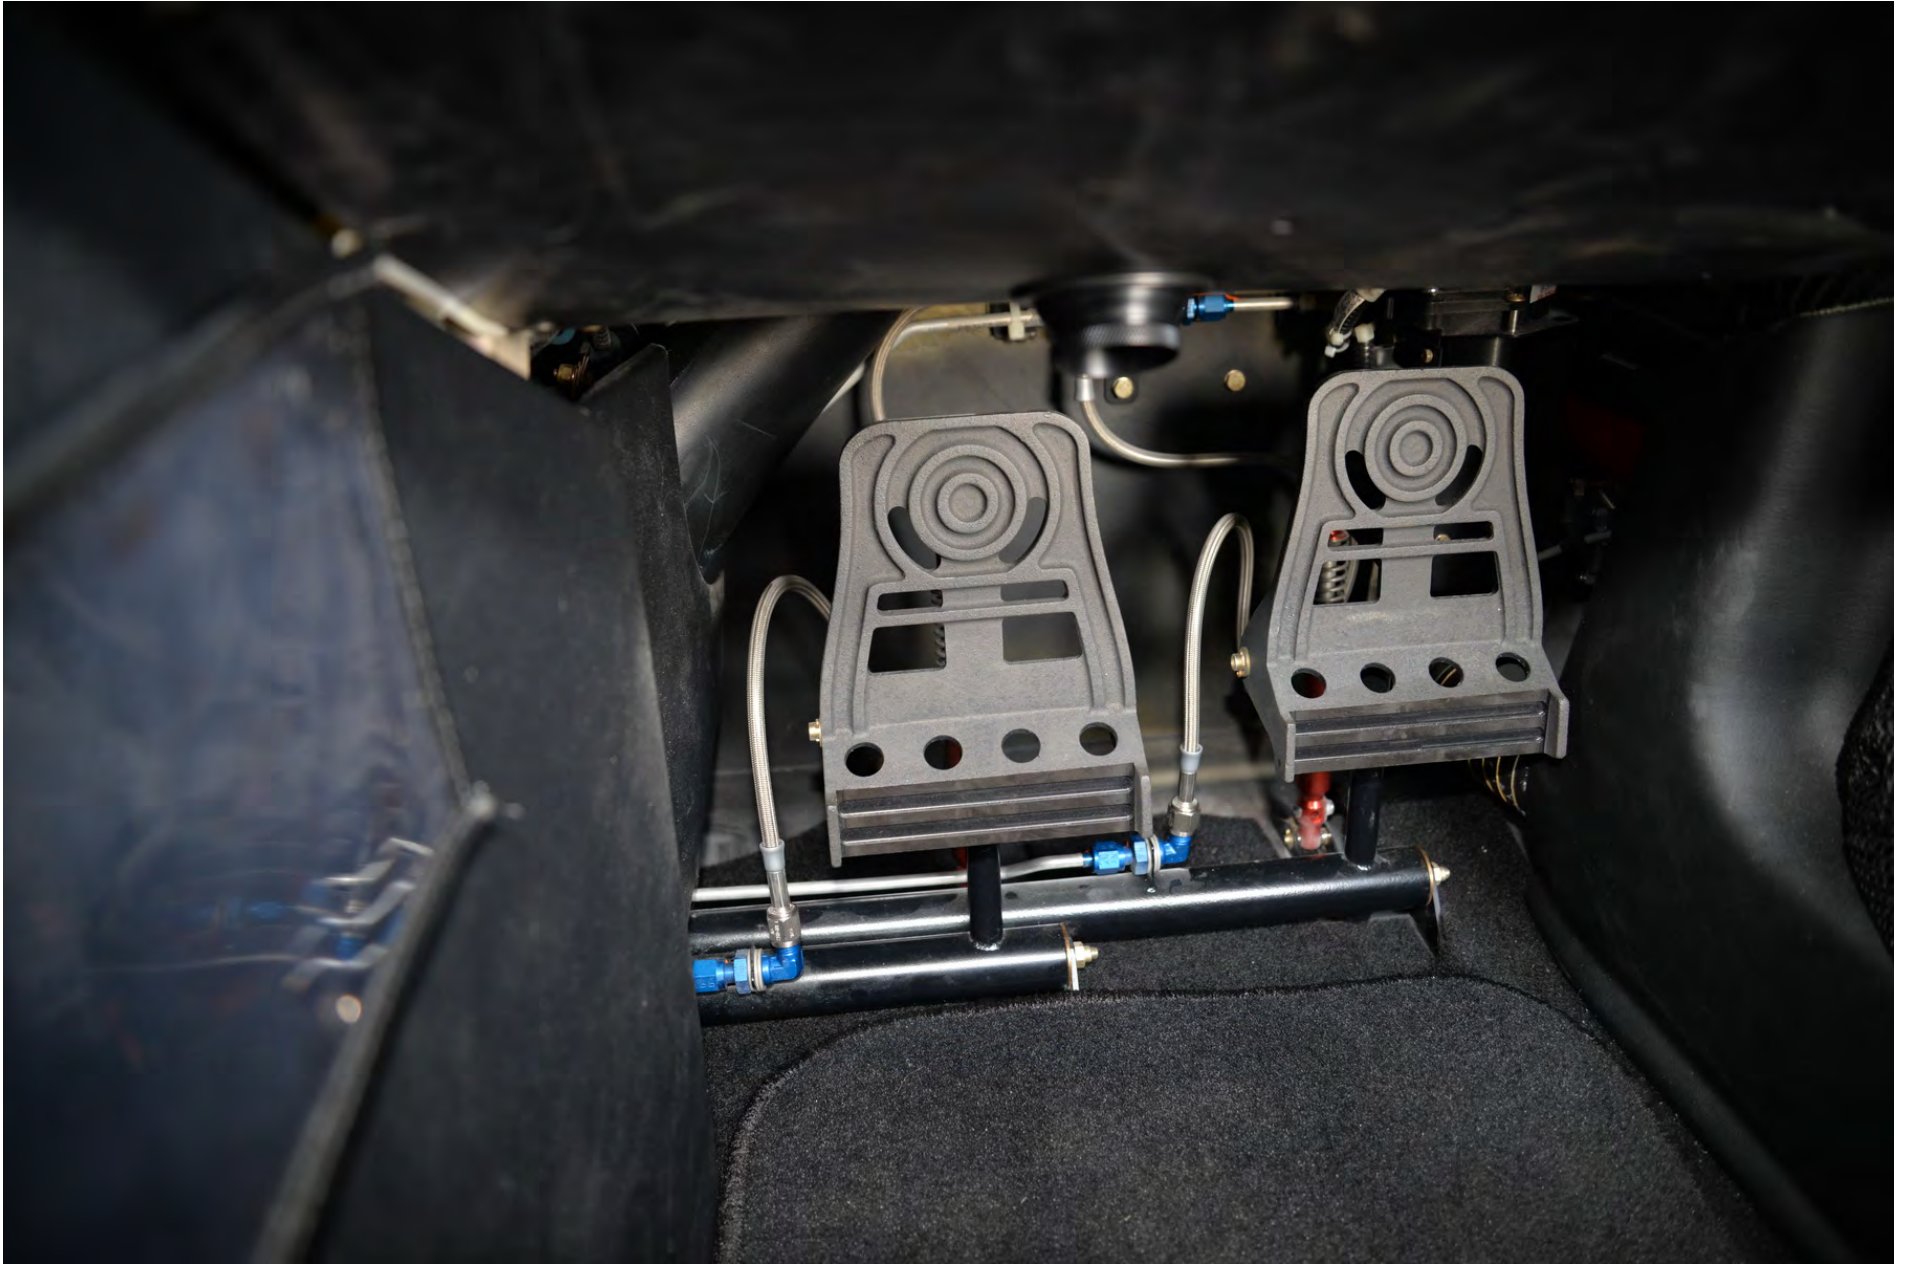
**Photo 15 - View of the right-side rudder pedals.**

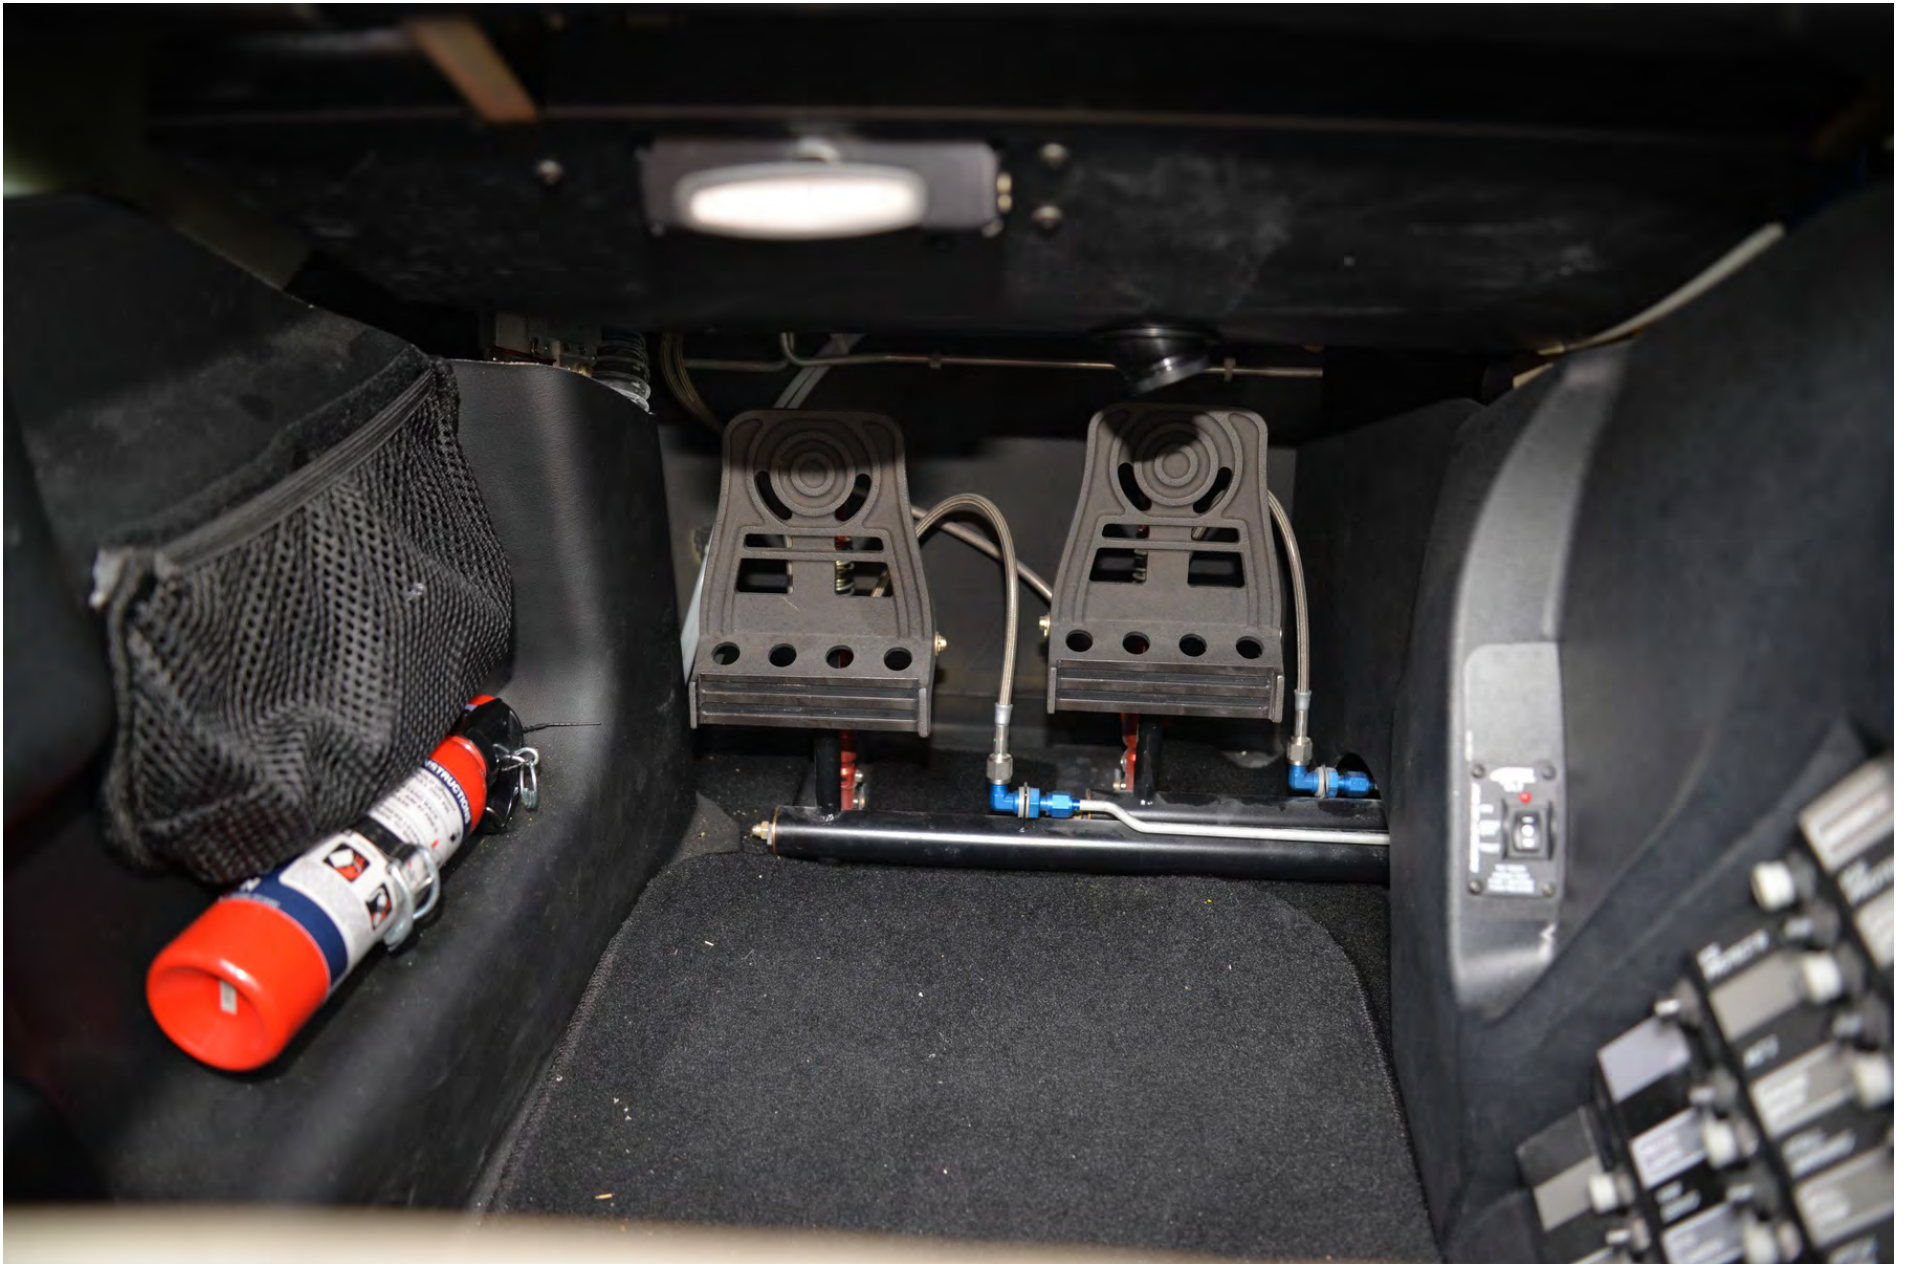
**Photo 16 - View of the left-side rudder pedals.**
