NATIONAL TRANSPORTATION SAFETY BOARD

Office of Research and Engineering

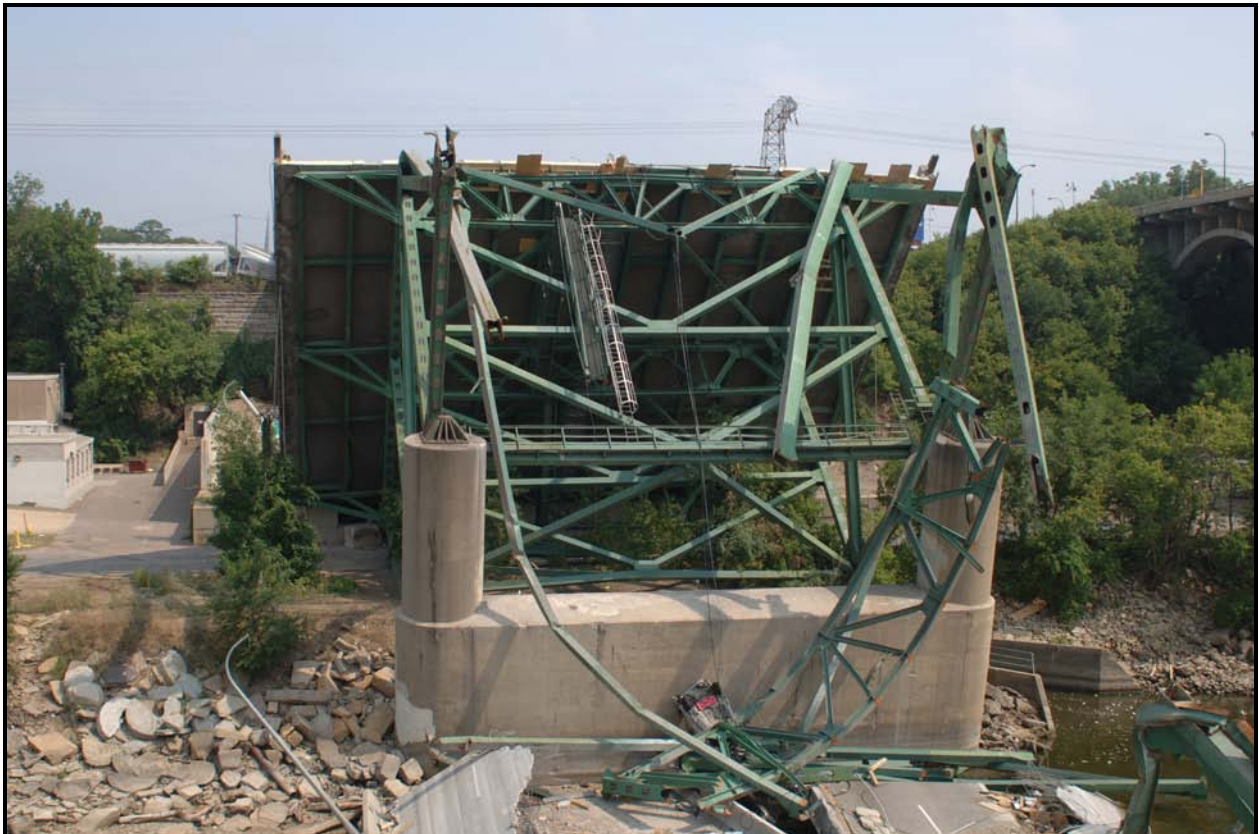
Damaged portion of the deck truss at pier 7, on the north side of the river, viewed looking north.

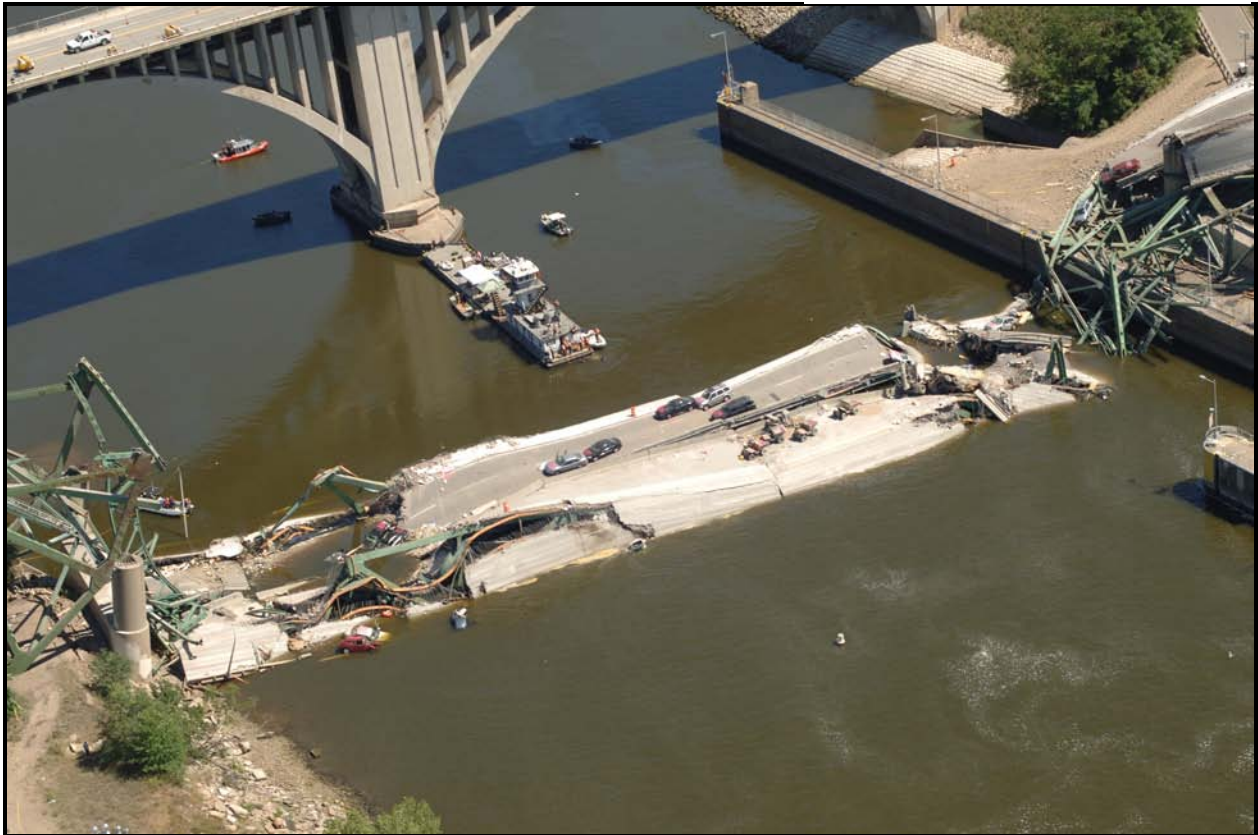
Collapsed portion of the deck truss over the river, viewed looking east and south.

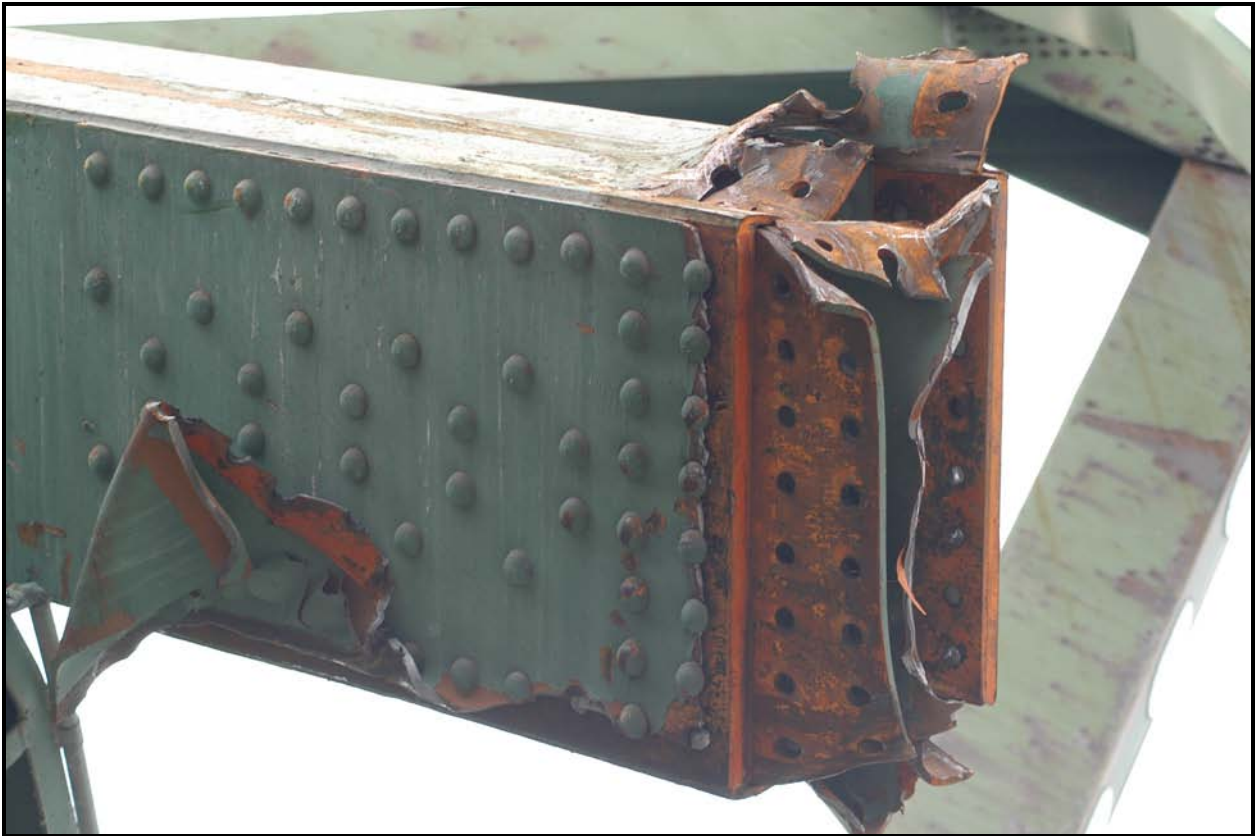
The end of U9/U10'W, showing the fractured west gusset plate.

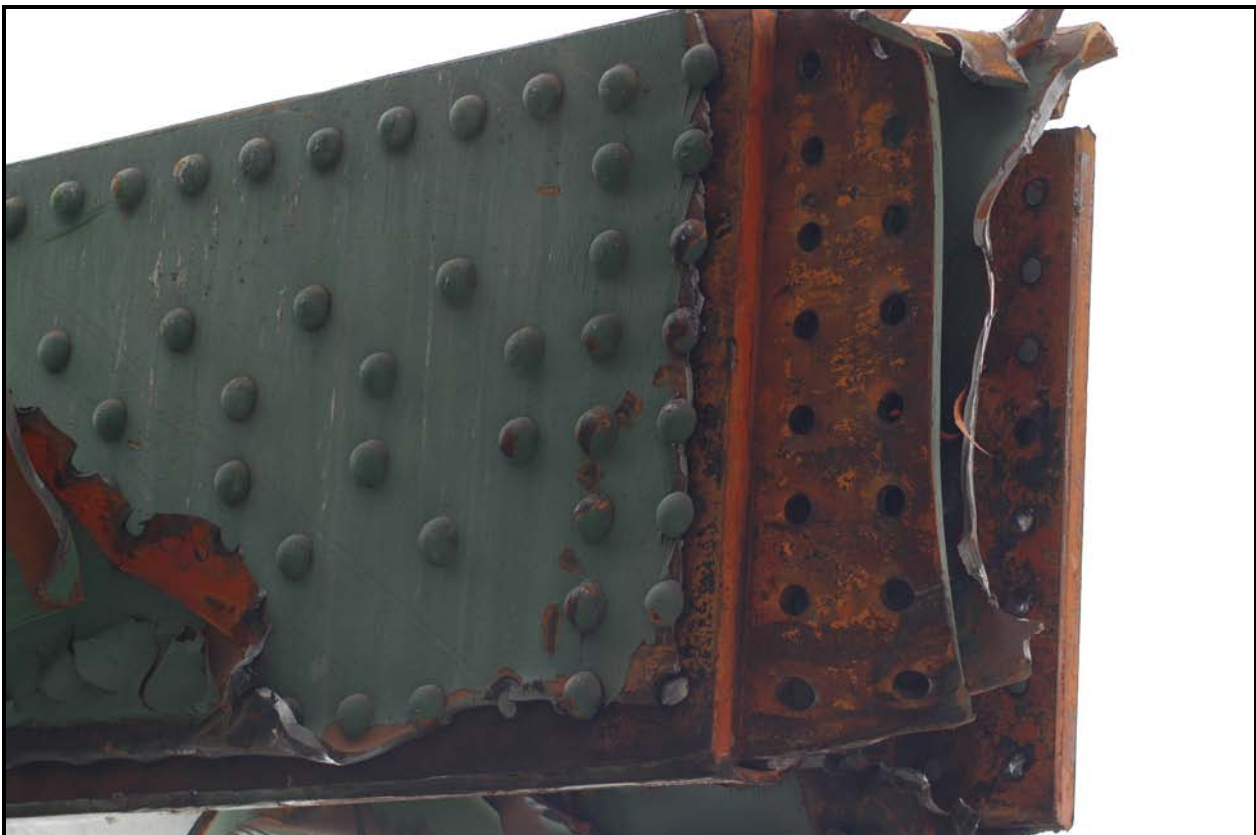
The end of U9/U10'W, showing the fractured west gusset plate.

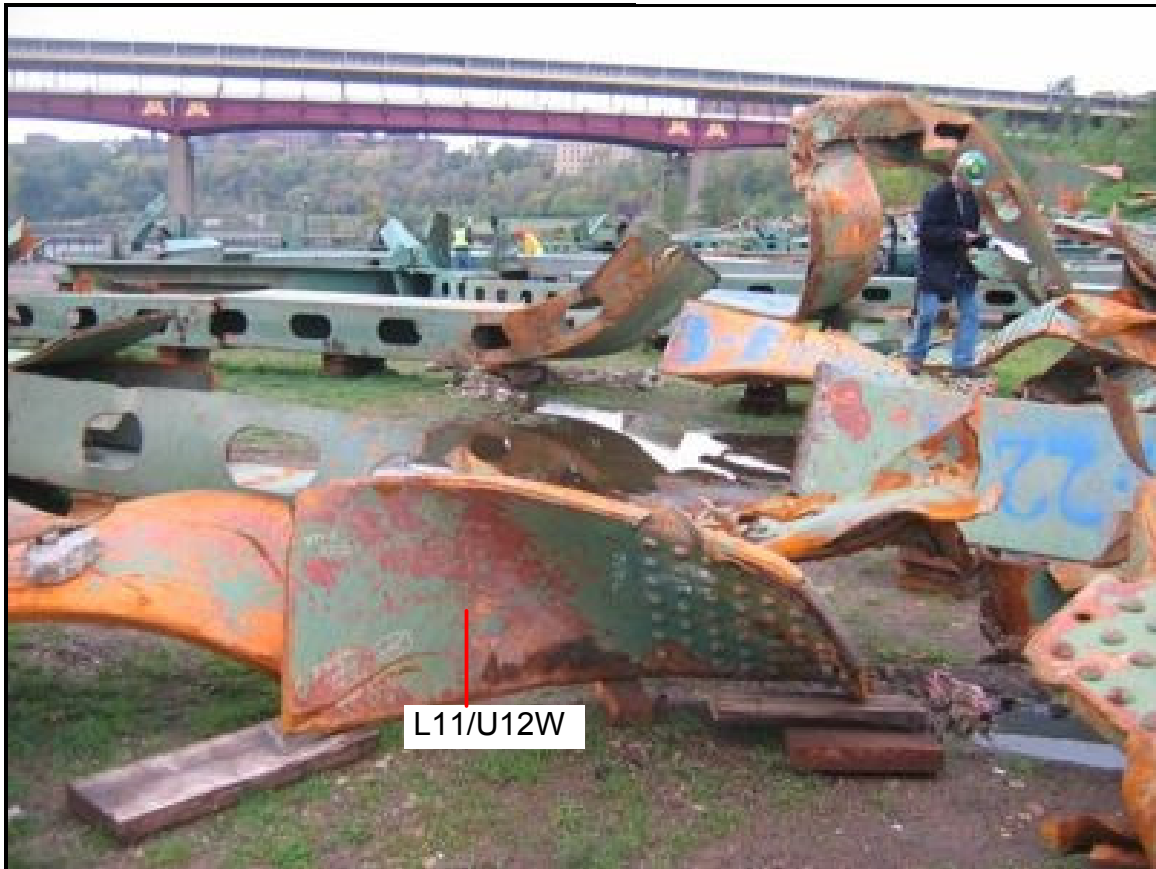
Node L11 West, with one side plate at the end of L11/U12W at center; other members to right.

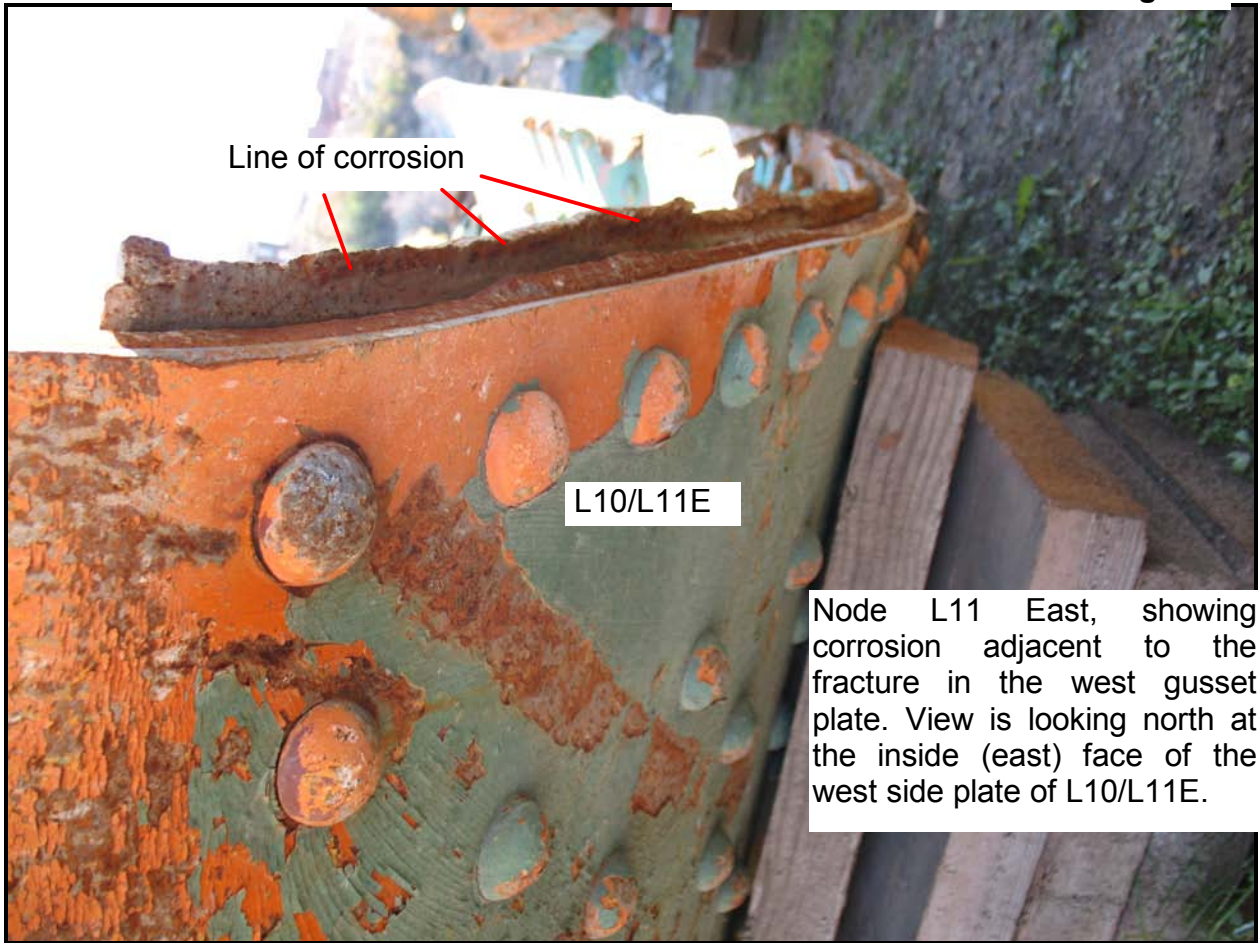
Node L11 East, showing corrosion adjacent to the fracture in the west gusset plate. View is looking north at the inside (east) face of the west side plate of L10/L11E.

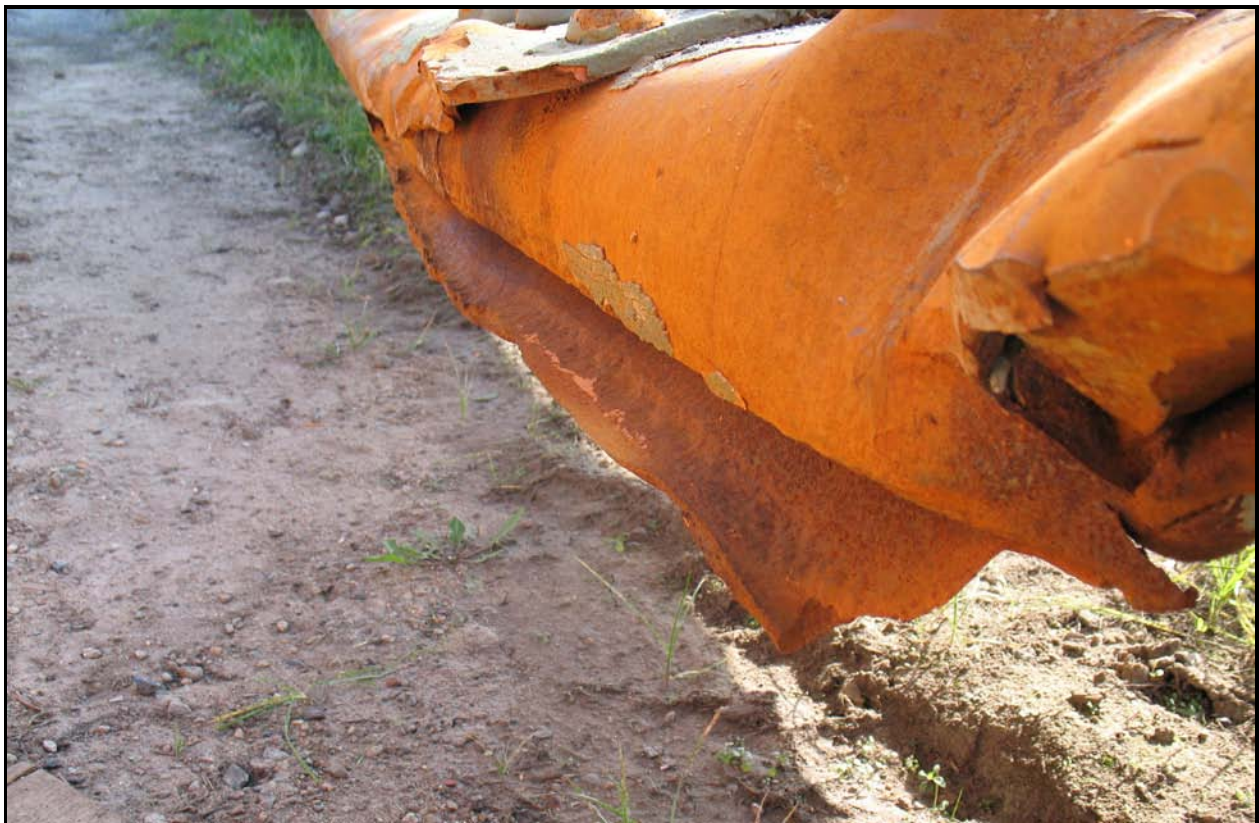
Node L11 West, showing corrosion adjacent to the fracture in the west gusset plate.

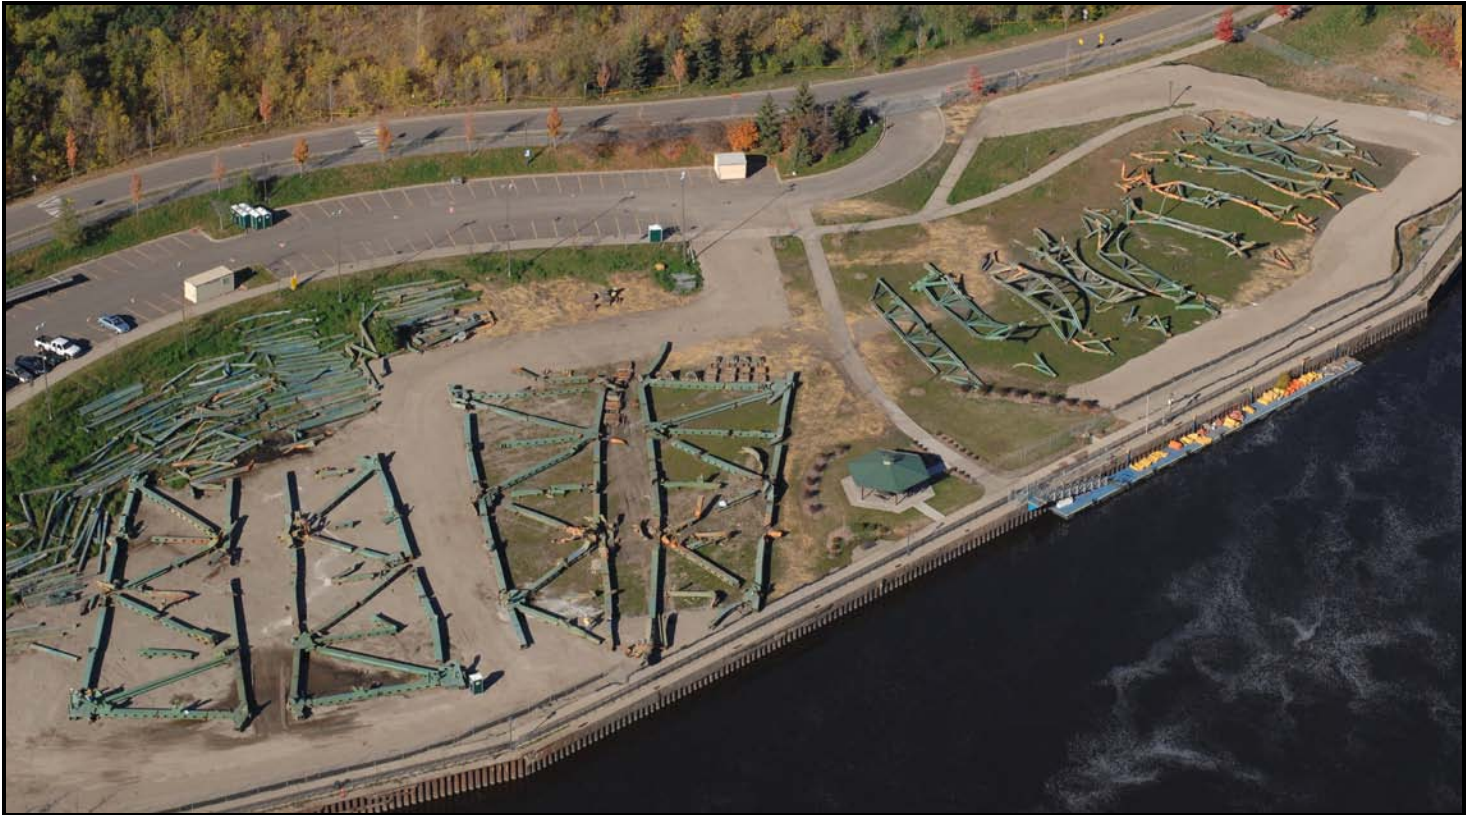
Bohemian Flats layout of the members of the center span of the deck truss. Floor trusses are on right, and main truss members are on the left. Looking west (geographically).
