Photographs of N117KP
Courtesy of the Federal Aviation Administration Inspector.

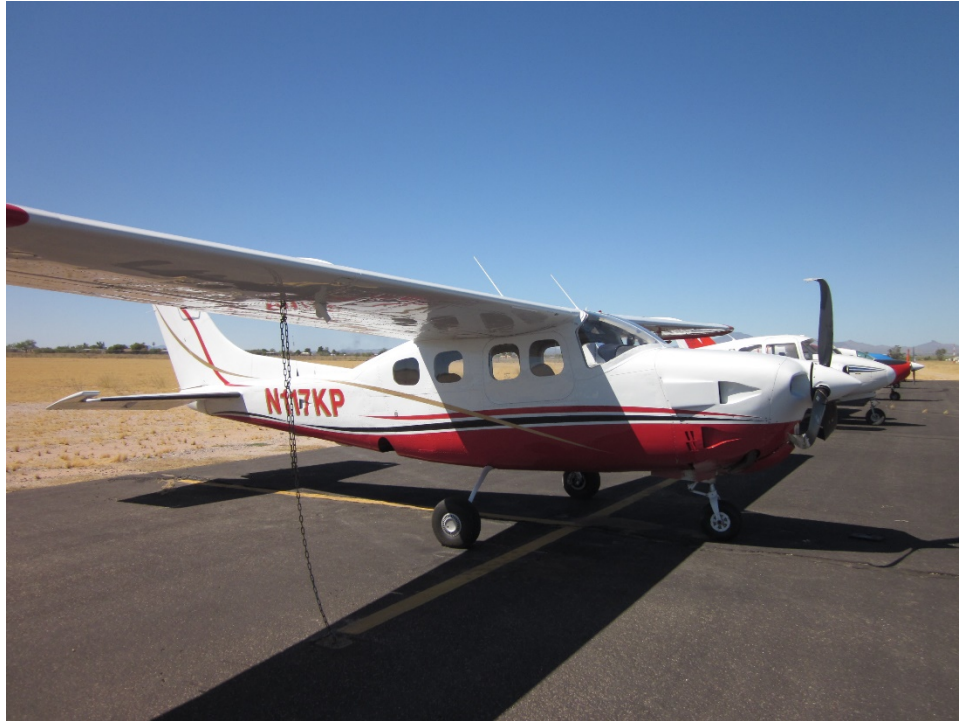
Figure 1: Right side of Airplane

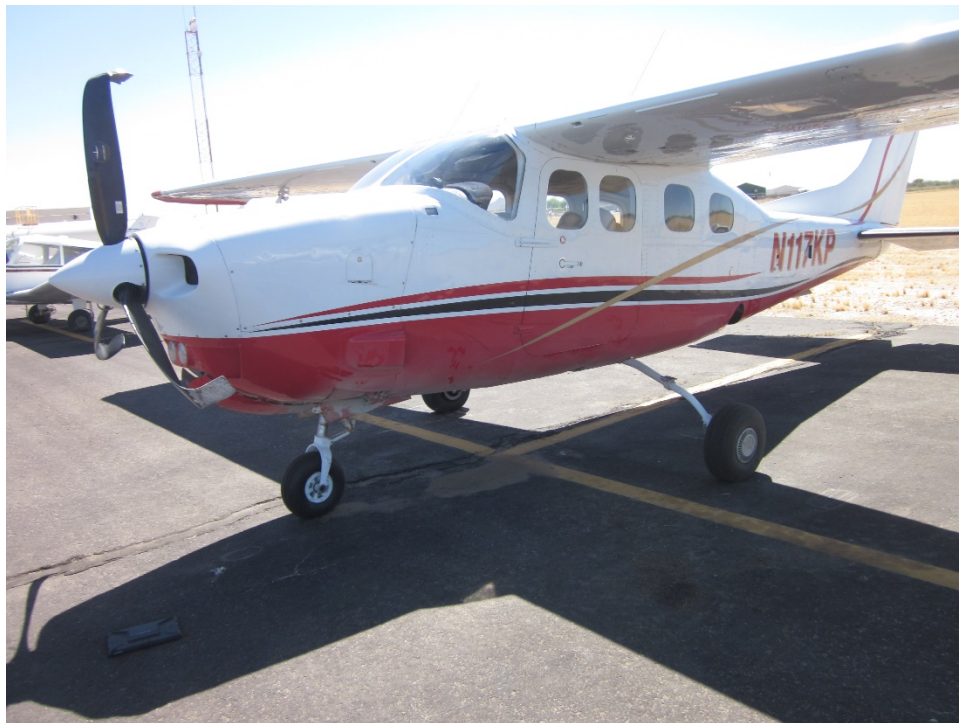
Figure 2: Left side of Engine

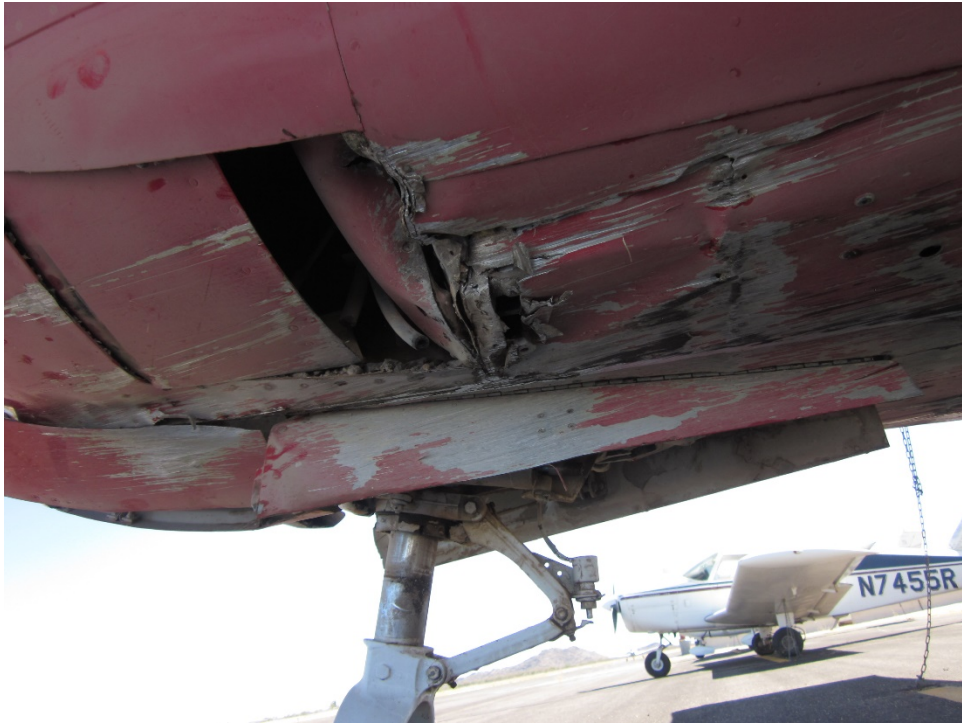
Figure 3: Belly Damage at the Nose Landing Gear

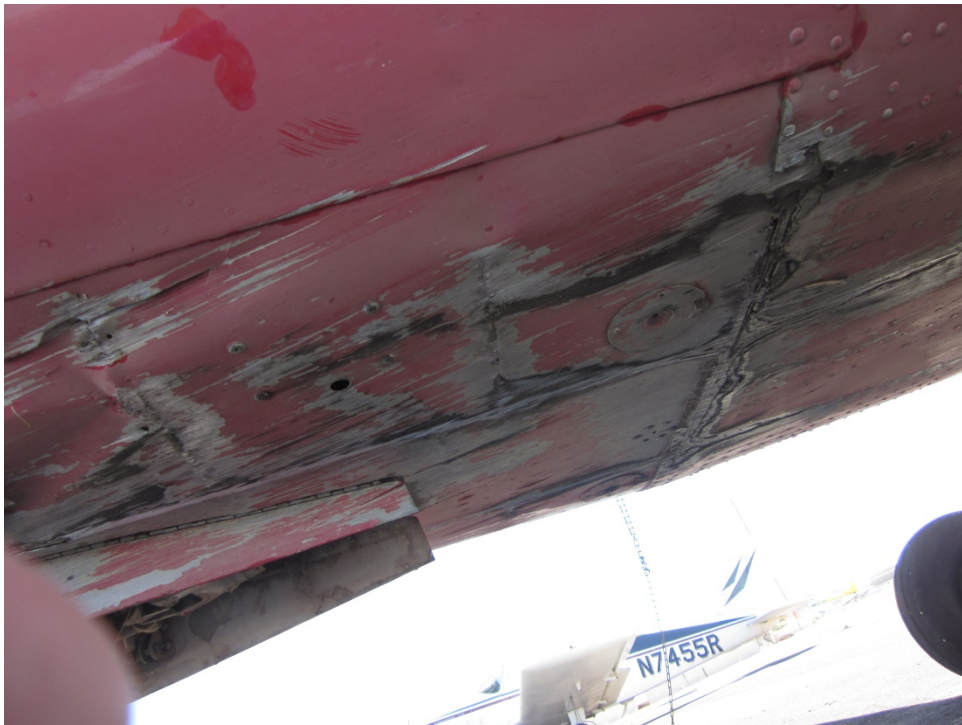
Figure 4: Belly Damage just aft of the Nose landing gear

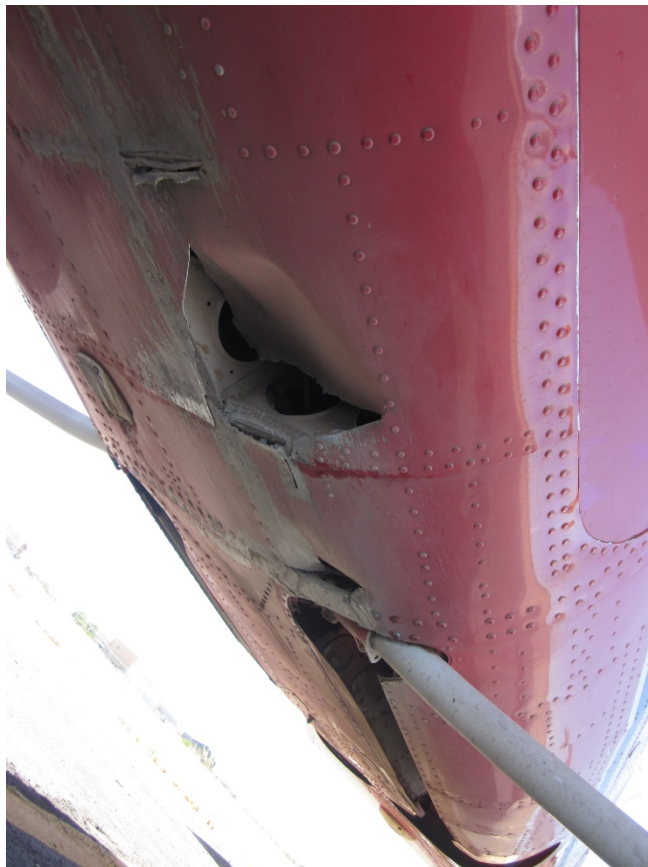
Figure 5: Lower Skin "hole" Damaging the Pressure Vessel

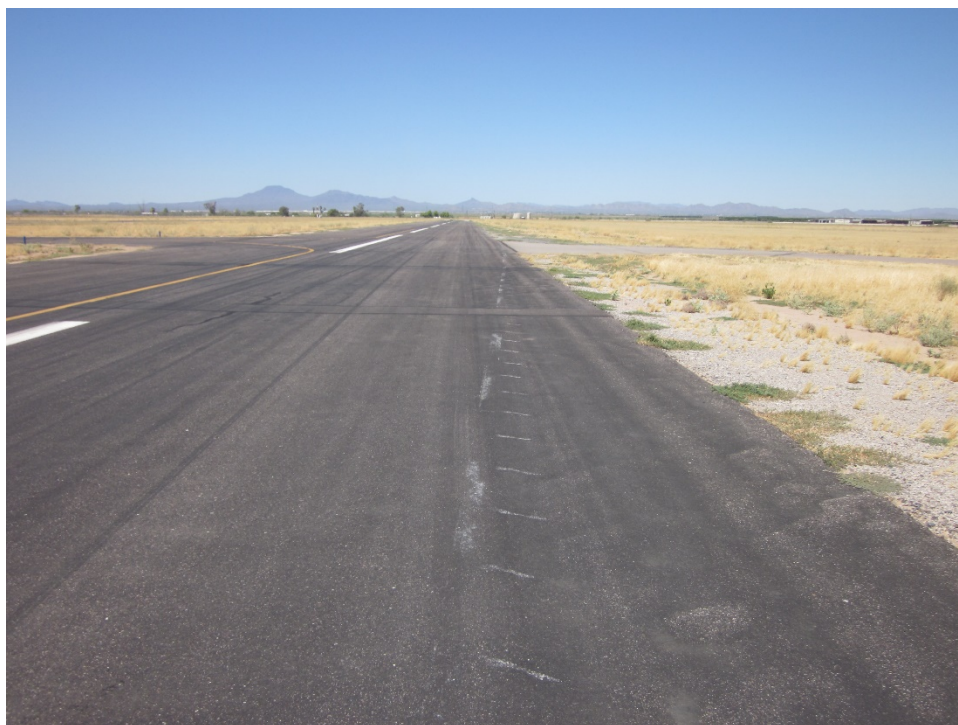
Figure 6: Runway Markings
