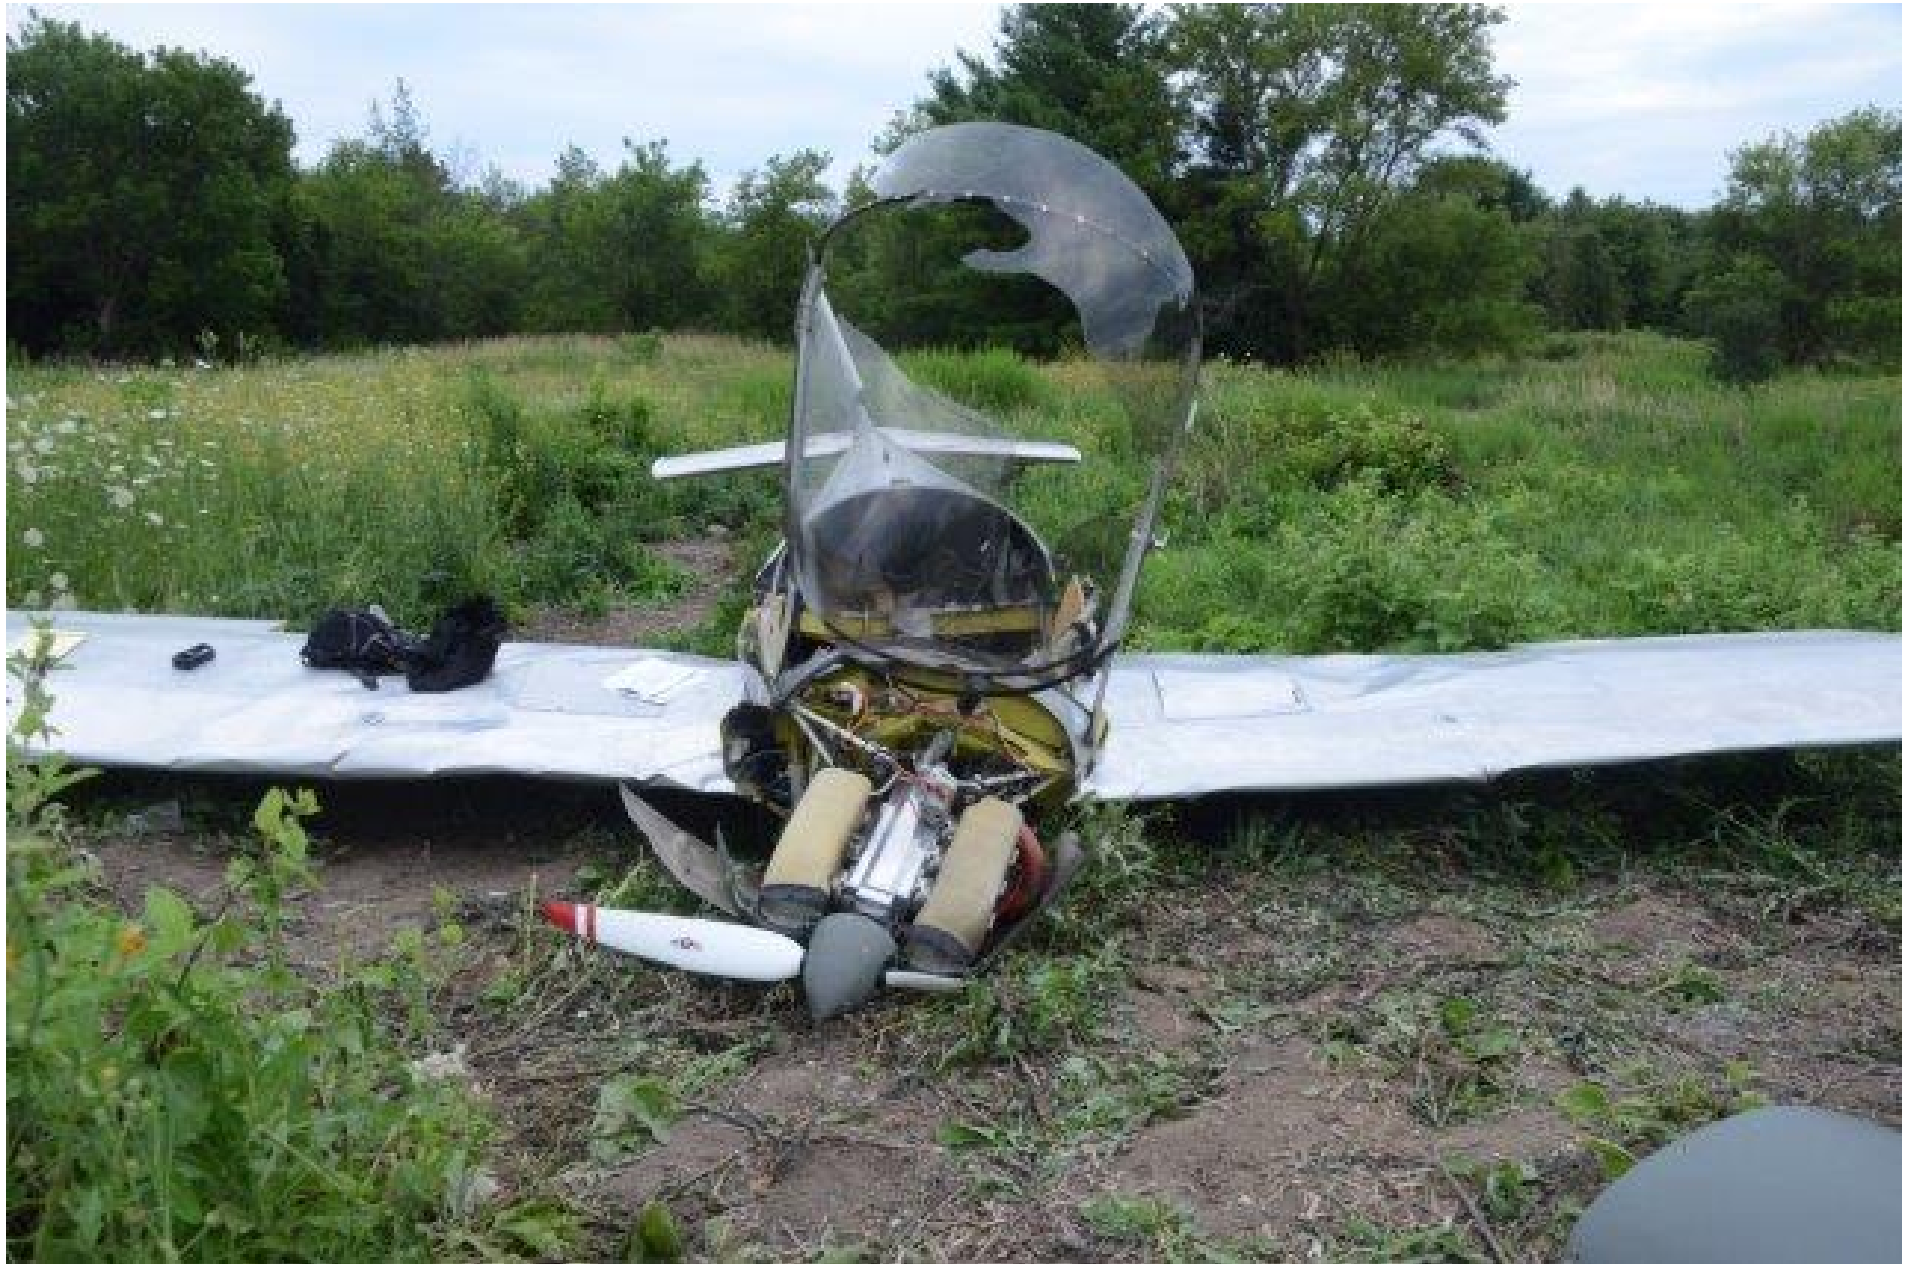
Photo 1 – View of the front of the airplane at the accident site.

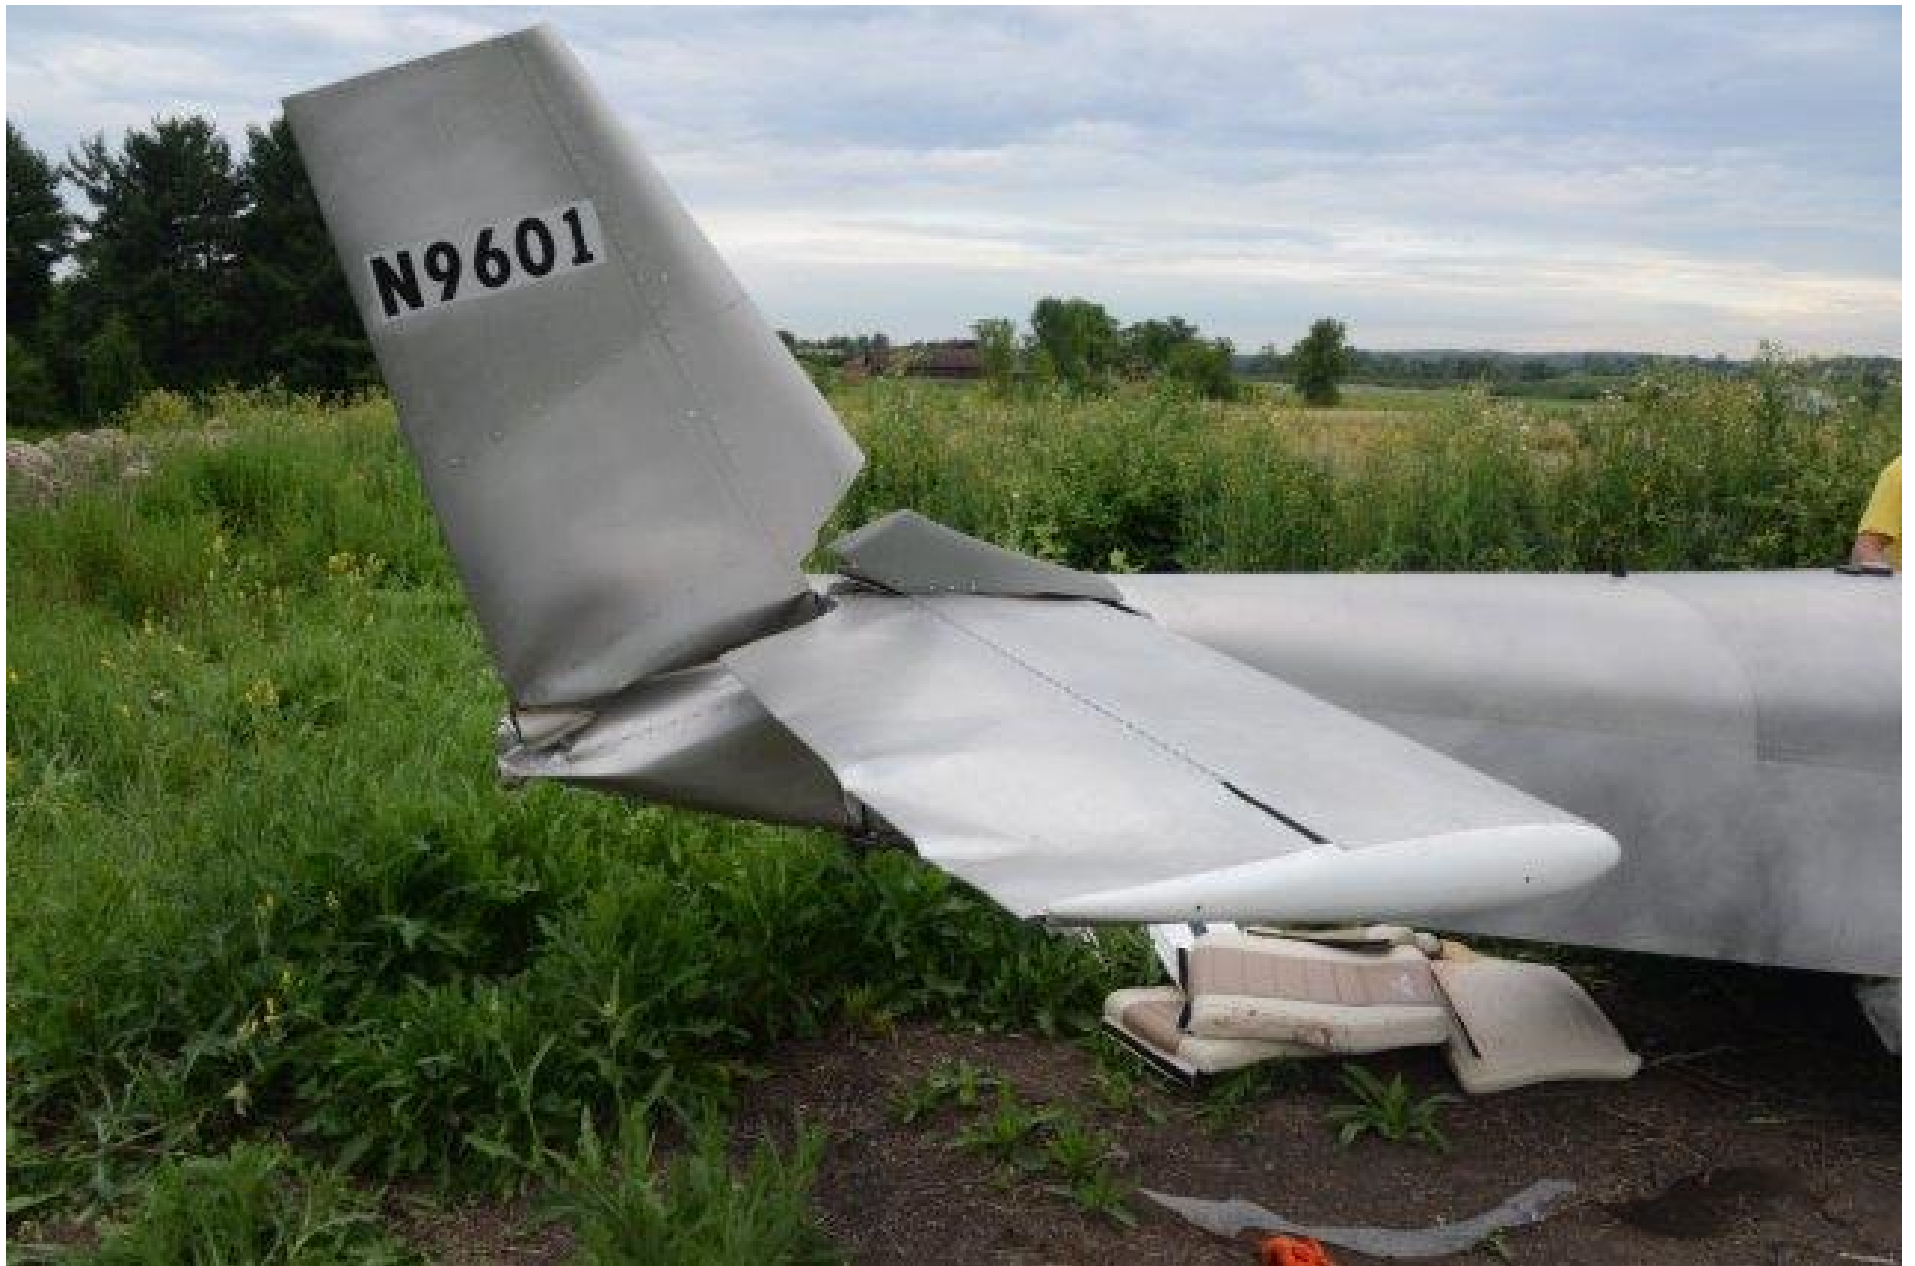
Photo 2 - View of the right side of the empennage.

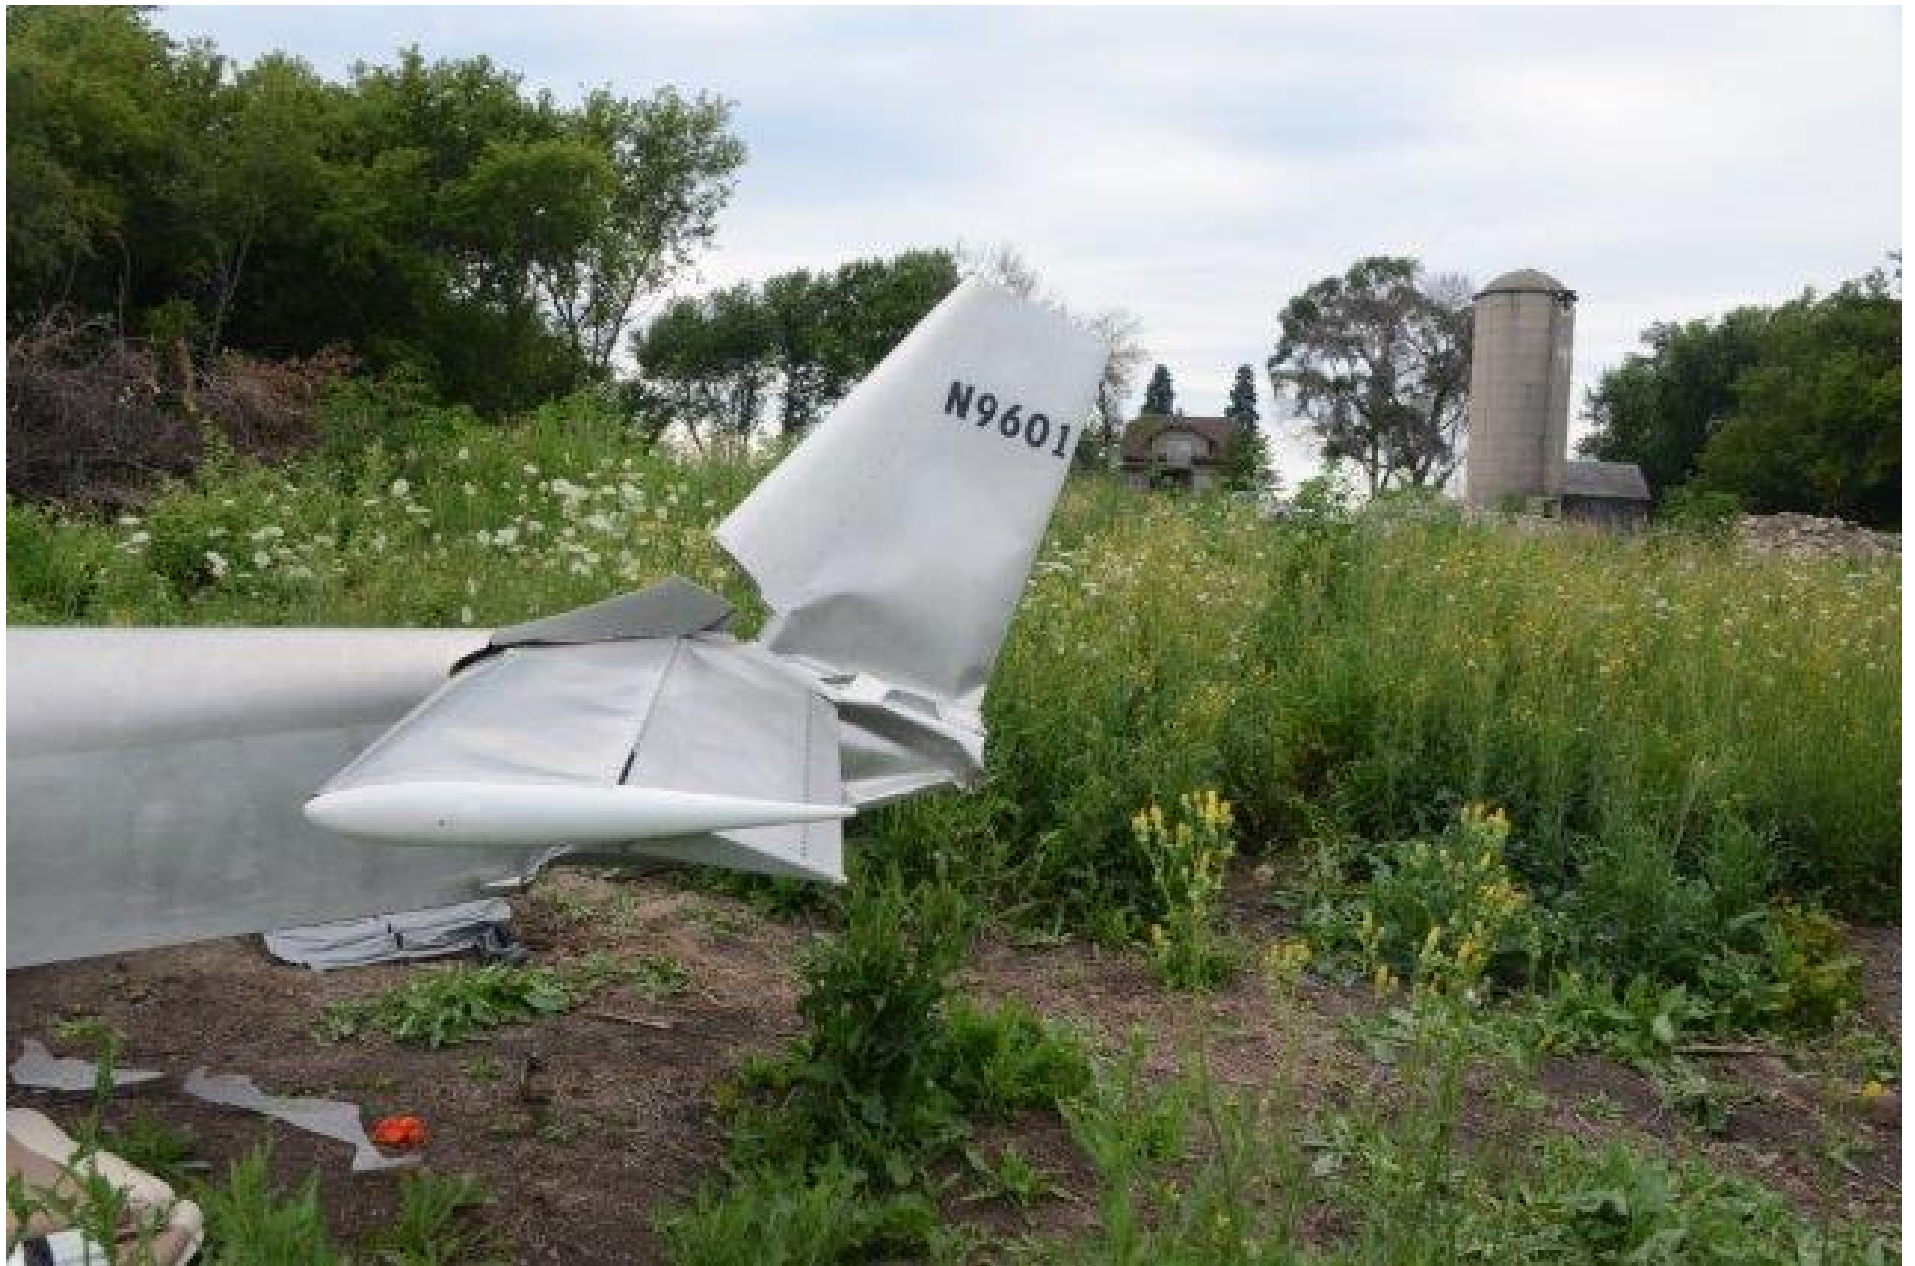
Photo 3 - View of the left side of the empennage.

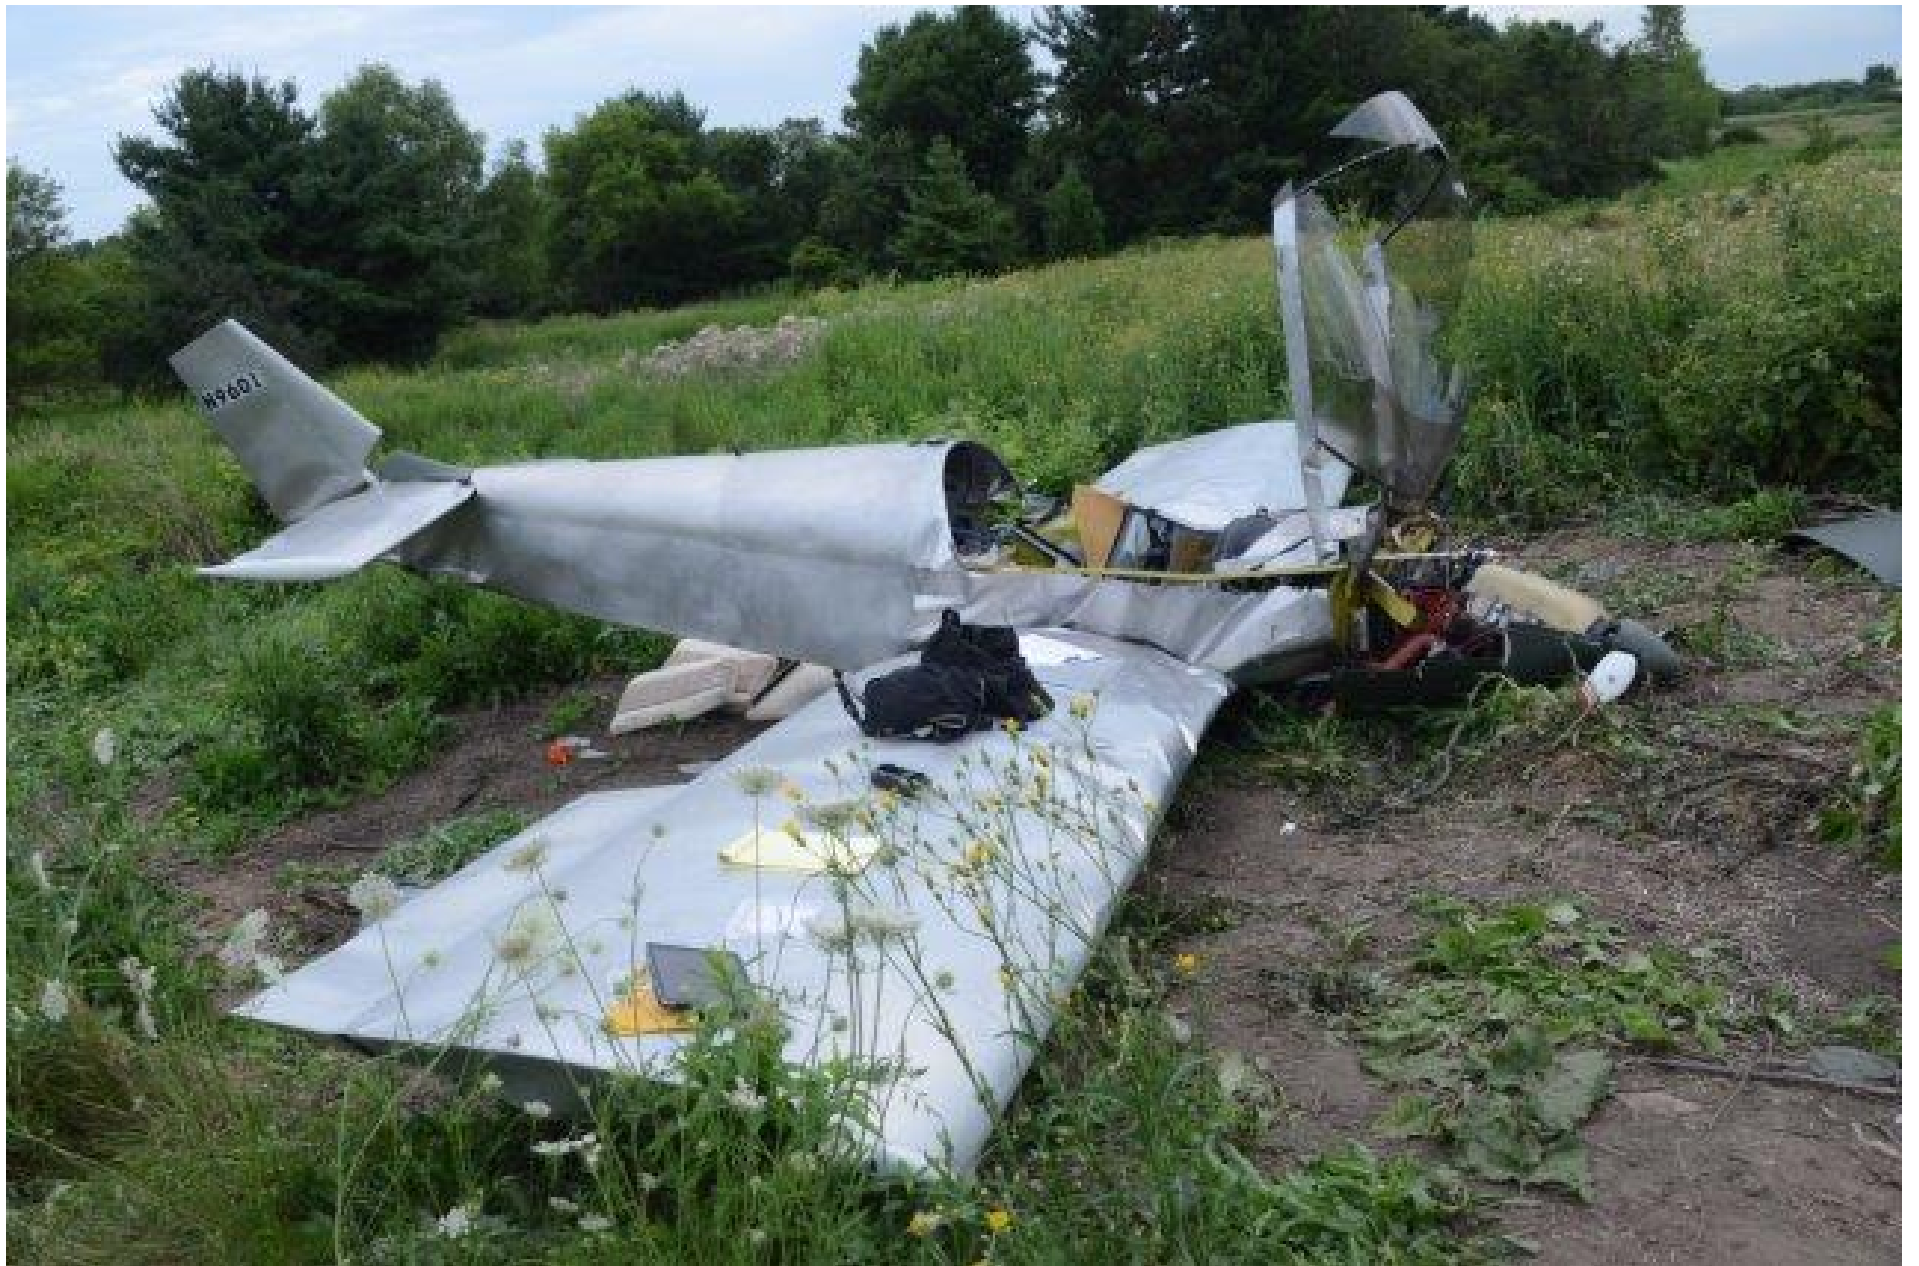
Photo 4 - View of the right side of the airplane.

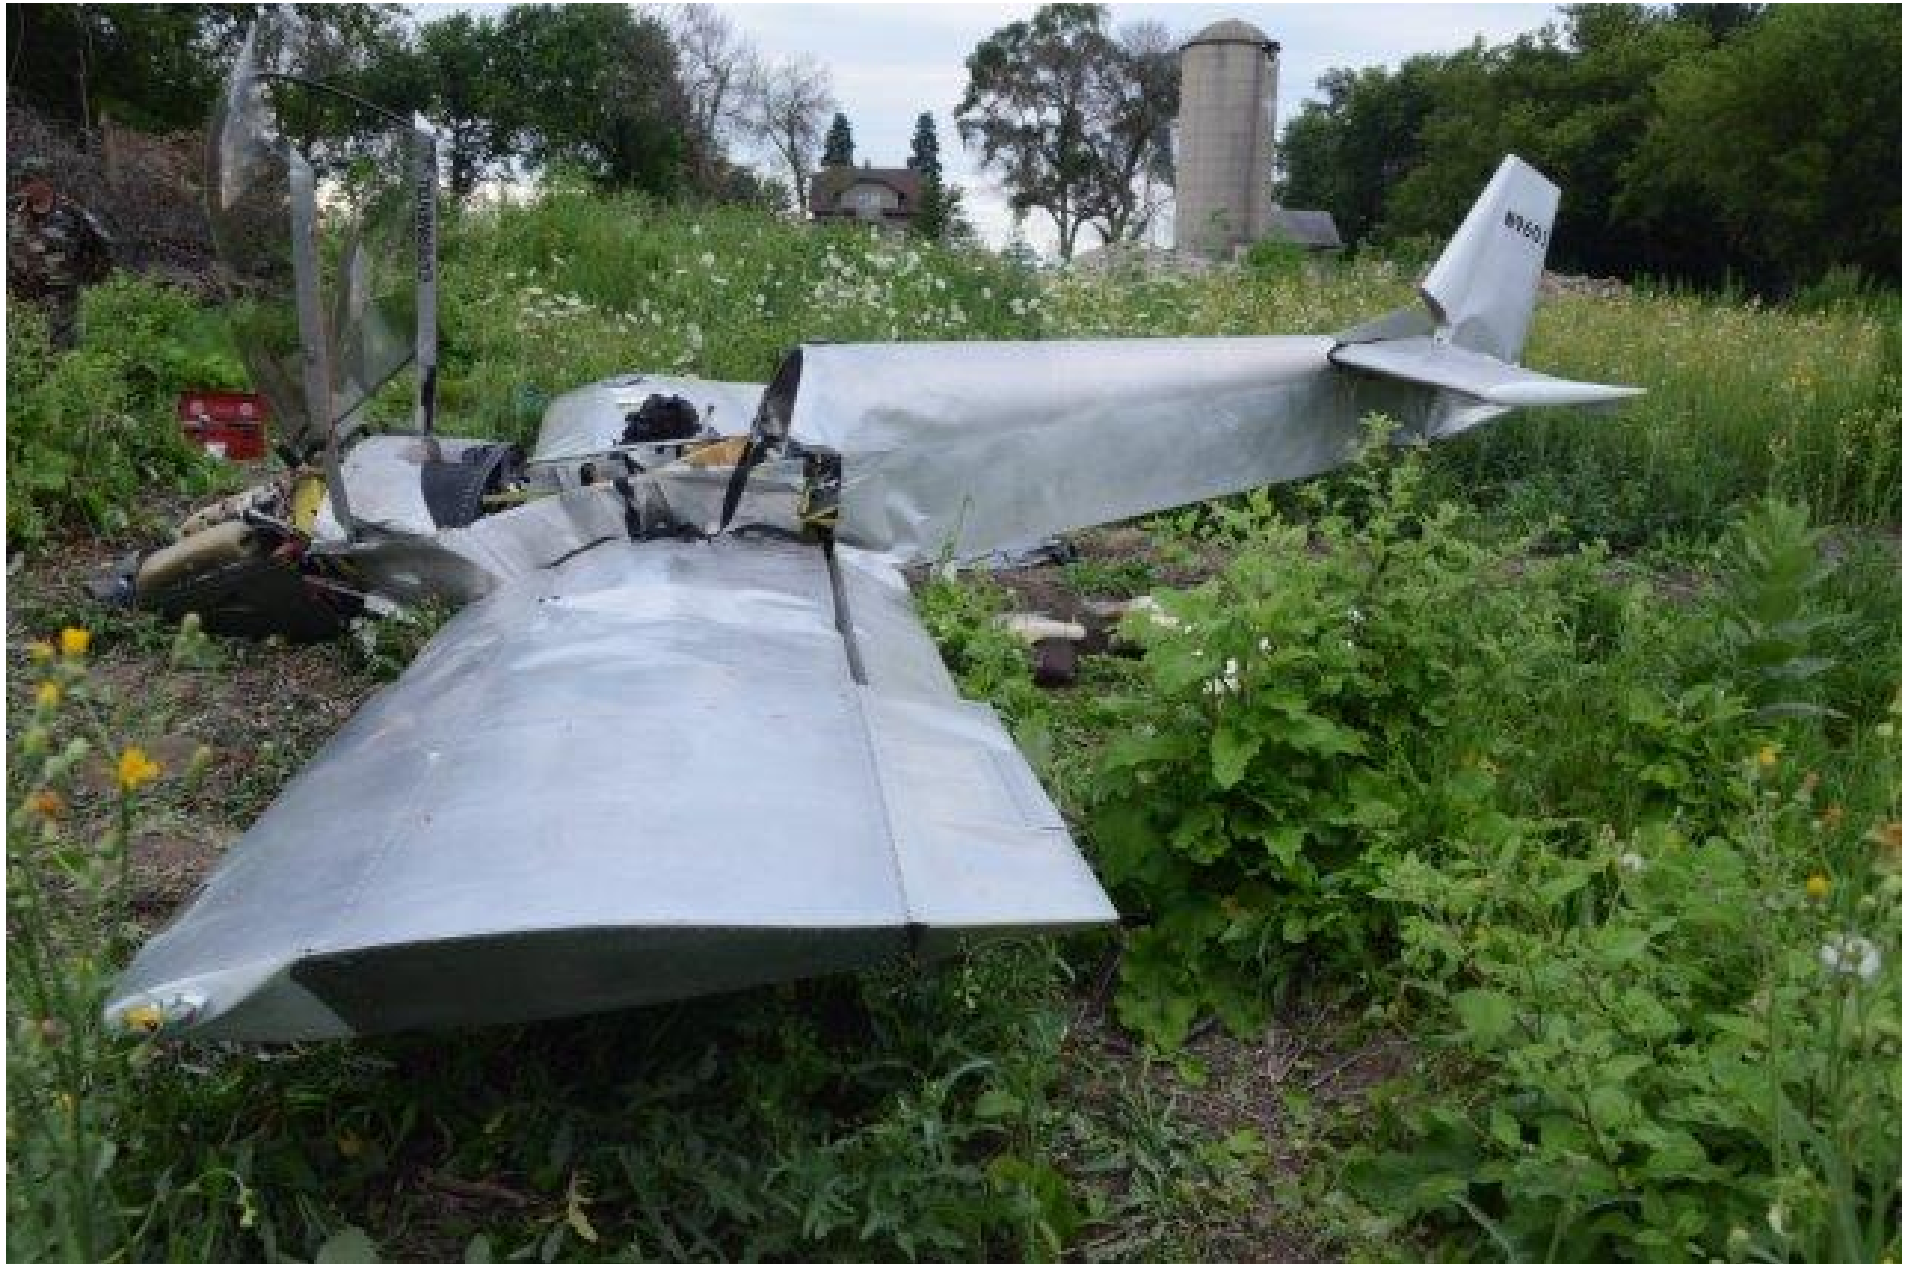
Photo 5 - View of the left side of the airplane.

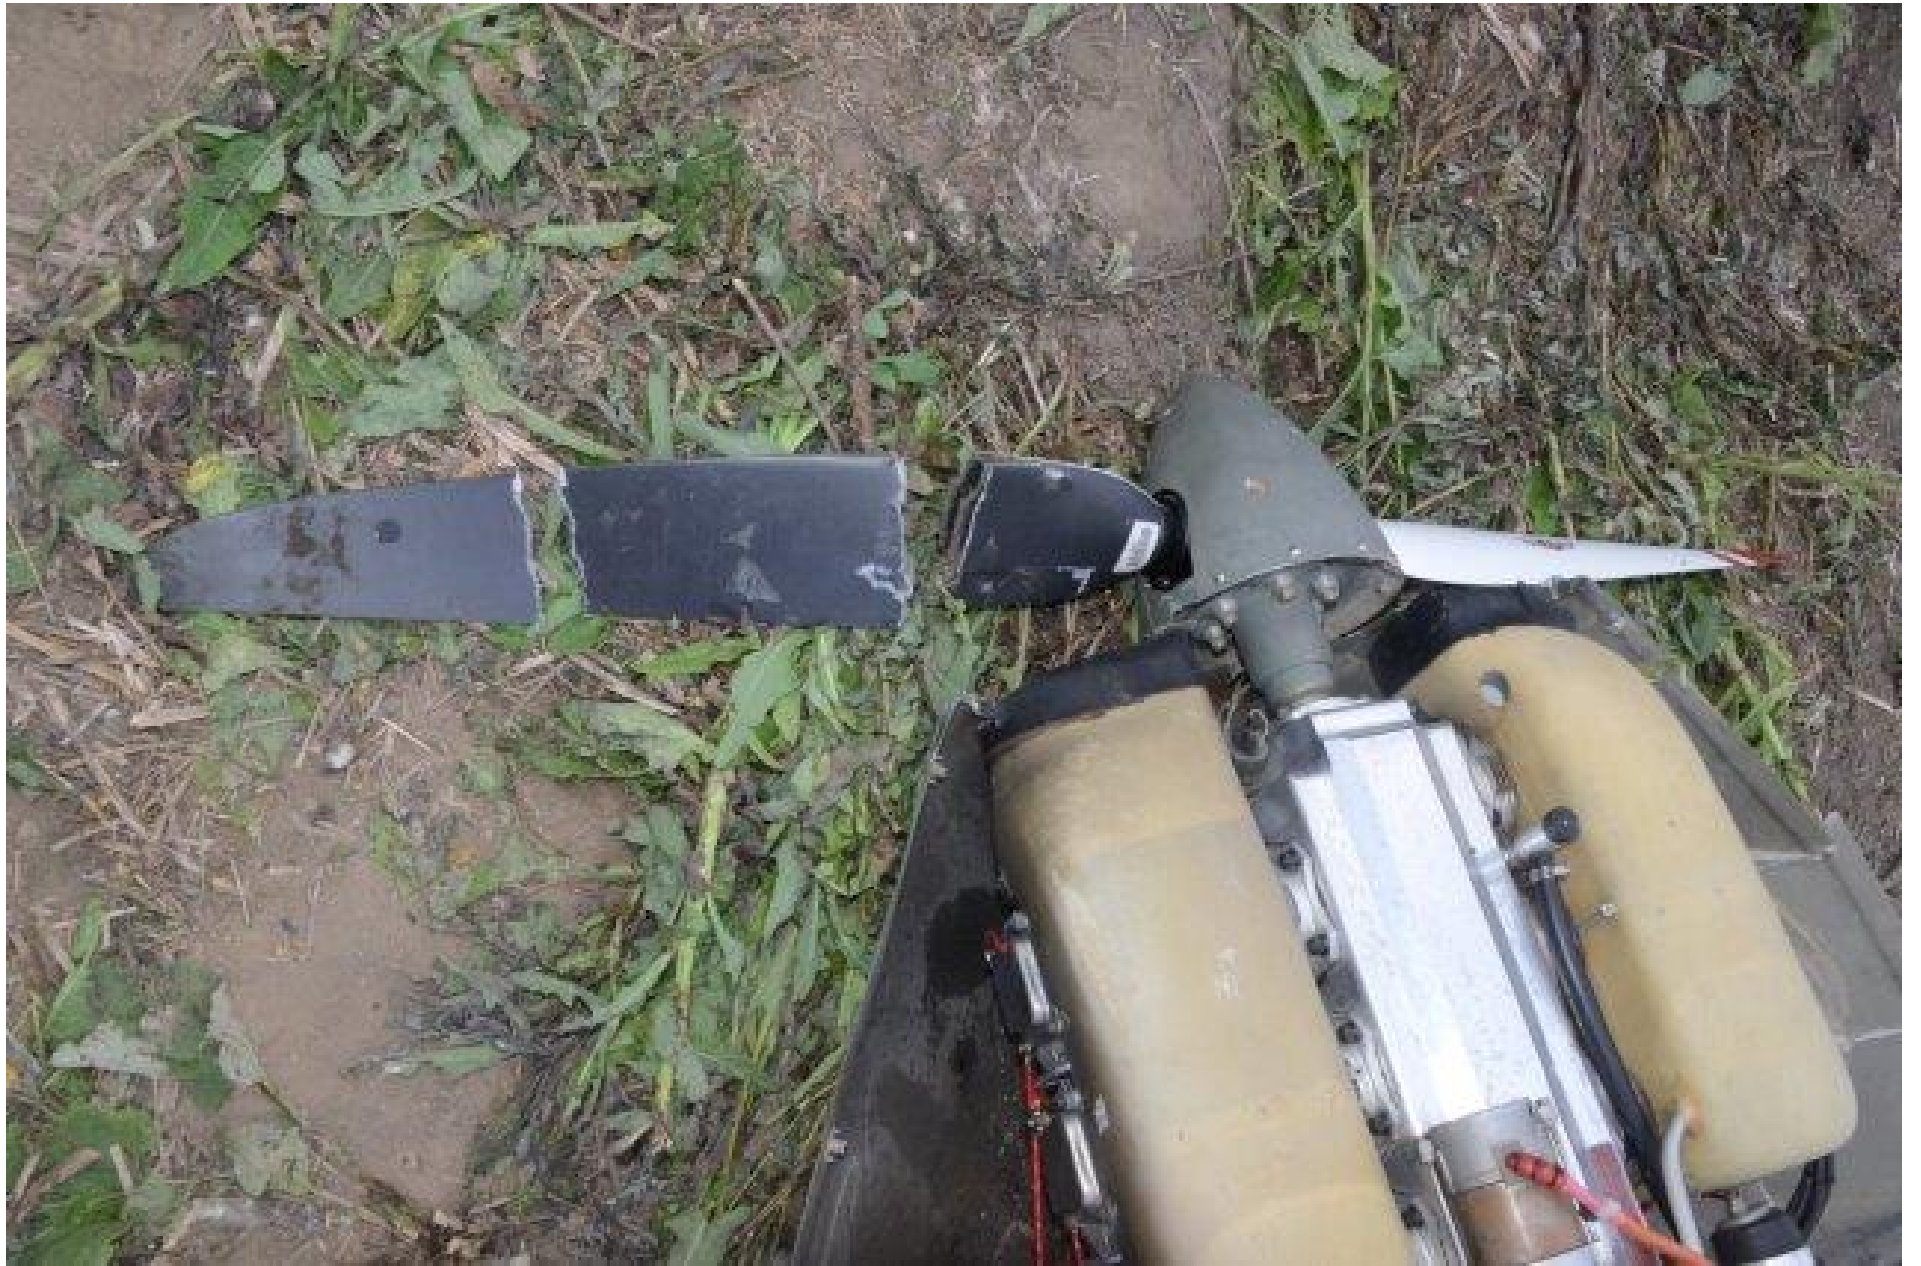
Photo 6 - View of the propeller.

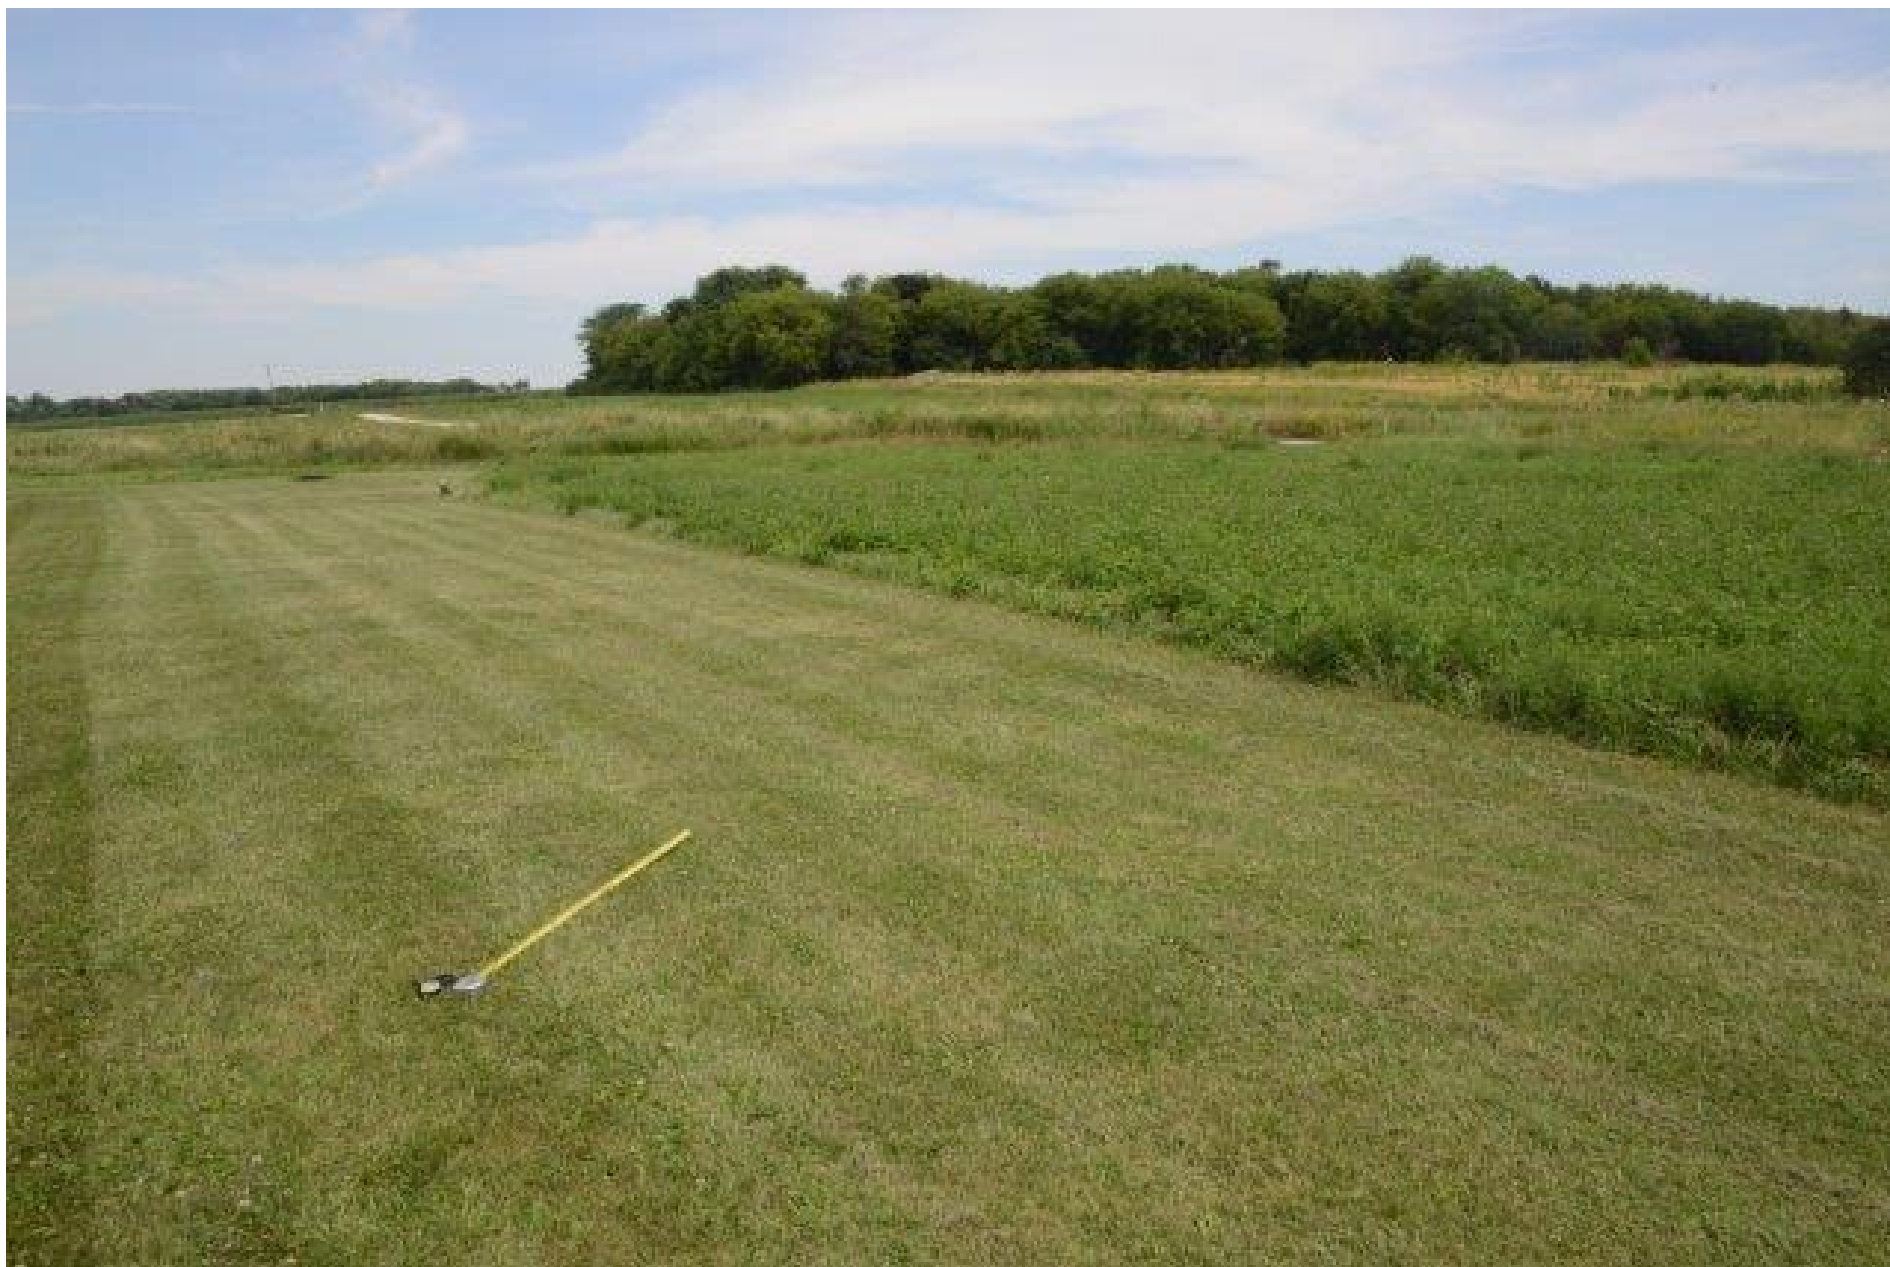
Photo 7 - View from a nearby runway towards the accident site.

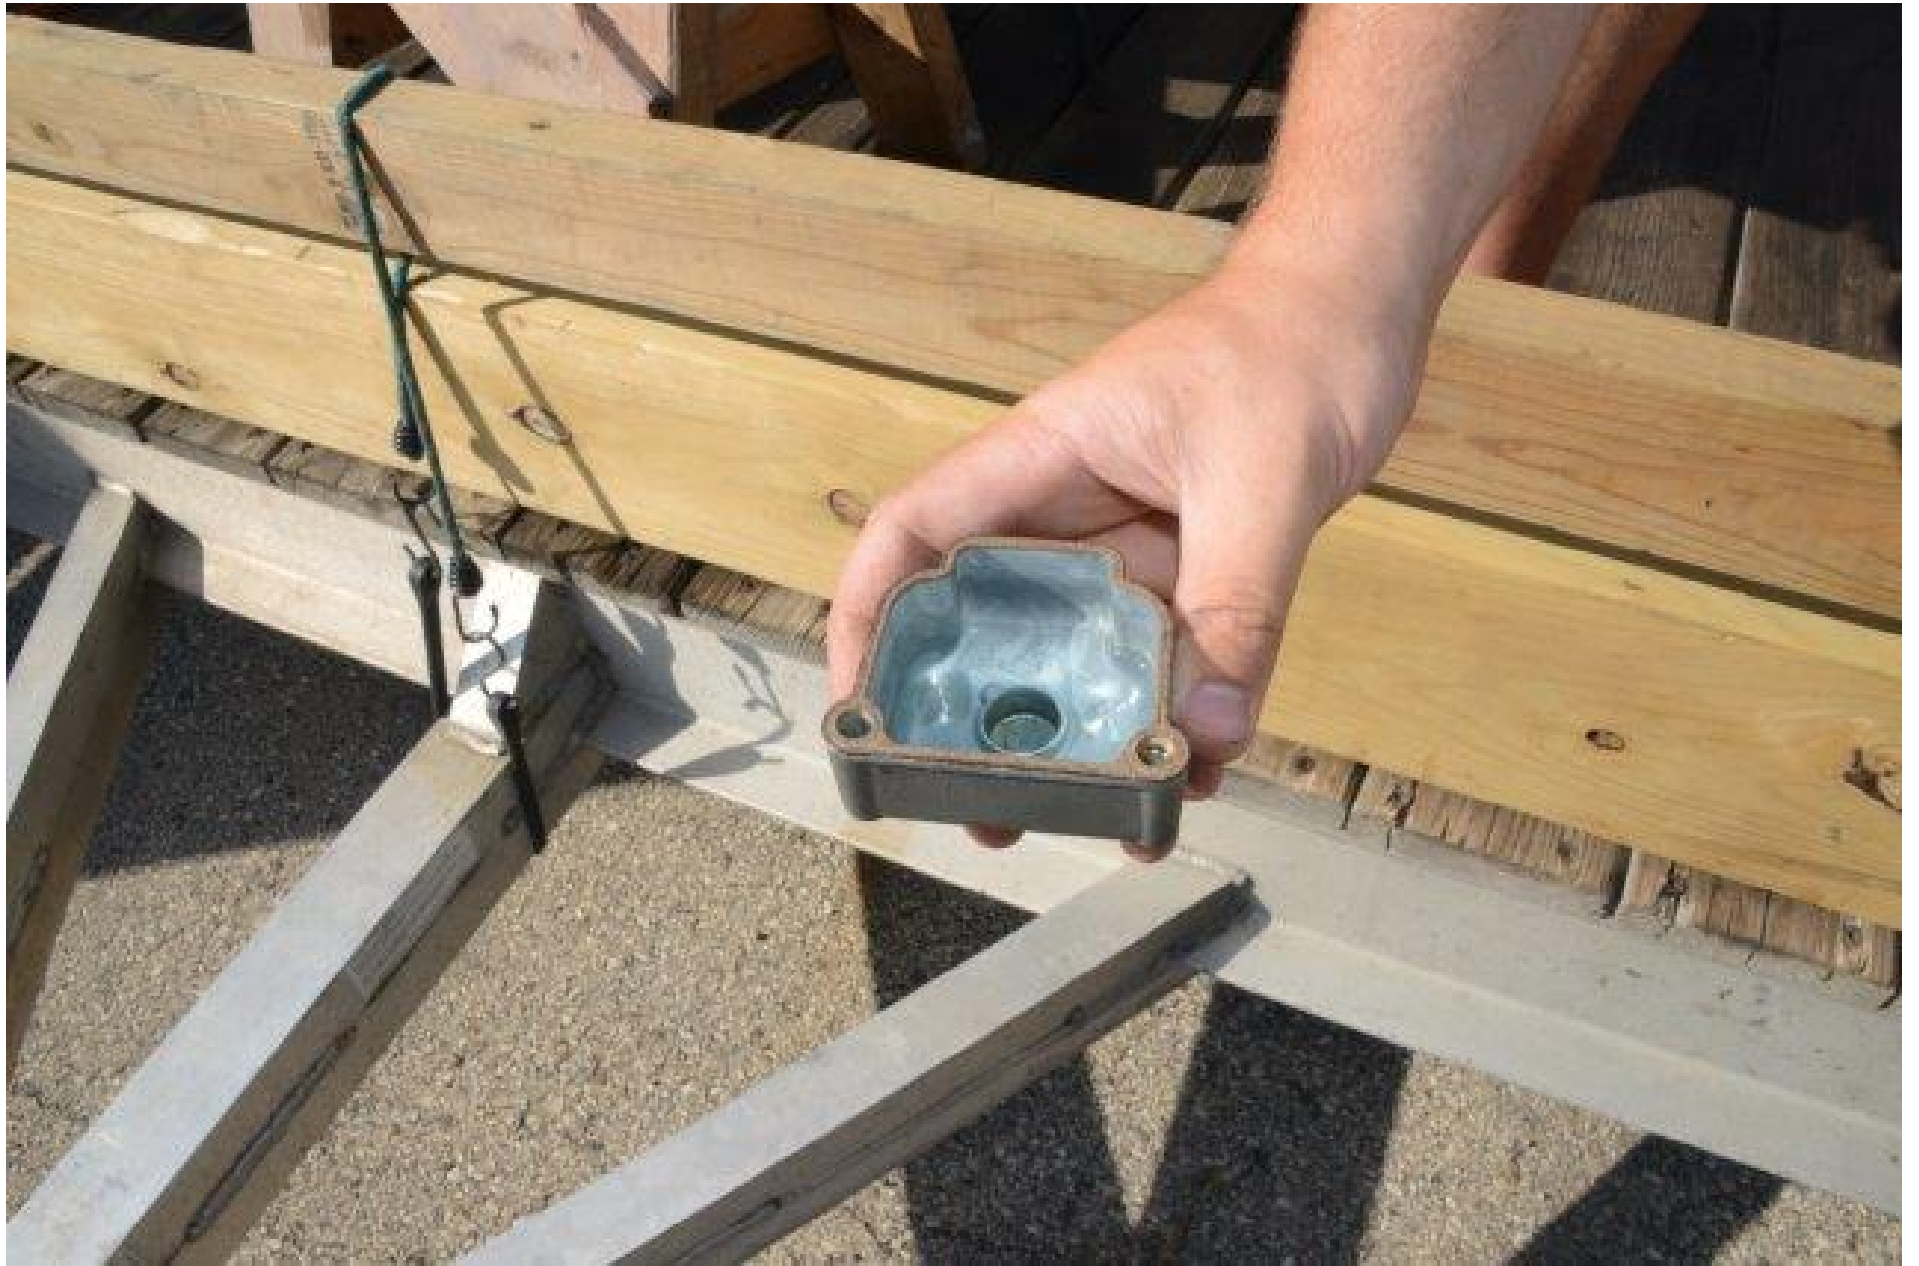
Photo 8 - View of the carburetor bowl with a blue liquid in it.

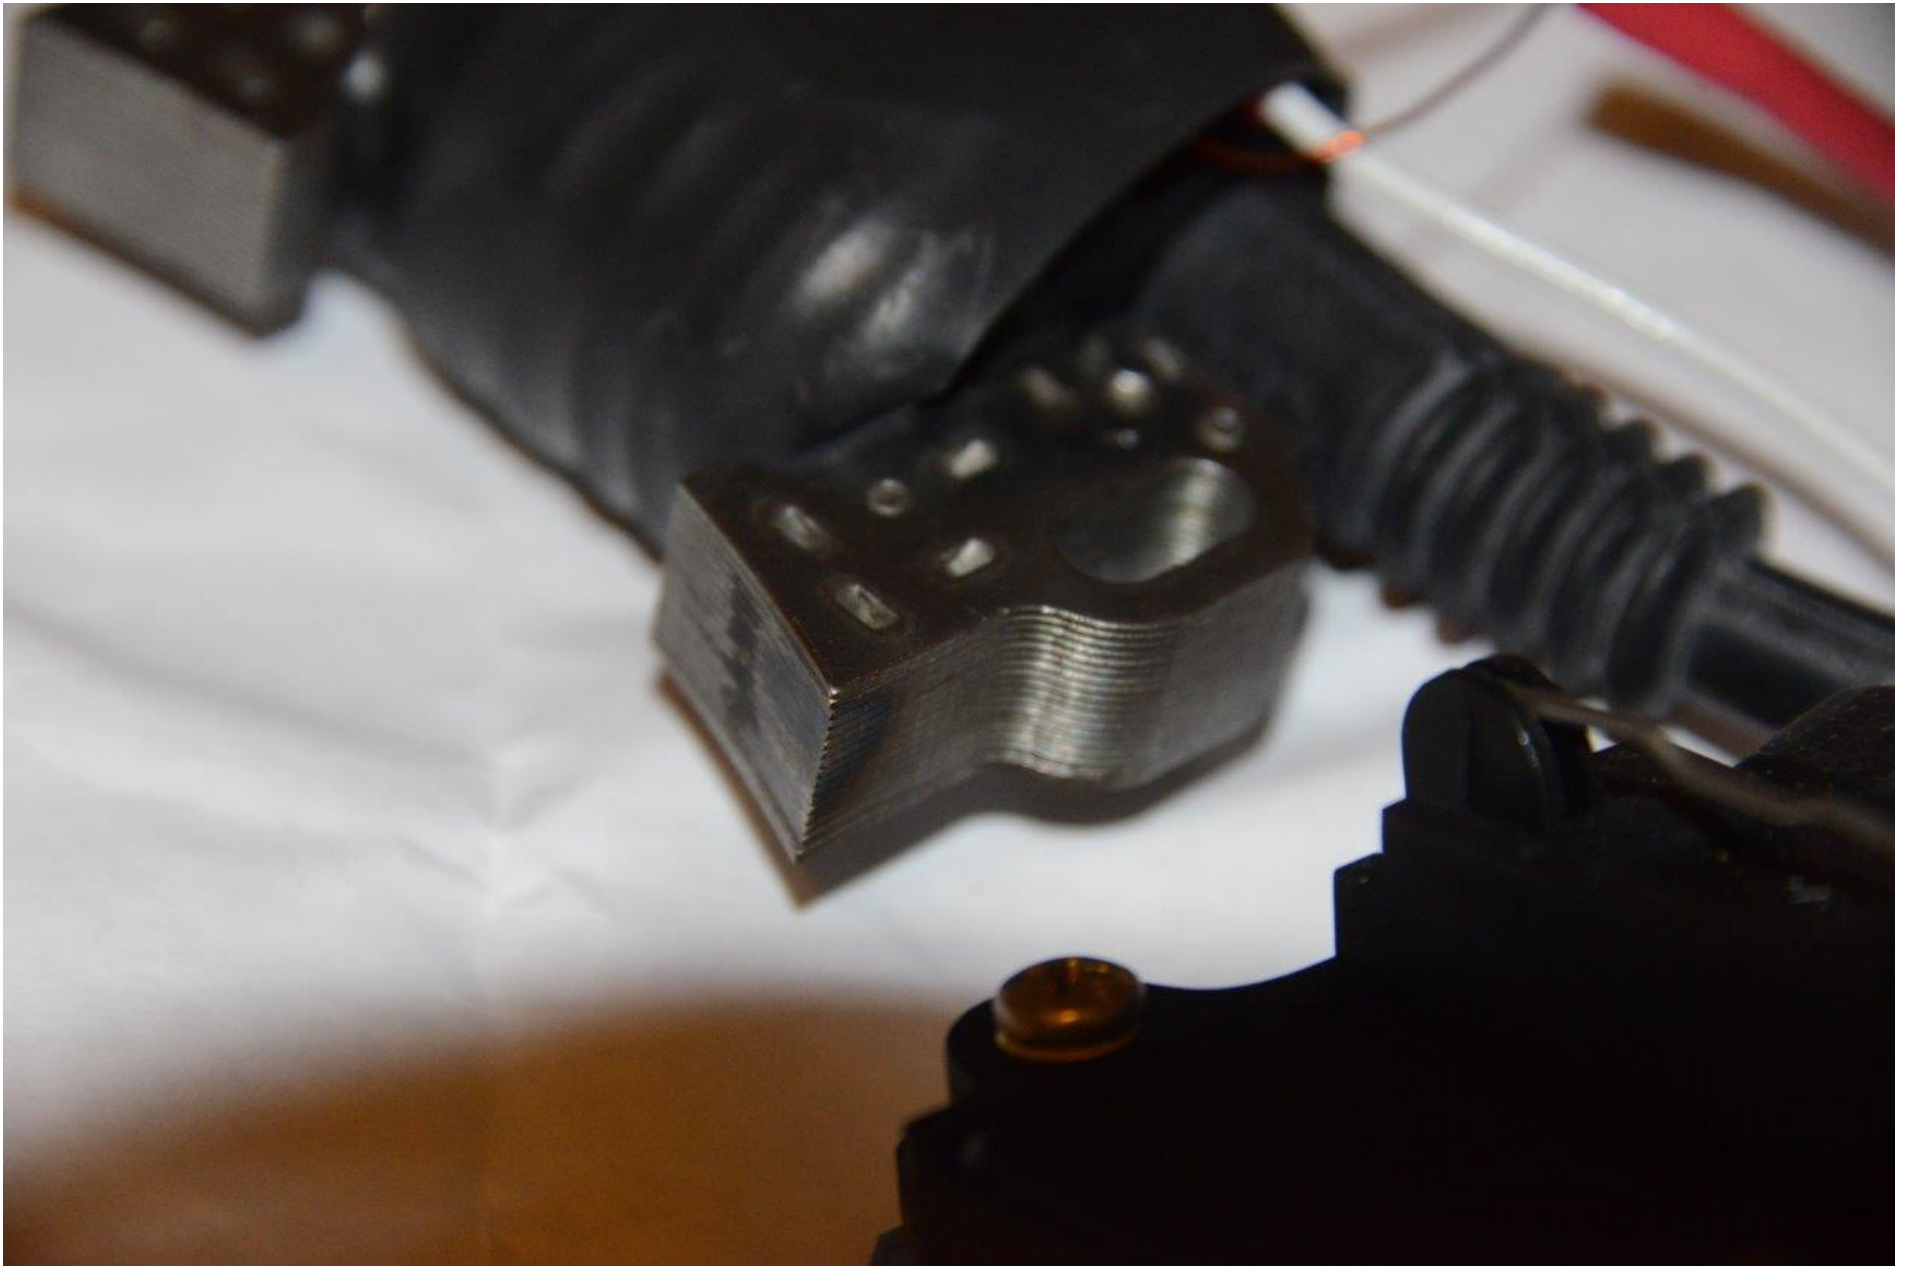
Photo 9 - View of a magneto reported to have been installed on the accident airplane.
